BONDS MILL CHANNEL, RIVER FROME

ARCHAEOLOGICAL MONITORING OF GEOTECHNICAL TEST PITS

commissioned by The Environment Agency

June 2016

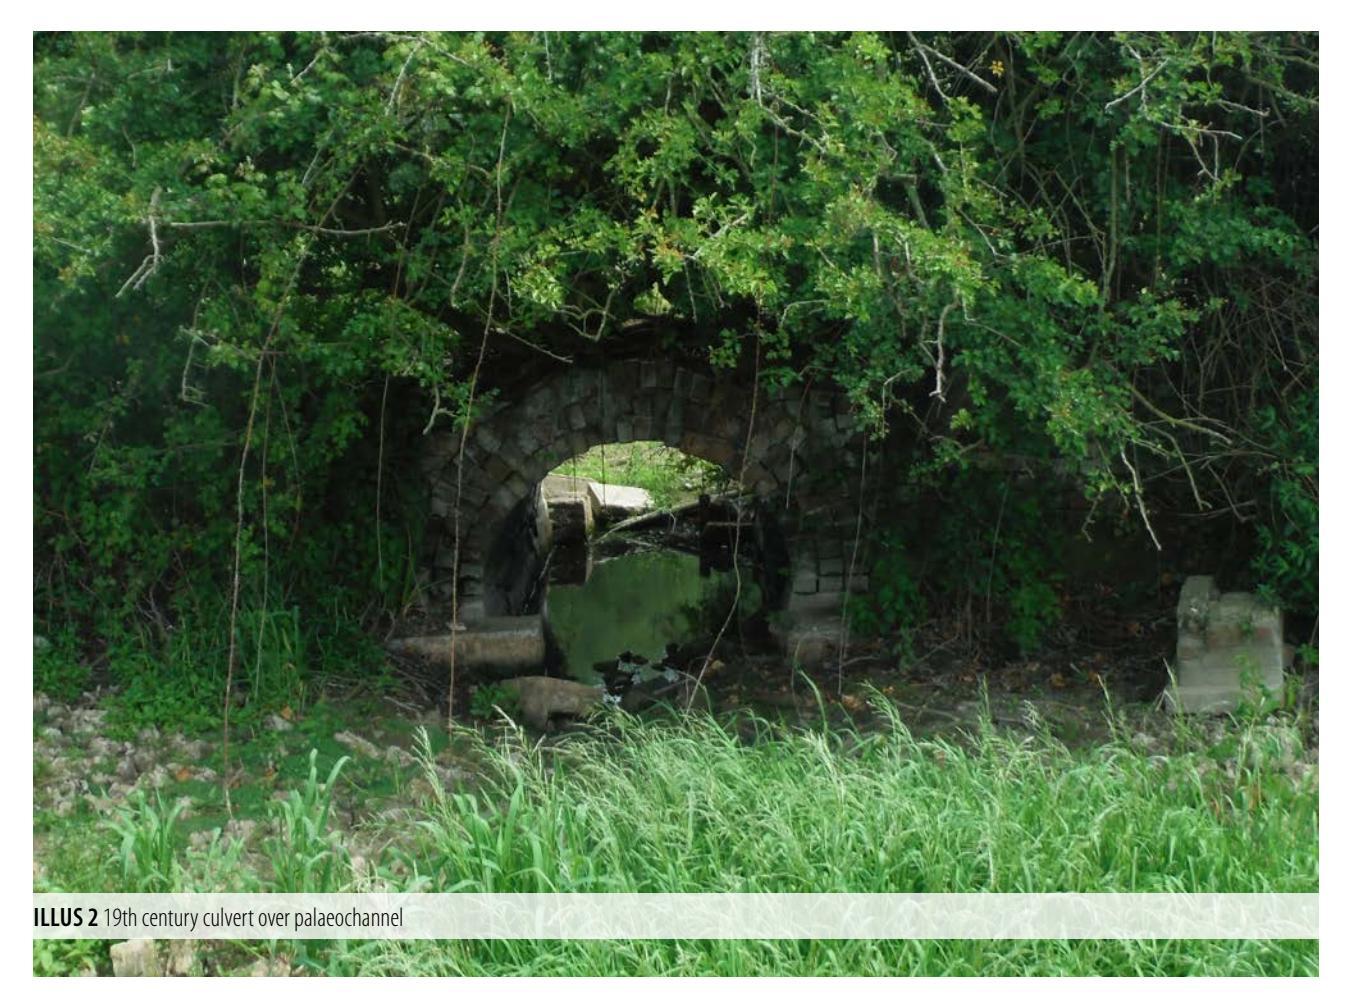
Culverts were constructed over the active channel in the nineteenth century (Illus 2). Water control structures appear both up- and downstream of the culvert in the form of grooved concrete upstands that appear to be able to take sluice boards. These are likely to have been used to control the flow of water within the channel, whether for stock watering or for the needs of the mill downstream. It is unclear exactly when these were installed.

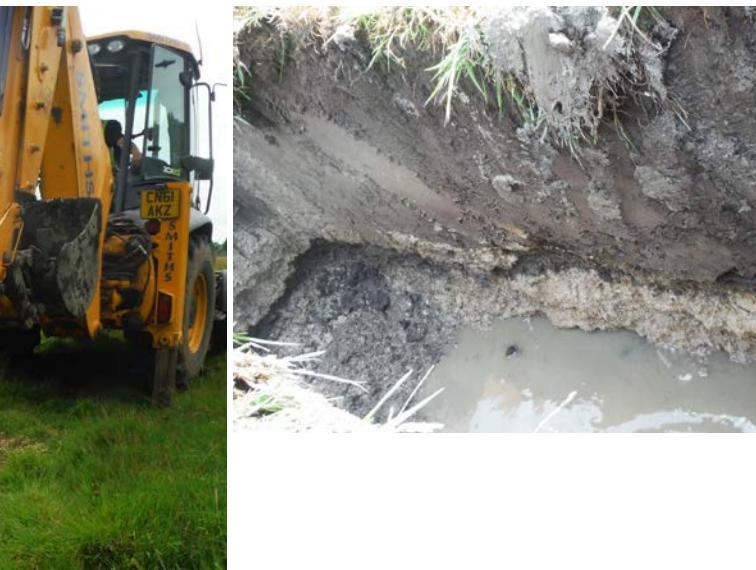
ILLUS 3 View of excavator at Test Pit 4 in Area 2 of the palaeochannel ILLUS 4 View of Test Pit 2 showing the light gravels at the base of the channel (2006)

Archaeological monitoring of the site was conducted on the 24th of June 2015. The works comprised machine excavation of six test pits. Each test pit was 2m in length and 0.6m in width and between 1.5m to 2m in depth, excavated at designated investigation points along the palaeochannel using a mechanical excavator equipped with a flat edged bucket (Illus 3).

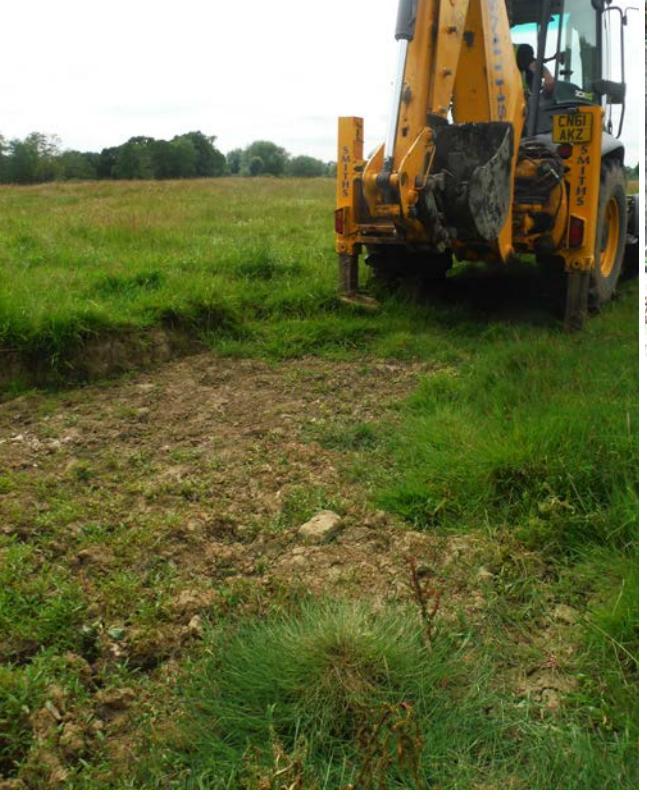
A dark brown greyish silt layer was observed in each test pit to a depth of 0.10–0.20m below ground level (BGL). This overlay a subsoil horizon of damp, grey, silty organic rich clay, which was interspersed with brown sandy clays, to a depth of 0.75–1.0m BGL. This layer was rich in decaying organic material and highly disturbed by roots. The underlying channel base was observed to be a generally well sorted white limestone gravel horizon. In Test Pits 1, 2, 3, 4, and 6 the base of the white gravel horizon was not reached because of the rising high water table, but in Test Pit 5, which was progressed more quickly, the base of the white gravel horizon was found at a depth of 2m. Beneath the white gravels in Test Pit 5, the dark blue Charmouth Mudstone bedrock was identified. The water table appears to lie at

the base of the organic rich clay layer above the well sorted gravels at approximately 0.80–1.0m BGL (Illus 4).

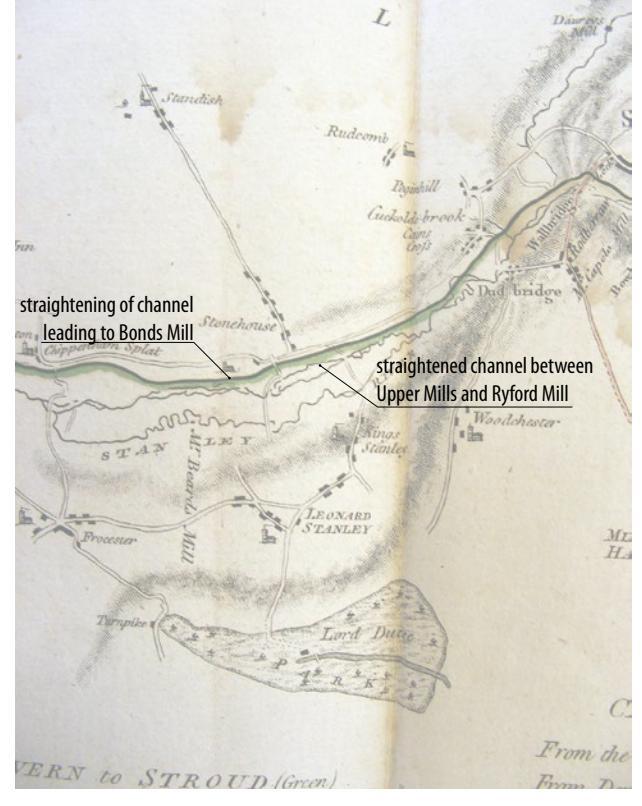
ILLUS A3.1 A Plan of the Thames and Severn Navigation Laid down from Actual Surveys by Rob Whithworth Engineer 1783

The 1783 plan (Illus A3.1) shows the channels relating to Bonds Mill as well as meanders in the southern arm of the River Frome downstream from Beards Mill. It seems unlikely that the map makers would have gone to both the trouble of mapping these, whilst at the same time omitting the straightening of this section, and therefore it seems reasonable to presume that this section of river was straightened after the date of the map. This appears to have happened by the early 19th century and the time of the Tithe map (Illus A3.3). Here some of the old meanders have been recorded on the tithe even after straightening of the river course. The northern section of the Frome is clearly straightened as far as Lower Mills. Interestingly the plots of land above both mills are referred to as Rack Hill, with a plot at the west end giving away its former function with the name 'Brick kiln Ground'. On the northern leg both the new artificial channel and the original one appear to be active (based on the dashed lines used for inactive channels on the southern water course).

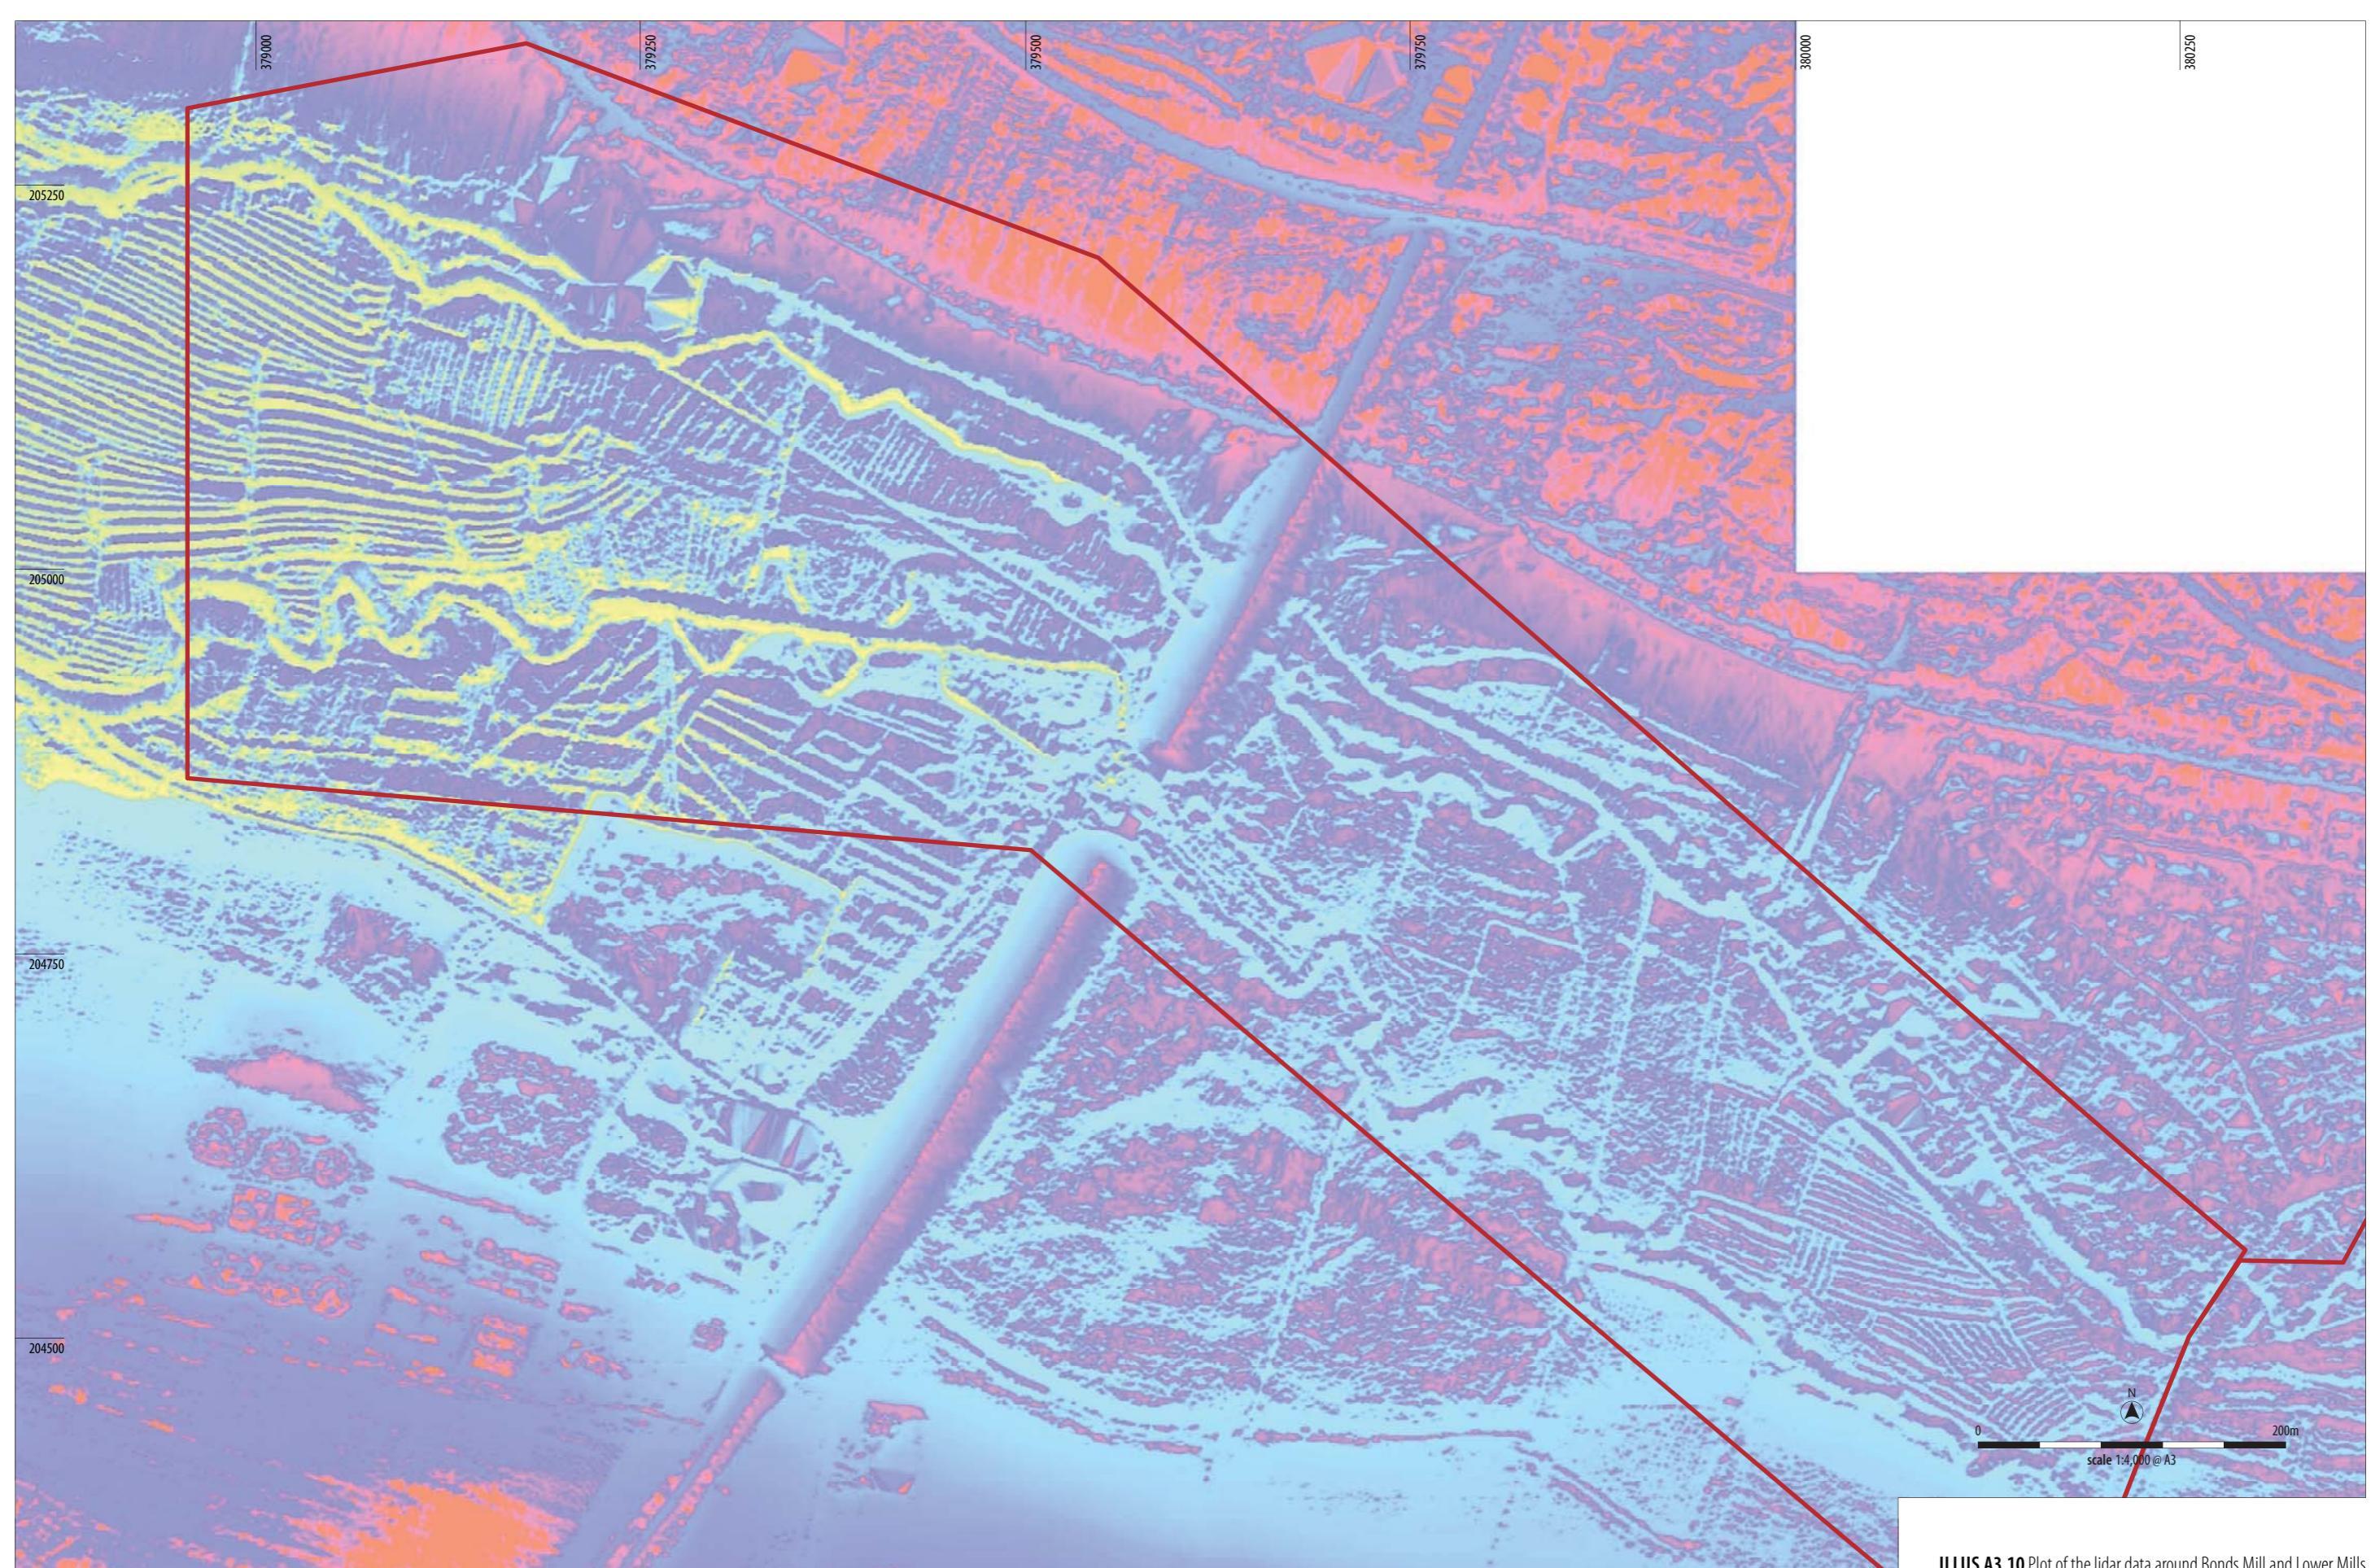
ILLUS A3.10 Plot of the lidar data around Bonds Mill and Lower Mills

The LiDAR data again clearly shows the outlines of open field systems in the valley bottom as well as the lines of former meanders of the river. Later drainage has again been introduced across these field systems to enhance drainage in the area. The complexity of former drainage systems in the area is clearly depicted in Illus A3.8, along with changes to the lines of former river channels.
