Bradbourne Mill, Bradbourne, Matlock

Watching Brief Report

ARS Ltd Report No. 2007/67 October 2007

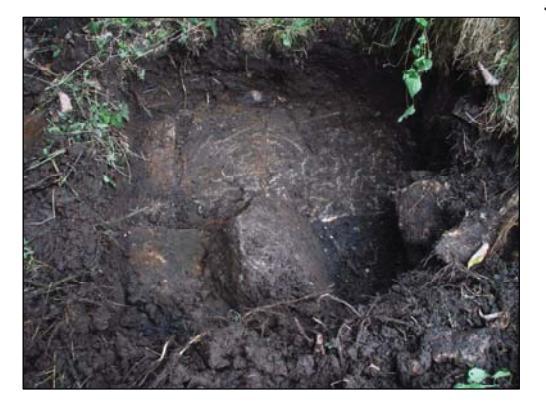
- 5.1.2 The soil and underlying sediments were all of natural origin and no archaeological remains or horizons were evident. The excavation of Flood Plain A did reveal a section of stone floor; this was an element of the west weir (Fig 3). The whole of the weir is to be exposed and retained in situ.

Fig. 3, Section of the west weir stone floor

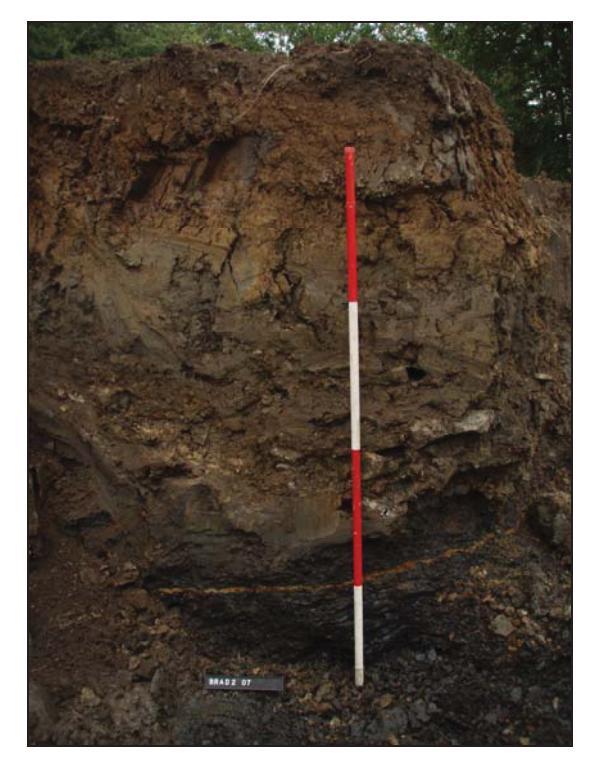
- 5.1 Excavation of the flood plains
- 5.1.1 Flood plains were excavated on the north and south banks of the brook to allow the dispersal of water in the case of a flood (Fig. 1). Flood Plain A was excavated between two weirs to the west of Barn B. An area of land was levelled northwards to a maximum width of 14m from the brook, and 0.3m above the water level. The ground was then sloped at an angle of approximately 50° northwards to form a bank that ascended to higher ground approximately 3m above. The depth of the ground excavated between the two weirs was approximately 2.4m; its stratigraphy is described as follows and can be seen in figure 4. A medium black (2.5Y 2.5/1) topsoil (201) existed across the site and was between 0.1m to 0.3m in depth. Below the topsoil (201) existed a dark yellow (10YR 4/4) clay (202) that contained occasional sandstone blocks. The clay (202) was found across the site and had a maximum thickness of 0.6m. Below the yellow clay (202) existed a very dark greyish brown (2.5Y/3/2) clay (203) which was located approximately 0.6m below the modern ground level and was 1.1m thick. Below the grey clay (203) was a layer of dark grey (2.5Y 3/1) mudstone (204) that contained sandstone blocks measuring between 0.1m to 0.8m. The layer of mudstone (204) was located 1.8m below the modern ground level and was approximately 0.17m thick. Below the mudstone (204) was a layer of firm black (5Y 2.5/1) shale (205), located 0.9m below the modern ground level and was approximately 0.1m thick. Below the shale (205) there existed a thin layer of orange (7.5YR 4/6) sand containing medium rounded pebbles (206) which was approximately 0.01m thick. The sand (206) lay above another deposit of black shale (207) that was excavated to a thickness of 0.35m. The total depth of the shale (207) was not established as it extended beyond the limit of the excavation.

Fig. 4, Section showing the contexts relating to Flood Plain A (Scale: 2m).

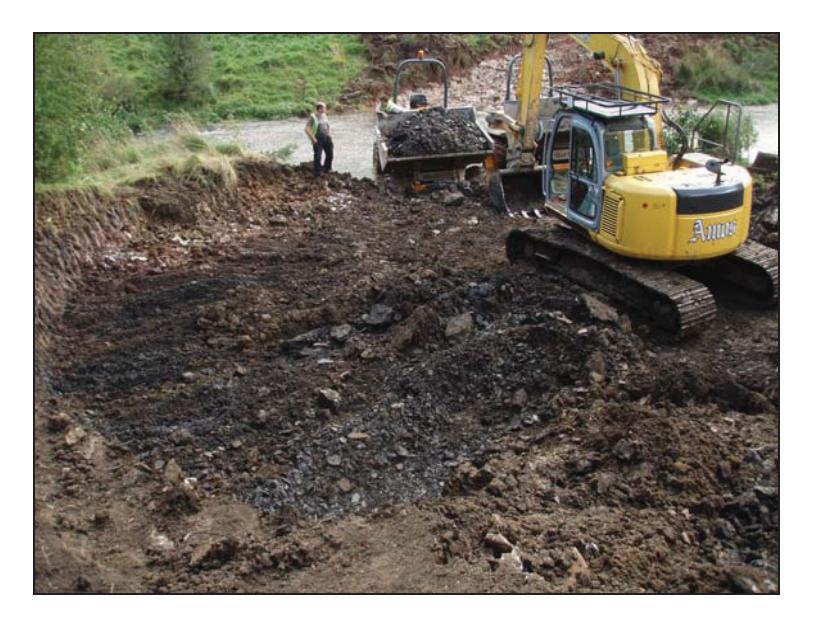
Fig. 5, Working shot of Flood Plain A under excavation (looking south west).

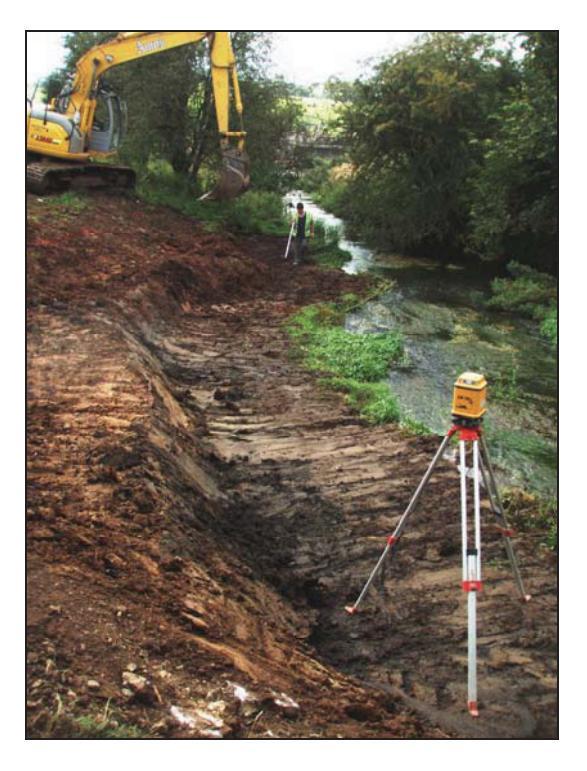
5.1.3 Flood Plain B was excavated on the south side of Havenhill Dale Brook, it was situated east of barn C and was approximately 135m in length (Fig. 1). The working plans required two terraces each measuring 2.5m in length to be excavated into the hillside, the ground would then be sloped off at 60° into the hillside. The plans were amended to protect established bushes and trees on the bank side, which did not allow the two terraces to be fully excavated.

Fig. 6 Assessing levels of the terraces on Flood Plain B

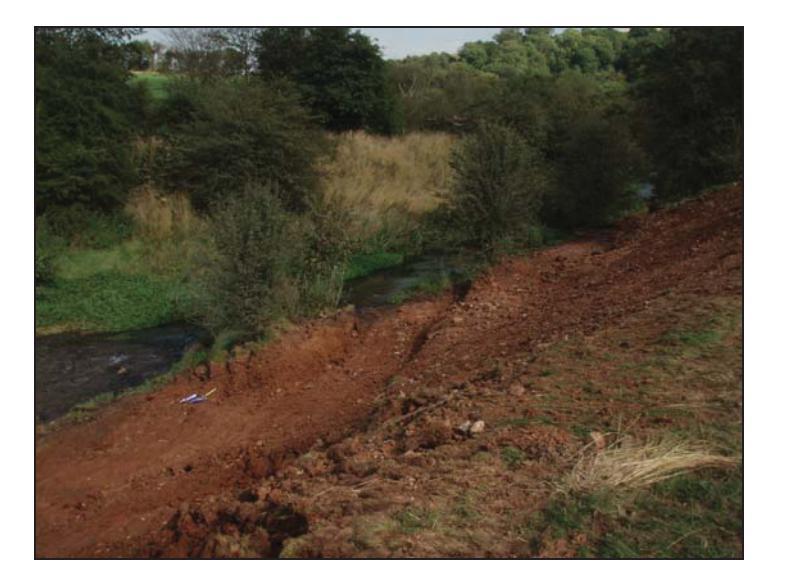
Fig. 7 Flood Plain B showing diversion around bushes and trees.

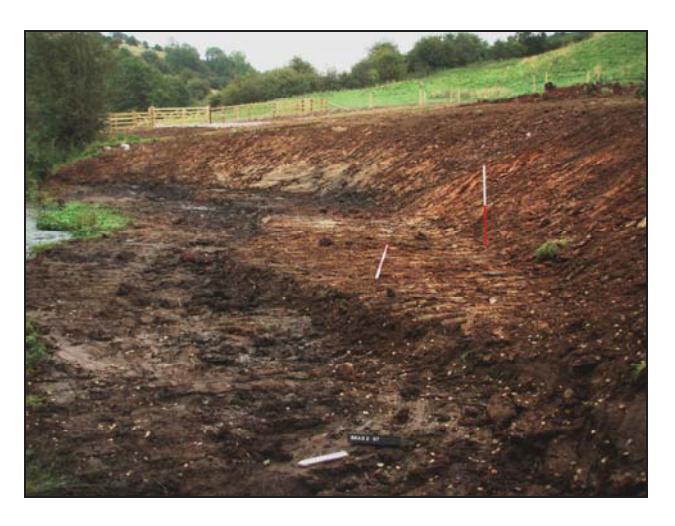
Fig. 8 East end of Flood Plain B looking east.

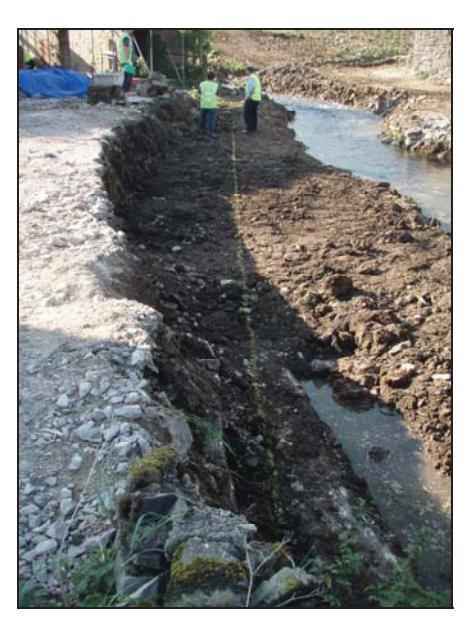
Fig. 9 Marking out line of Trench 1looking east

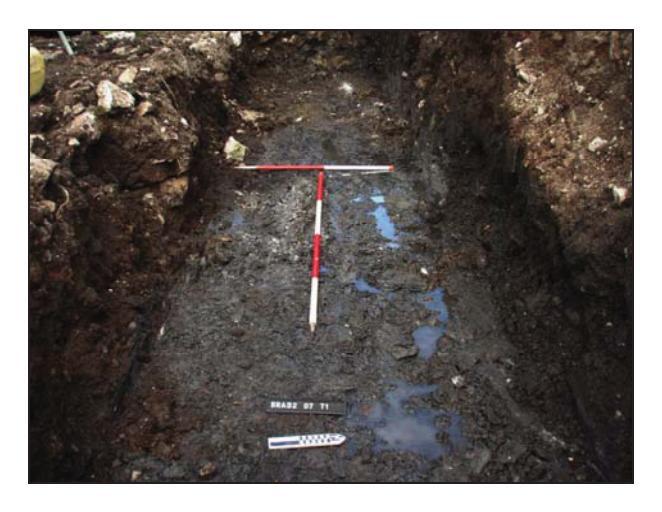
to 0.2m at its eastern extent. The trench was excavated to a depth of 0.85m; the first layer consisted of type one gravel and sand 0.2m in depth overlaying a dark brown clayey soil 0.25m deep. This in turn overlay grey/buff clay with small pockets of orange clay 0.4m deep with mudstone appearing at this horizon. From this level a trench 0.5m deep 1.9m wide was excavated which extended further into the mudstones and shales (Fig. 10).

Fig.10 Trench 1 looking east (scale 1 & 2m)

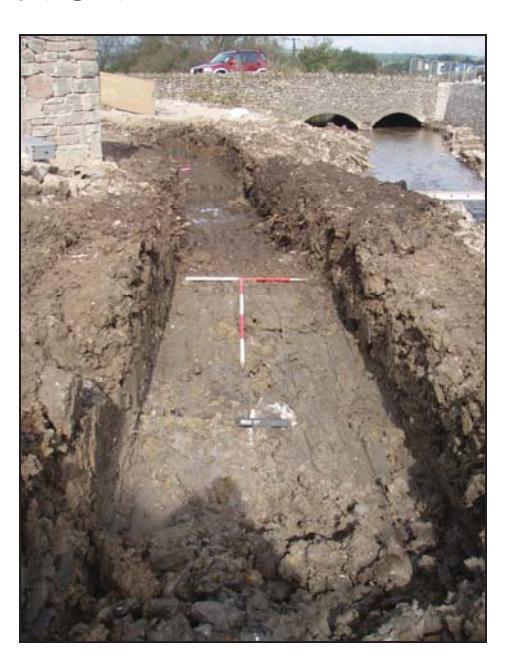
5.2.2 Trench 2 was located south of the brook and north of barn C (Fig 1). The surface area again consisted of type one gravel. After removal of this layer dark brown subsoil containing sandstones and tree roots was revealed, this overlay the grey/buff clay as found in trench 1. The trench was excavated to a width of 1.3m with a variable depth between 0.5 and 0.9m. At the western section of the trench mudstone and shales were exposed, while towards the east, the horizon became the grey/buff clay (Fig 11).

Fig. 11 Trench 2 looking west

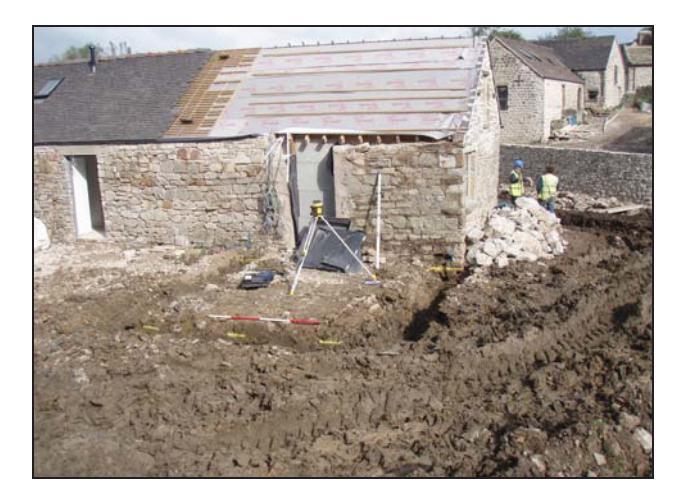
Trench 3 excavated to the rear of barn C, was excavated to accommodate the footings for an extension to be attached to the barn seen in Fig.12. The trench was excavated to a width of 1m x 0.9m deep and terminated in a layer of grey/buff clay.

Fig. 12 Trench 3 extension to barn C

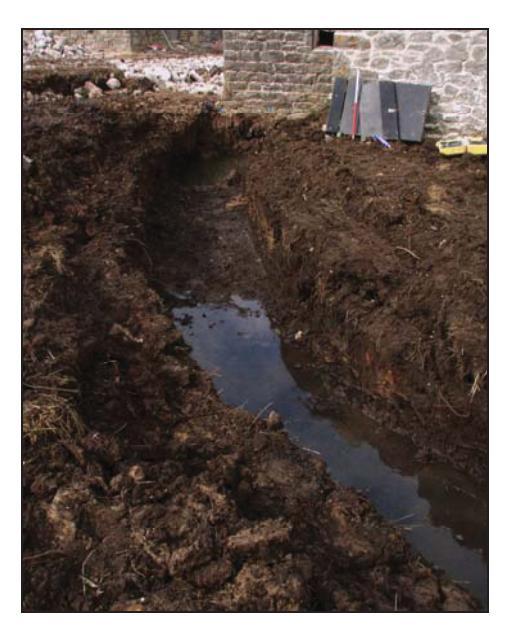
5.2.3 The flood defence system was completed with the excavation of trench 4, which was situated on the north bank of the brook and abutted barn B (Fig 1). A bank of clay and soil was deposited in the brook to allow the excavation of a trench in this section (Fig.13). Curving from the west wall of barn B the trench extended northwards until it abutted the existing west wall of the west weir, to which the flood wall will be tied. Soil and clay was excavated down to mudstone and shale, with a band of poorly sorted sandstone rocks encountered in the northern section of the trench. The trench was 0.6m to 0.9m in depth and 1.4m wide to within 1m of the existing weir wall where it was reduced to 1m in width.

Fig. 13 Trench 4 cut into redeposited soil and clay
