Land at St Stephen's Place, Trowbridge, Wiltshire

Archaeological Evaluation Report

Ref: 79561.02

December 2011

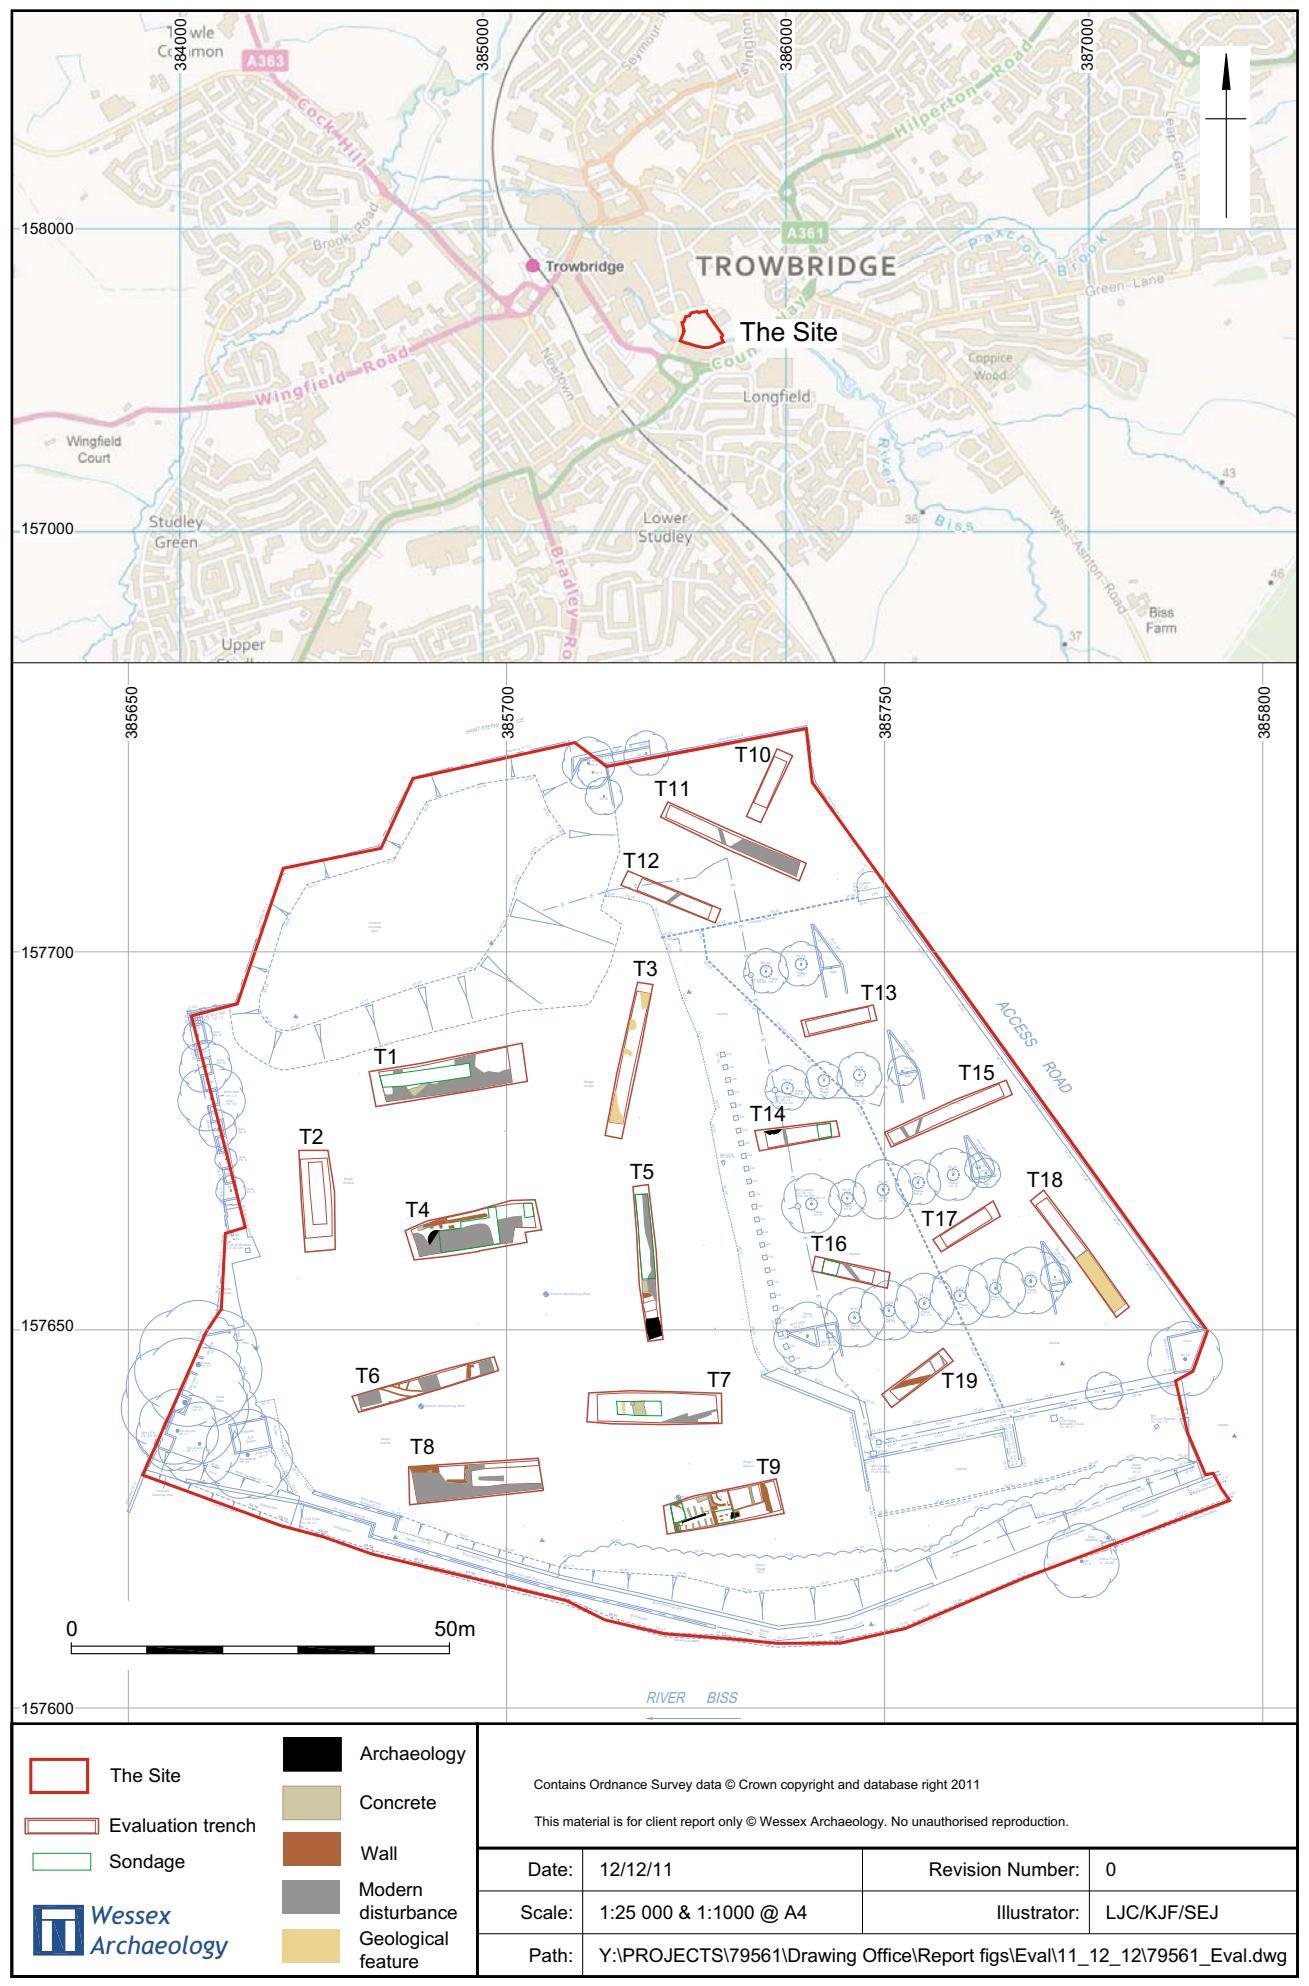
Site location; trenches and archaeology

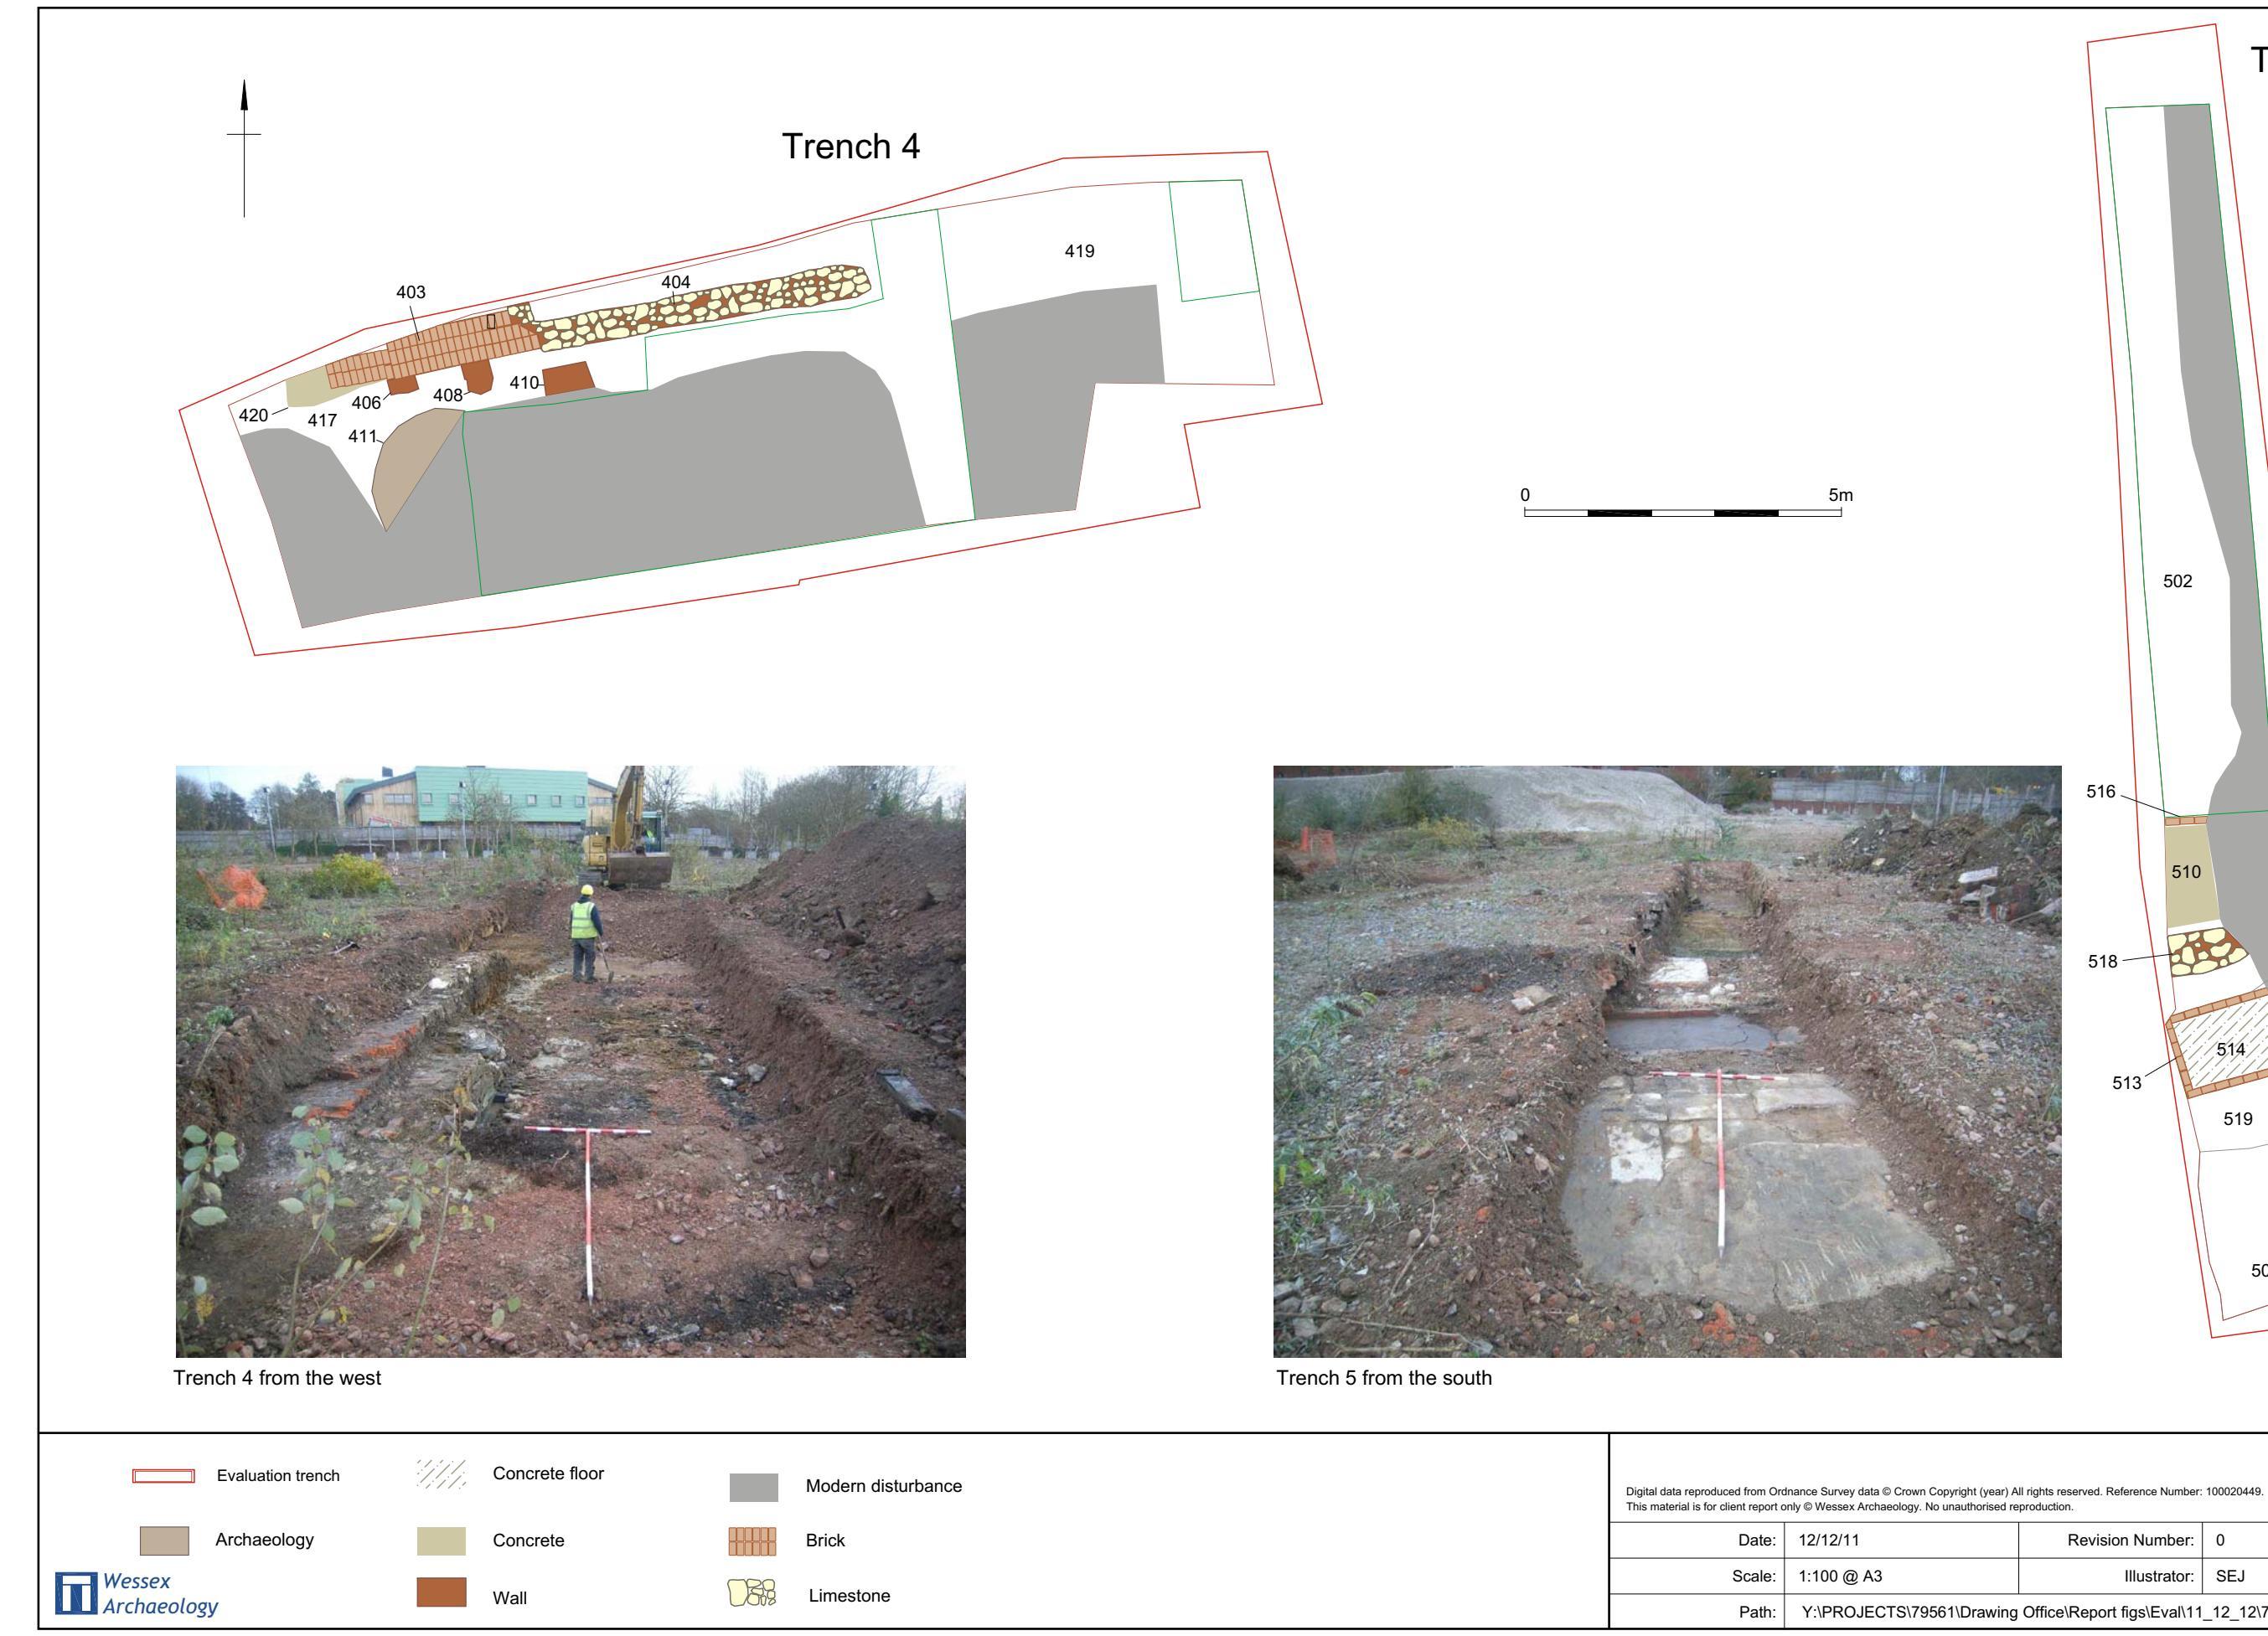
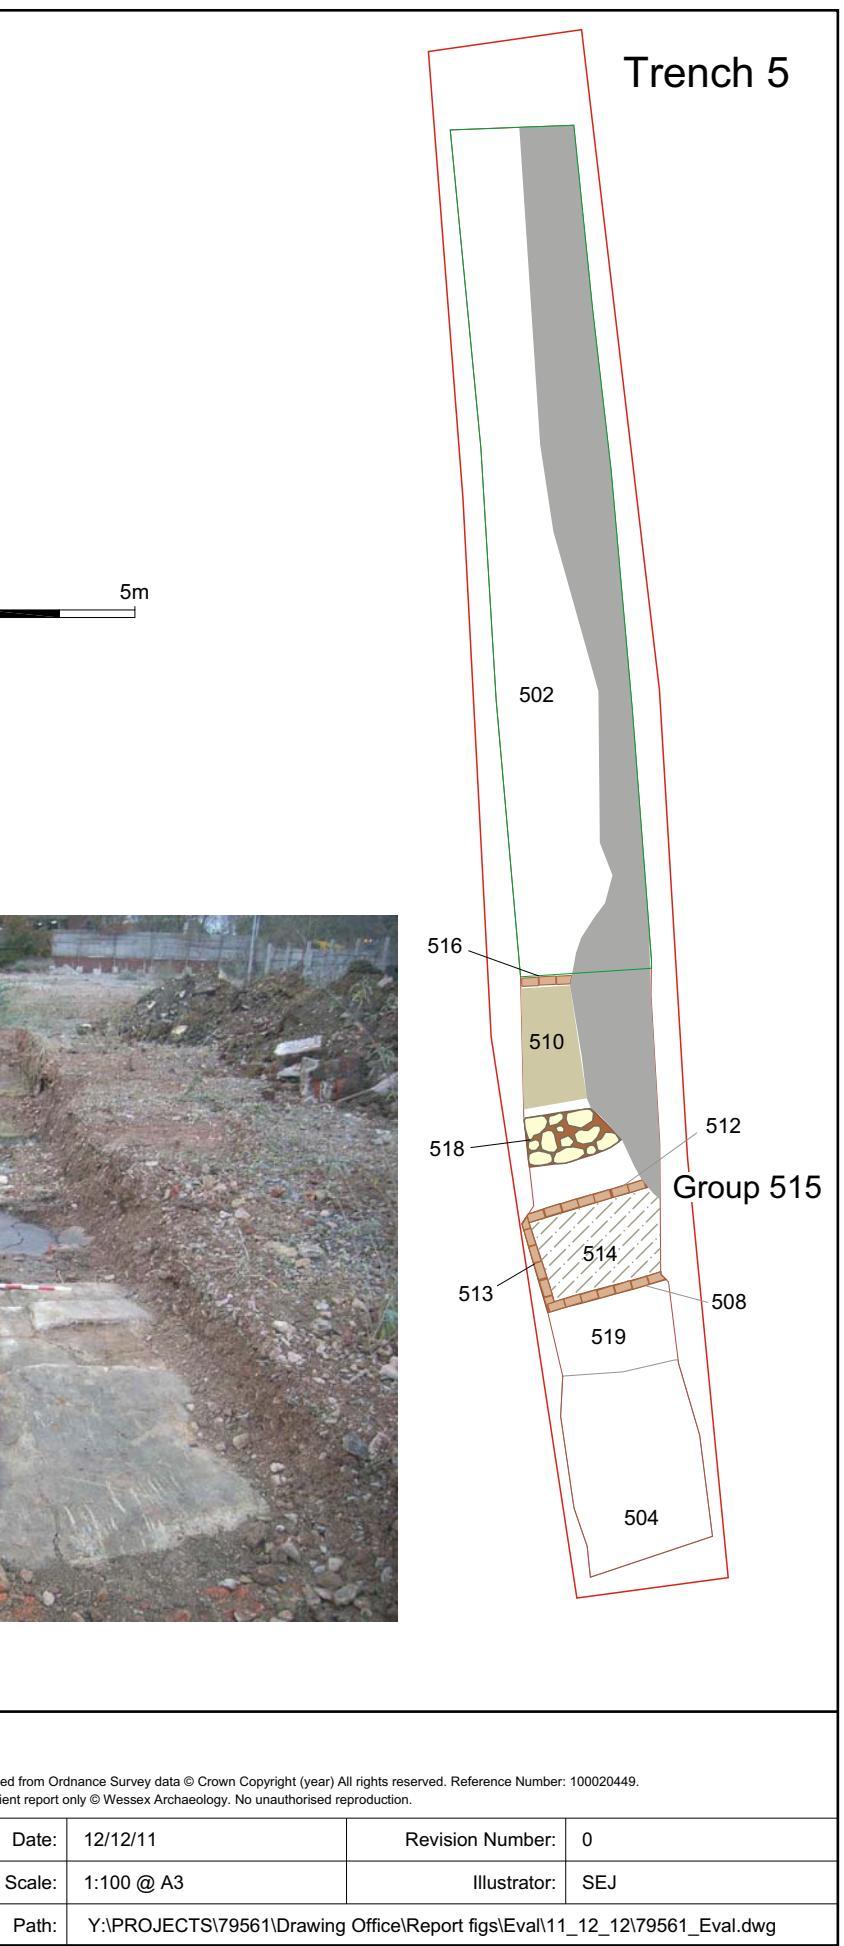
- 7.6.1 **Trench 4** revealed a number of structures associated with the mill known to be on Site.
- 7.6.2 The stratigraphically earliest observed deposit was layer **417**, a mid grey brown layer of reworked natural geology, disturbed as a result of the initial construction of mill related structures and trample activity. This deposit sealed the natural geology which was observed as river borne gravels **419**, most likely deposited as a result of high energy flood events. The natural was encountered at 0.68m below the current ground surface at a height of **34.94m aOD**.

- 7.6.3 Cutting directly into layer 417 was 402; the foundation trench for a roughly east/west aligned wall 404 constructed of roughly shaped limestone blocks. Wall 404 was encountered at 0.26m below the current ground surface at a height of 35.52m aOD and was butted at its western end by brick structure 403, clearly a second phase of construction, set upon a concrete foundation within cut 420. Both 403 and 404 appear to form the southern wall of a building extending to the north, however due to massive truncation by later disturbance this cannot be confirmed. Two small brick pads 406 and 408 butt the southern side of 403 and the remains of a truncated possible north/south aligned wall 410 was also observed.

- 7.7.2 At the southern end of the trench less than 0.10m below the ground surface at a height of **35.44m aOD** structures associated with the mill were observed. The stratigraphically earliest deposit was **519**, a layer of reworked natural geology; the result of trample and possible initial construction activity which was cut through by structural elements.

- 7.7.3 The potentially earliest structure was a truncated east/west aligned wall 518 constructed of roughly hewn limestone blocks, set into 519. Adjacent to this was Group 515 (formed of walls 508, 512 and 513 and concrete floor 514), a rectangular structure which was backfilled with clinker rich deposit 517. Two floor surfaces were observed, a simple concrete floor edged by possible wall 516 was identified just north of 518 and to the south, a surface composed limestone blocks, diamond patterned firebricks and concrete (504).

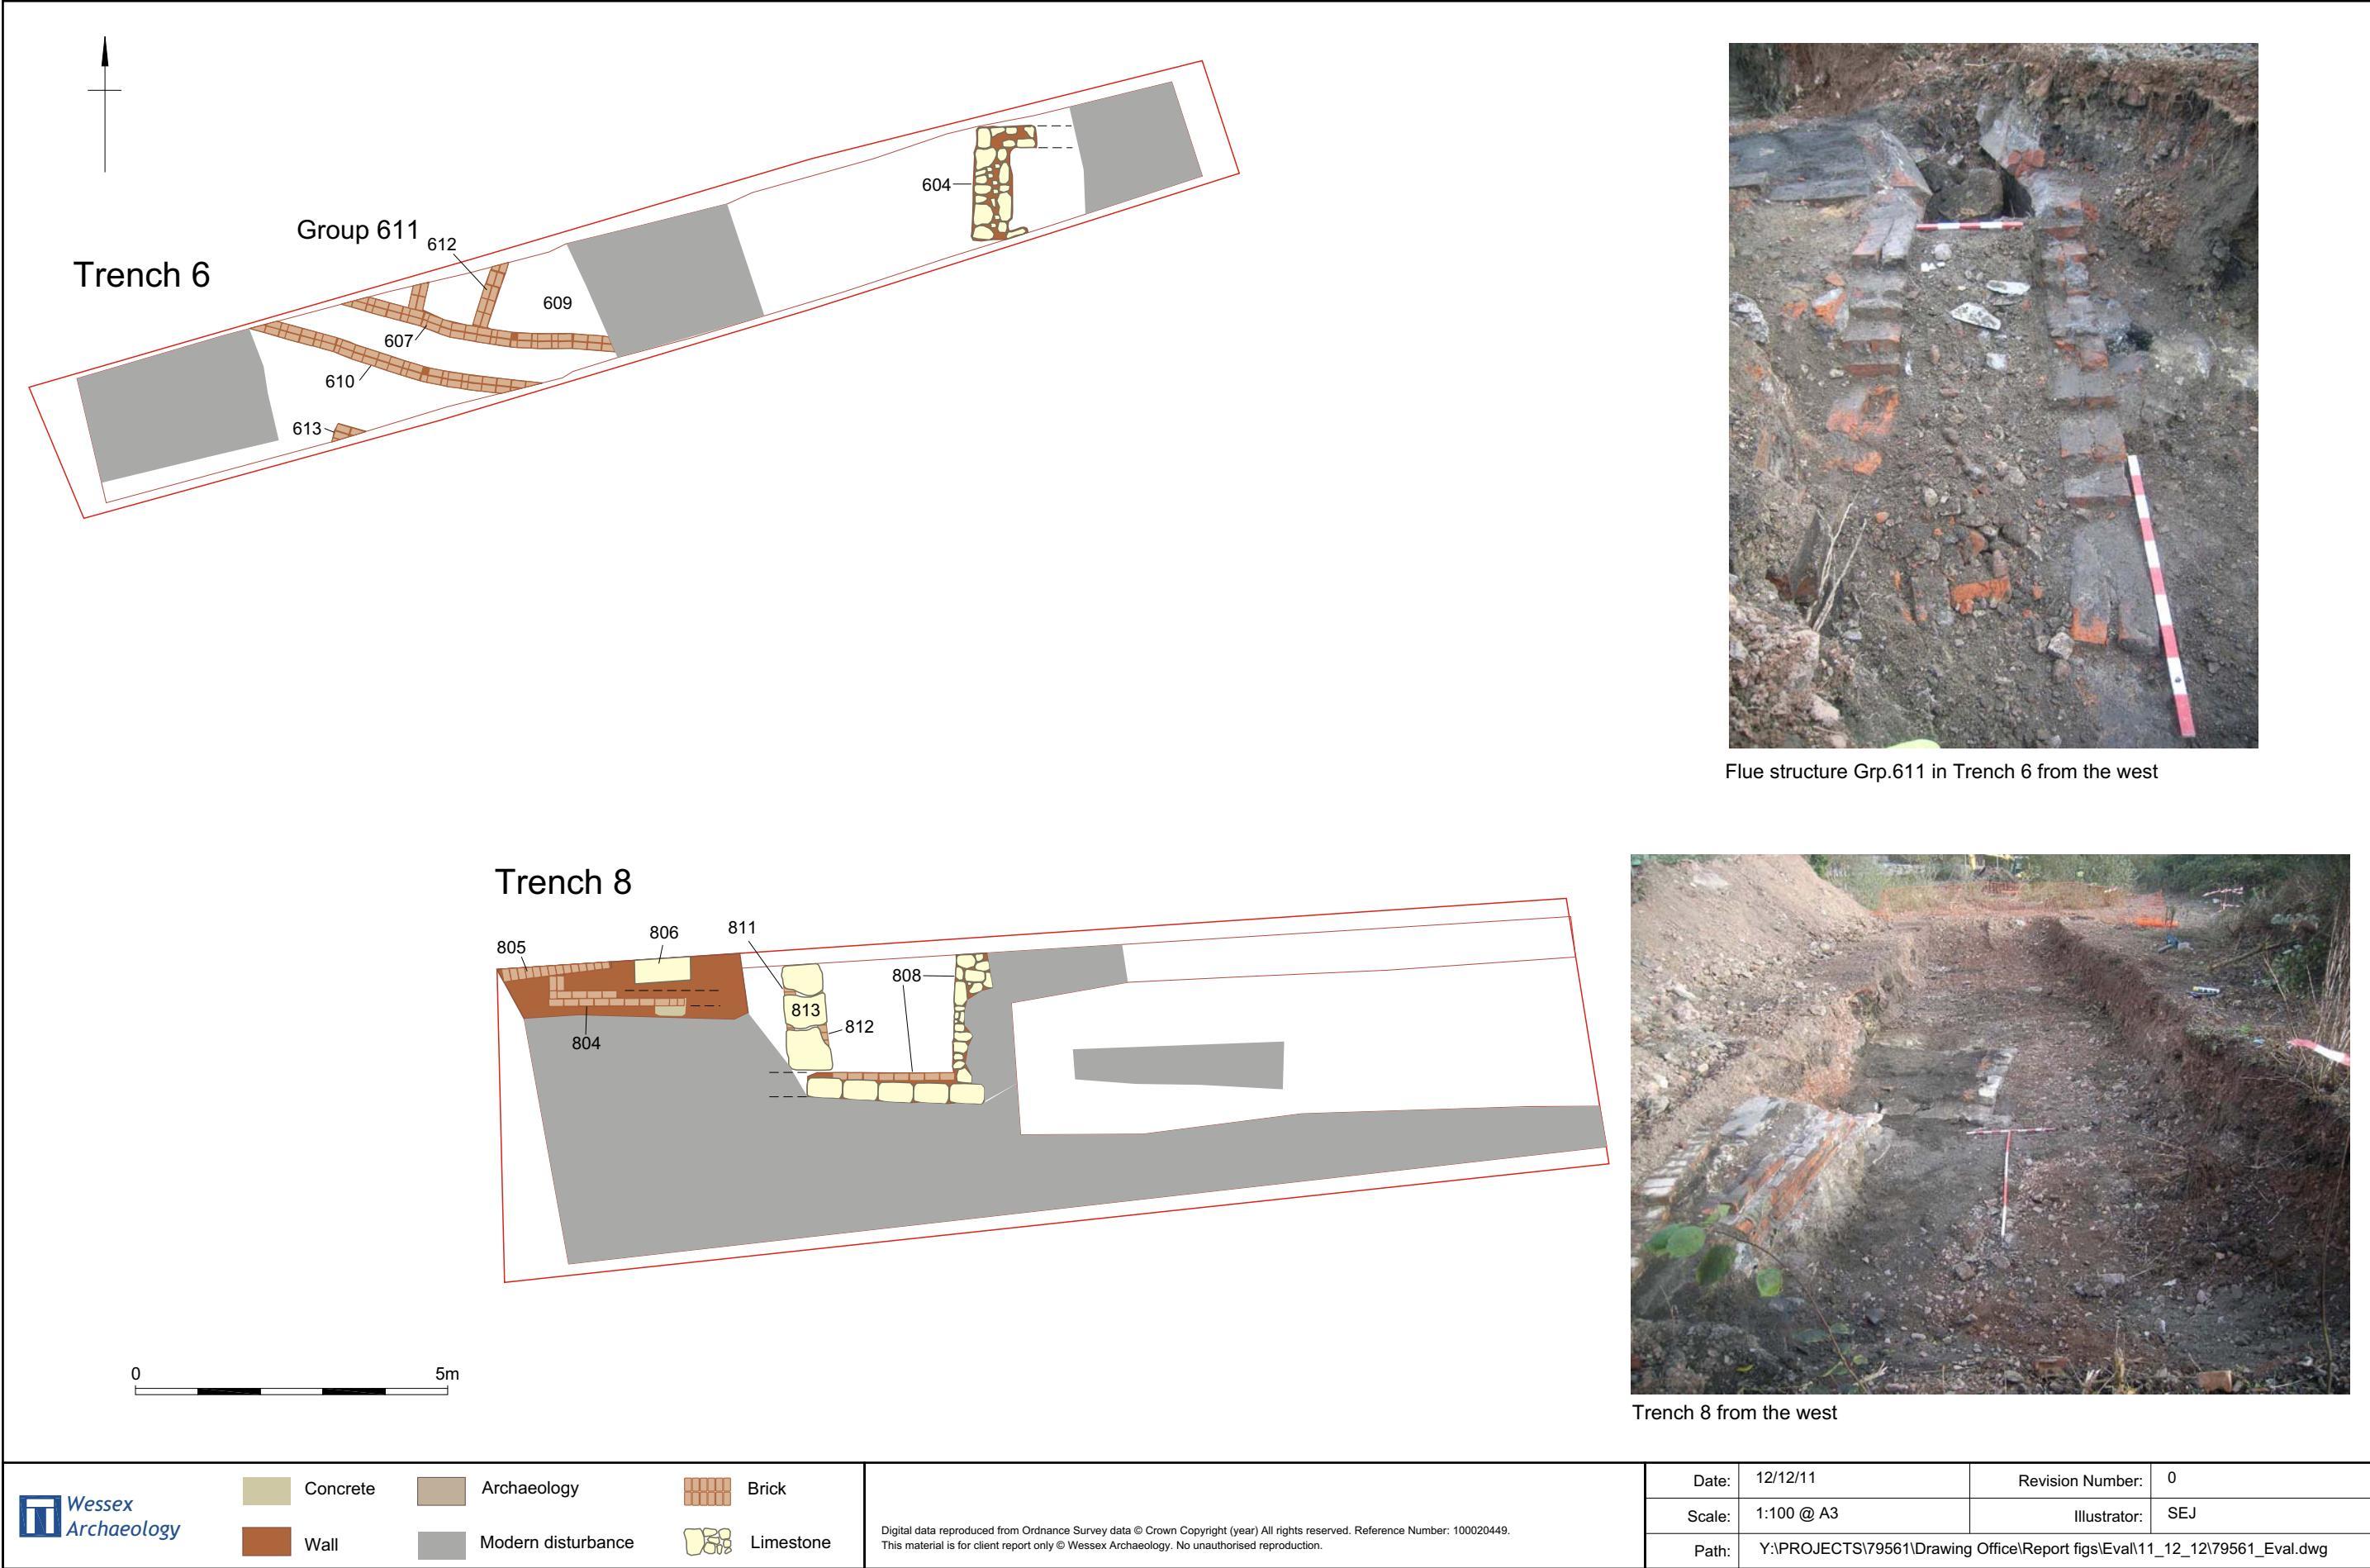
At the western end of Trench 8 a truncated east west aligned brick wall **804** was revealed at just 0.13m below the current ground surface at a height of **35.35m aOD**. **804** was partially overlain by later brick wall **805** and possible flooring slab **806**. These features had been heavily truncated. Following the removal of over 1m of disturbed ground the south east corner of a possible building constructed from roughly hewn limestone blocks was observed. **804** was associated with north south aligned brick lined culvert cut **811**, capped with limestone blocks **813**. These features had also been heavily disturbed and a sondage was excavated through this disturbed ground to a depth of 2.20m below the current ground surface to a height of **33.57m aOD**. No natural geology was observed.

Detail of Trenches 6 and 8

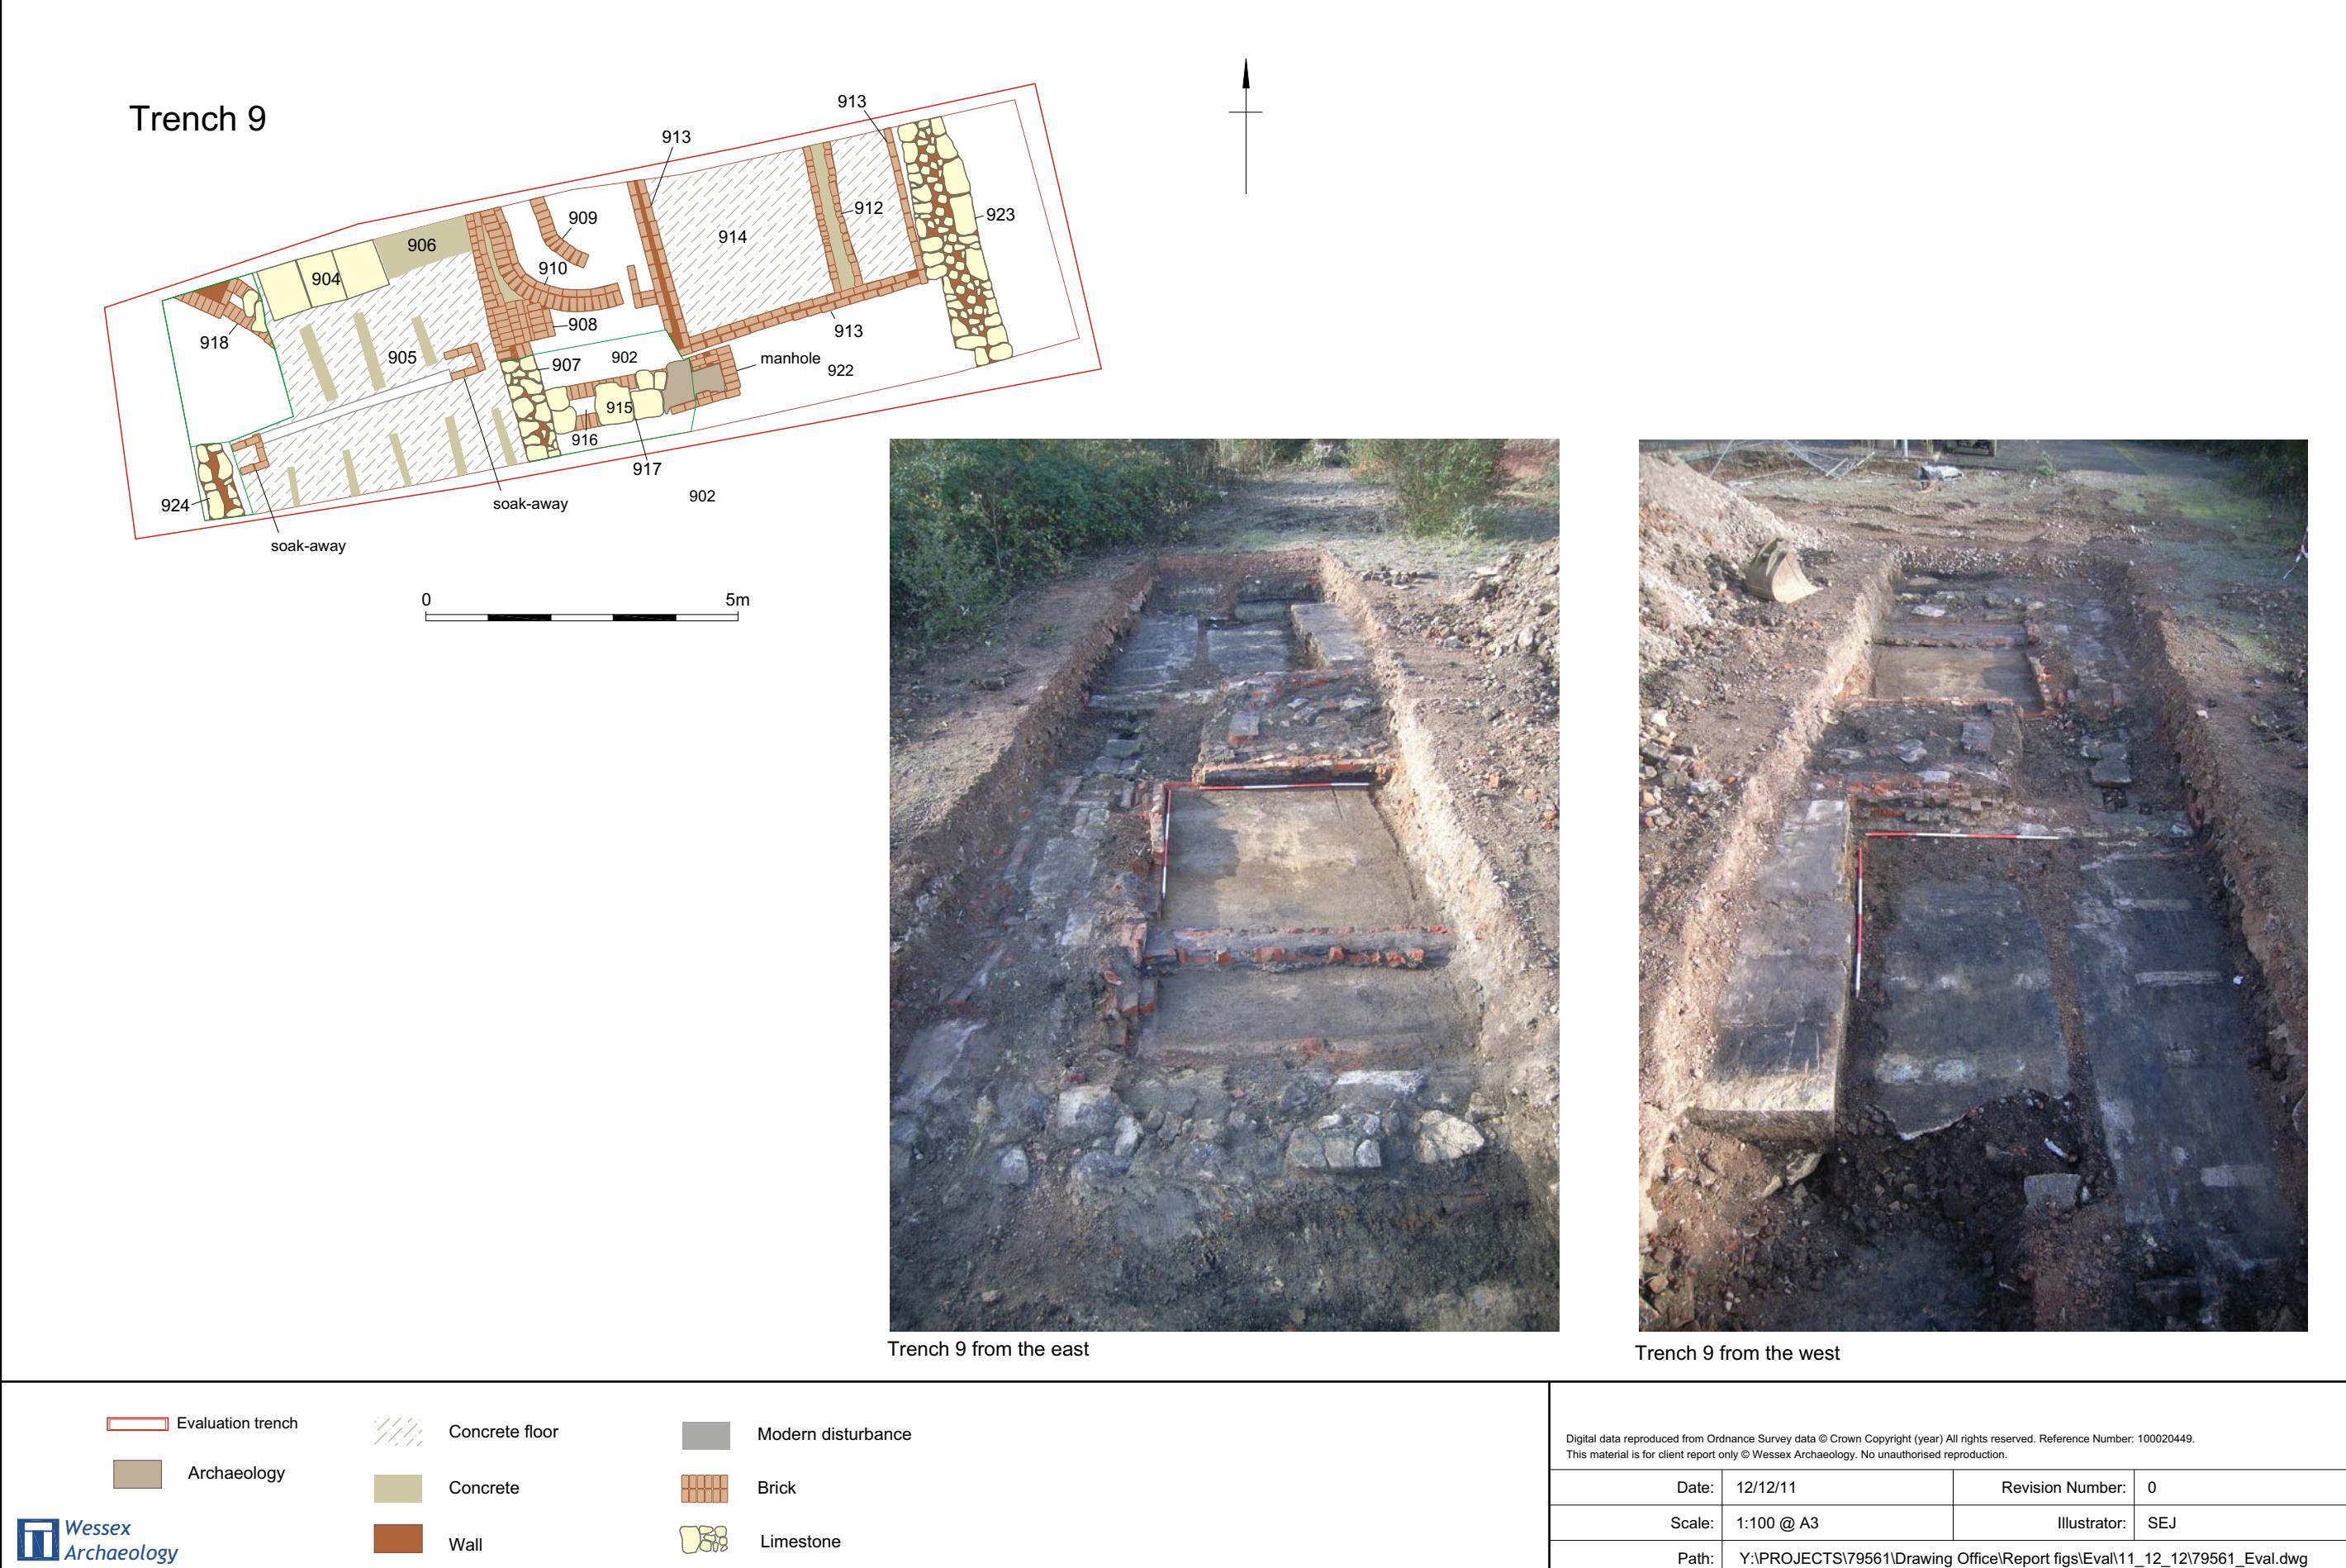
- 7.11.2 At the eastern end of **Trench 9** was wall foundation **923** constructed of roughly hewn limestone blocks and in view of its substantial thickness (0.95m thick), potentially formed the eastern outer wall of a mill building. To the west of **923** were two parallel limestone block built wall footings; **907** and **924**, potentially formed individual rooms within the mill. Wall **924** was heavily truncated, whereas **907** was sealed by the remnants of a brick wall.

- 7.11.5 The structures within **Trench 9** were sealed by rubble from demolition of the mill.
- 7.12 Trenches 10 18
- 7.12.1 **Trenches 10- 18** were located on the eastern half of the Site, and revealed only modern levelling deposits sealing the natural alluvial geology. A number of modern services were observed cutting the geology however these were not investigated due to hydrocarbon contamination. A number of deep sondages were excavated through the natural geology to confirm that the material was *in situ* and not sealing early archaeological remains.

Detail of Trench 9
