CHIPPING WATER TREATMENT WORKS Chipping, Hertfordshire

Archaeological Monitoring Report

Prepared on behalf of Veolia Water Partnership

Report no.358 July 2006 © The Heritage Network Ltd

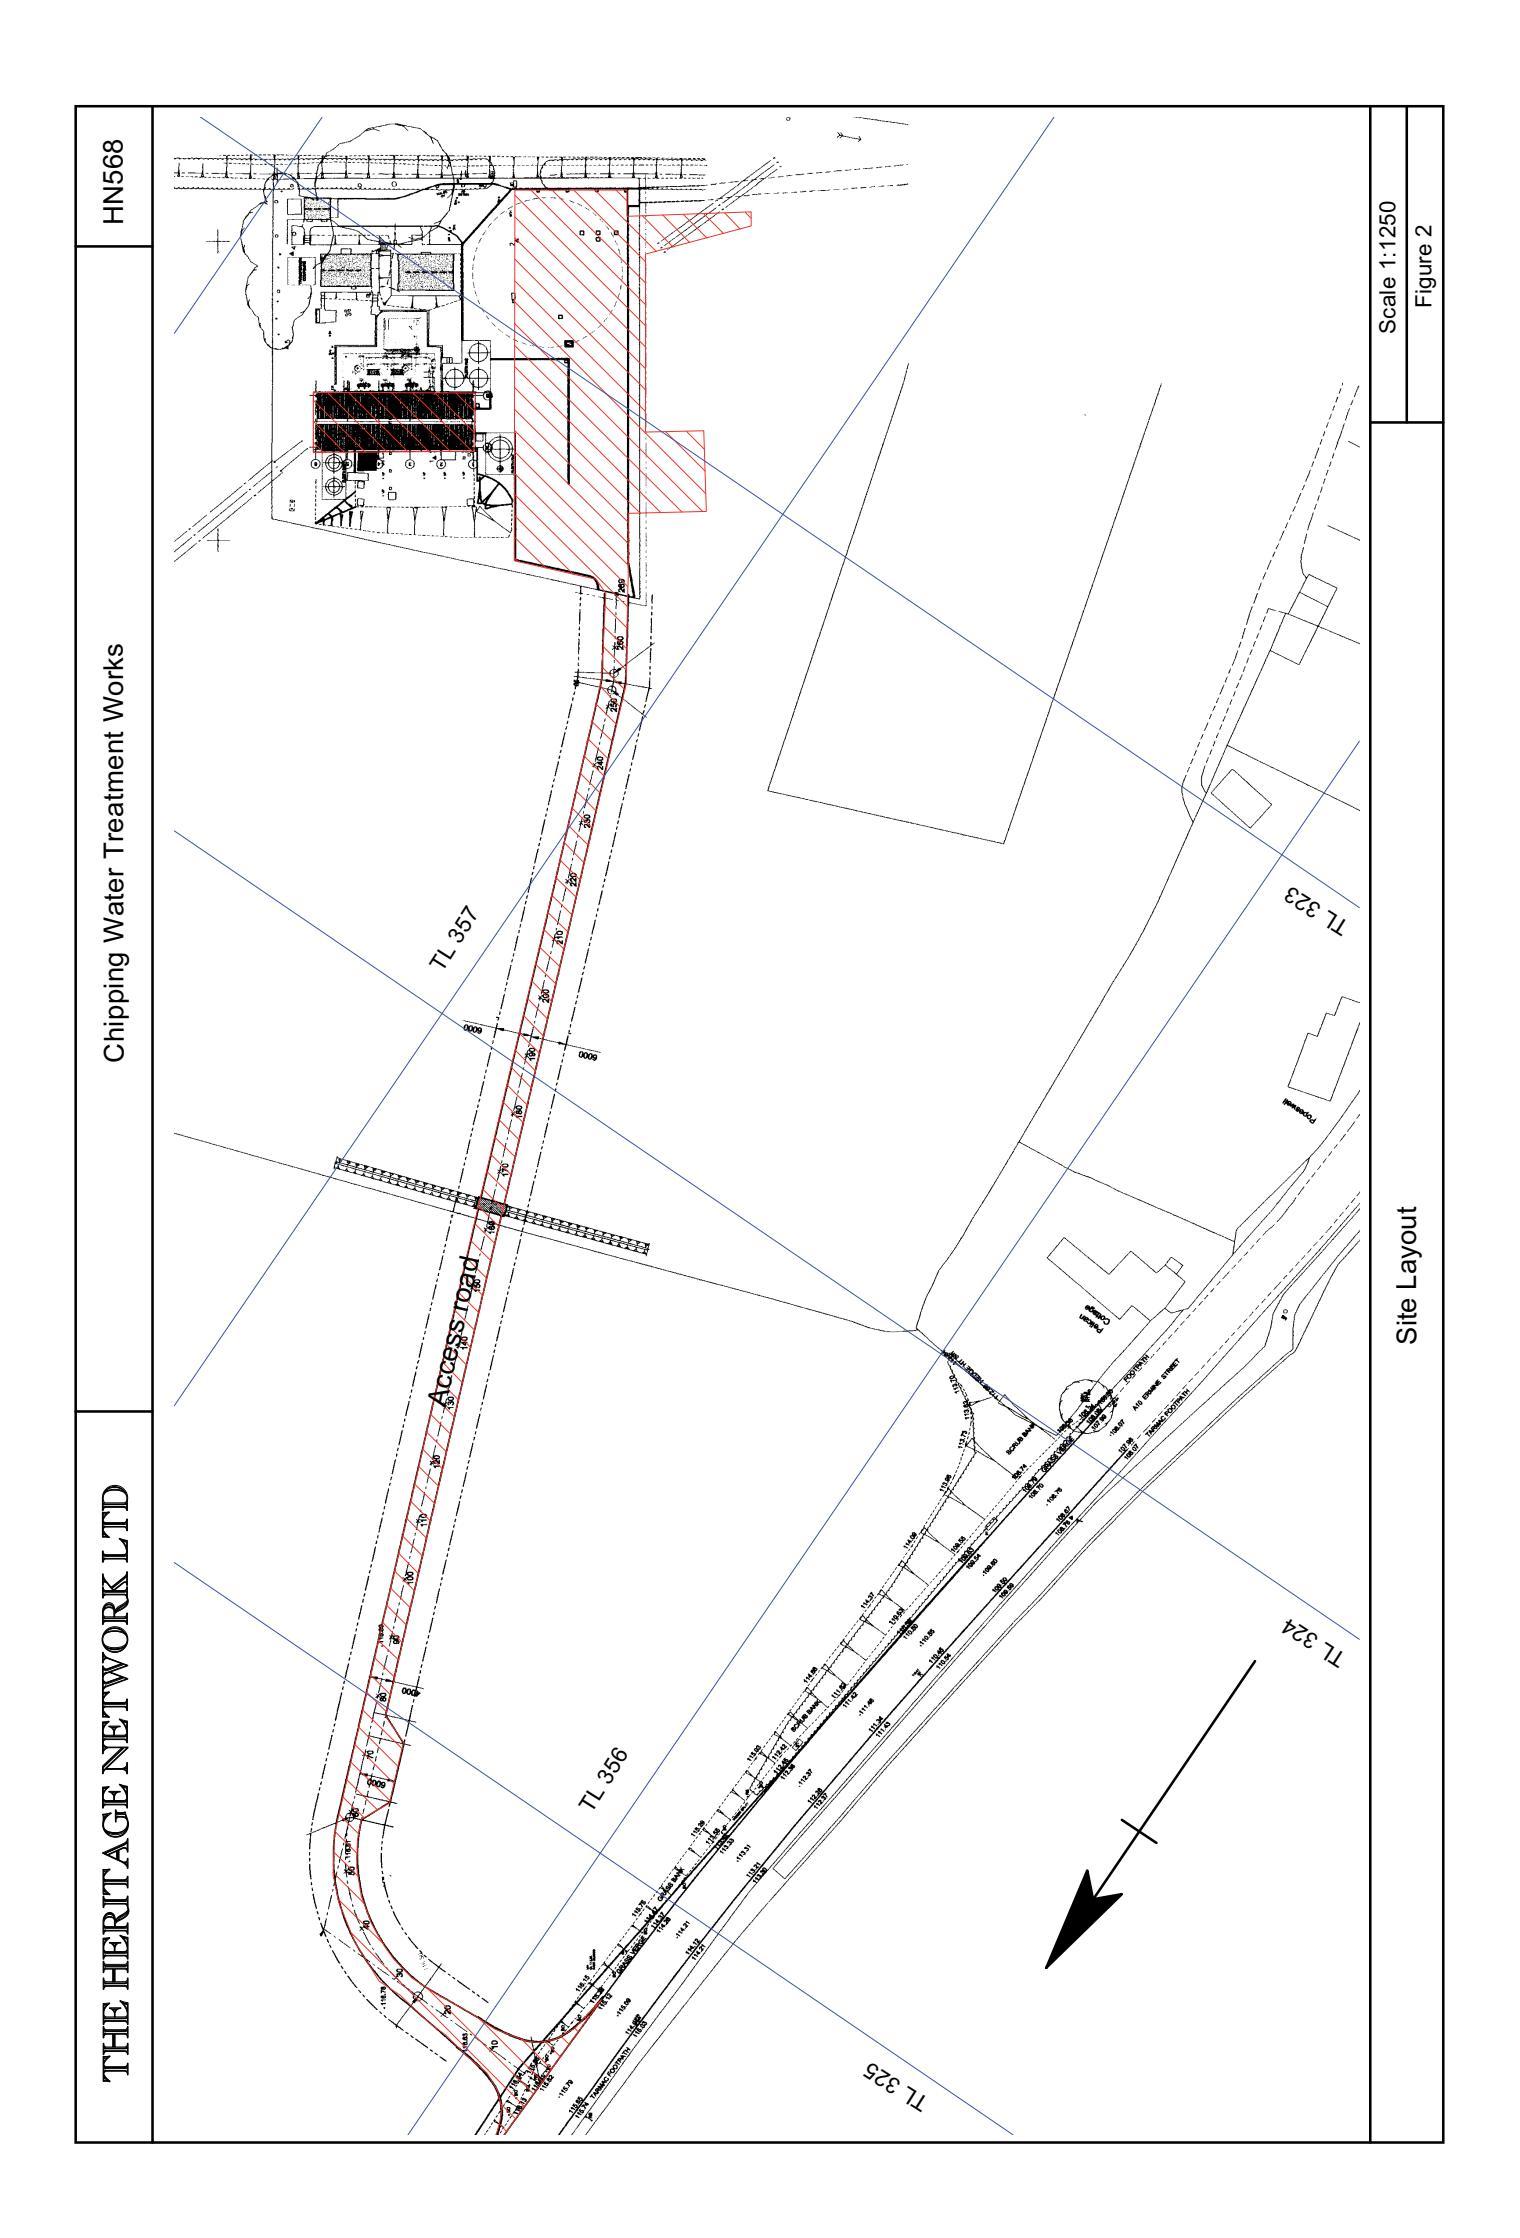
The existing pumping station lies within arable farmland to the east of Chipping. The present study area covers the existing pumping station, a plot of land immediately to the west, and a narrow corridor of land running north – south to form a new access road (Figure 2).

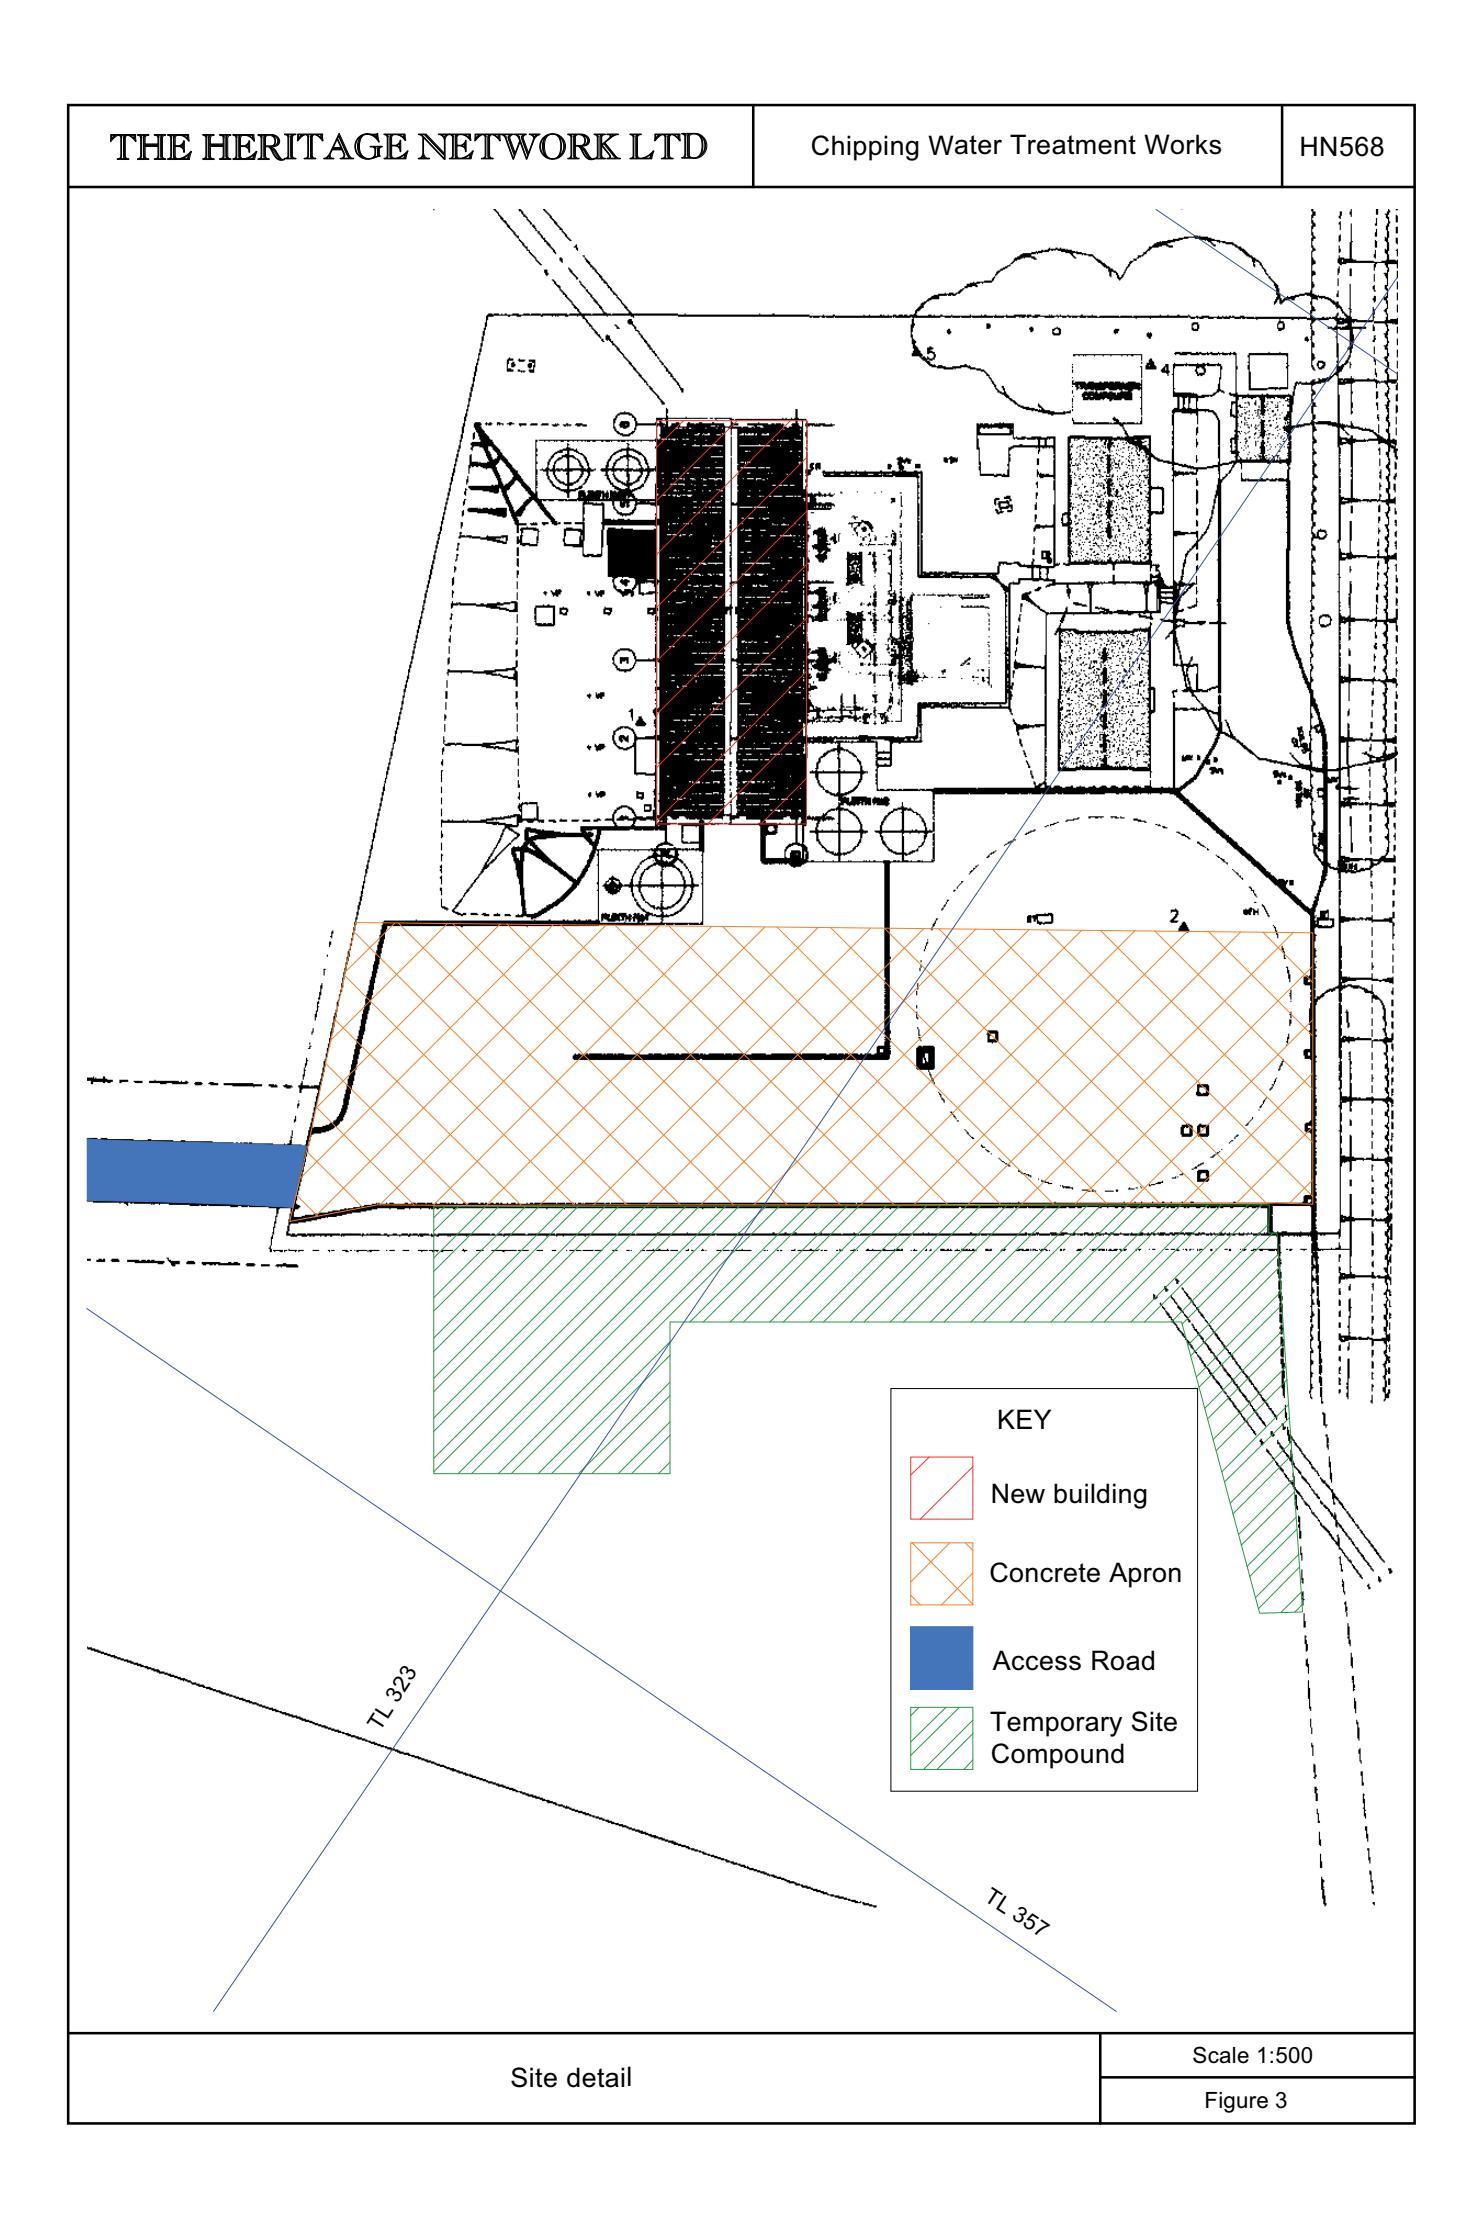
2.1 A temporary site compound was created to the west of the development area (Figure 3). The ground level within the compound was reduced by a maximum depth of approximately 0.40m. This was sufficient to remove the firm, dark olive brown (2.5Y 3/3), silty clay topsoil from across the majority of the compound. Beneath the topsoil the natural drift geology of olive brown clay with flints was revealed.

A single boundary ditch [101] was revealed running across the compound on a north – south alignment. The ditch, which had a maximum width of 0.40m, was preserved in situ beneath a geotextile membrane which was laid down prior to the level of the compound being built up. Two small fragments of ceramic building material of late post-medieval or 19^{th} century date were recovered from the surface of the firm, dark olive brown, silty clay fill (102).

Ground reduction for a new concrete apron was undertaken immediately to the west of the existing treatment works (Figure 3). Approximately 0.25m of topsoil was removed revealing the underlying natural drift geology. The stratigraphy was identical to that observed in the temporary site compound.

Boundary ditch [101] was observed continuing on a north-south alignment.

The new building was located within the boundary of the existing water treatment works between a large settling tank which has a soil mound over it to the north and an enclosure surrounding tanks and pumping equipment to the south (Figure 3).

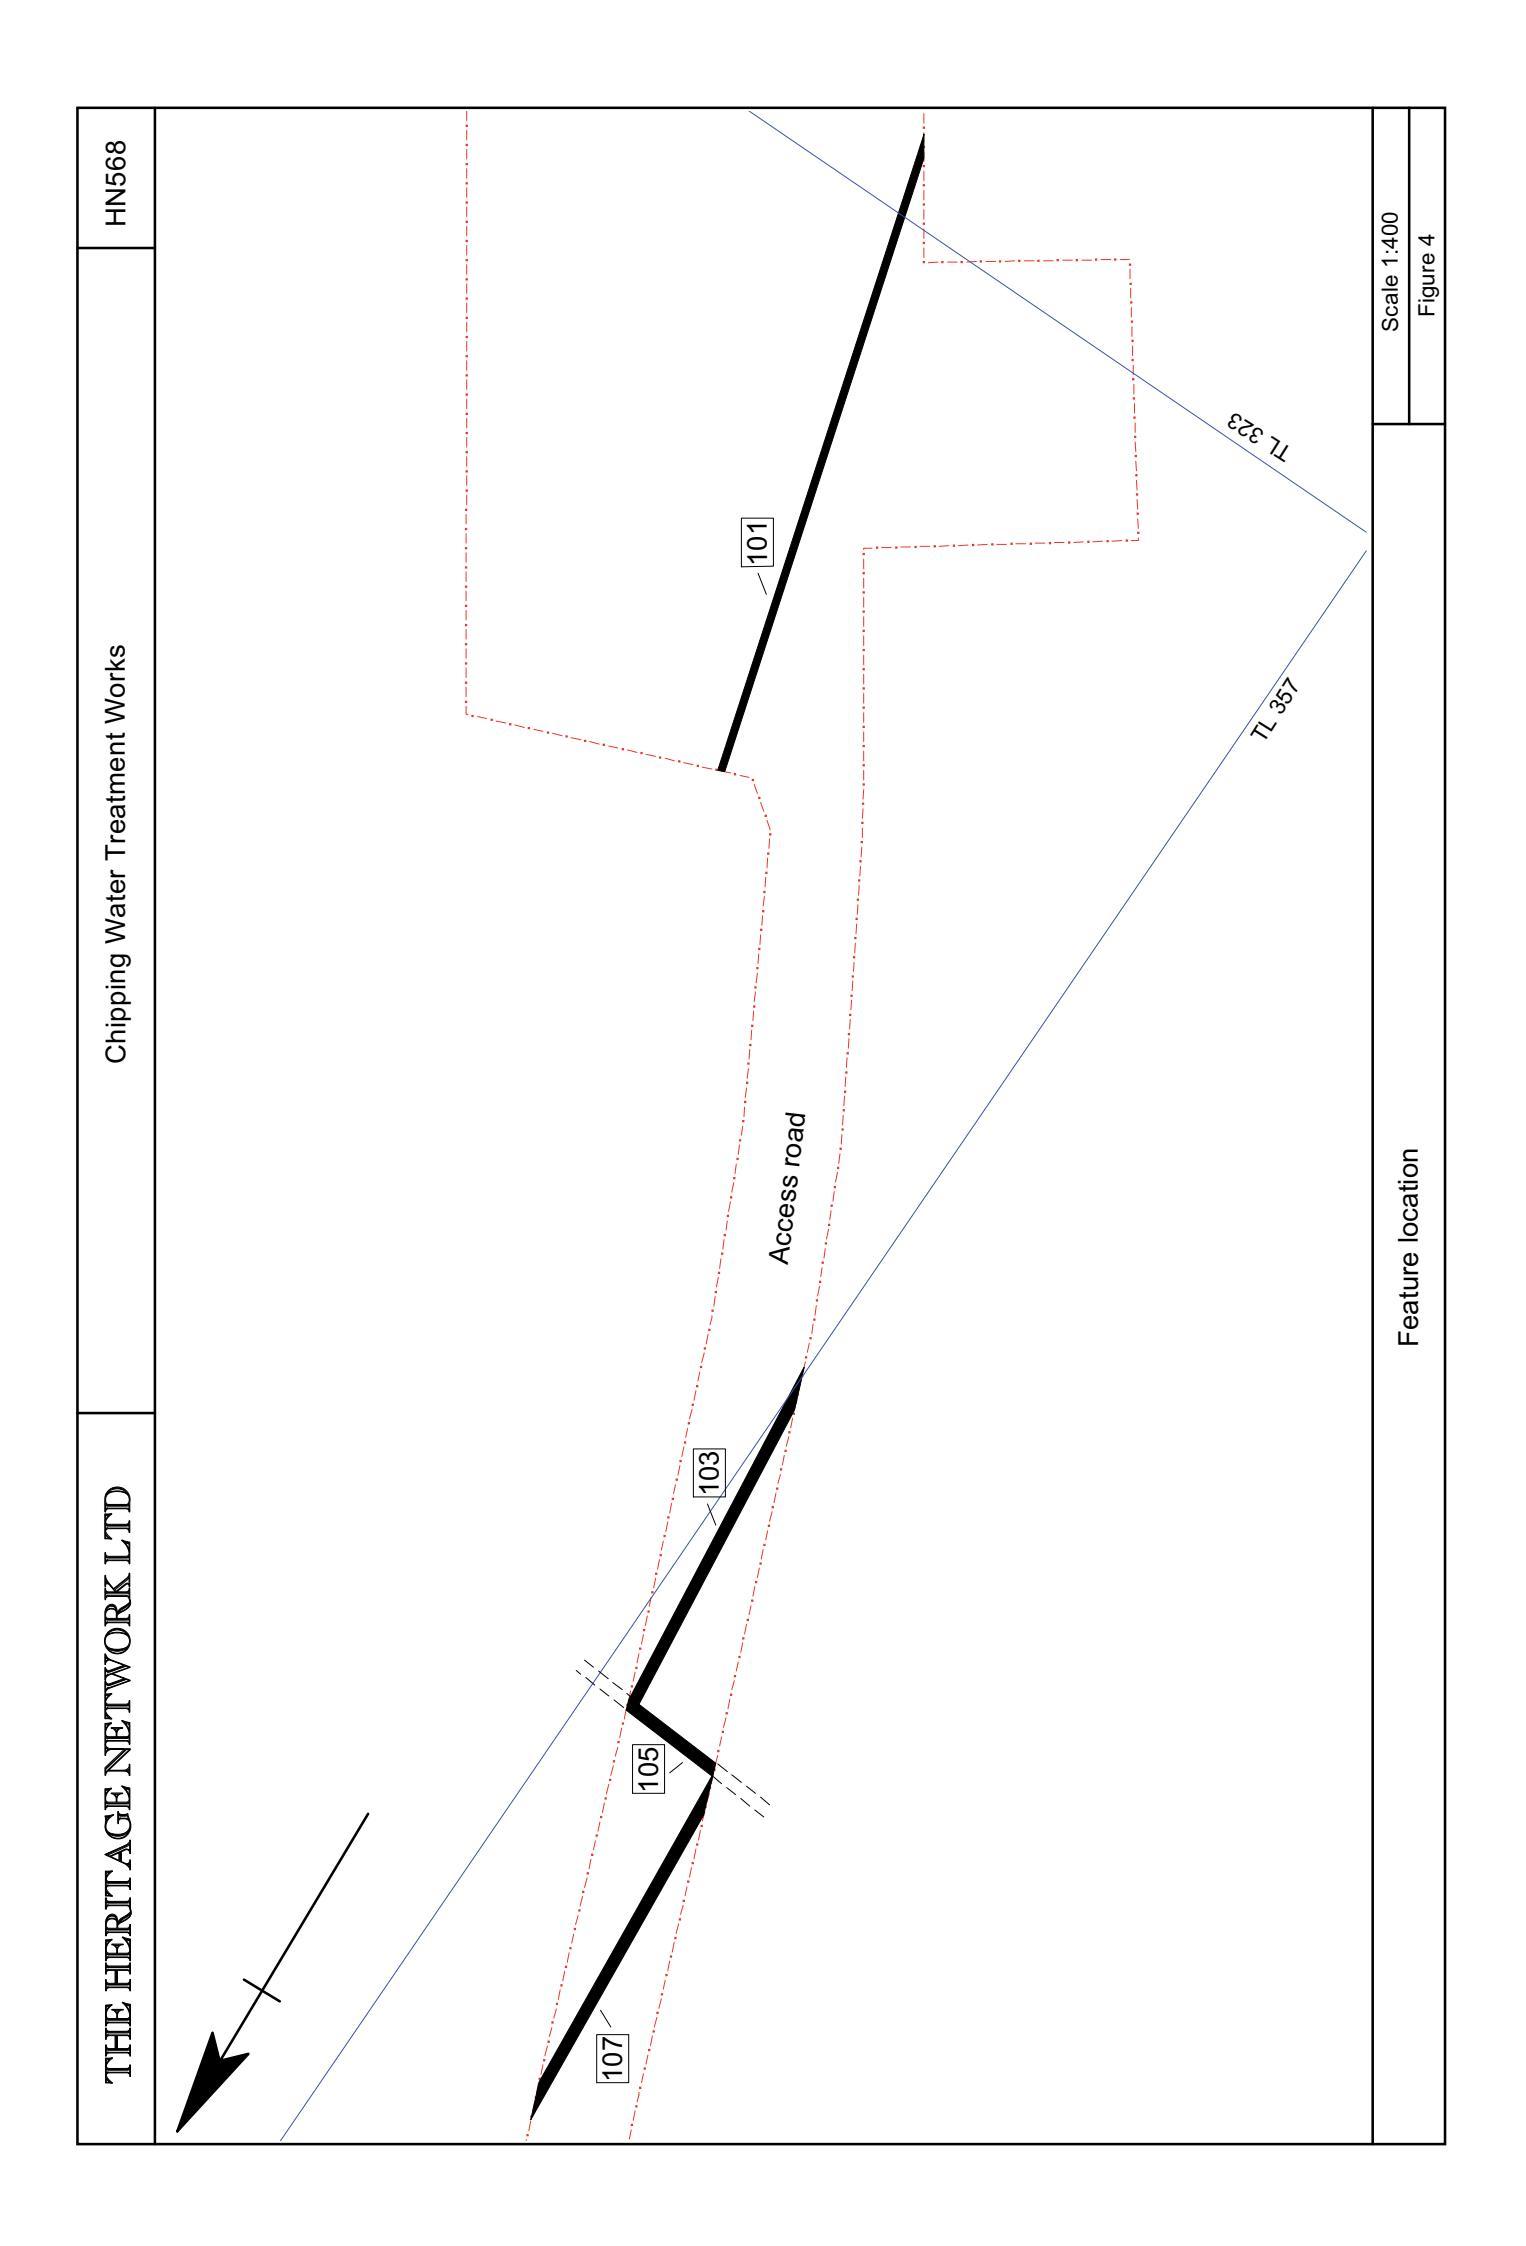
A new access road was excavated linking the treatment works with the A10 to the north of the village of Chipping (Figure 4). The topsoil was removed along the length of the new road. Following this a layer of geotextile material was laid down and covered with granular material. The road measured approximately 5.0m in width and had a total length of approximately 295m.

Three related ditches were revealed during the machining of the access road: [103], [105], and [107] (Figure 4).

- Ditch [103] was observed running across the access road on a north south alignment. The ditch had a width of approximately 0.60m. The ditch was preserved in situ beneath a layer of geotextile membrane prior to the level of the new road being built up. The fill (104) of firm, olive brown, slightly silty clay yielded abraded pottery sherds of Romano-British date.

- Ditch [105] was observed running across the access road on an east west alignment. The ditch had a width of approximately 0.65m. The ditch was preserved in situ beneath a layer of geotextile membrane prior to the level of the new road being built up. The fill (106) of firm, olive brown, slightly silty clay yielded abraded pottery sherds of Romano-British date. The ditch has a junction with ditch [103] close to the edge of the access road. The fills of the two ditches are identical suggesting that they are contemporary.

- Ditch [107] was observed running across the access road on a north south alignment. The ditch had a width of approximately 0.65m. The ditch was preserved in situ beneath a layer of geotextile membrane prior to the level of the new road being built up. The fill (108) of firm, olive brown, slightly silty clay yielded no archaeological artefacts. The ditch has a junction with ditch [105] close to the edge of the access road. The fills of the ditches are identical suggesting that they are contemporary.

The three ditches appear to be contemporary with each other. The pottery recovered from them is highly abraded and is unlikely to have been in its primary place of deposition. The ditches are most likely to be boundary ditches and may represent part of a field system predating the present one.
