Tissington Silo Level 3 Survey - Historic Building Recording Client: Tissington Estate

Melanie Lloyd Morris Mel Morris Conservation

14th March 2022

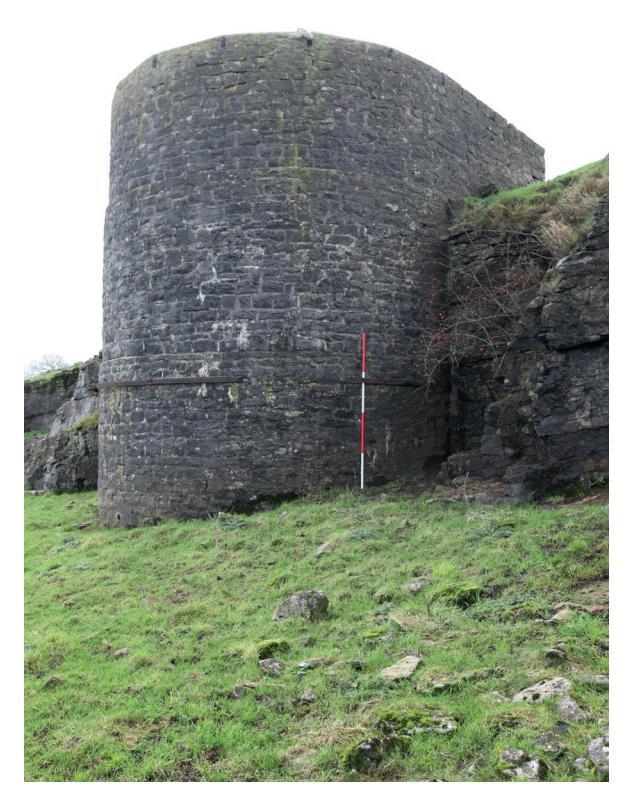
Plate 8 (ref. ext01_02_01_22) The tower from the north, built into the quarry face, which appears to have been deliberately part-removed to accommodate this structure.

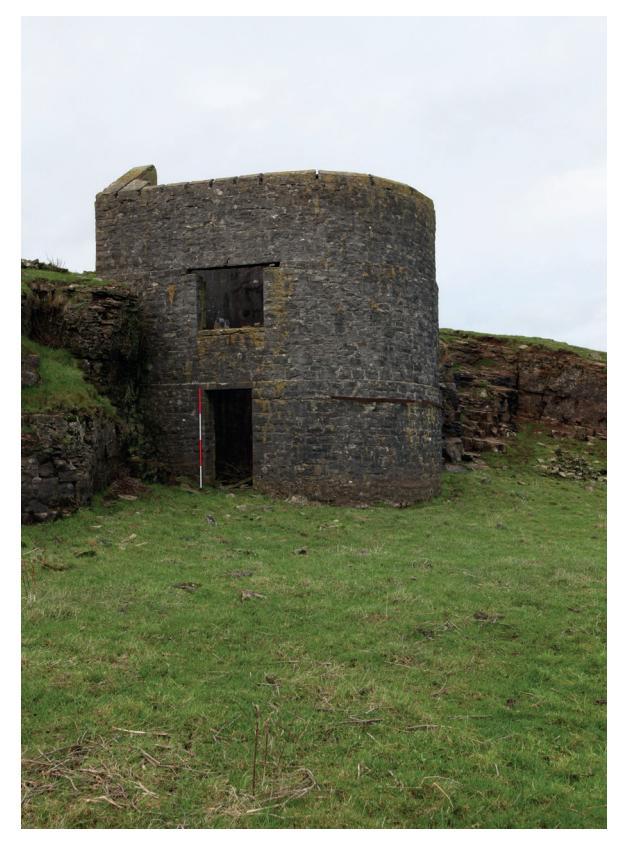
Plate 9 (ref. ext05_02_01_22) The tower from the south, with a single point of entry and single window at the second stage of the tower.

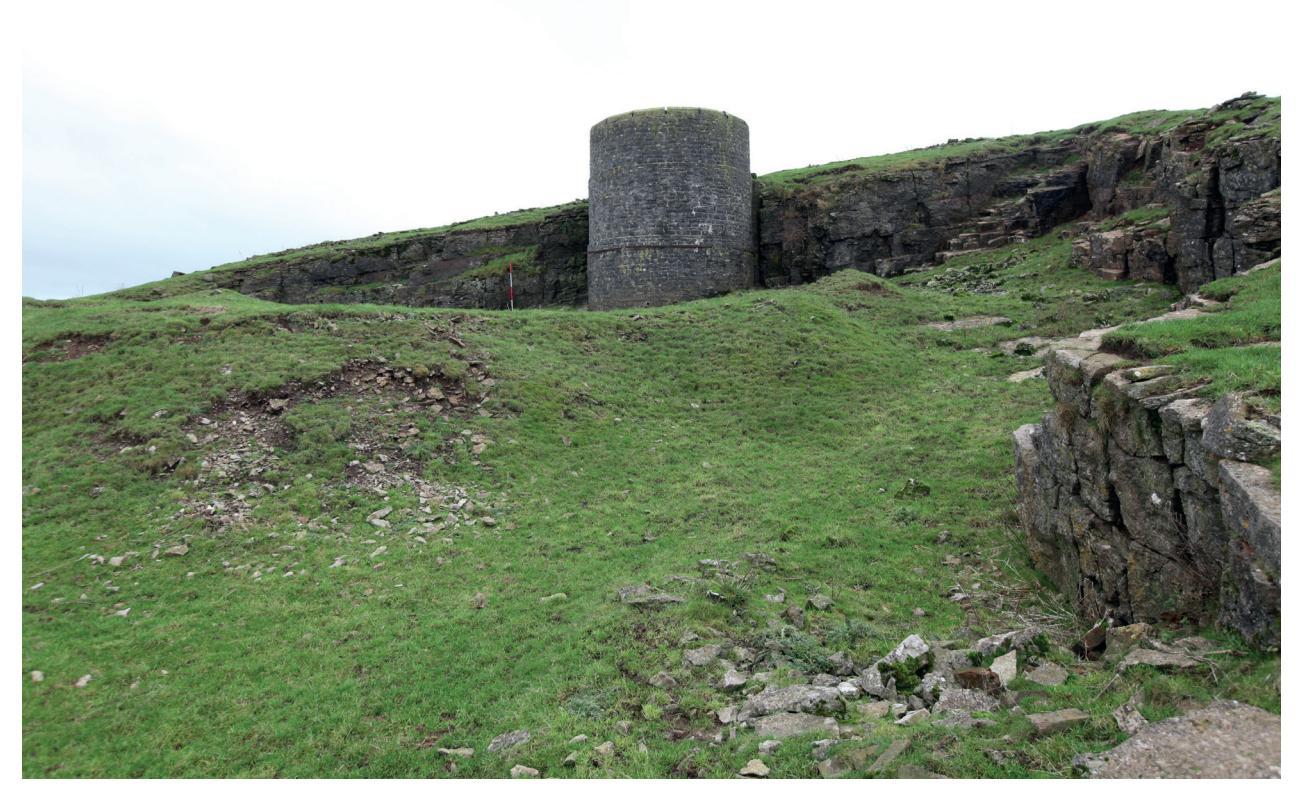
Plate 10 (ref. ext13_02_01_22) View of the tower built into the east face of the quarry. To the immediate left is the rubble base of the former limekiln, which has been largely dismantled, leaving a platform. It seems highly likely that the highly durable carboniferous limestone stones for the limekiln were robbed out and re-used for the tower.

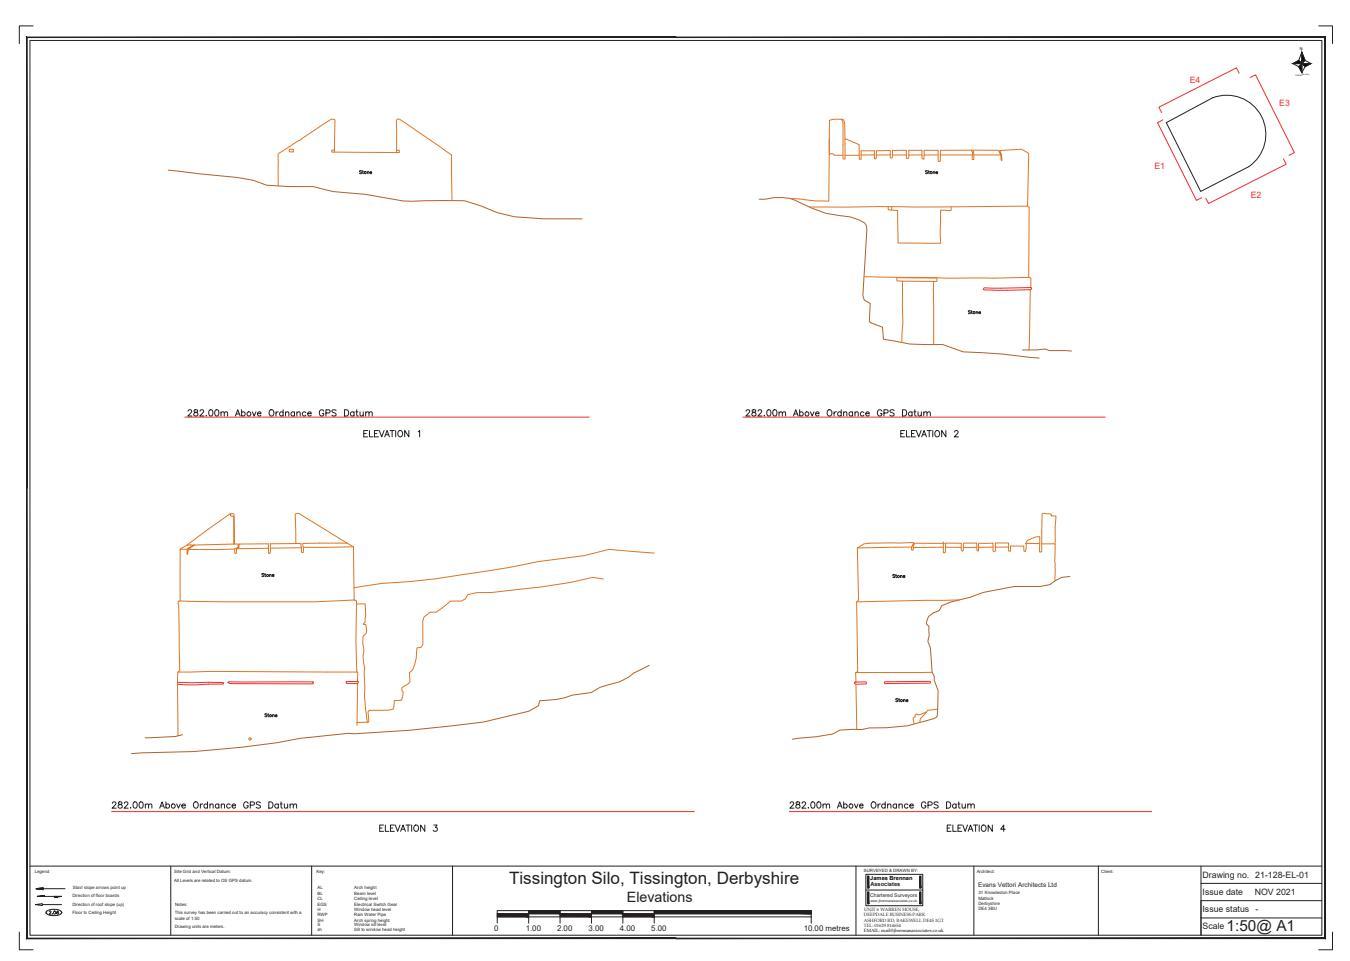
Plate 12 - Measured survey elevations of the tower (James Brennan Associates). This sheet is also reproduced as a separate PDF for scaling purposes.

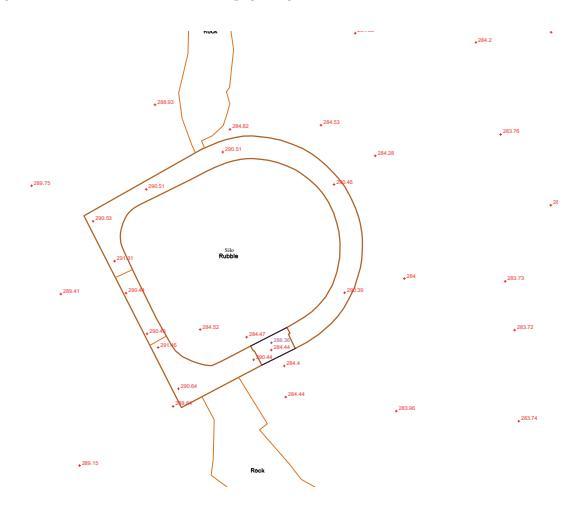
Plate 13 - Detail of floor plan of the tower, showing the semi-circular curved walls to the front and the squared walls to the rear, which have been built into the cut-out rock face. This shows a substantial amount of rock was quarried out to accommodate this structure.

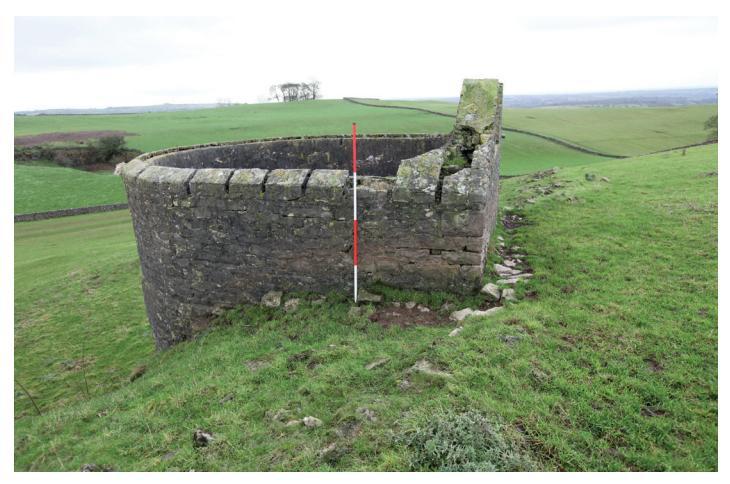
Plate 14 (ref. ext09_02_01_22)

This shows clearly the curved form of the building on plan and the wall-head with the narrow slots for the former rafters, which suggests an insubstantial roof.

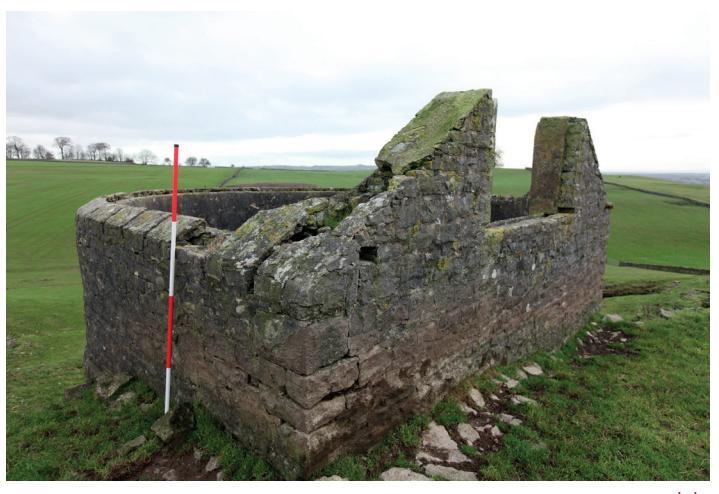
Plate 15 (ref. ext08_02_01_22)

West former gable at the third stage of the tower, with the apex missing and mortared capping to the walls.

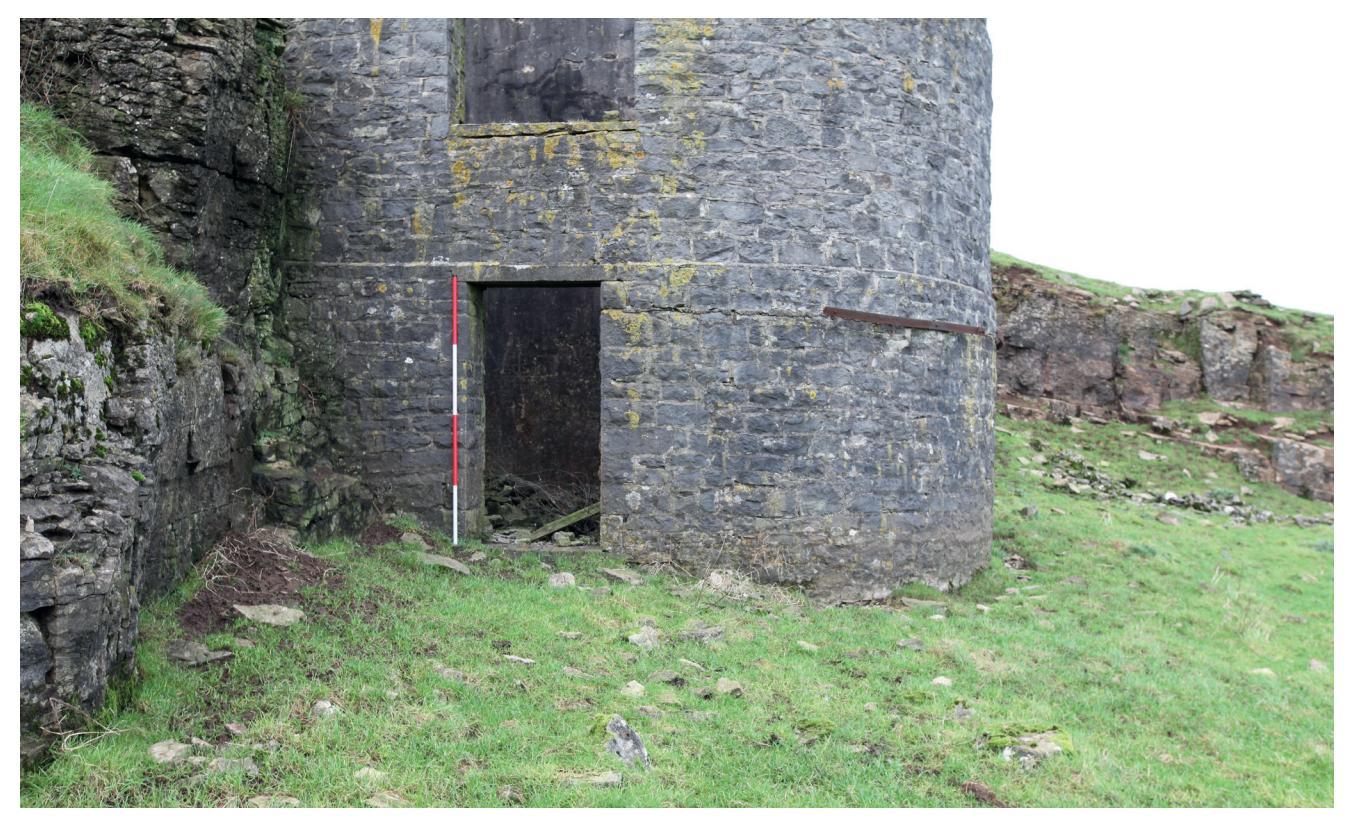
Plate 16 (ref. ext06_02_01_22) Bottom stage of the tower with step evident, which runs in-line with the door lintel, and length of wrought iron strap,.

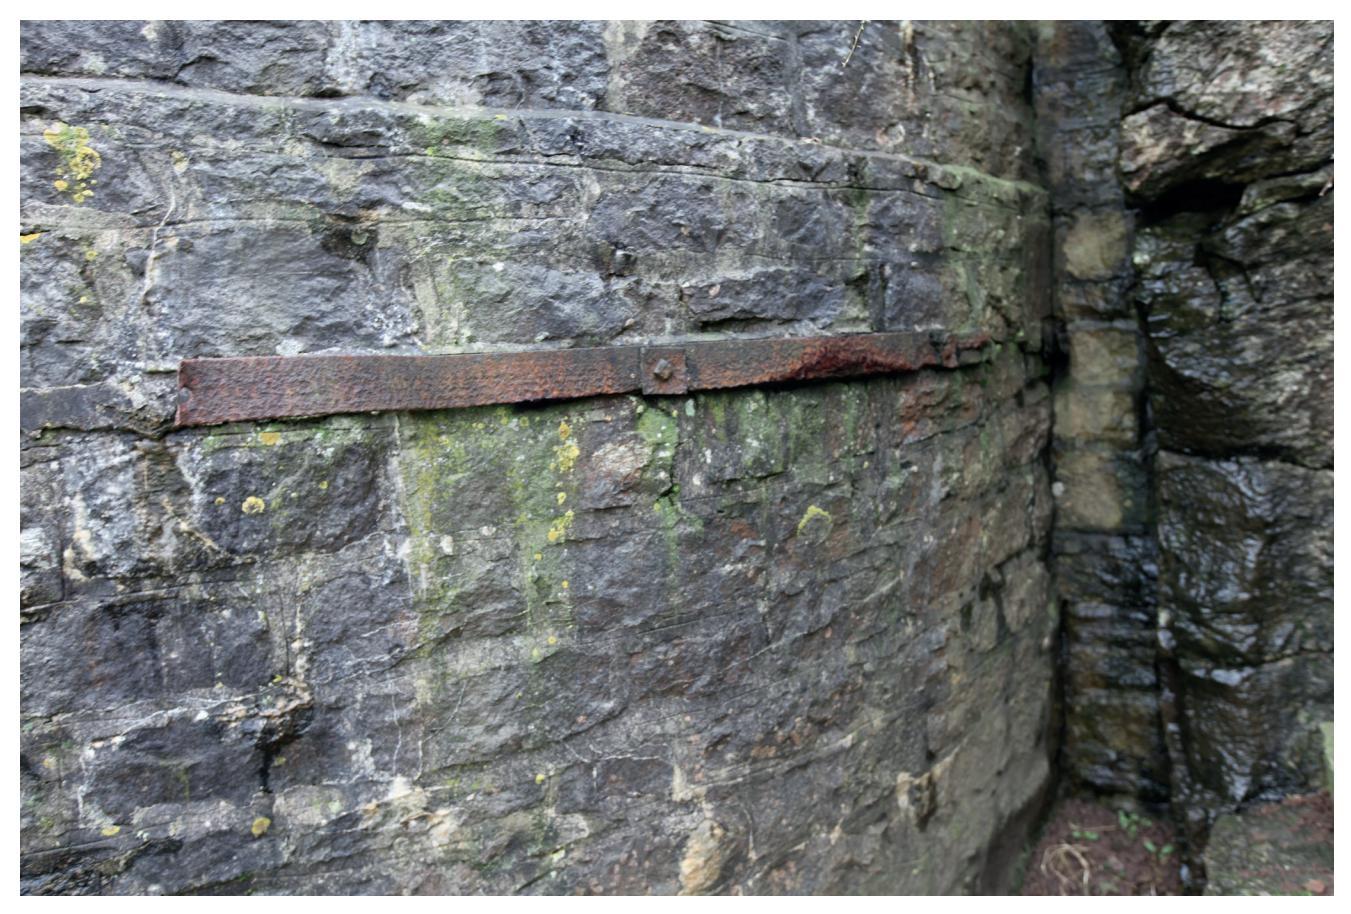
Plate 17 (ref. detail_banding_3_020122)

Section of wrought-iron or steel strap to the bottom stage of the tower, which has been part mortared onto the surface of the stone and attached with a series of square-headed bolts and squared 'washers'.

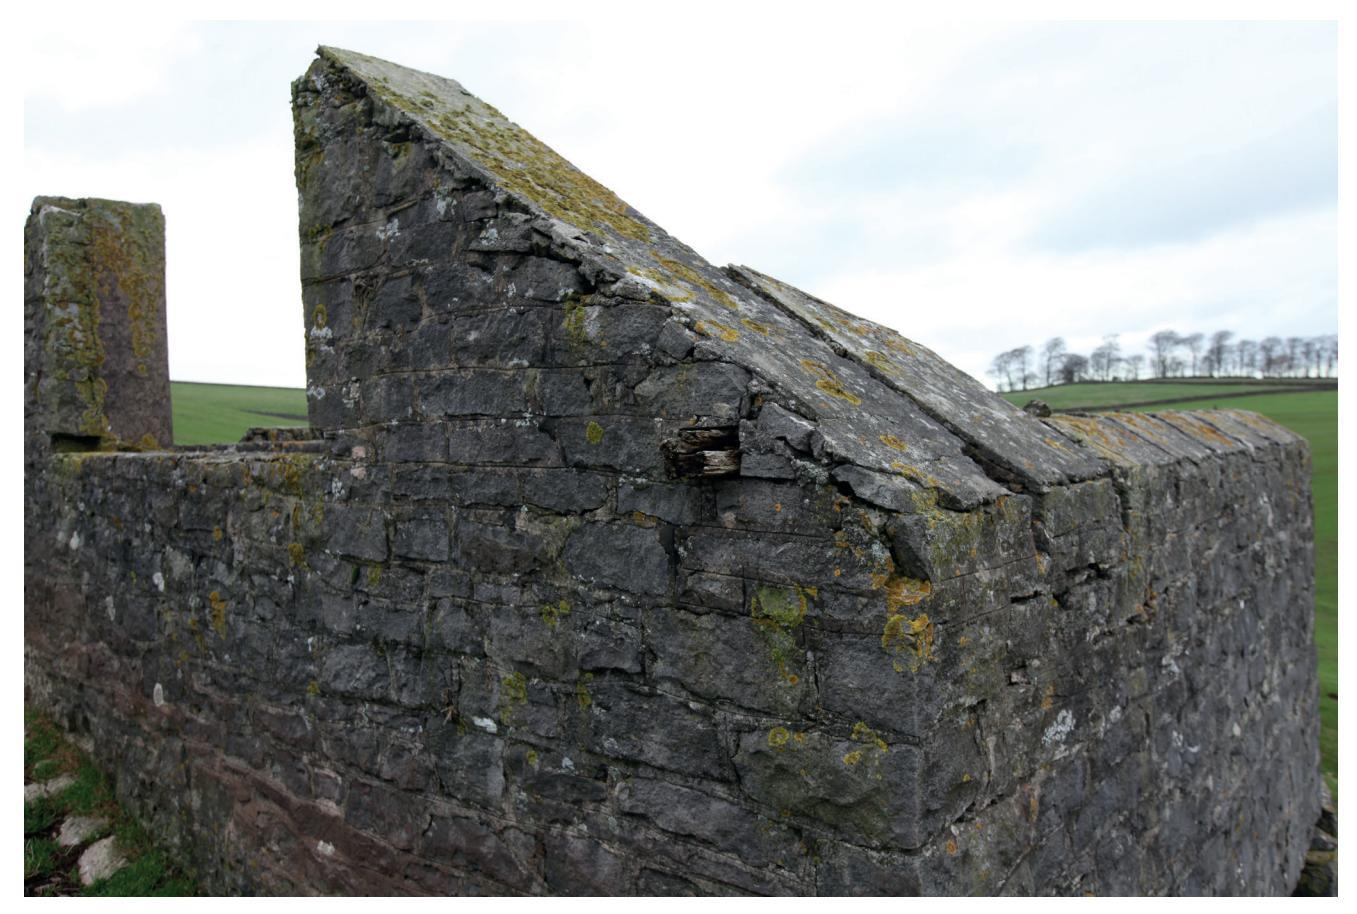
Plate 18 (ref. detail_west_gable_southern_eaves_020122) A small fragment of the timber inner wallplate pokes out from the wall. Cement render has been buttered over the wallhead to protect it and appears to have been added in anticipation of a roof.

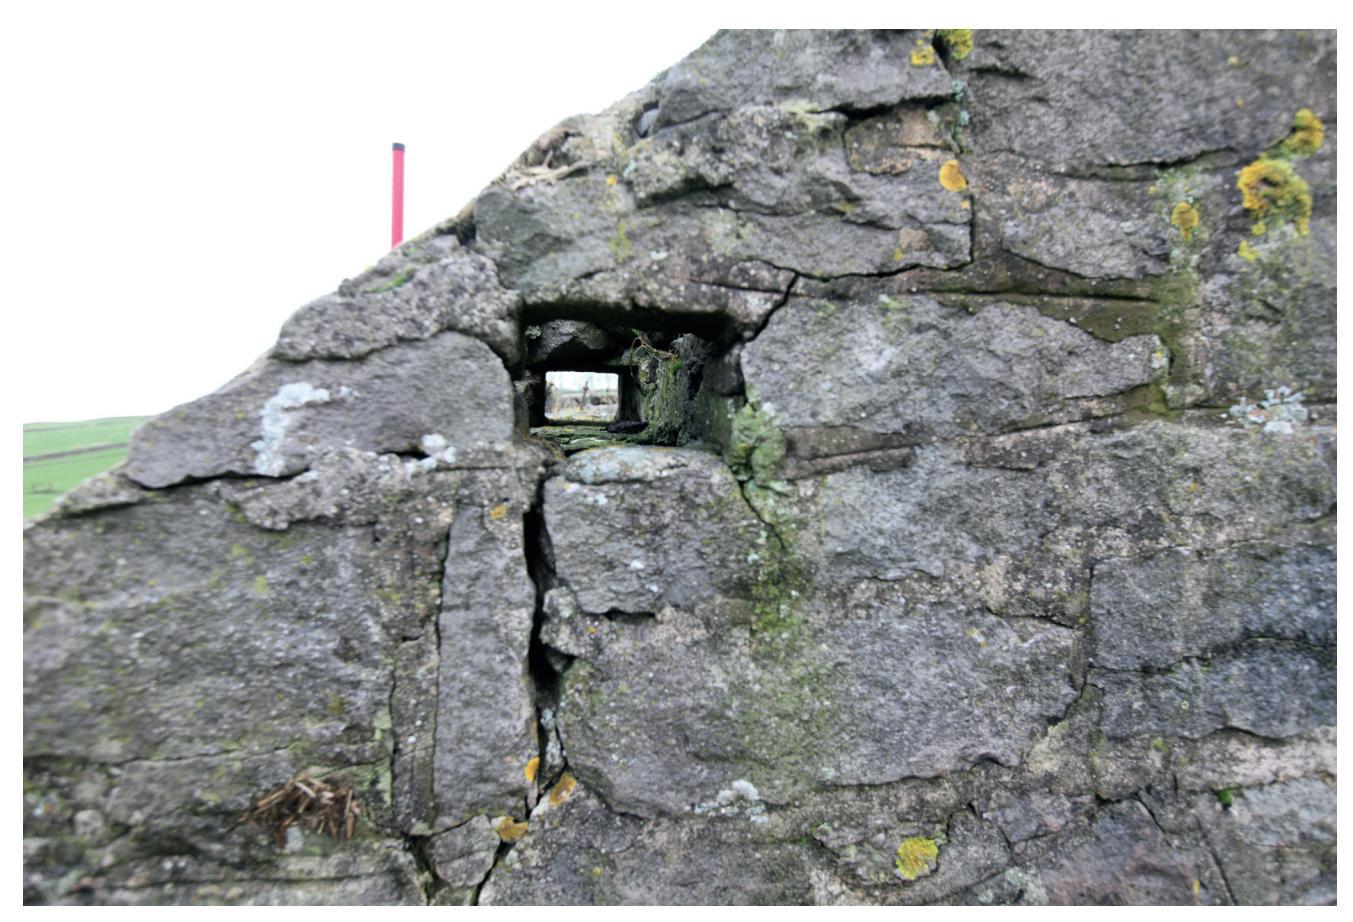
Plate 19 (ref. detail_north_eaves_wallplate_020122) The wall-plate on the north side of the tower is missing but the slot where it has rotted away remains, with clear sight of a bolt on the same alignment.

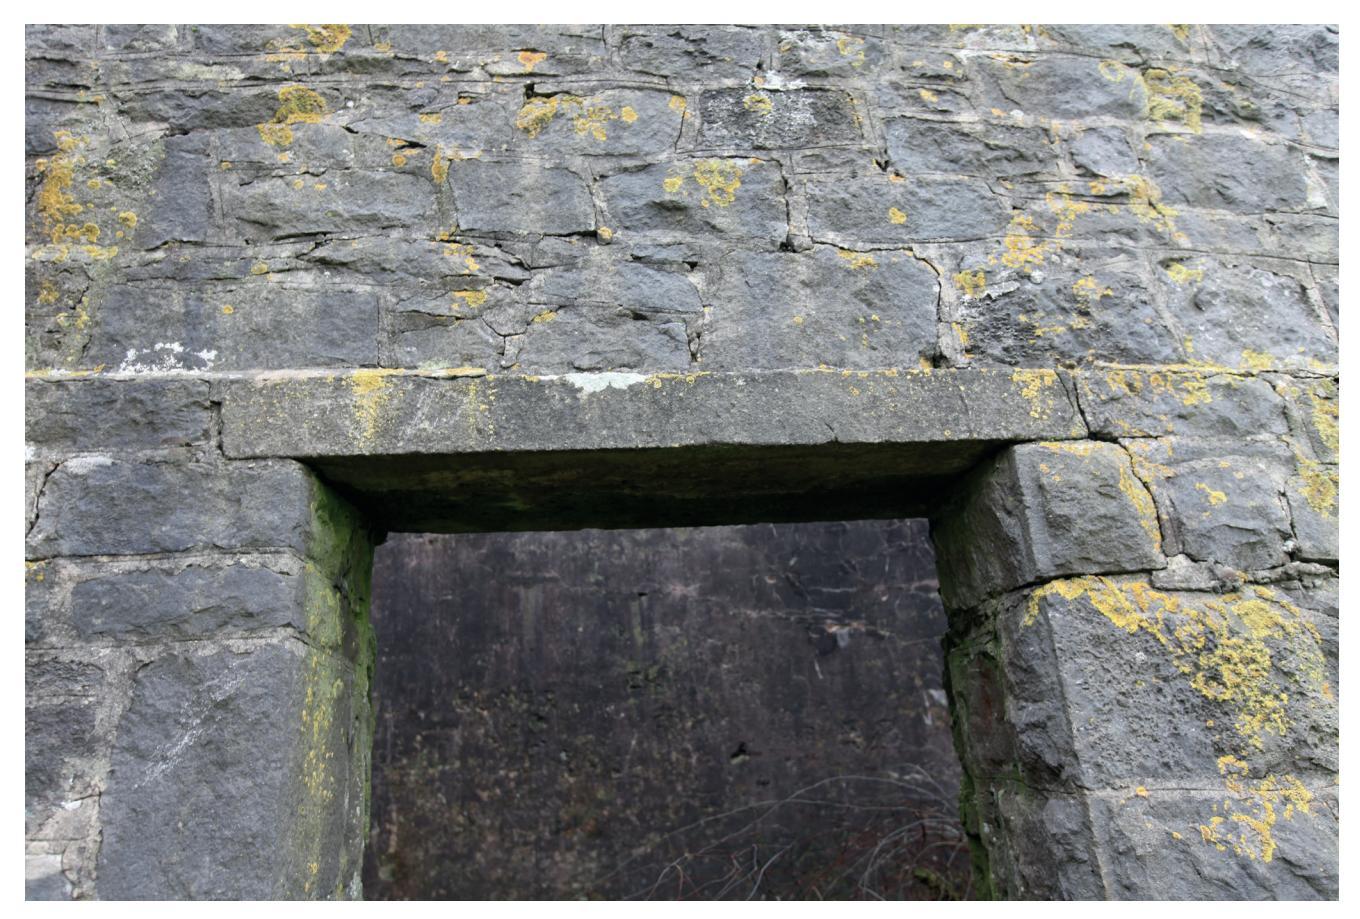
Plate 20 (ref. detail_lintel_020122) Fissile limestone lintel over the only doorway. The lintels to the back have rotted away. A crack fracture suggests some slight movement.

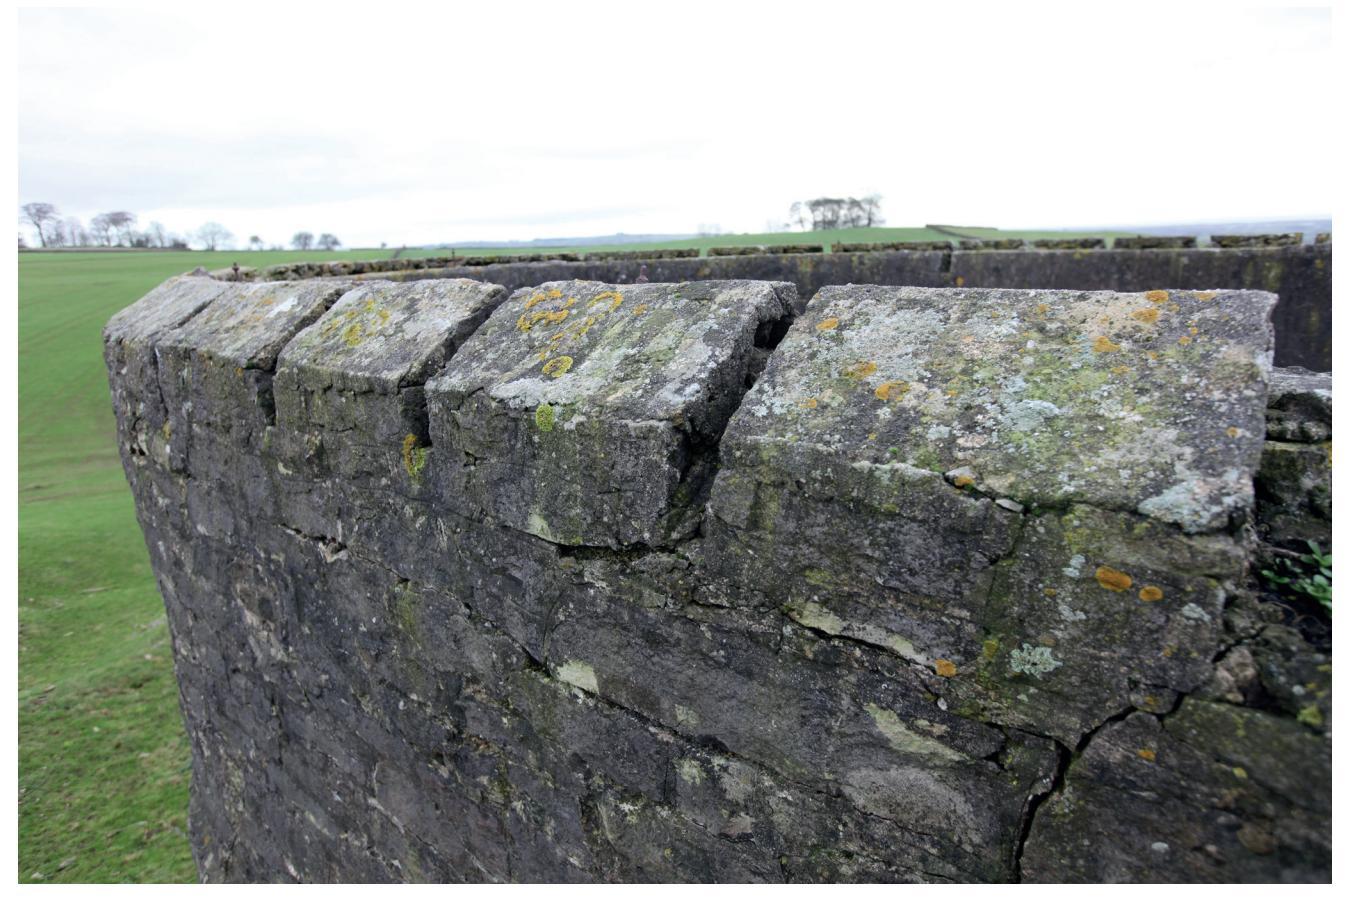
Plate 21 (ref. detail_north_eaves_wallhead_020122)

Detail of the location of former narrow rafters. Considering that there was no roof in 1945, these have stood the test of time remarkably well. The lack of projecting masonry suggests that the rafter feet would have projected far 4 beyond the wall.

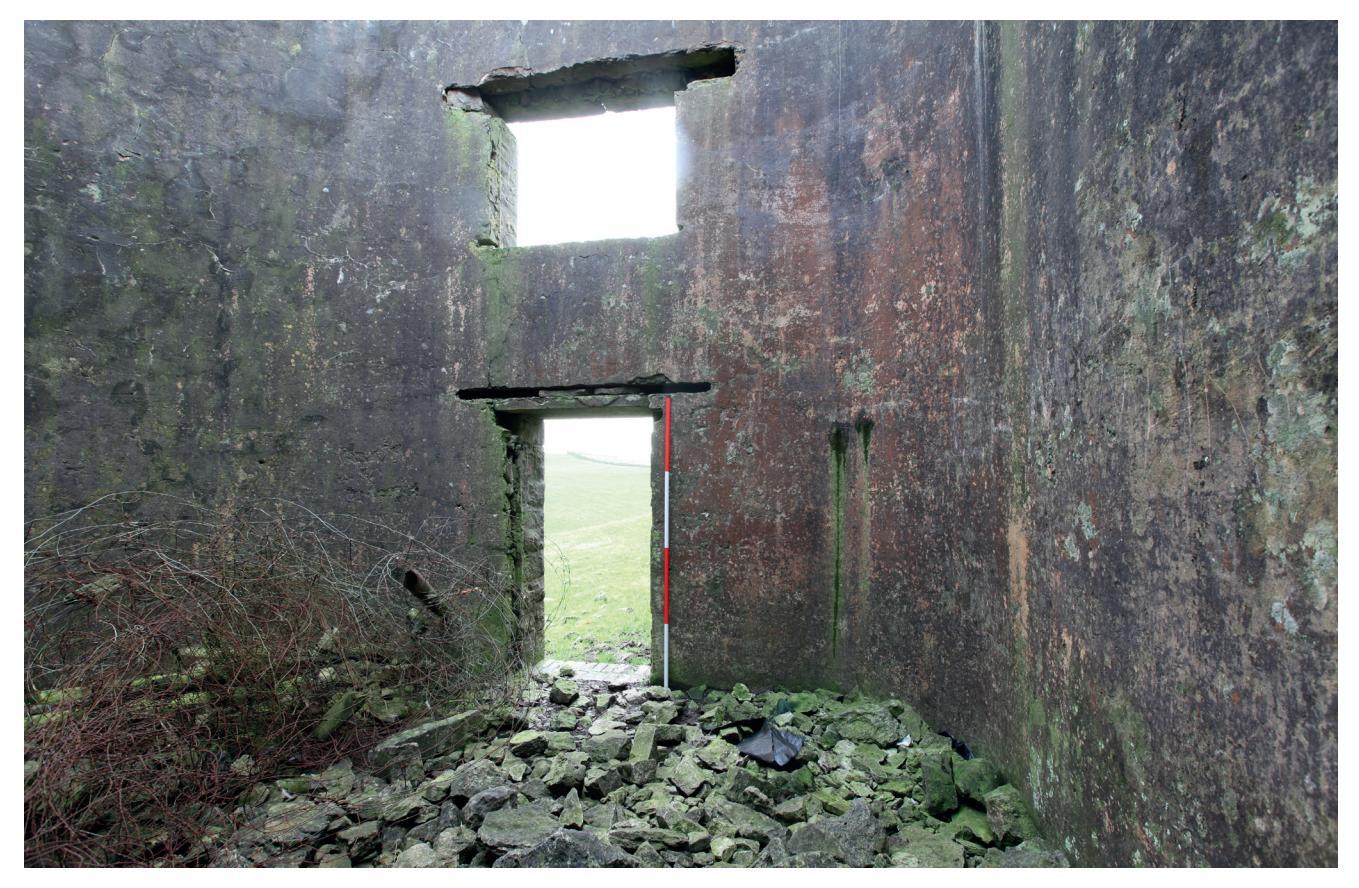
Plate 22 (ref. int04_02_01_22)

Internal cement-rendered walls. The internal lintel over the door was probably timber, which has rotted away over time. The external stone lintel over the window has collapsed, creating the impression of a larger internal lintel now.

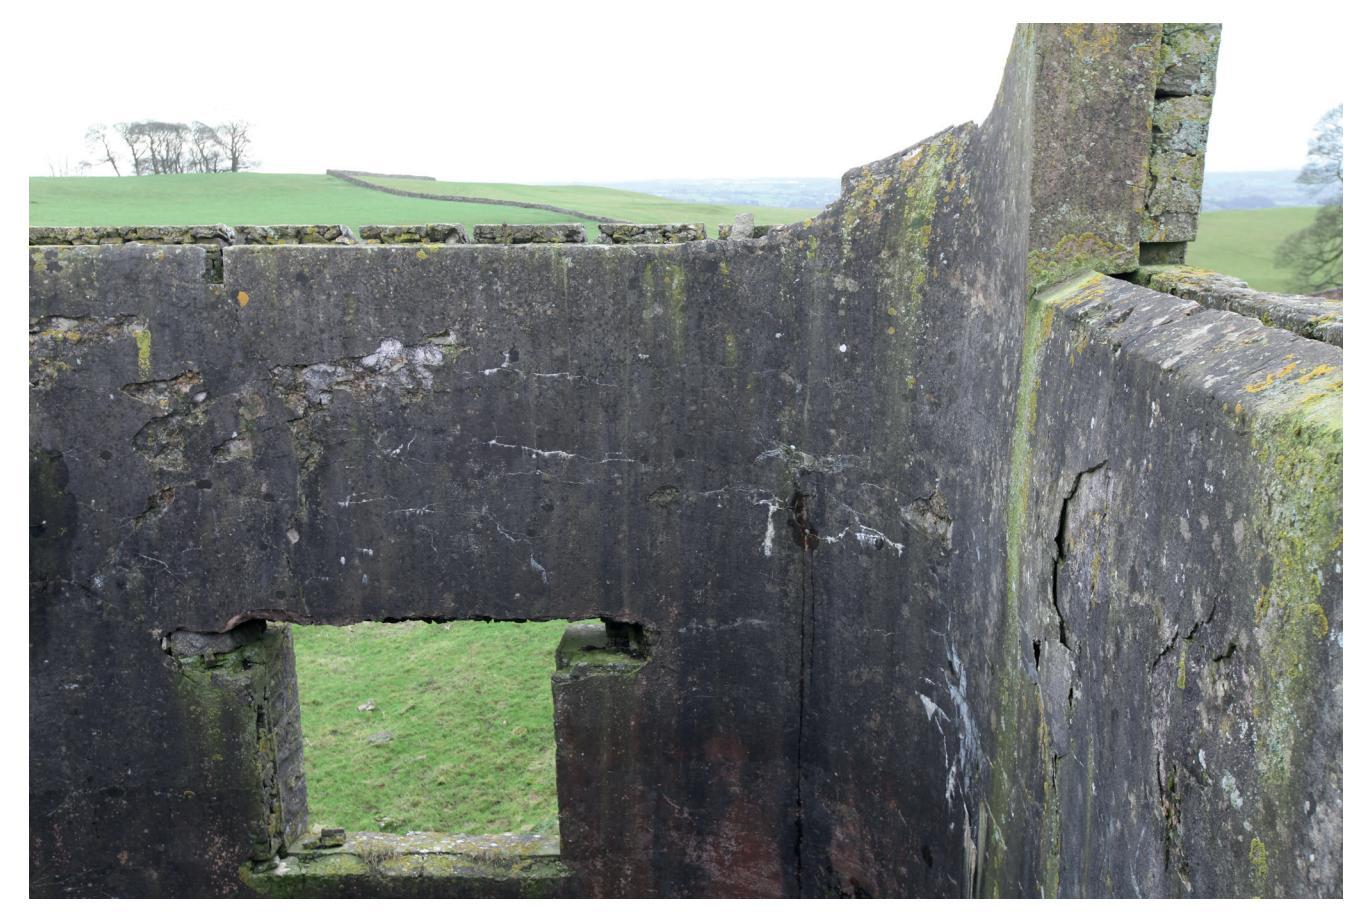
Plate 23 (ref. int08_02_01_22)

Wall-head at the upper stage of the tower, with shelf for the former wall-plate still visible; a deeper slot within the internal masonry / render (top left) may have formed a cross-bracing piece. Cement render reveals that the west gable 'window' or opening was face-planted, whereas the window to the middle stage of the tower was fixed to the back of the opening and finished flush.

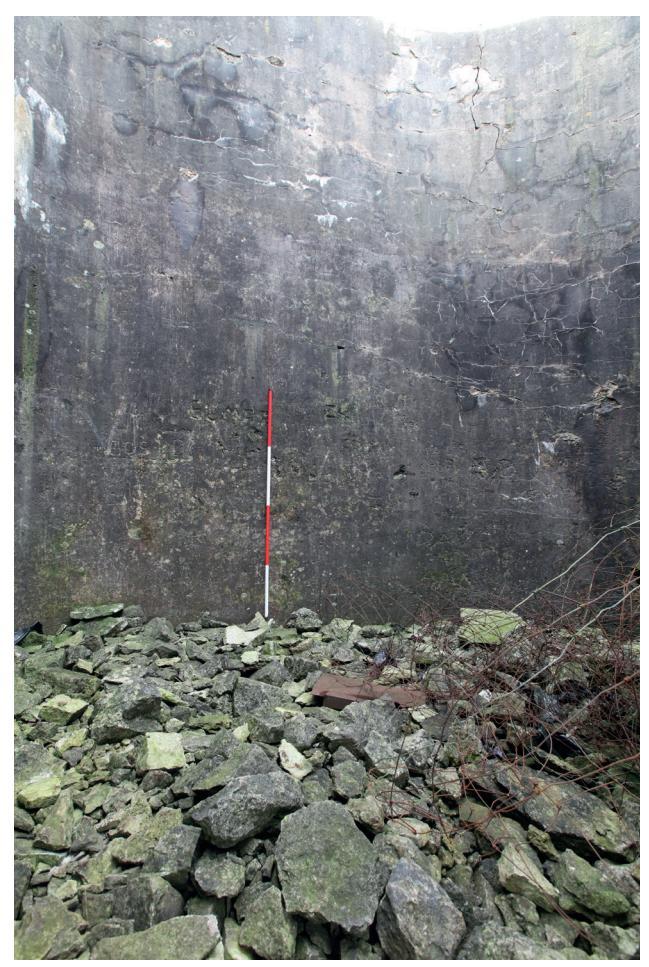
Plate 24 (ref. int02_02_01_22) Junction of rubble floor and rendered walls

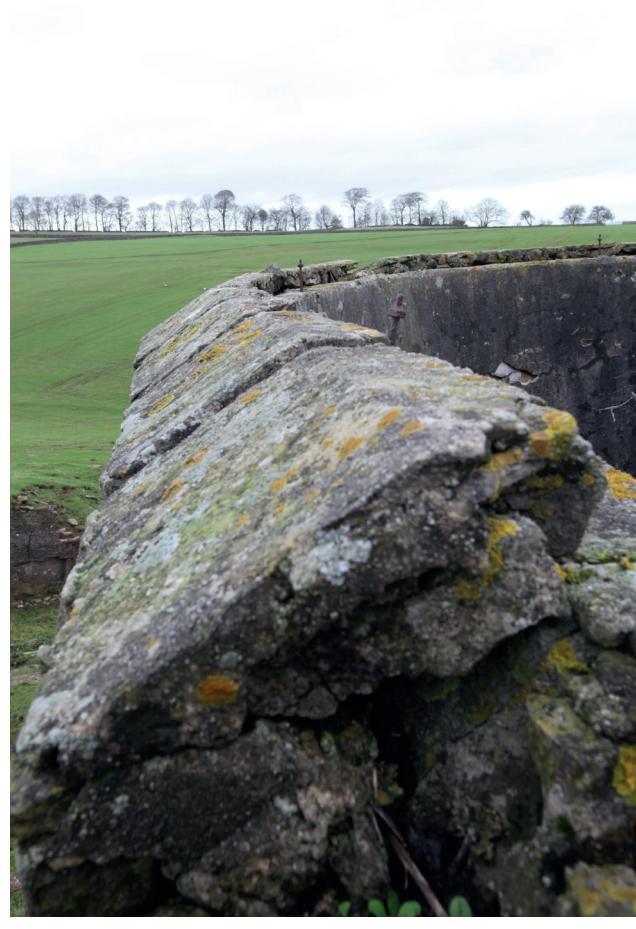
Plate 25 (ref. int12_02_01_22) Location of internal wall-plate and threaded bolts

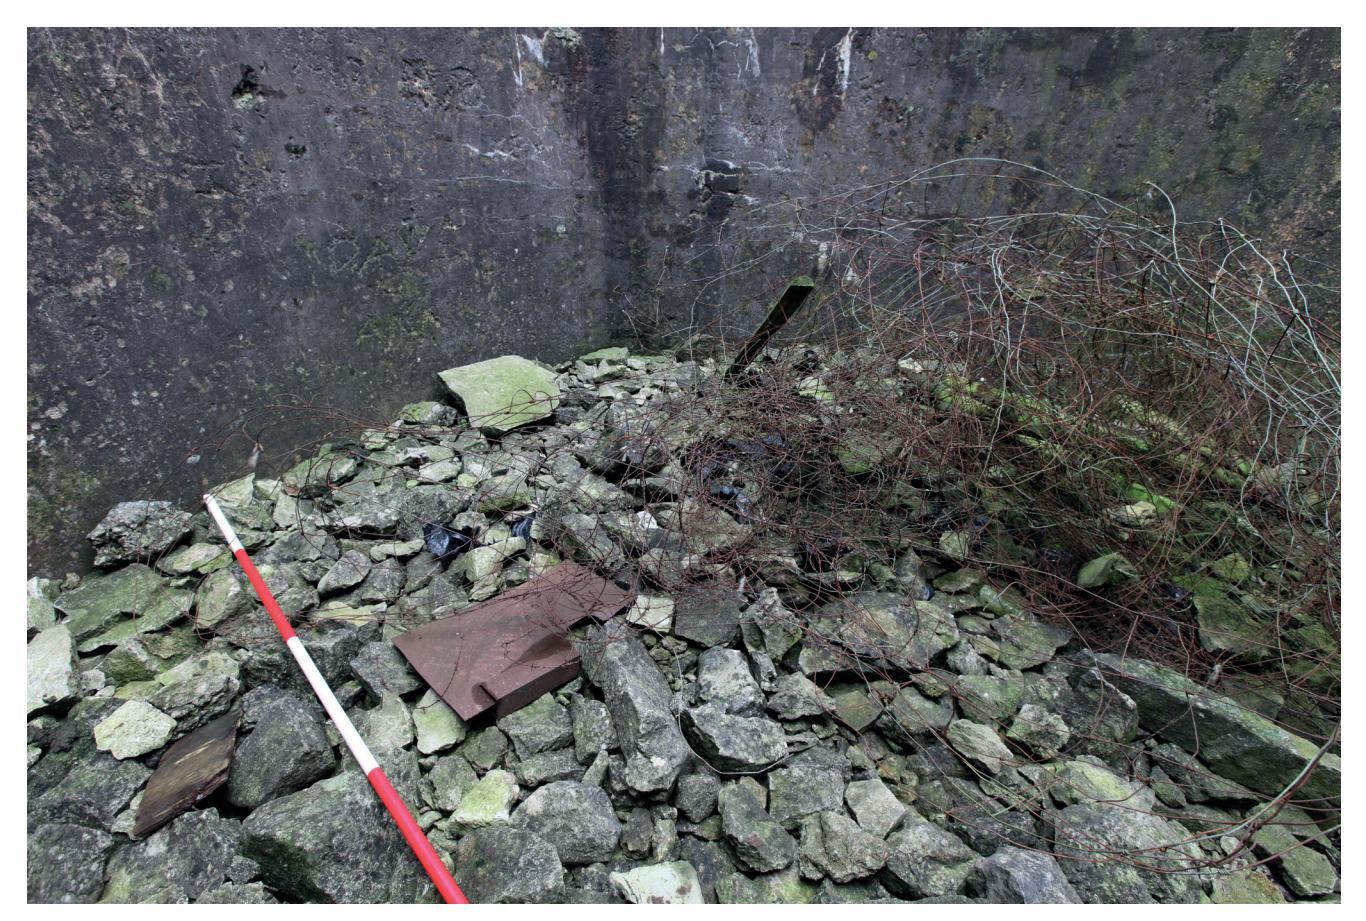
Plate 26 (ref. int07_02_01_22) - rubble stone floor

The floor of the structure is largely rubble limestone fill. There are no signs that this is rubble from collapse of the gable of the structure, so careful investigation and excavation will be needed to determine whether the limestone is part of the original finish or whether the structure had a flat floor. If it had a flat floor, excavation may be able to determine whether there were any fixings in the floor for machinery or a staircase.
