# **ARCHAEOLOGICAL OBSERVATION**

### SHIPTON MOYNE WATER MAIN REPLACEMENT SCHEME PHASE II SHIPTON MOYNE **GLOUCESTERSHIRE**

#### NGR: ST 89848 88462 - ST 90995 90265 **REF: BA1201SHBWP2**

NOVEMBER 2013

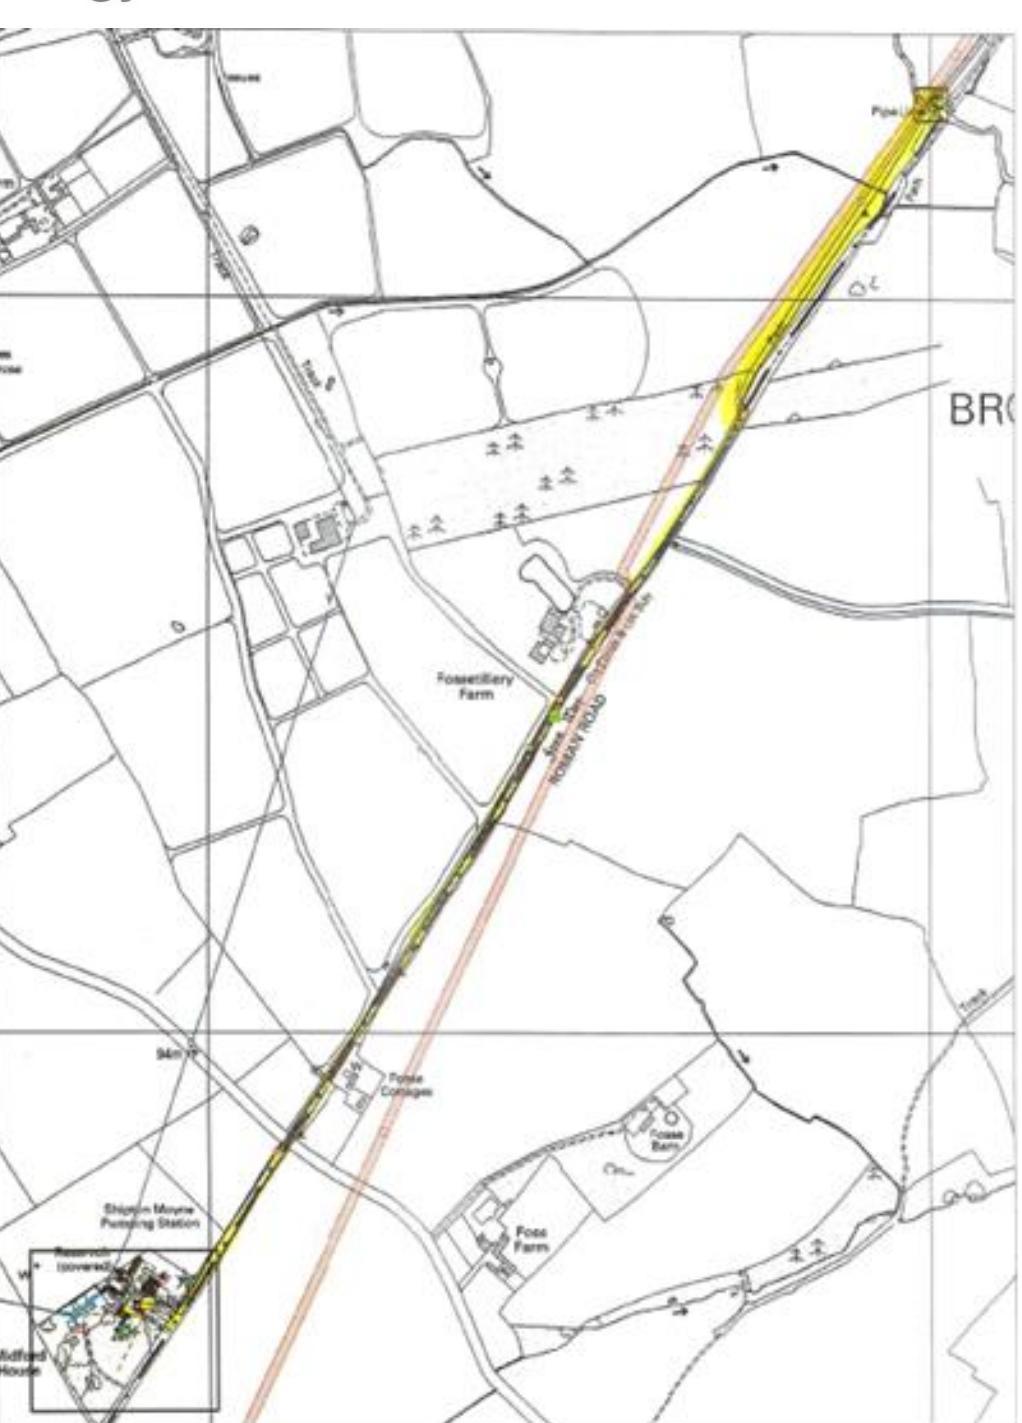
Fig 1: Plan showing the route of the pipeline from Shipton Moyne Pumping Station to the River Avon (marked in yellow) with an existing gas pipeline marked in red

Border Archaeology was instructed by Bristol Water plc, to carry out a programme of Archaeological Observation along the specified route (*fig. 1*) during ground works. The observed section of pipeline extended NE from Shipton Moyne Pumping Station (NGR ST 89848 88462) for 1484m along the line of the Fosse Way and 534m through fields immediately W of the Fosse Way, terminating at the crossing of the River Avon (Tetbury Branch) at NGR ST 90995 90265. The work was carried out by Border Archaeology in compliance with Bristol Water's *Code of Conduct*. The site and trench plans are based on drawings supplied to Border Archaeology by Bristol Water for information.

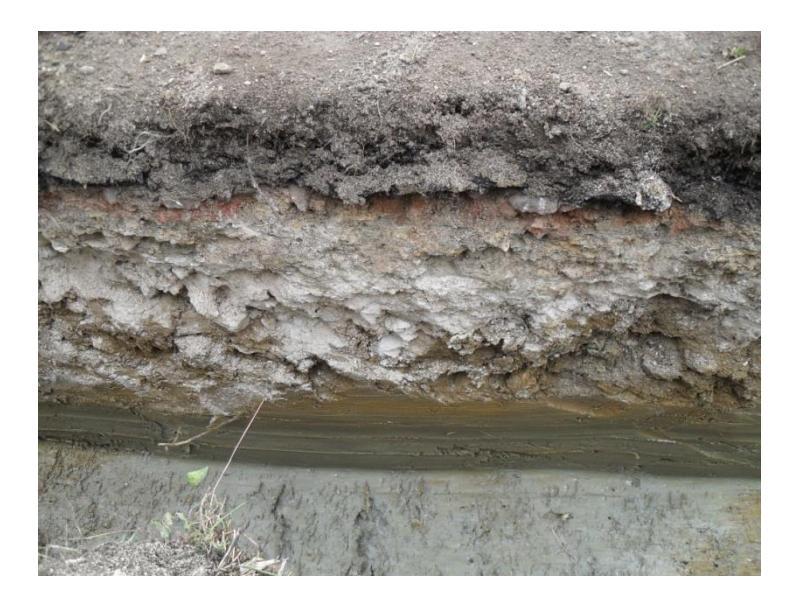
Plate 1: SE-facing view of road stratigraphy between Shipton Moyne pumping station and the crossroads

The following deposits and features were encountered from the point at which the pipeline exited the Pumping Station and continued NE along the Fosse Way towards the crossroads with an unclassified road leading NW-SE from Shipton Moyne to Malmesbury. A total of six contexts were observed along this section of trenching, the uppermost (101) consisting of a tarmac layer, 0.20m thick which overlaid a thin deposit of brick rubble (102) 0.05m in thickness representing a sub-base deposit for the modern road. Underlying (102) was a 0.45m thick layer of well compacted medium to large limestone fragments set in a greyish-brown silty matrix (103) with frequent inclusions of brick rubble and tar, interpreted as a road make-up deposit of probable late post-medieval or modern date, probably postdating construction of the pumping station (built in 1919).

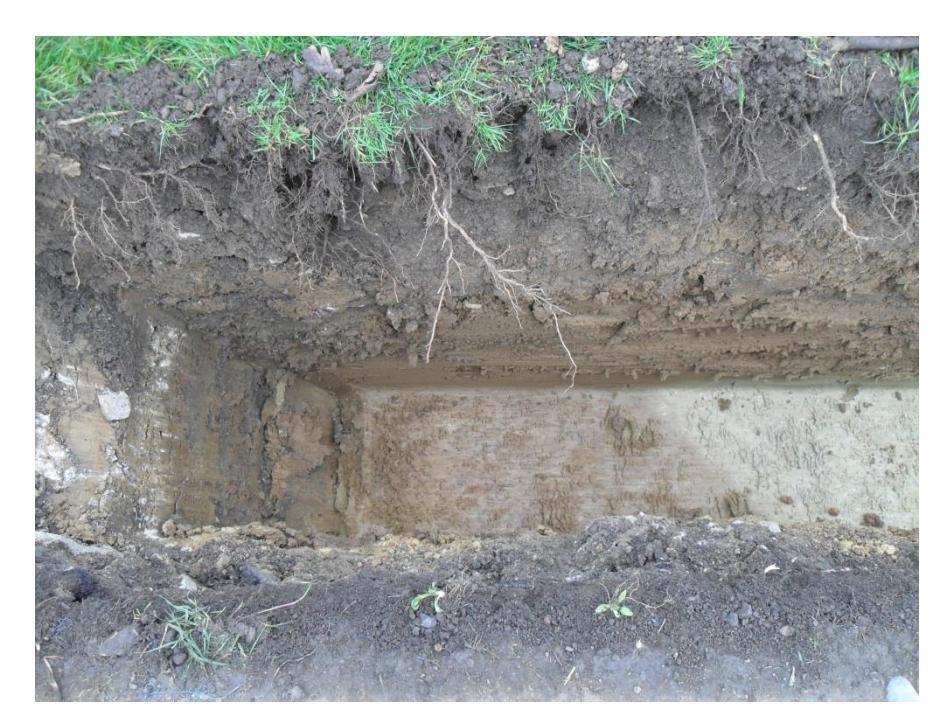
Plate 2: W-facing view of E-W aligned linear [208] identified in trenching to NE of crossroads

Two features were observed in this section of trenching, the first comprising a roughly E-W aligned linear [208] identified towards the base of the trench approximately 20m NE of the crossroads. This appeared to be the cut of a field drain (*Plate 2*); however, moments after discovery, the trench flooded and, with it located so close to the crossroads, it was never revealed again with such clarity.

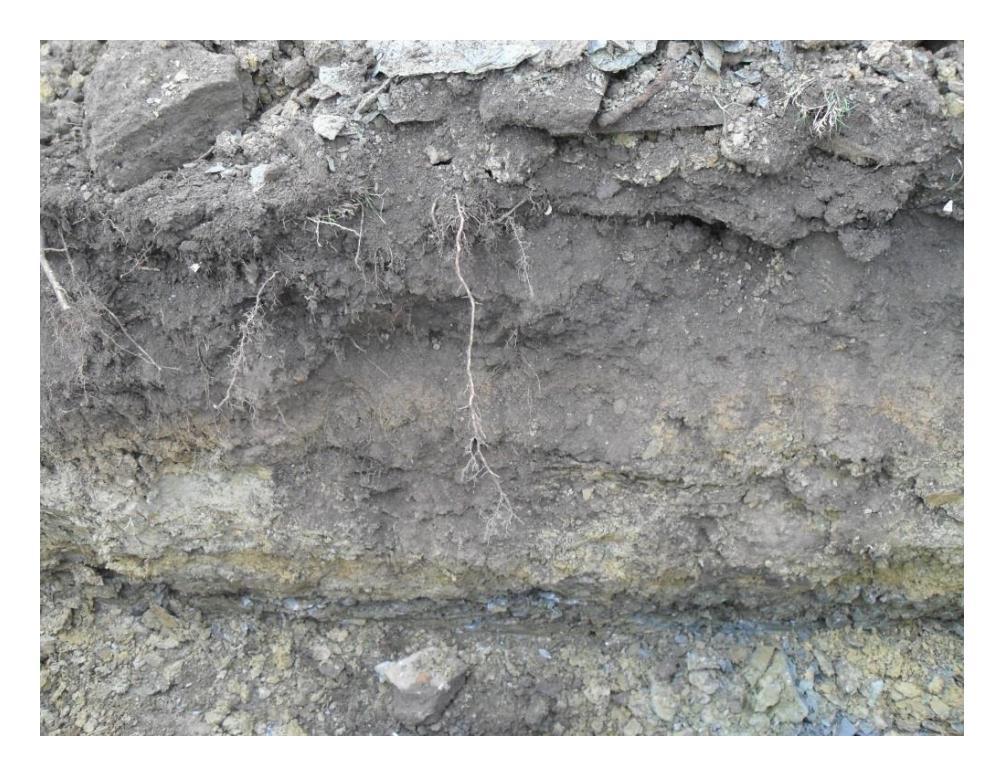
Plate 3: W-facing view of midden area outside Fosse Cottages

Immediately opposite Fosse Cottages, the pipeline trench encountered a distinct midden spread (209) containing early 20<sup>th</sup> century domestic waste underlying (202) at an approximate depth of 0.40m (*Plate 3*). The midden spread, measuring roughly 0.10m thick, comprised a dump of glass bottles, bone, iron and late 19<sup>th</sup>/early 20<sup>th</sup> century pottery within a greyish-brown gritty silty clay matrix. The bottles, and particularly bottle caps, were indicative of late 19<sup>th</sup> or early 20<sup>th</sup> century date. The proximity of the deposit to the cottages would explain the domestic nature of the material.

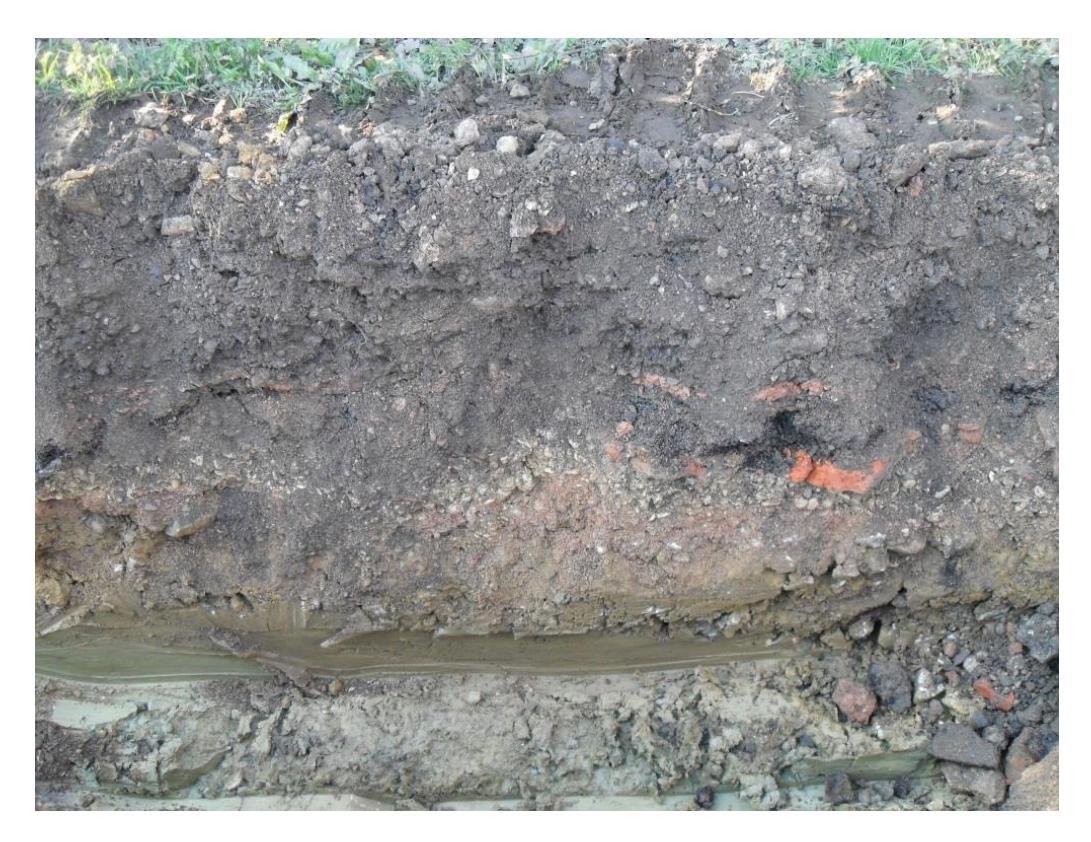
Plate 4: SE-facing view of substantial brick rubble layers within the road stratigraphy to the NE of Fosse Cottages

From NGR ST 90253 89075, as the road incline gradually levelled out, the stratigraphy was recorded as consisting of the tarmac road surface (301), 0.10m thick which in turn overlaid a substantial deposit of red brick rubble within a greyish-brown silty matrix (302), extending to a depth of 0.70m and overlying a moderate to well compacted greenish clay with rubble fragments (303) which in turn overlaid a firm orange/blue sandy clay (304) extending to the base of the trench (approximately 1.10-1.20m). The brick fragments were both frogged and unfrogged and were incorporated with fragments of plaster and iron (*Plate 4*).

The bricks were most likely associated with the brick and tile works situated immediately W of the Fosse Way, in the location of present Fossetillery Farm, which were first recorded in 1859 as a tilery and limekiln site and which are marked as 'Fosse Kiln' on the OS 1<sup>st</sup> edition map. The site appears to have remained in operation at least until the late 1890s. A hammer with a rubber grip was found amongst the bricks but appears to suggest re-deposition. The depth of the brick deposits precluded any possibility of encountering surviving Roman road surfaces and the regular levelling of the brick deposits suggests they were not merely used to fill potholes but that substantial road construction works were carried out, presumably in the late 19<sup>th</sup> century.

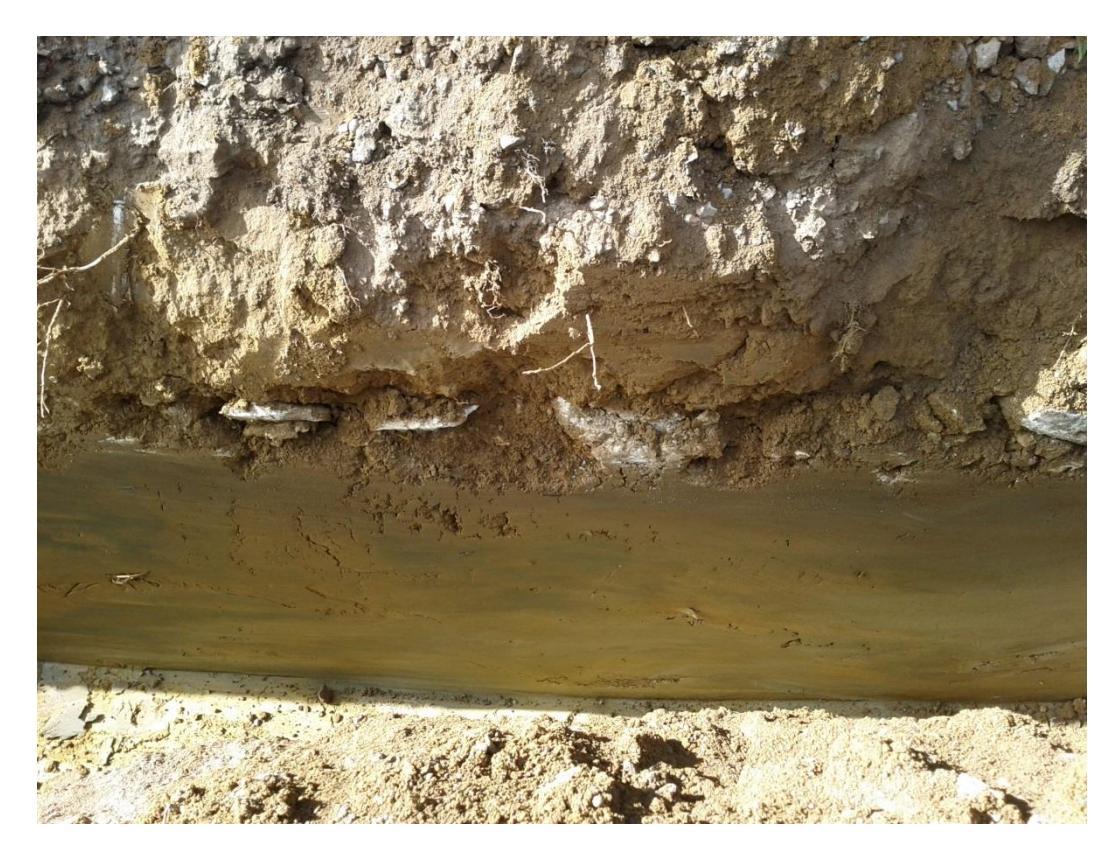
Plate 5: View looking SE showing NW facing section of trenching adjacent to badger setts between Fosse Cottages and Fossetillery Farm

The badger setts had impacted substantially on the stratigraphy, which comprised a 0.10m thick layer of tarmac and gravel (401) representing the modern road surface, underlying which was a loosely compacted pink and greyish-white gravel make-up deposit (402), approximately 0.30m thick. This in turn appears to have overlaid a thin band of moderately compacted yellowish-brown silty clay, 0.10m in thickness (403) containing occasional medium sized flattened stones which might represent faint vestiges of earlier road surface, possibly of Roman date although there was insufficient evidence to confirm this hypothesis as much of the stratigraphy in this section had been heavily disturbed by the badger setts.

Underlying (403) was a moderate to well compacted yellowish-brown clayey sand (404) with occasional stone inclusions which extended to the base of the trench (approximately 1m depth).

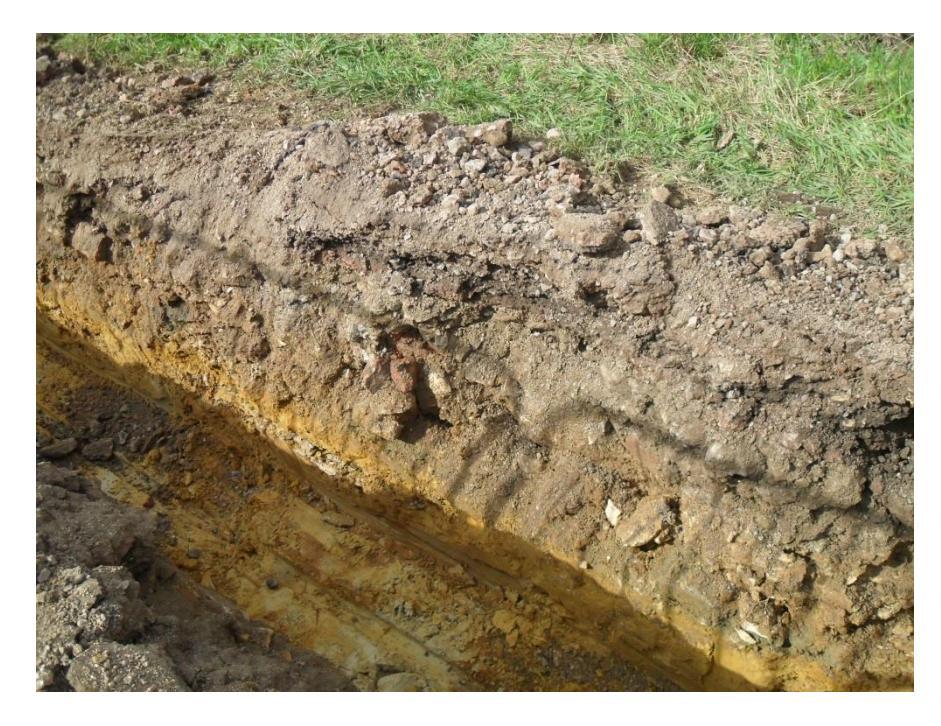
Plate 6: View looking SW showing SE-facing section of trenching to SW of Fossetillery Farm

Continuing NE beyond the area of the badger setts towards Fossetillery Farm, the stratigraphy again exhibited evidence of change. A total of four contexts were observed, the uppermost consisting of a substantial layer of tarmac representing the modern road surface (501), 0.30m in thickness, which in turn overlaid a friable tar and brick rubble deposit (502), approximately 0.10m thick. Underlying (502) was a 0.30m thick deposit of moderately compacted golden yellow gravels (503) which in turn overlaid a well compacted blue sandy clay (504) interpreted as natural substrate. It is possible that (503) may represent evidence of a make-up deposit associated with the earliest construction of the Fosse Way (*Plate 6*).

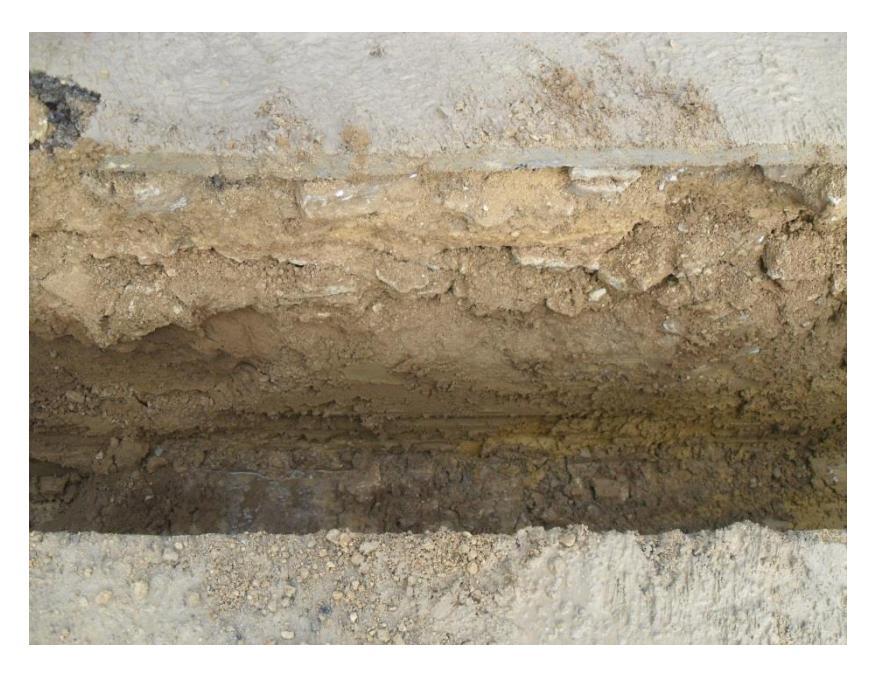
Plate 7: View looking NW showing SE-facing section of road stratigraphy SW of Fossetillery Farm

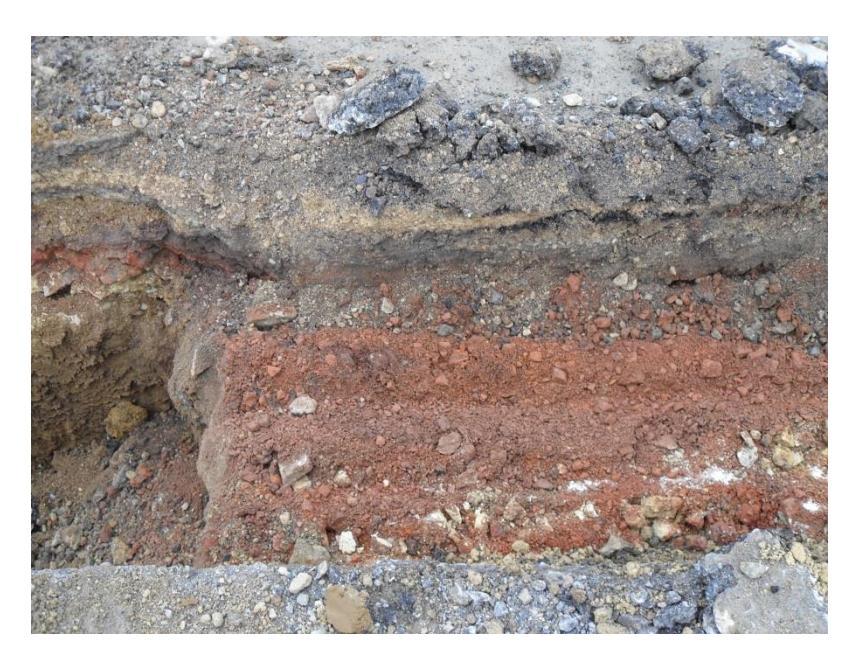
Plate 8: View looking NW showing road stratigraphy immediately E of Fossetillery Farm

Immediately to the E of Fossetillery Farm, the natural orange sandy clay substrate (703) was encountered at a shallow depth of only 0.20m below existing ground level, the overlying deposits consisting of the tarmac road surface (701) overlying a thin, loose to moderately compacted layer of brick rubble fragments (702). It seems highly likely that the previous road surfaces were lifted and re-laid as part of improvement works around the house and farm buildings in the 19<sup>th</sup> and 20<sup>th</sup> centuries. As such, any trace of the Roman road had been destroyed and the only observable features beneath the road were the linear cuts for the old water main [704] and the modern gas main [705] running NNW-SSE across the road.

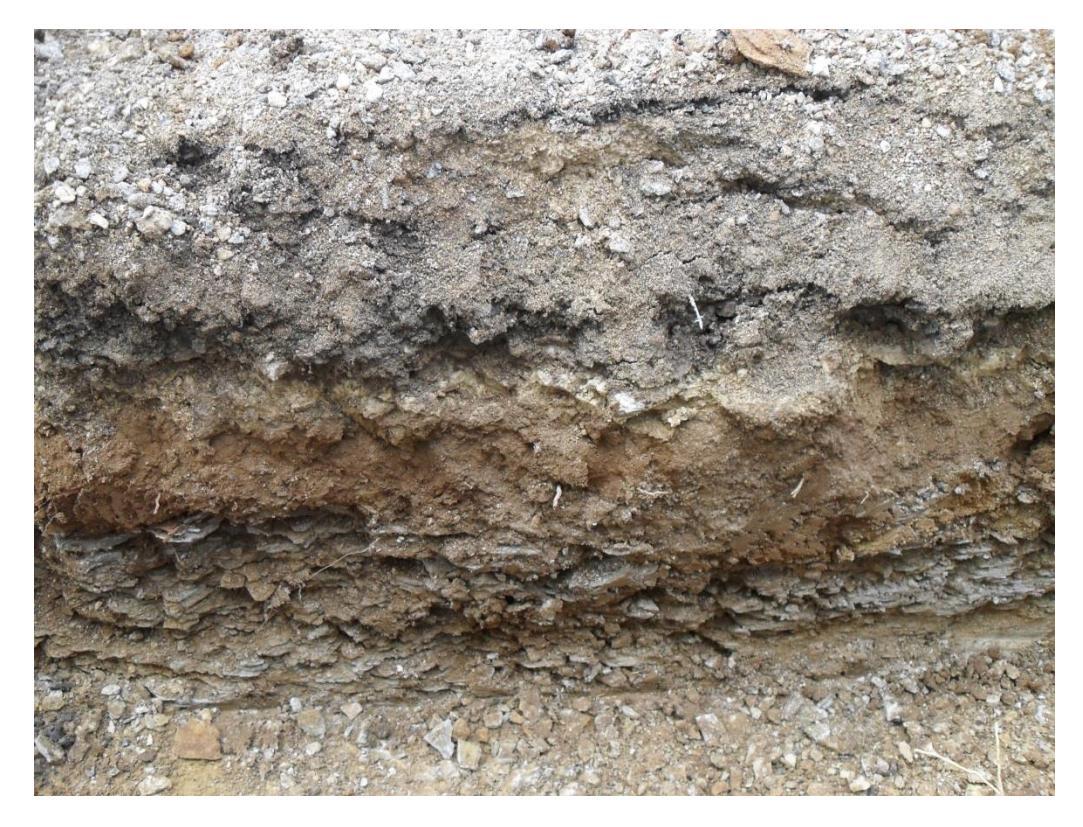
Plate 9: View NW showing SE facing section of road stratigraphy beyond road junction to NE of Fossetillery Farm

Beyond the road junction to the NE of Fossetillery Farm, the stratigraphy again changed, with the modern tarmac road surface (801) overlying a grey clayey silt (802) 0.20m thick with frequent stony inclusions, underlying which was an orange red sandy clay (803), 0.40m in thickness, which in turn overlaid the natural limestone bedrock (804), recorded at a relatively shallow depth of 0.70m below ground level (*Plate 9*).

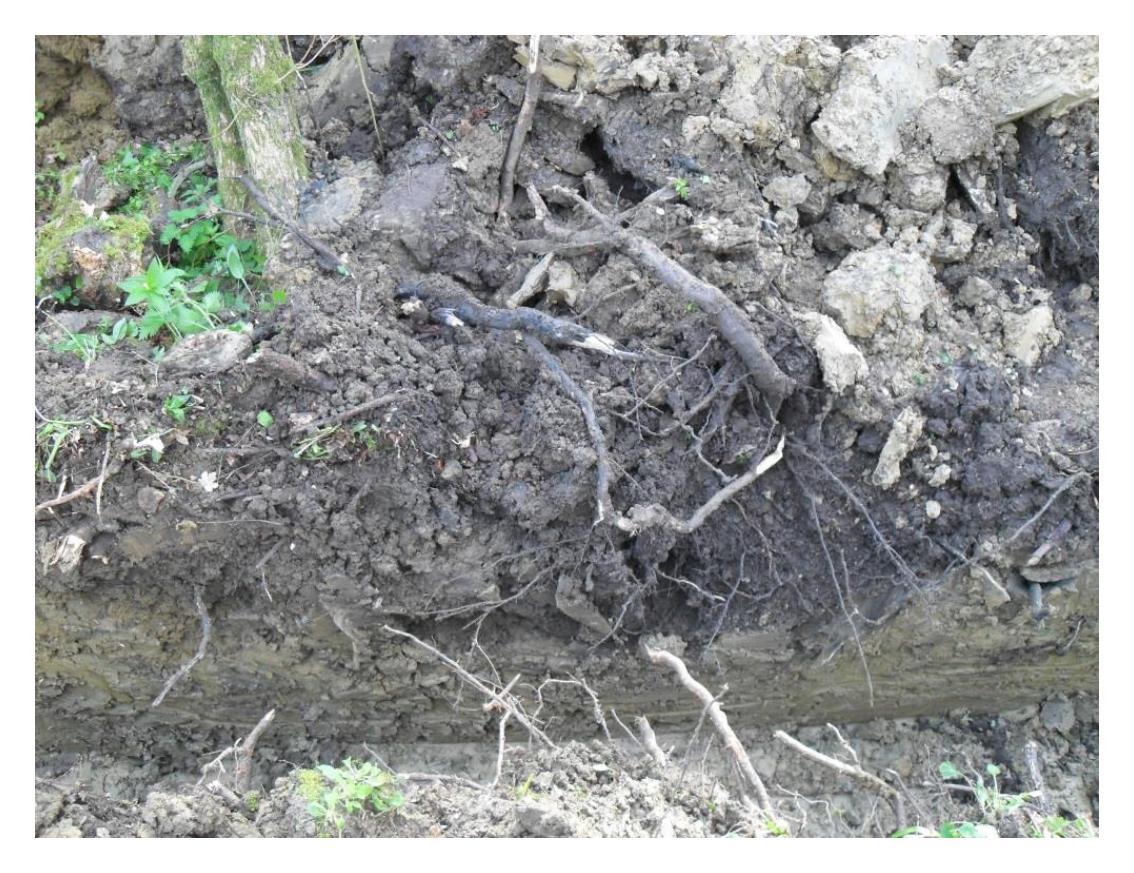
Plate 10: View looking NW showing NW-facing section through bank alongside Fosse Way

Where the pipeline crossed into the fields bordering the NW side of the Fosse Way an earth bank (903) and slight ditch [904] were visible on the ground surface parallel and immediately adjacent to a short section of the road (*Plate 10*). However, this bank and ditch appeared almost certainly to relate to a field boundary of late post-medieval or modern date as it lay wholly within the topsoil, with no suggestion of the subsoil having been cut or re-deposited. This was further complicated by the extreme root action affecting that section through the bank and ditch impacted by the pipe trench. Several land drains crossed the field and an open drain formed the field boundary to the NE field.

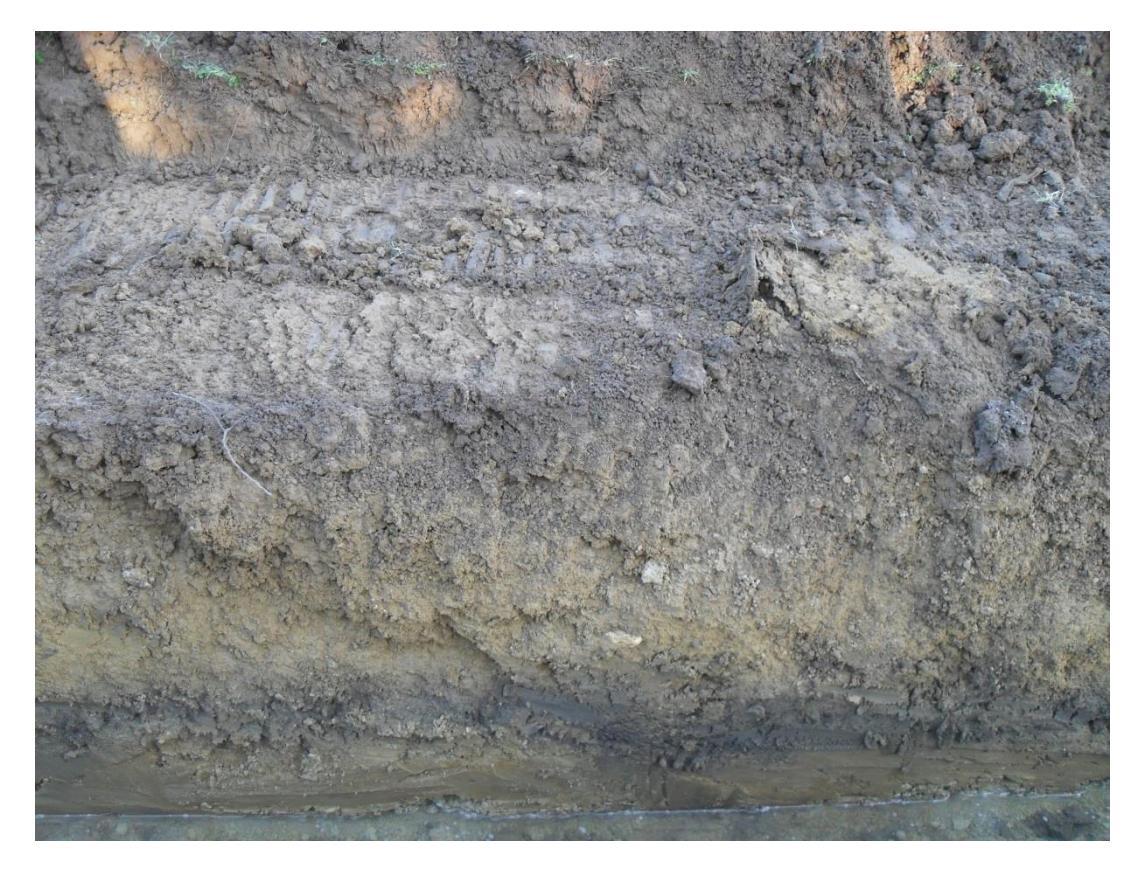
Plate 11: SE-facing view of alluvial layers identified in the vicinity of the River Avon at the NE end of the pipeline route

As the land sloped towards the River Avon, the stratigraphy changed from that exhibited in the first field to a series of alluvial deposits (*Plate 11*).

Underlying the topsoil (9101) at a depth of 0.20m was a brownish-yellow sandy clay (9102) with frequent shells and occasional small stones, with thin alluvial bands (9103) of brownish-grey silty sandy clay within the same deposit. Beneath (9103) was a deep deposit of bluish-grey alluvial marl (9104), identified at a depth of 0.60m and extending to a depth of 1.3m below ground level. Due to health and safety constraints, it was not possible to obtain a sufficient sample from this deposit for further assessment.
