Minninglow Limekiln Level 3 Survey - Historic Building Recording Client: Mark Edge, Minninglow Grange

Melanie Lloyd Morris BA Hons, Dip. Arch. Cons, IHBC, MRTPI Mel Morris Conservation

14th September 2022

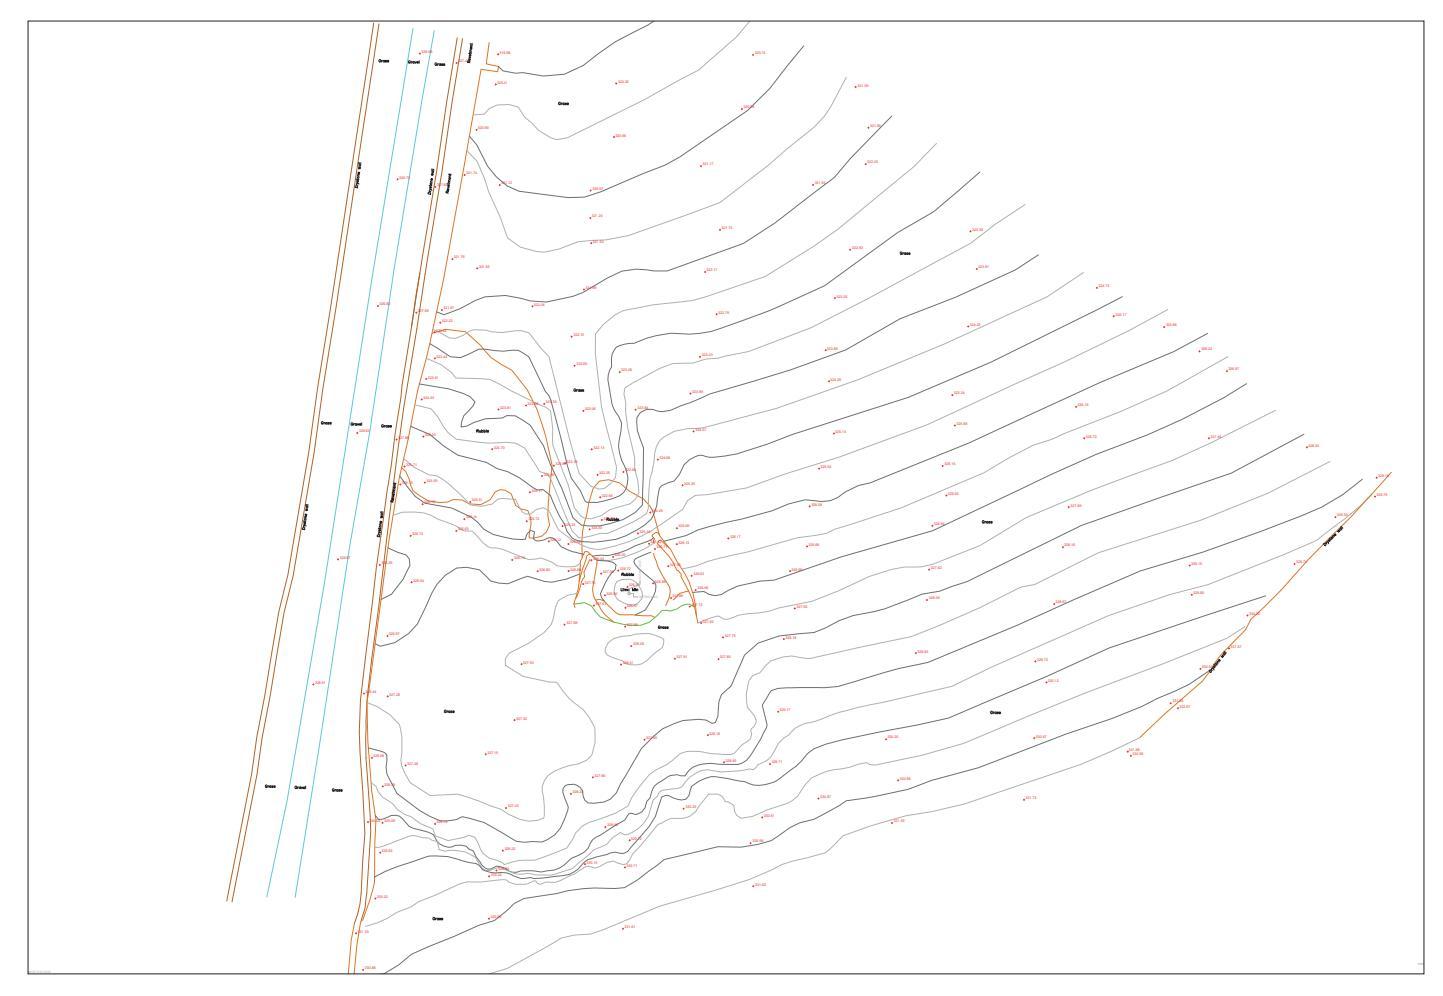
Plate 3 - Survey Drawing of the Limekiln, route of the railway and quarried area to the south (James Brennan Associates)

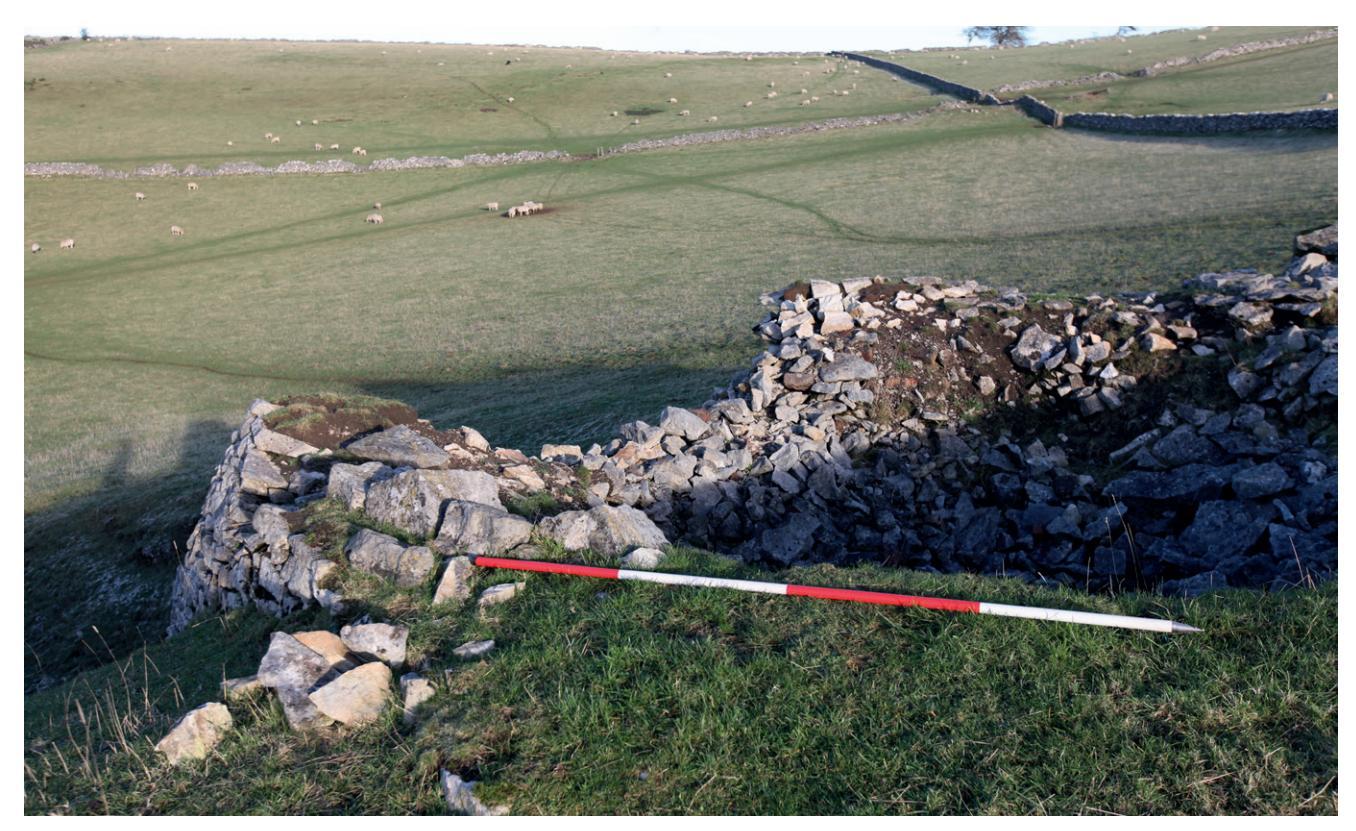
Plate 11 (01_040122) West flank apex, showing current 'crest' of remaining limestone rubble, where collapse has taken place.

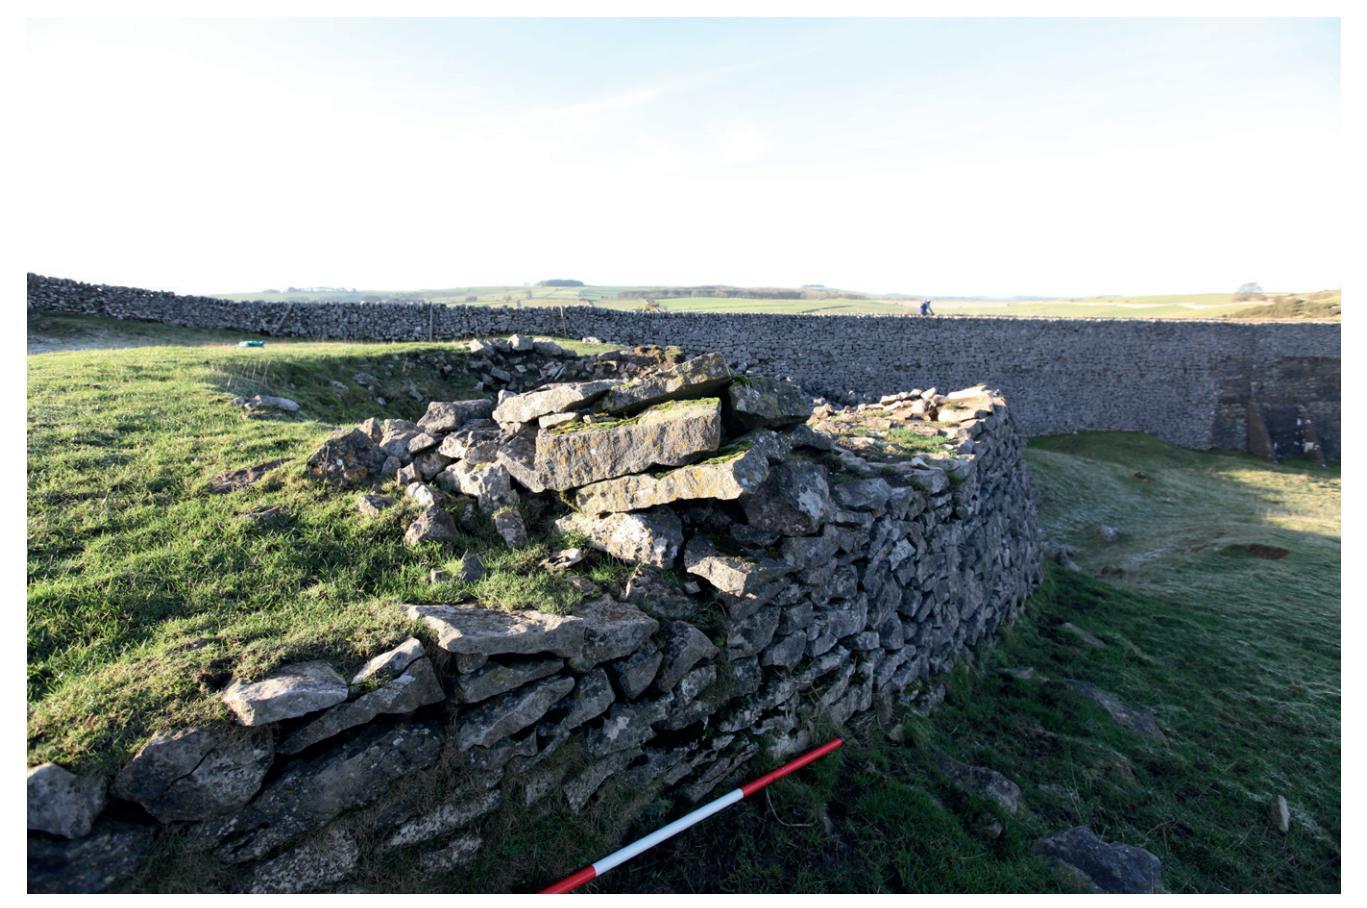
Plate 16 (15_040122) East flank with straight-sided batter

The structural engineer's report refers to a 1.5 degree batter. This is not an even batter and there is a distinct tapering change in the outward face of the kiln at the northern apex where the batter is closer to 15 degrees, as recorded in photographs.

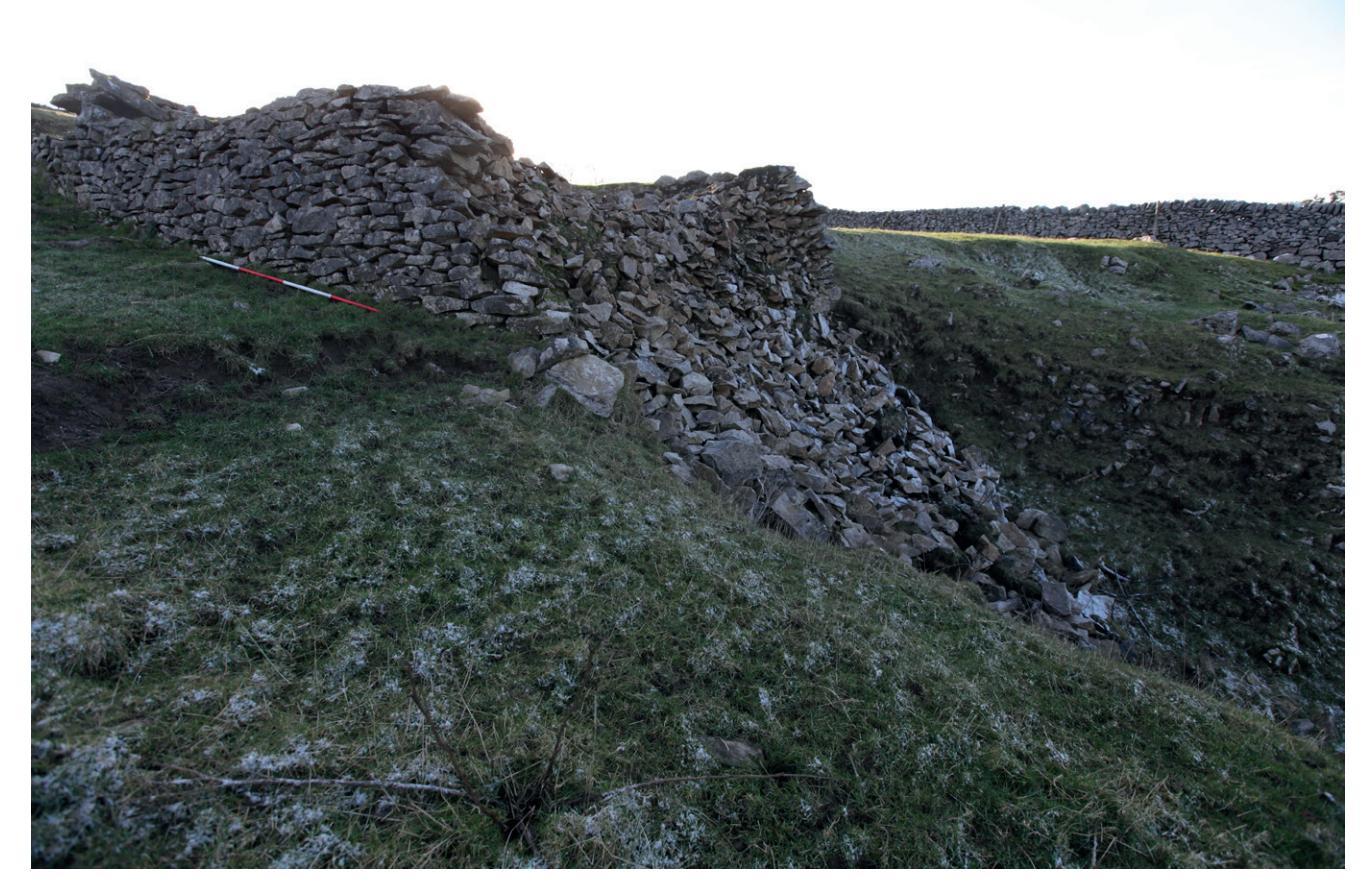
Plate 18 (18_040122) East flank and area of collapse to north

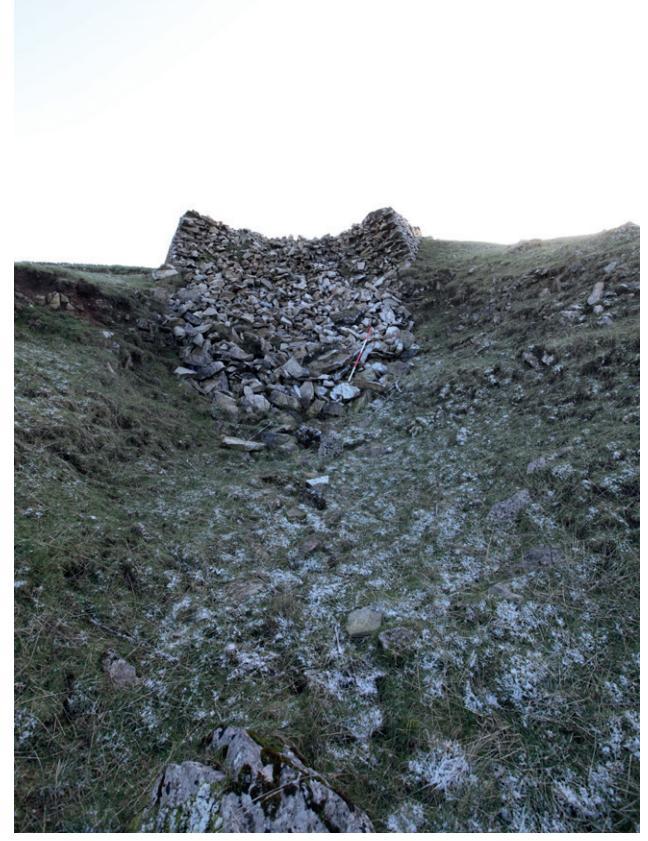
Plate 19 (21_040122) Viewv of collapsed north face

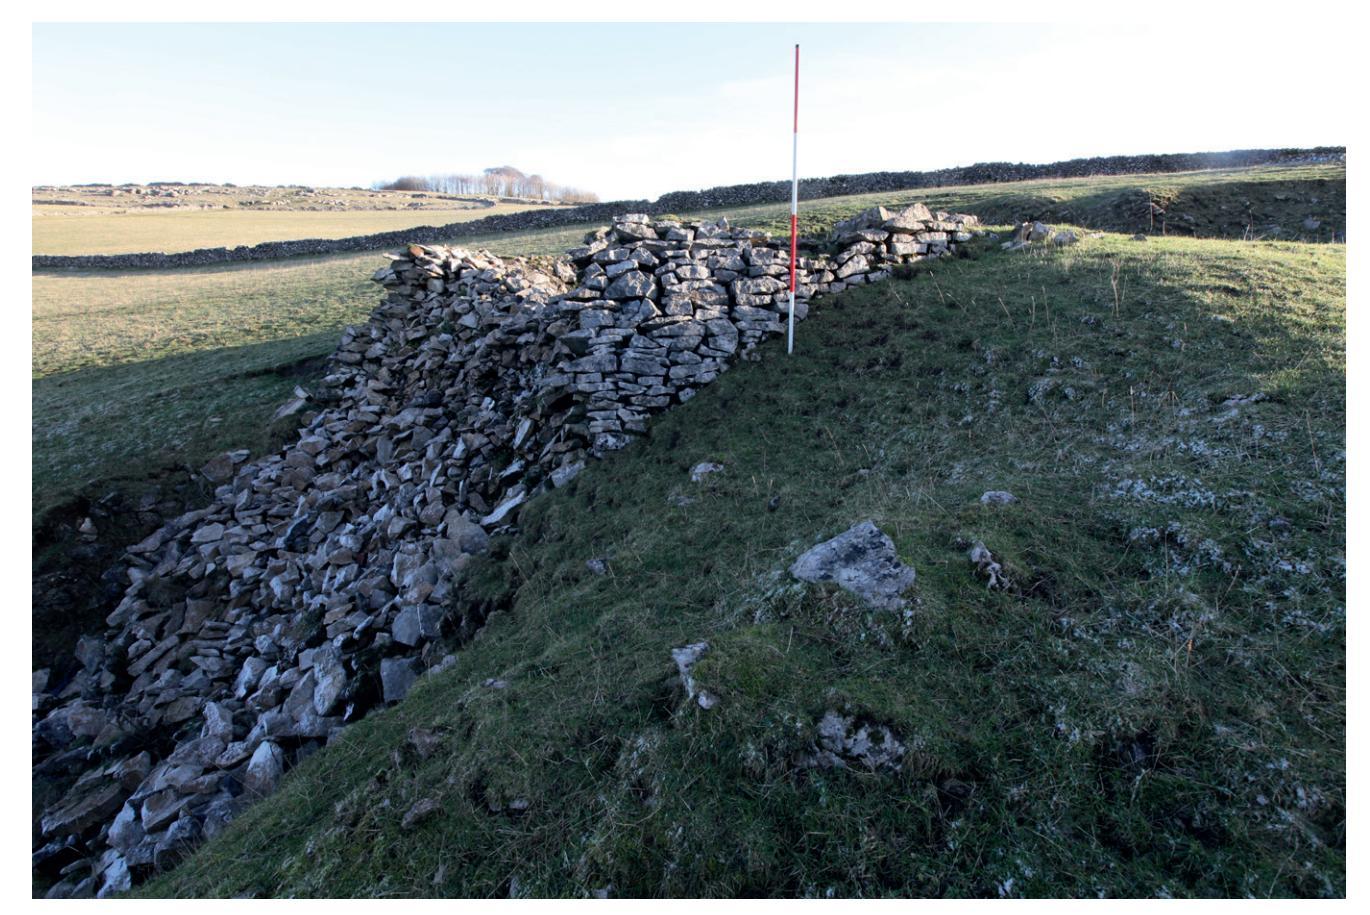
Plate 21 (23_040122) $\,$ - west flank remains and collapsed rubble

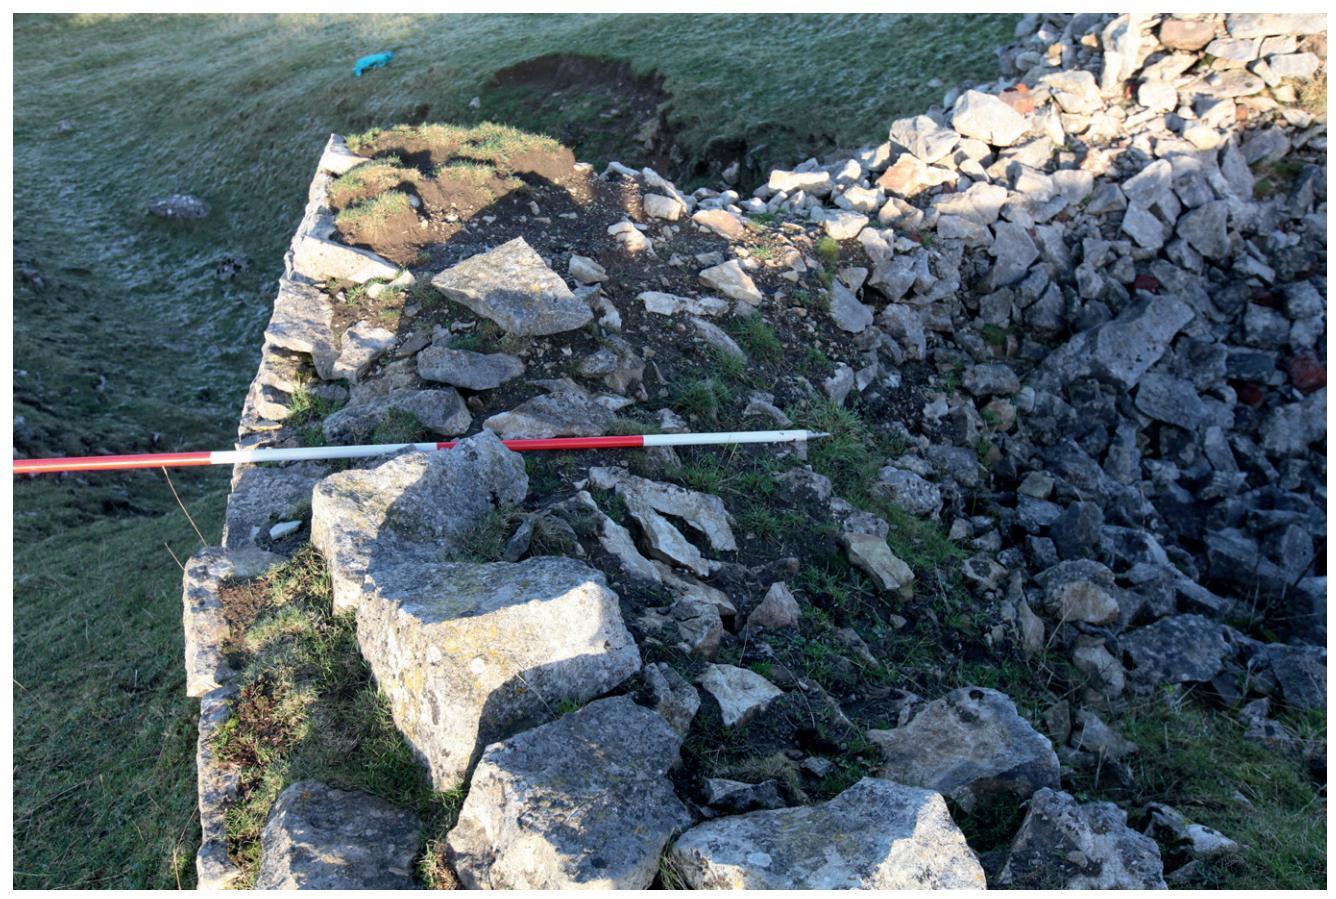
Plate 22 (27_040122) Apex of west flank with straigjt-sided batter and very slight curve towards the former north face (collapsed)

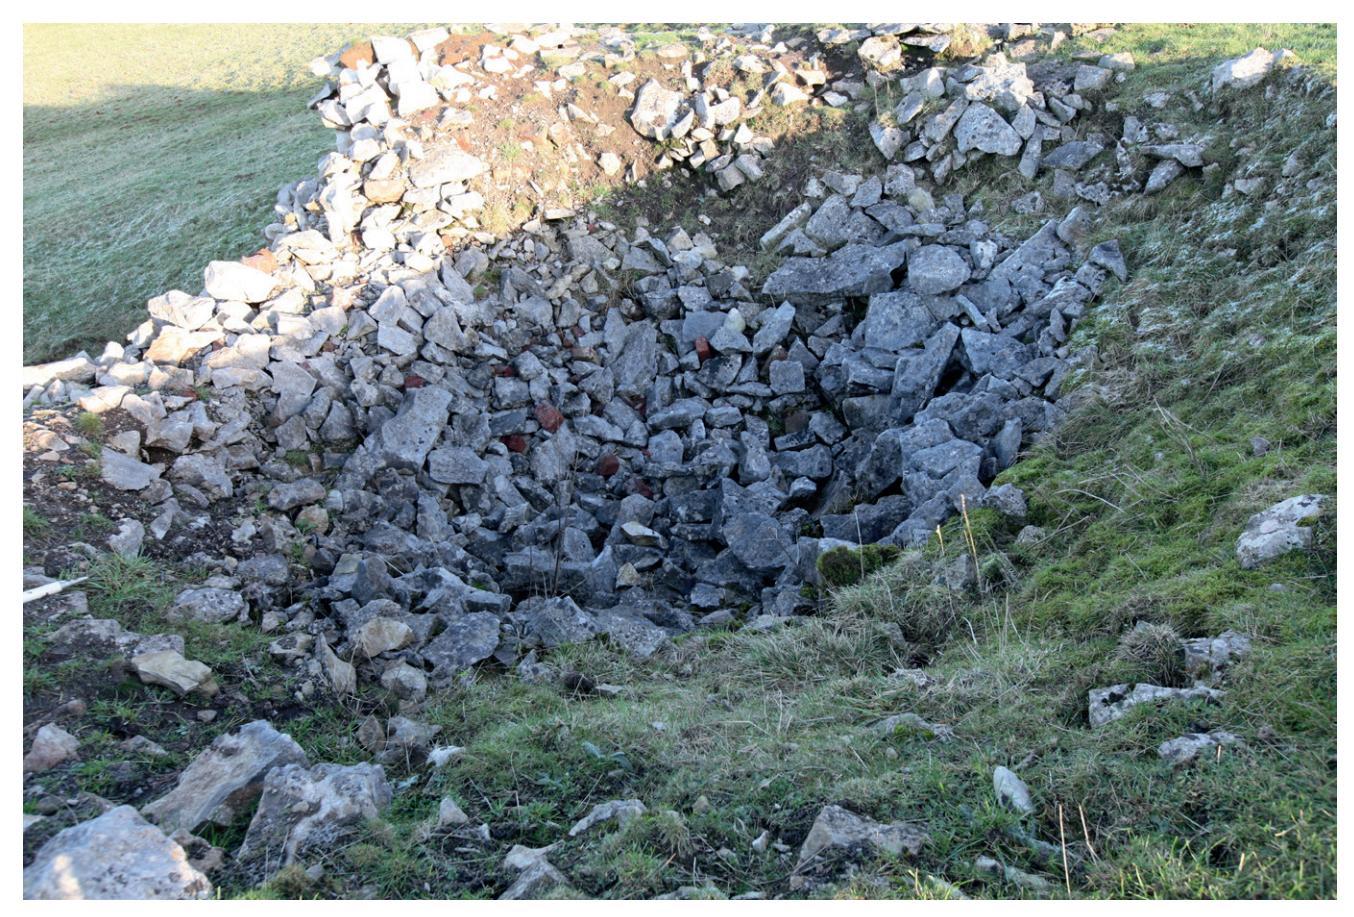
Plate 23 (29_040122) Rubble and remains of charge

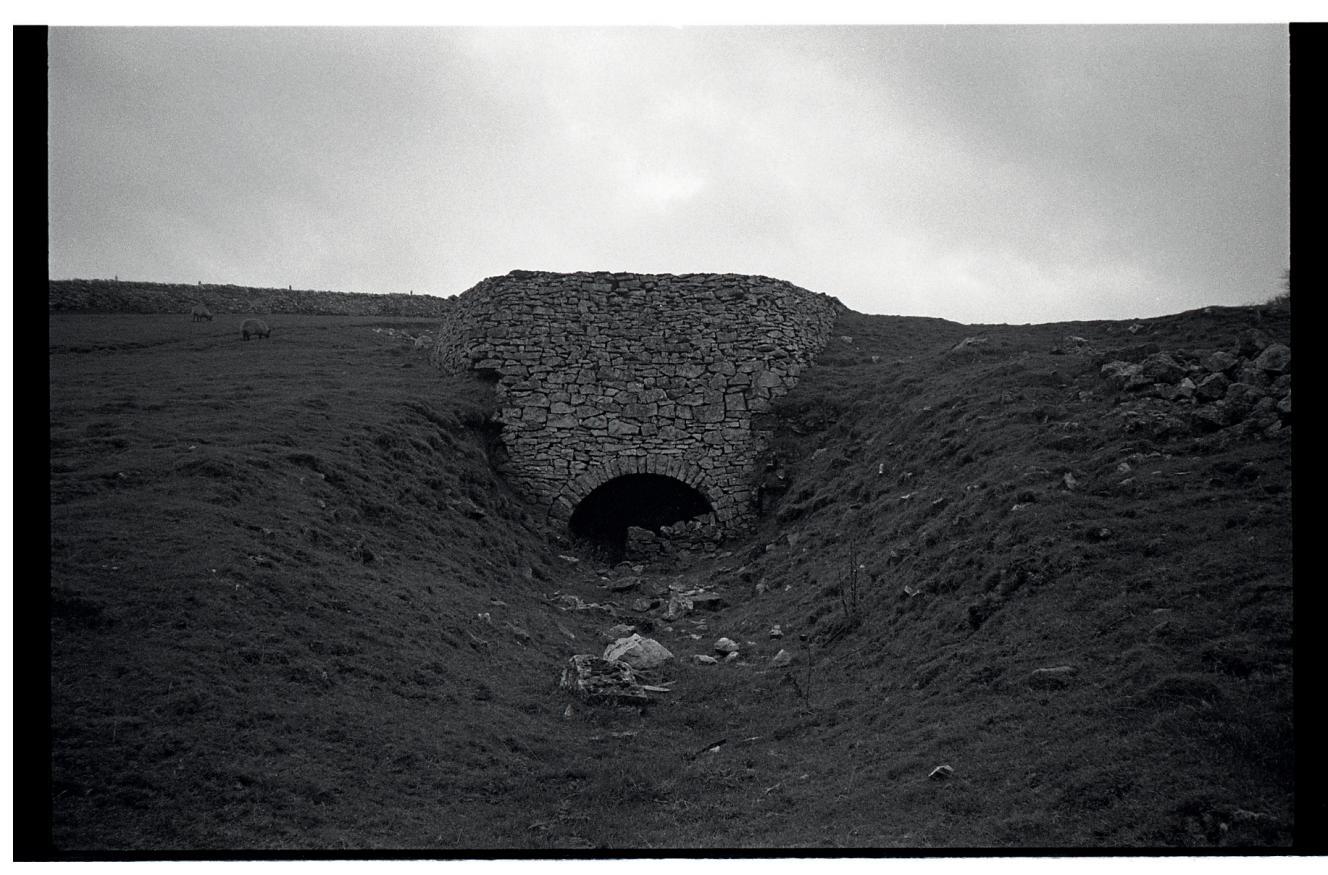
Plate 26

Peak Park photograph from 1984 (00095). The segmental arch is even with an inserted section of wall.

The Limekiln was photographed in 1984 and 1995 by the Peak Park. Black and white photos illustrate the draw hole with a small section of boundary wall within the arch, presumably to prevent sheep from entering. At that time the top of the limekiln had a soft capping of turf, and this appears to be a deliberate form of consolidation; it has a uniform finish. By 1995 the short section of drystone wall within the draw hole had partially collapsed. The last set of Peak Park record photos date from 2002 and are in colour. The only obvious difference is that some of the side / flanking soil is more heavily eroded and a little more of the base of the kiln to the east is visible, with some large gaps in the masonry (see arrow – plate 30). Photographs taken by David Hitchins in around 2009 show similar details but have one notable addition, which is a photograph within the draw hole. None of the Peak Park images show the draw hole. This reveals that the Draw Hole is lined with blocks of gritstone ashlar, not limestone, within a separate lower vault than the outer limestone masonry. A photograph taken on

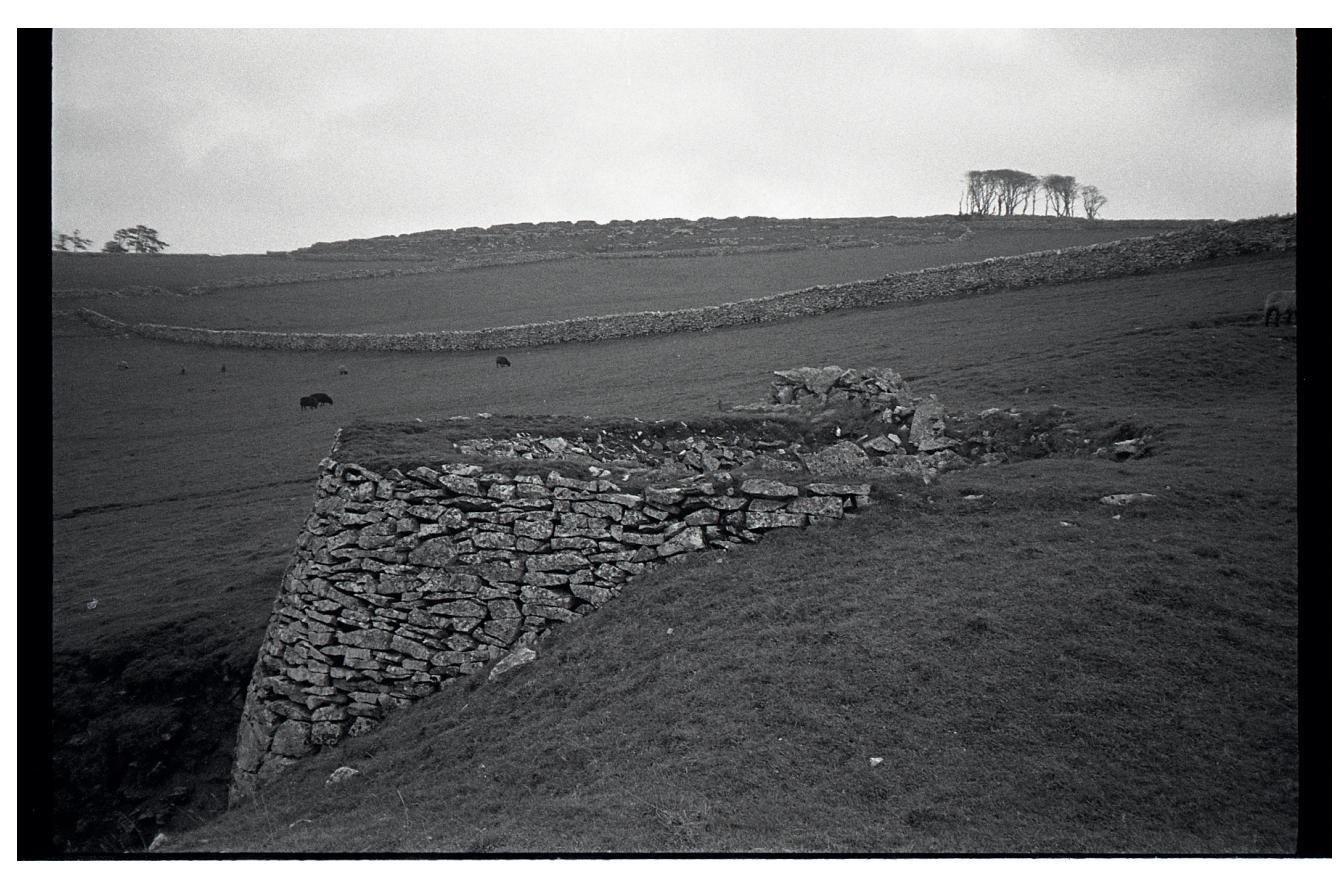
Plate 27

Peak Park photograph from 1984 (00096). The distinctive batter to the north face shows an angle of approximately 15-degrees at the apex. Compare with Plate 24. A large area of masonry to the west flank has collapsed.

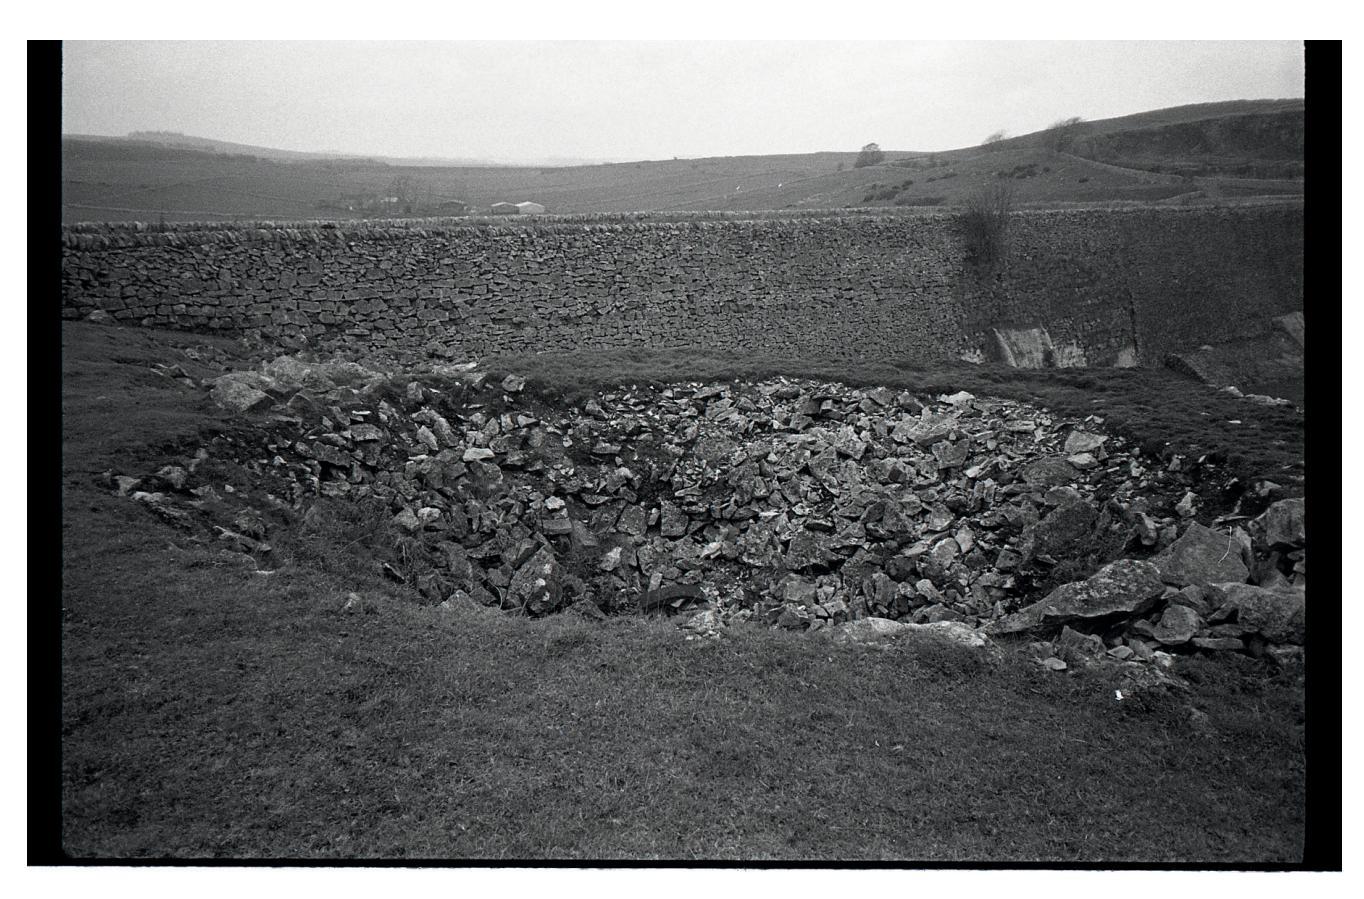
Plate 28

Peak Park photograph from 1984 (00098). Compare with Plate 29 below. A large area of masonry to the west flank has collapsed. This image shows it to be a relatively even upper face, capped with turf.

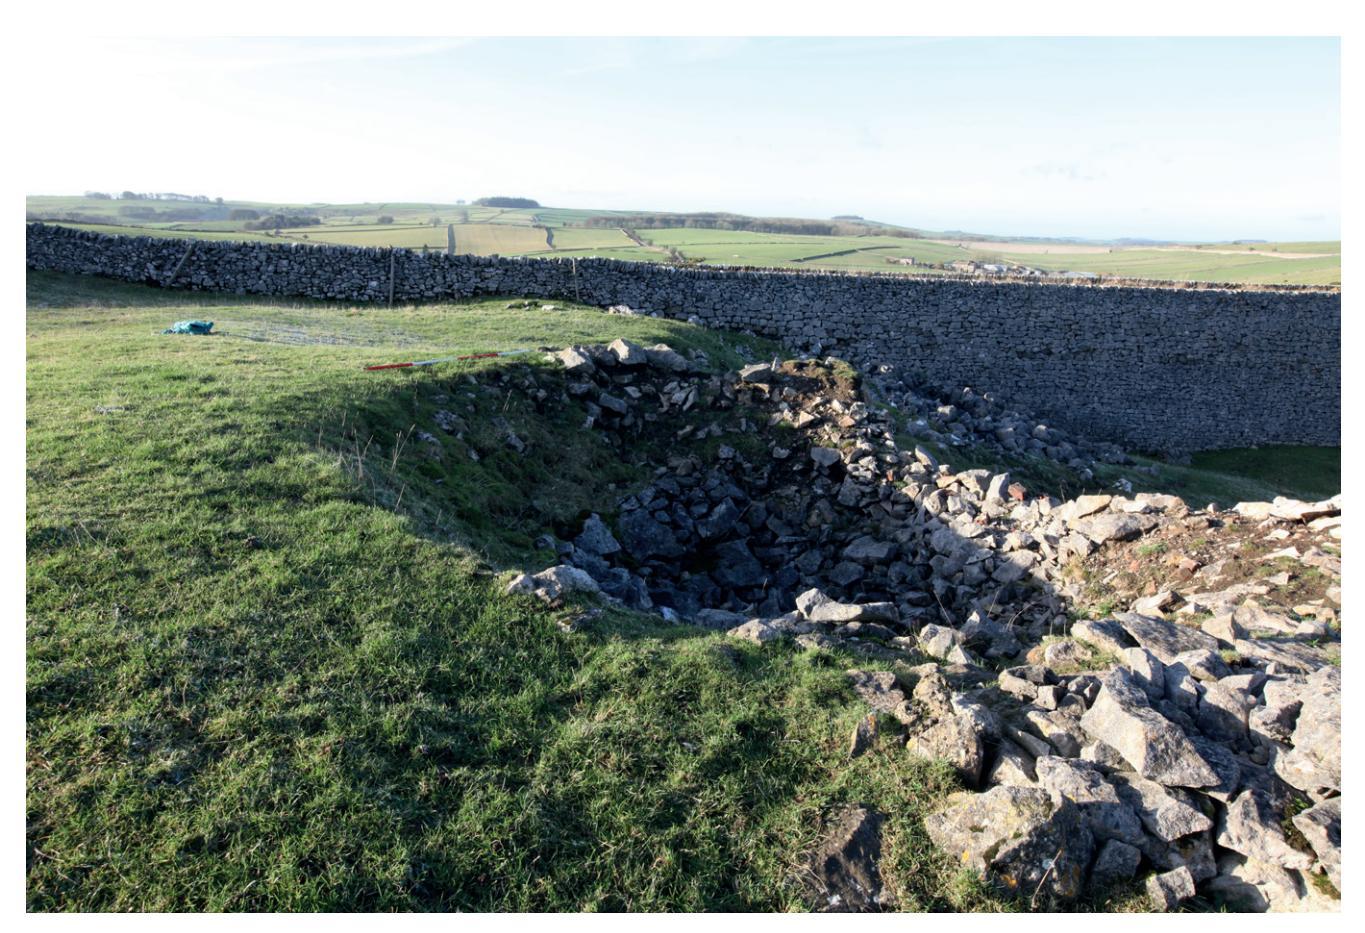
Plate 29 (12_040122)

Comparison with plate 28 from 1984 suggests that a large amount of the charge has inwardly collapsed into the 'bowl'. Photographs from 2002 suggest that this inward collapse had already taken place.

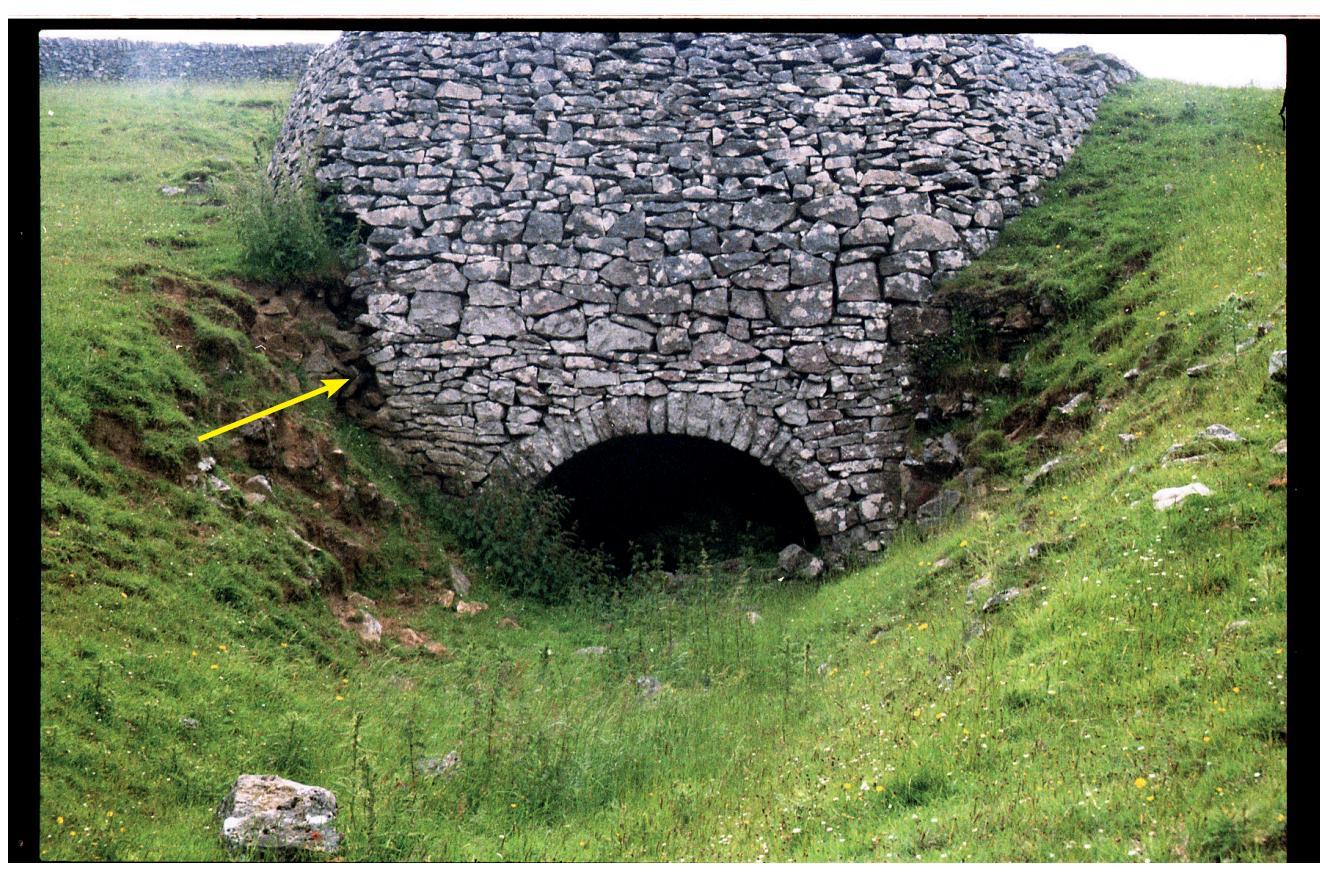
Plate 30 (000245) photo of 2002, Peak Park, showing erosion

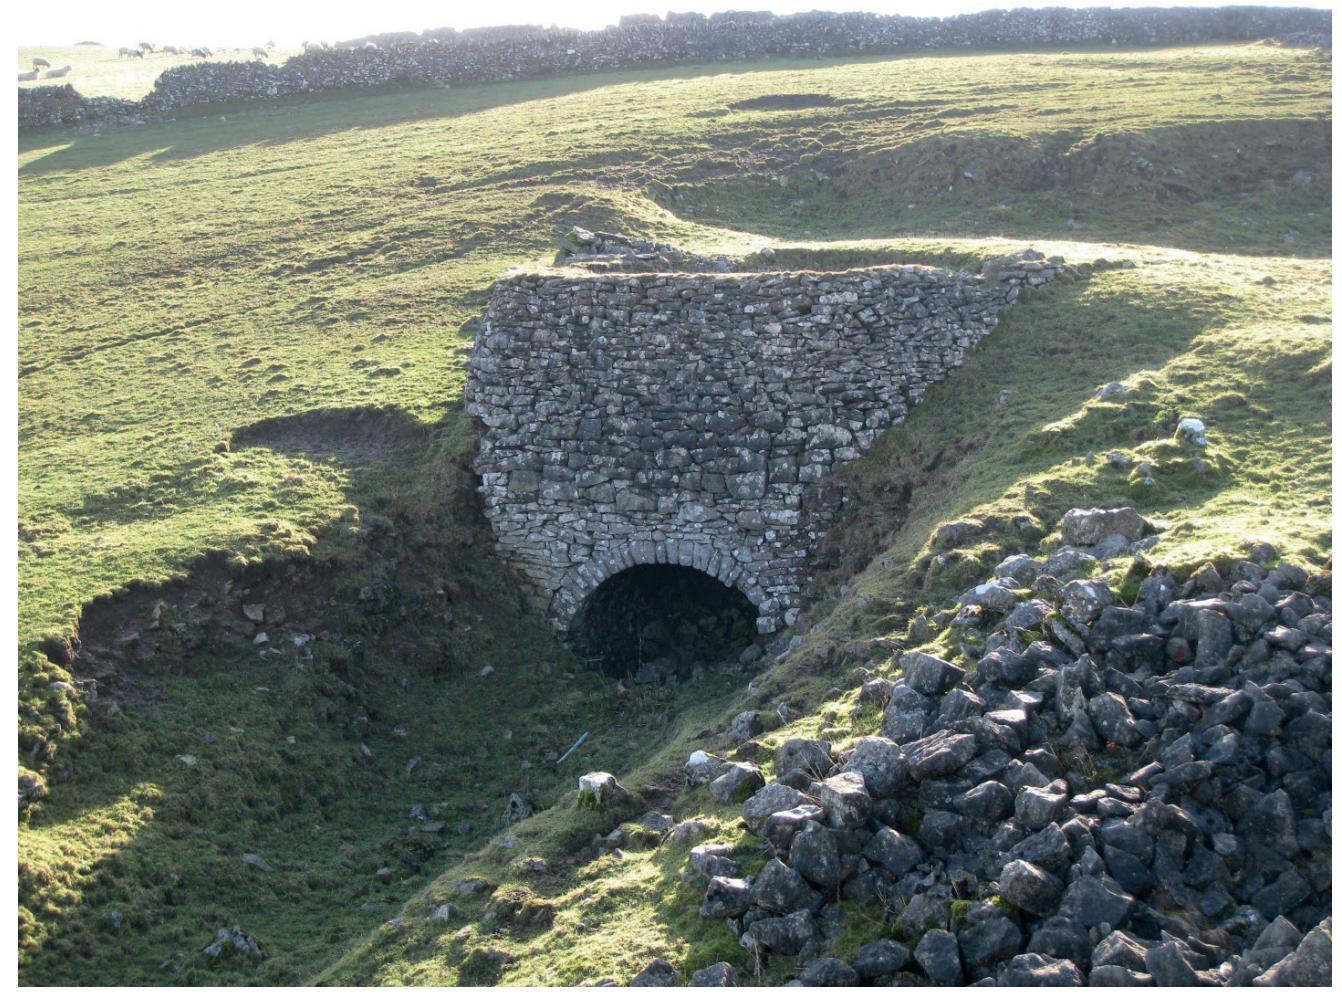
Plate 31 (9th Feb. 2018 - 1335285) photo by Anna Badcock (Peak Park) The photo shows a similar amount of masonry to that recorded in 1984.

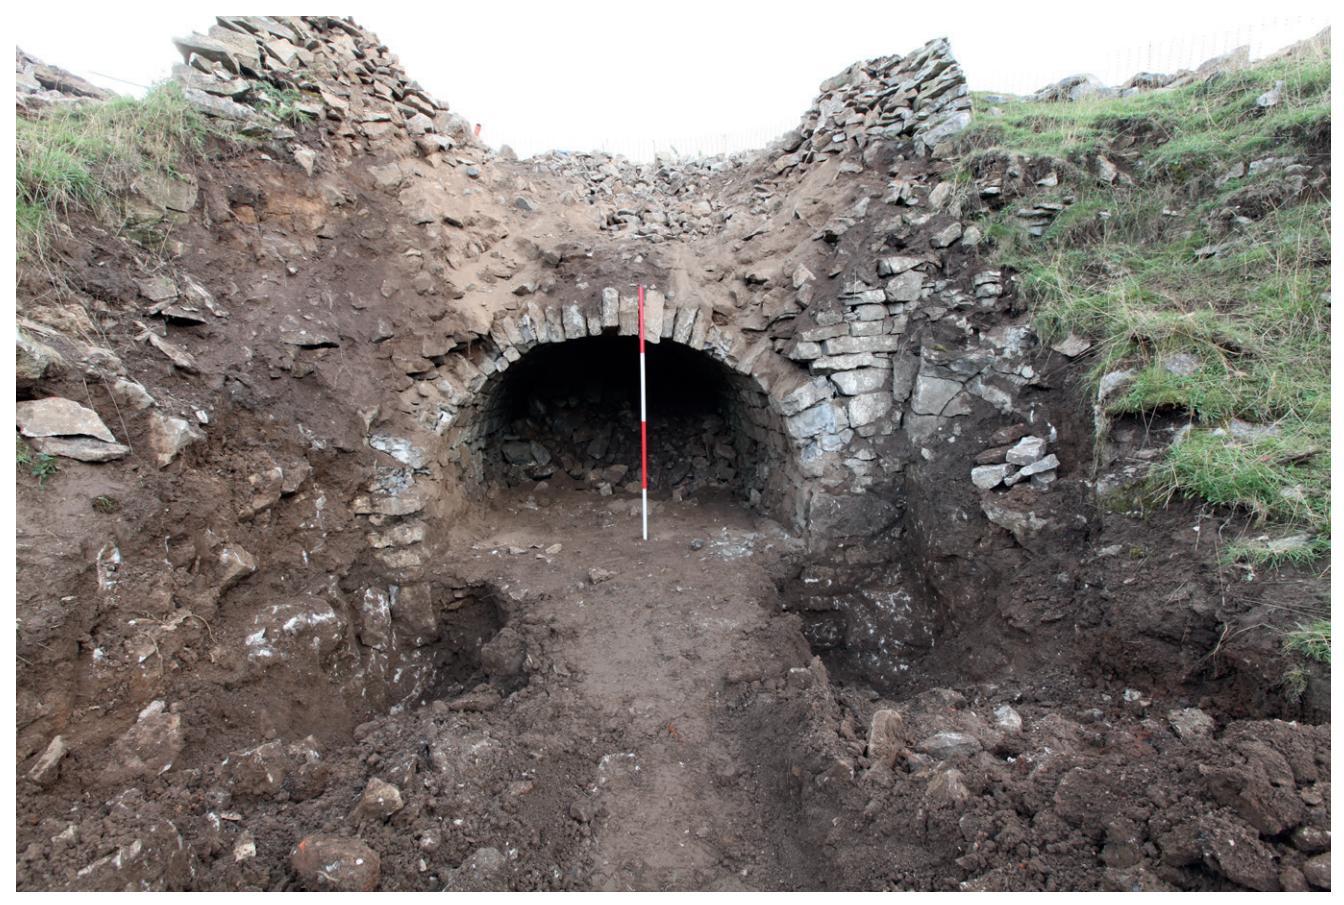
Plate 32 (37_070922) - post excavation of rubble. Note limestone bedrock to both sides at base.

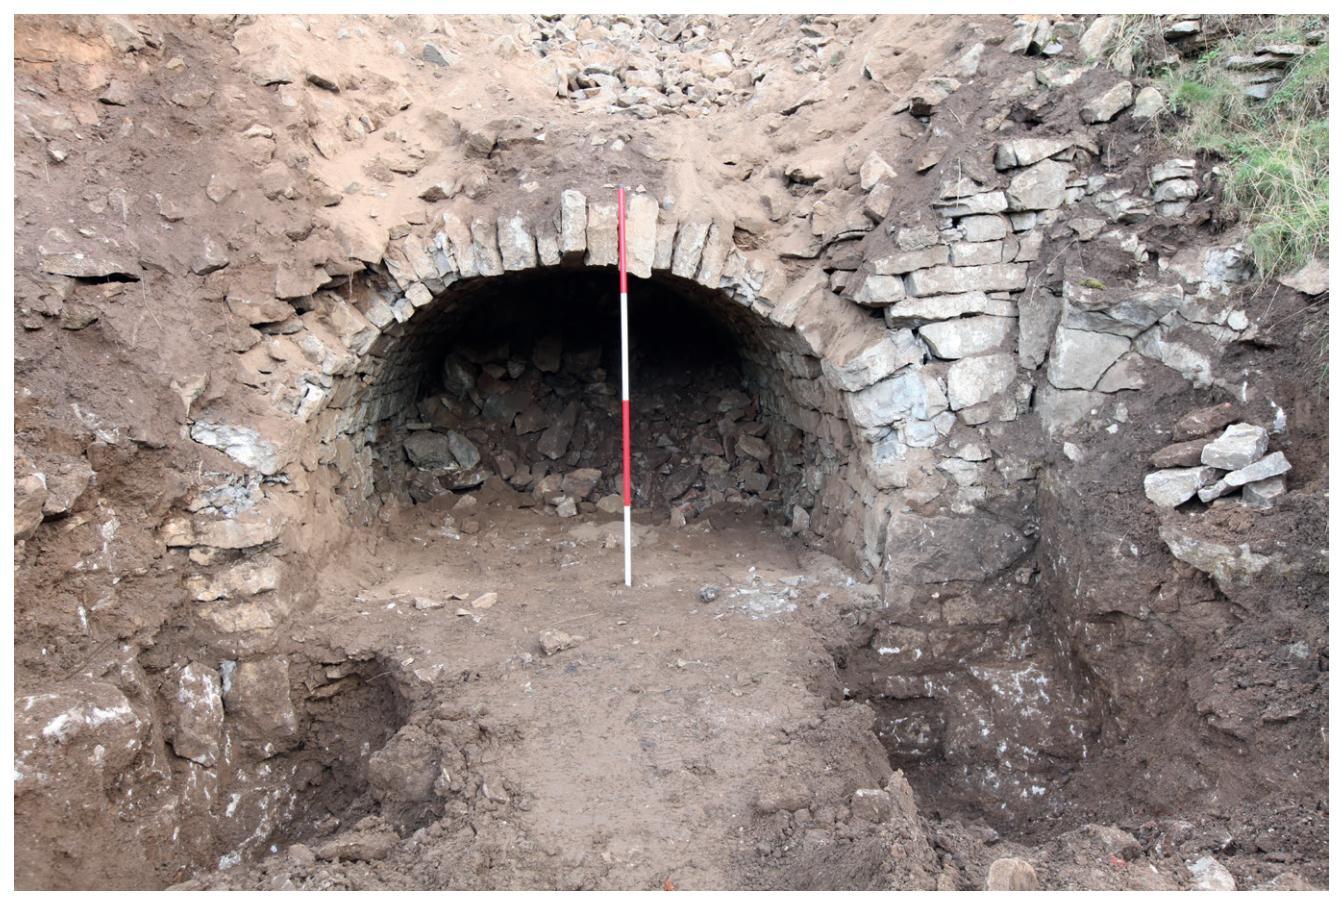
Plate 33 (36_070922) post excavation of rubble. Note dressed face of arch is missing

- The dressed stones from the face of the arch had collapsed and approximately 800mm of the face of the arch has collapsed. The arch is not even.
- The base of each abutment finishes in partially dressed limestone with approximately 500mm of dressed jointed stone previously covered over, as seen in photographs from January 2022. Approximately 500mm of bedrock is visible in front of the base of this dressed stone, suggesting that this would have been back-filled with crushed limestone as a base for cart access under the arch.

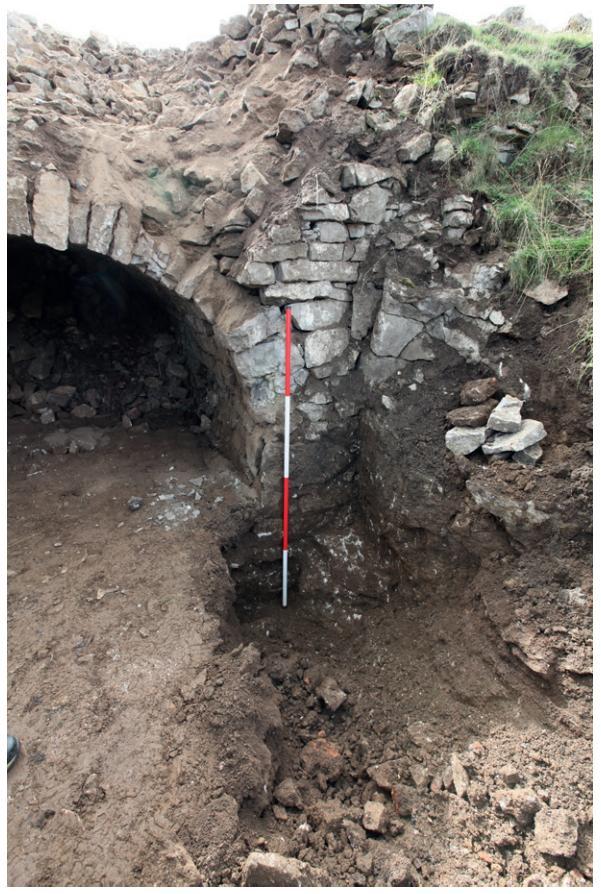
Plate 35 (42_070922) right abutment. 500mm of bedrock at the base of the excavated pit.

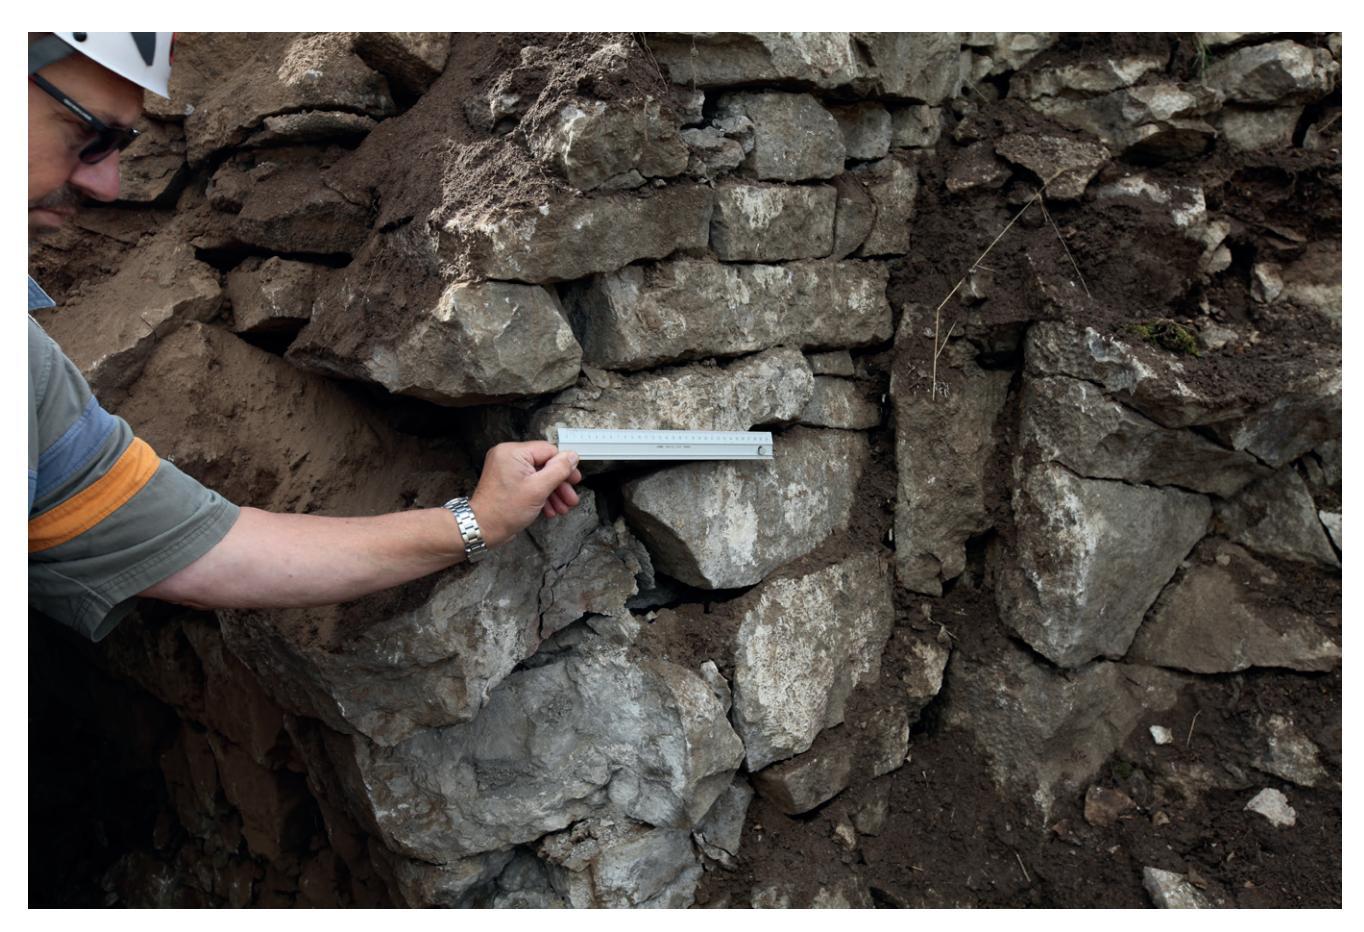
Plate 36 (50_070922) right abutment with 30cm rule and natural limestone bedrock to the right, with some shatter / fissure marks from blasting

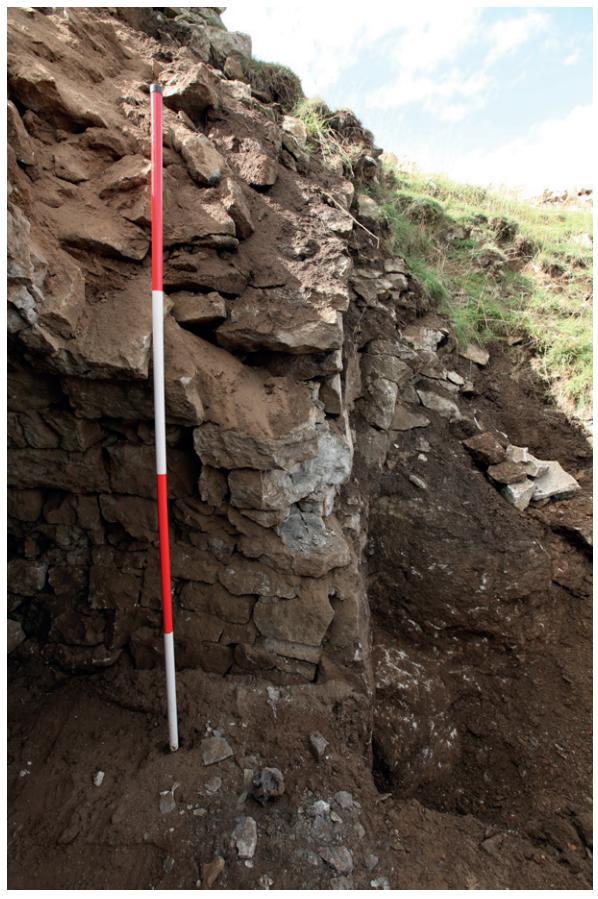
Plate 37 (49_070922) right abutment with losses and missing face of arch

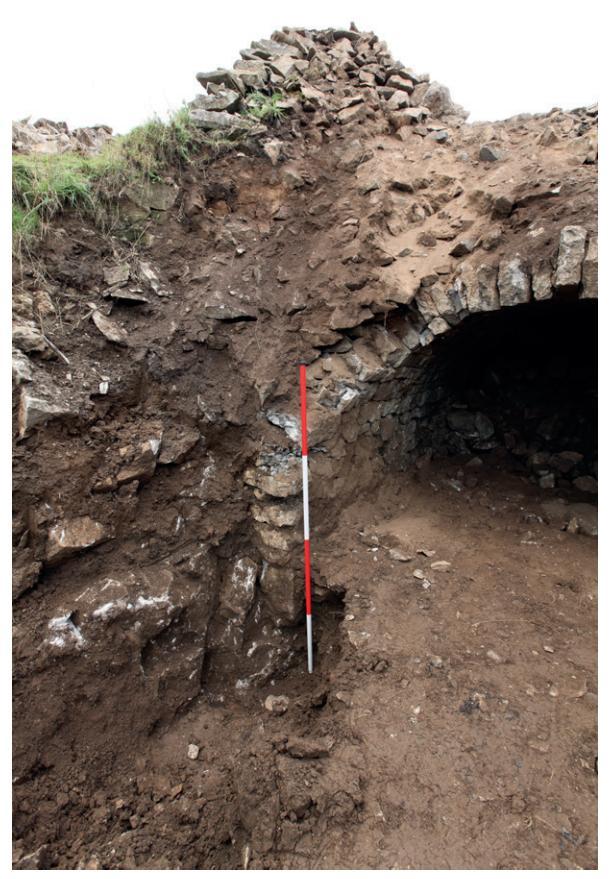
Plate 38 (44_070922) left abutment with bedrock at the base and to the left
