Minninglow Limekiln Level 3 Survey - Historic Building Recording Client: Mark Edge, Minninglow Grange

Melanie Lloyd Morris BA Hons, Dip. Arch. Cons, IHBC, MRTPI Mel Morris Conservation

14th September 2022

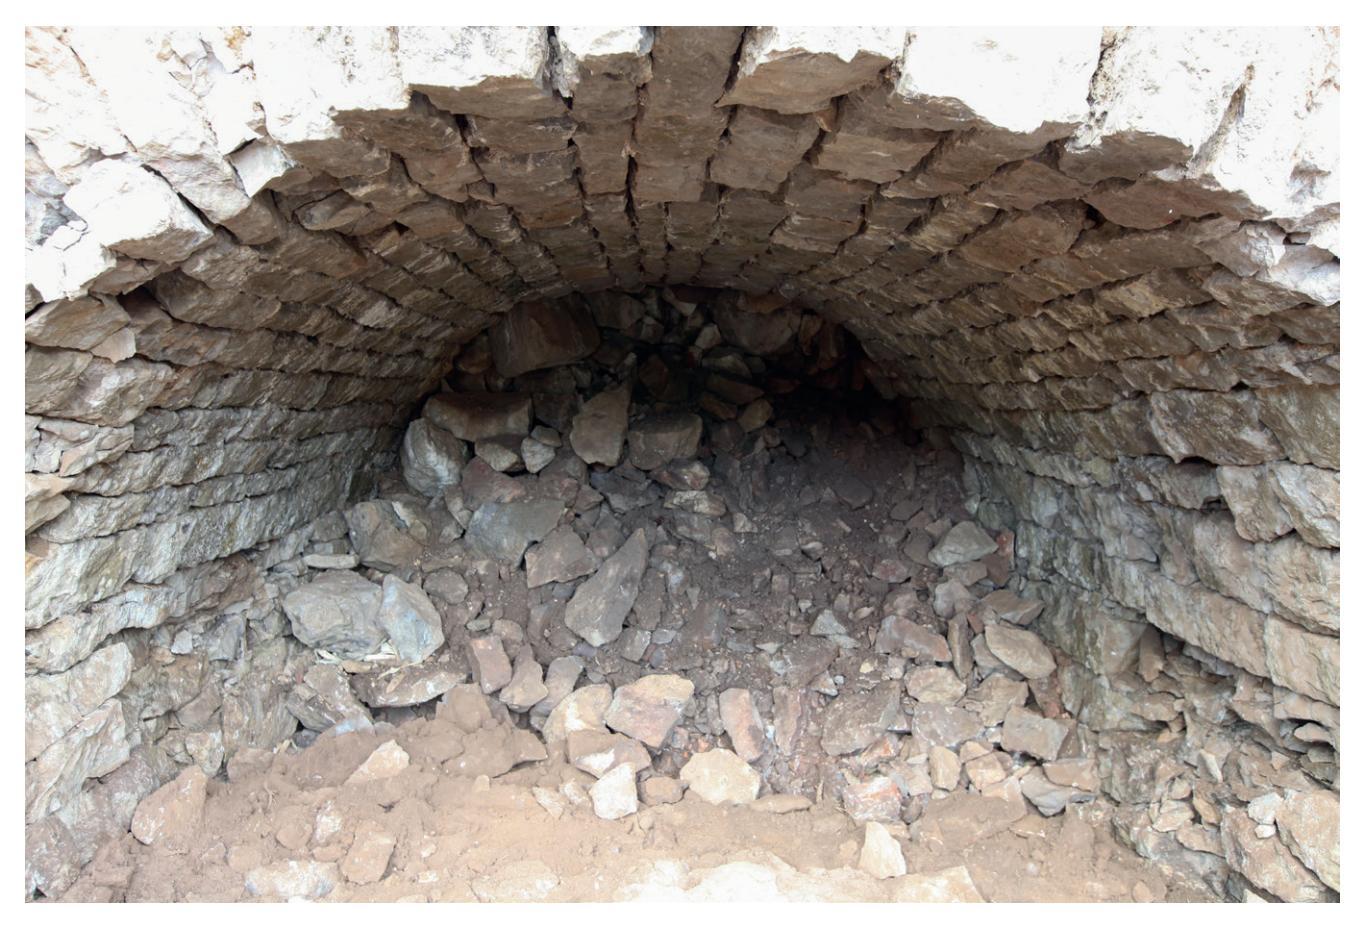
Plate 39 (46_070922) underside of arch in limestone with rubble from kiln core

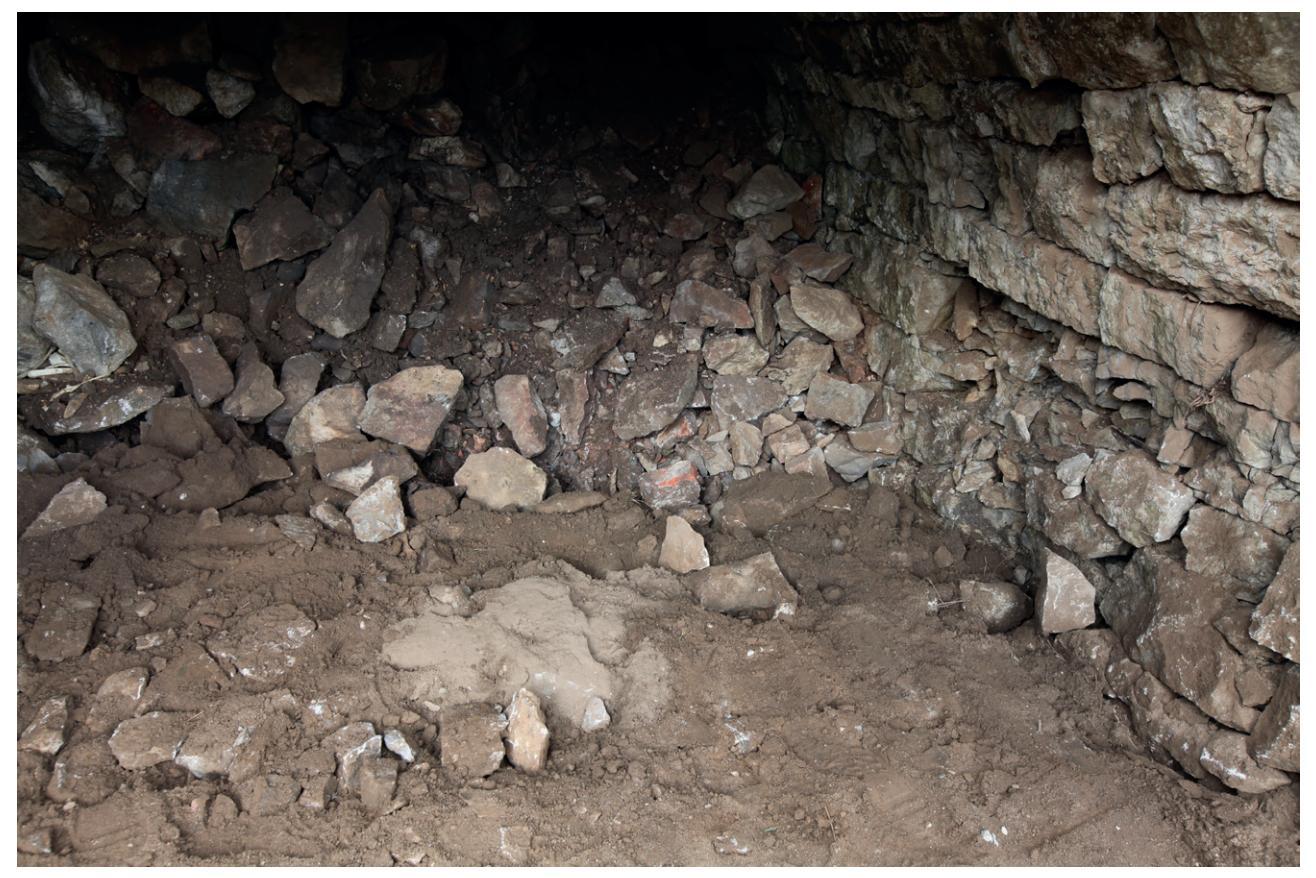
Plate 40 (48_070922) rubble fill at base of kiln. No signs of charge. Building rubble with sandstone, brick and limestone, with some burnt slag deposits.

- The 'rubble charge', which is referred to in the list description, is mainly building rubble, as it contains extensive deposits of brick and sandstone, although there were also some pieces of vitrified slag. These materials would not have been added to the charge, as they would have contaminated the limestone. It appears, therefore, that a large proportion of the material which was inserted into the kiln was building rubble, in order to 'cap' the kiln and prevent livestock from being harmed and falling into the kiln.
