The Tanyard, Shifnal, Shropshire.

> An Archaeological Evaluation, 2006

THE TANYARD SHIFNAL, SHROPSHIRE. AN ARCHAEOLOGICAL EVALUATION, 2006.

Planning Application Number 05/0863

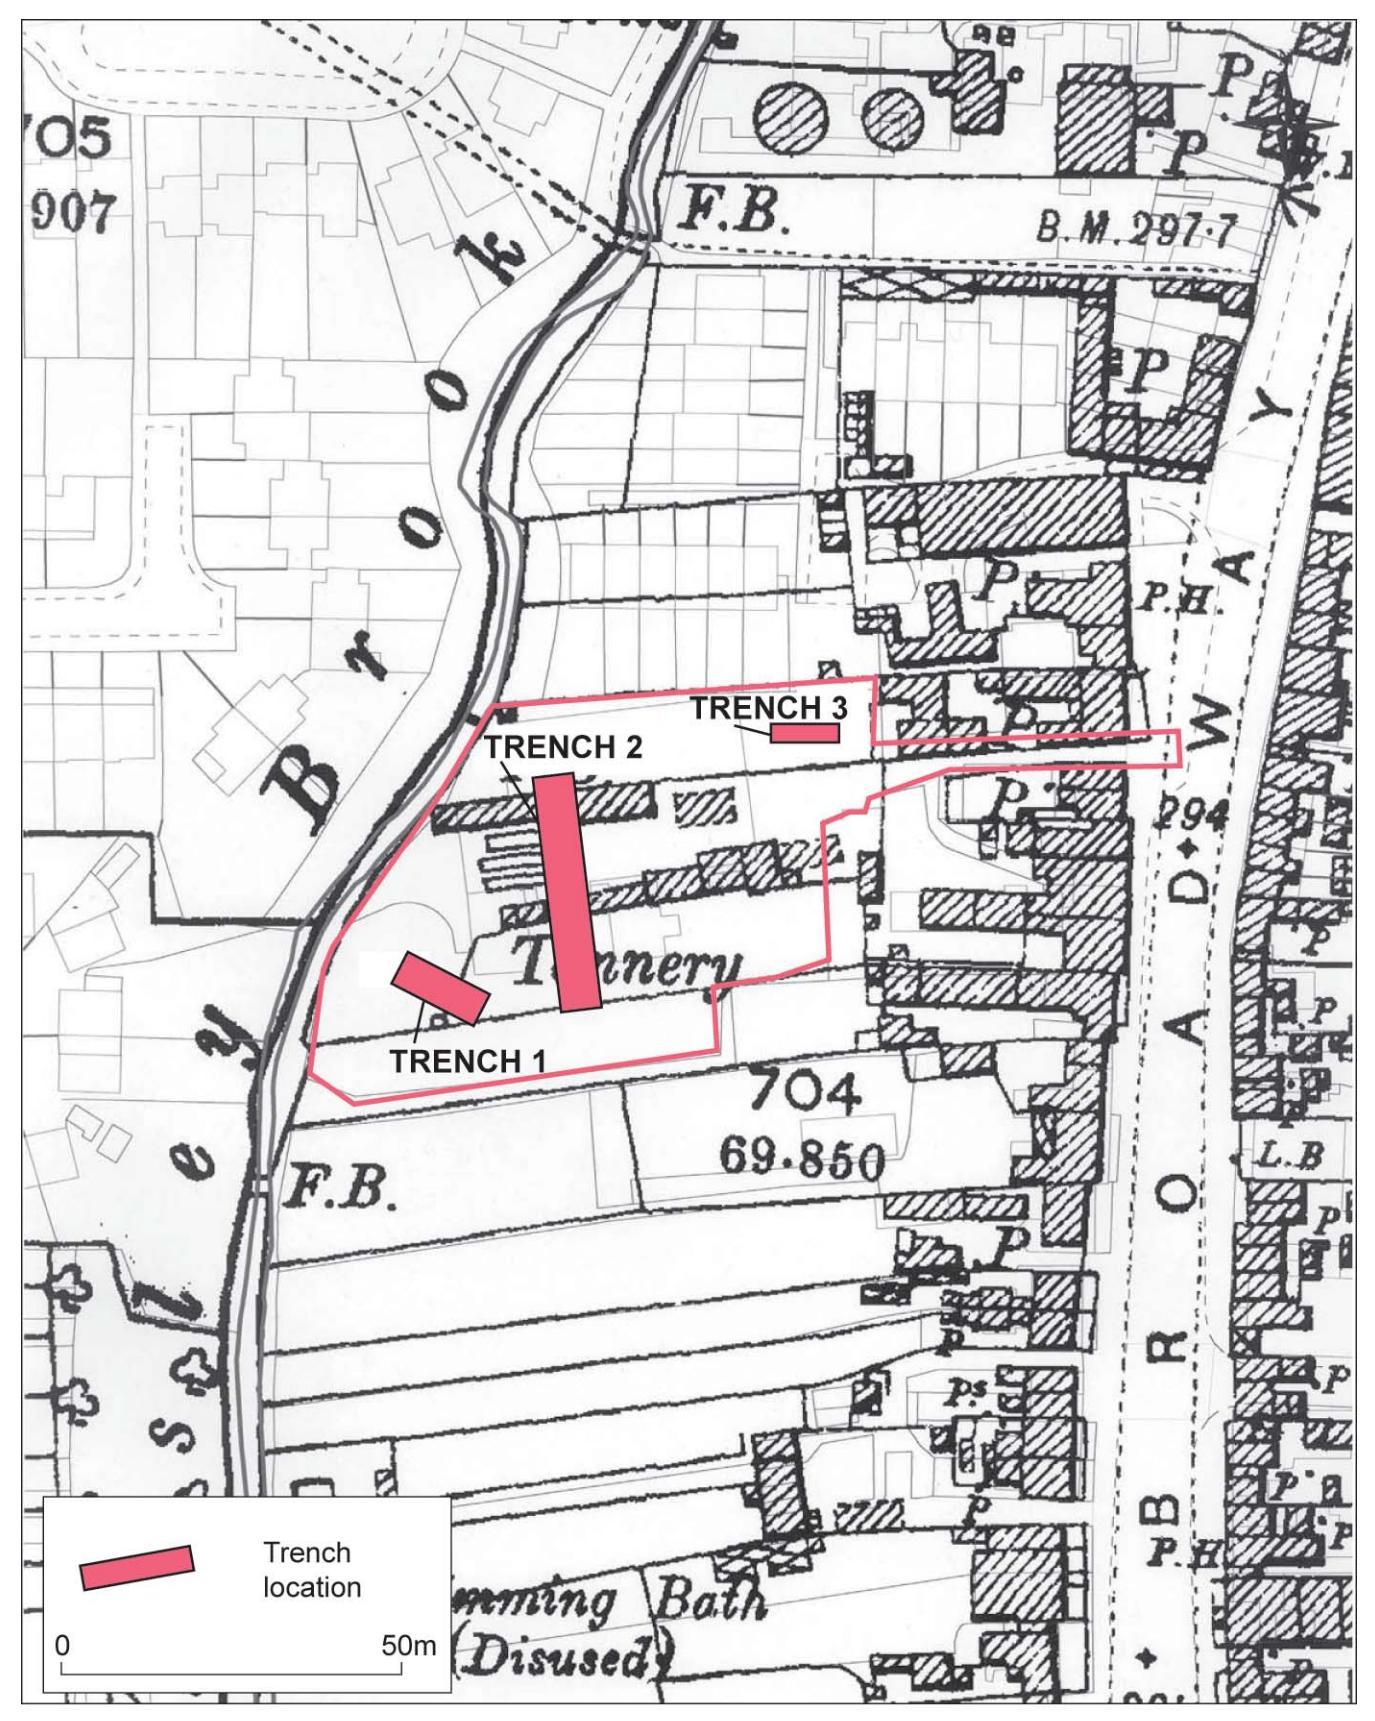
Fig.2

A total of 3 trenches were excavated across the site (Fig. 2). Trenches 1 and 3 were located to investigate surviving medieval remains associated with the laying out of the planned town in the 14th century. Trench 1 was located to examine deposits close to the brook along the western boundary of the site, to identify possible early industry associated with the water course. Trench 2 was located within the tannery complex to assess its survival. Trench 3 was located to assess occupation and land use behind the frontage of the main road.

Trench 1 was located towards the western boundary of the site (Fig. 2, Plate 1). This was located to identify any activity related to the Wesley Brook that flows down the western boundary of the site. This trench was 6m wide and 14m long and was excavated to a depth of 3m.

Trench 2 was aligned north-south and was located in the middle of the site (Fig 2). It was 30m long and 6m wide, and was machine excavated to a maximum depth of 2m below the current ground surface (85.81m AOD).

Trench 3 was 10m long and 2m wide, aligned east-west and located towards the eastern side of the site (Fig. 2, and Plate 5). It was located to identify potential back-plot activity within the area relating to properties along the High Street-Broadway.

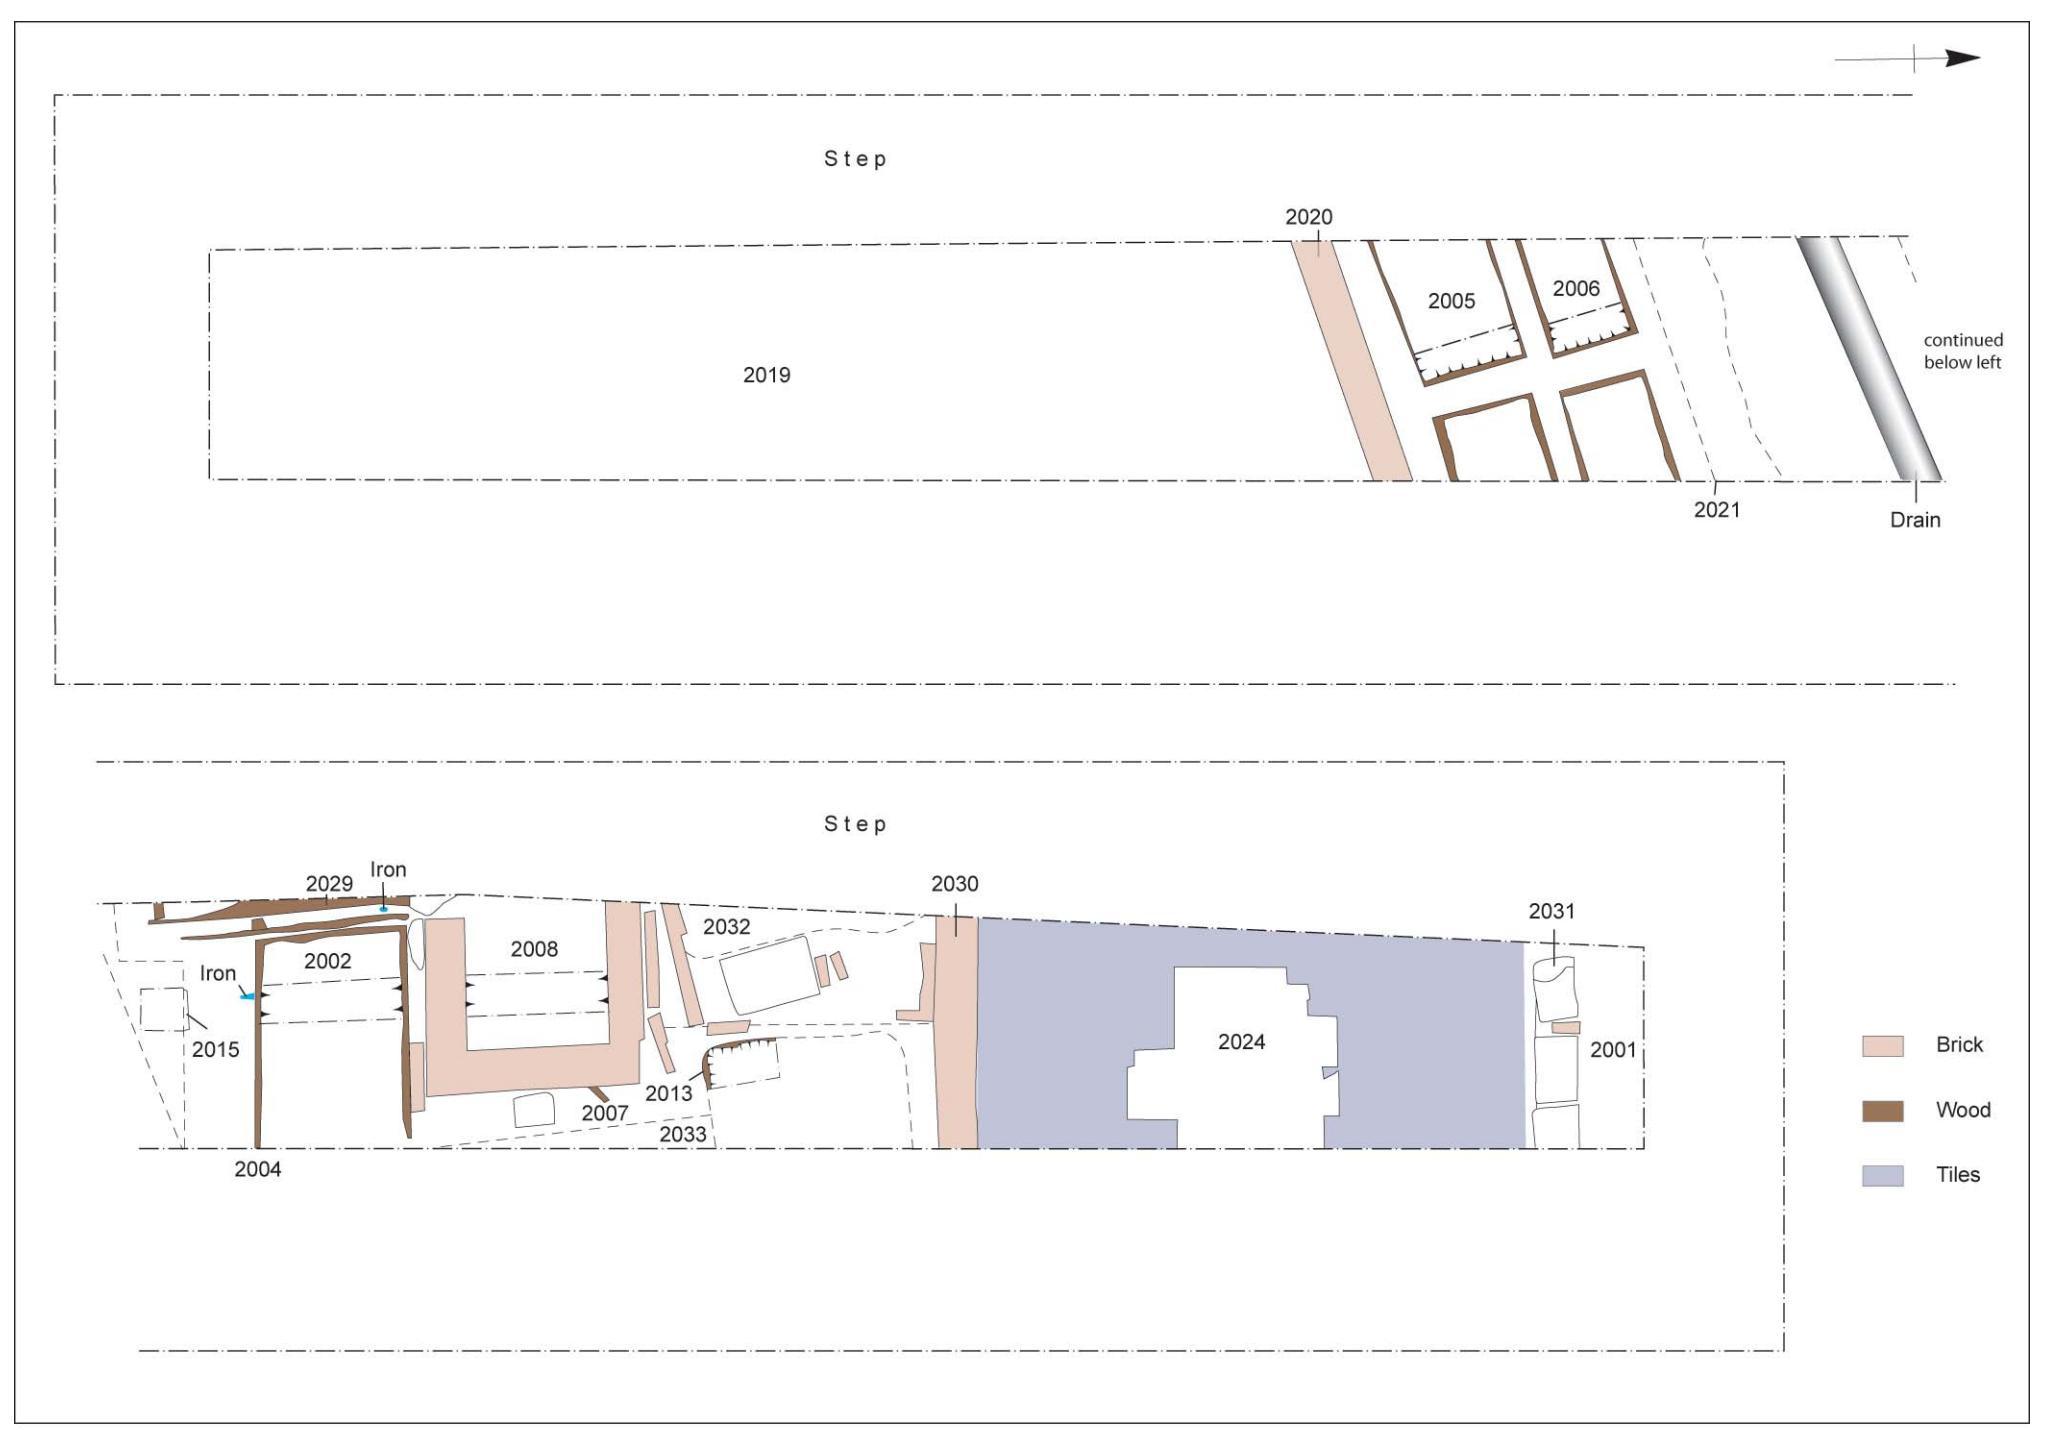
The earliest deposits identified in the trench were at the southern end where a layer of alluvial silt (2019, Fig. 3) indicated the continuation of the palaeochannel identified in Trench 1. No further naturally occurring subsoil horizons were encountered within the area of this trench. Early garden soil horizons were preserved at the south end of the trench (2017 and 2018, Fig. 4) which together measured 0.65m of build up.

The majority of the deposits surviving in the trench could be identified as being associated with the tanning complex. At the northern end of the trench were the remains of a structure (Figs 3 and 4, Plate 2), which was 6m wide and consisted of an outer wall to the north, constructed on sandstone footings (2031), and a brick built wall (2030) to the south. Internally the structure had a well-preserved quarry tile floor (2024) surviving in-situ.

To the south of this structure were a series of pits (Figs 3 and 4 and Plates 3 and 4), that comprised two separate pit complexes. The northern series (Plate 3) abutted the external wall (2030) of the building. A total of five pits (2004, 2007, 2013, 2029 and 2032), closely grouped, were identified The complex was three pits wide, with an overall width of 7m. However, the full length and extent of this range of pits could not be ascertained within the confines of the trench and two of the pits (2029 and 2032) were so close to the baulk that they could not be excavated for health and safety reasons. They were defined by pink clay linings, their internal widths ranged from 1.3-2.25m and the two pits that were excavated to their full depth (2004 and 2007) were 1m deep.

To the south of this range of pits was a second pit complex (2021) which was 3.1m wide (Figs 3 and 4, Plate 4). These were again defined by their clay linings, and were sub-divided by the insertion of wooden dividers at 0.9m intervals. The fills of two of these subdivisions were (2005 and 2006) found to consist of burnt coal and clinker. The north and south walls of the complex were constructed from sandstone, and survived to a height of 0.6m, three courses high. They were structural, used as a revetment wall around the edge of the pit complex, rather than forming part of the lining, and originally were probably higher which would have made the pits semi-sunken.

Between the two sets of pits there appeared to be a break in activity (Figs 3 and 4), which was probably where the yard surface around the pit complexes had been. Unfortunately the cut for a large modern drain truncated deposits at this point. However, the northern edge of a cut

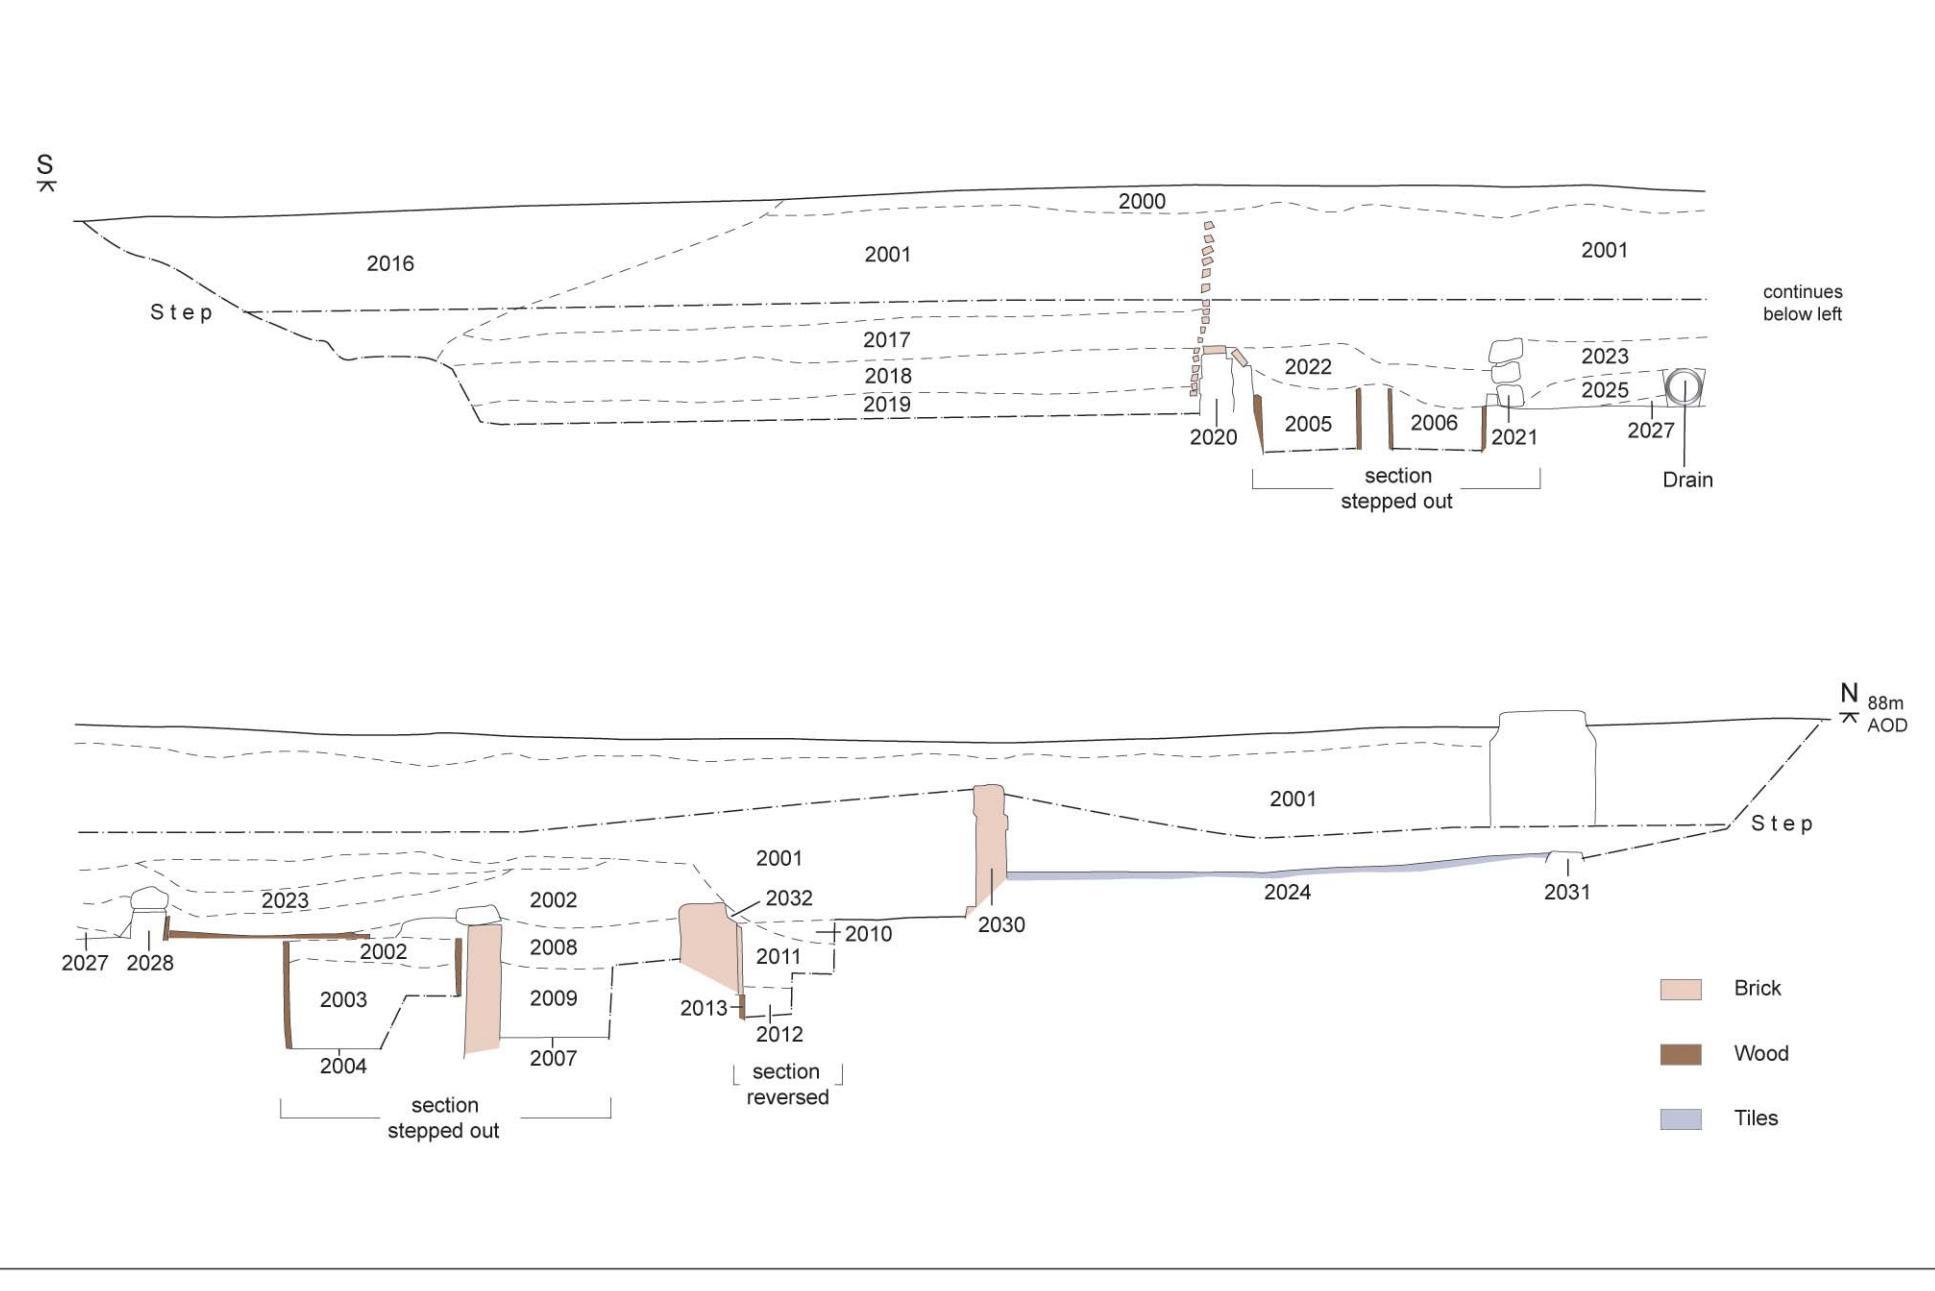
Large wooden planks lined three of the pits (2004, 2013 and 2029), and there was evidence, in plan, for the stabilisation of these with wooden posts and metal pins, on the outside of 2004 and 2029 (Fig. 3). Pit 2007 was lined with bricks and it is probable that Pit 2032 was also. In Pit 2004 and Pit 2013 the earliest fills (2003 and 2012) consisted of the waterlogged remains of chipped bark. Above this, in Pit 2013, was a layer of compact waterlogged organic material, similar to the primary fill of Pit 2007 (2009). Surviving at intervals between the pits were the remains of sandstone paving slabs. The upper fill of all of the pits was a very compact black ash and clinker deposit that was part of the same layer (2002) that sealed the whole complex.

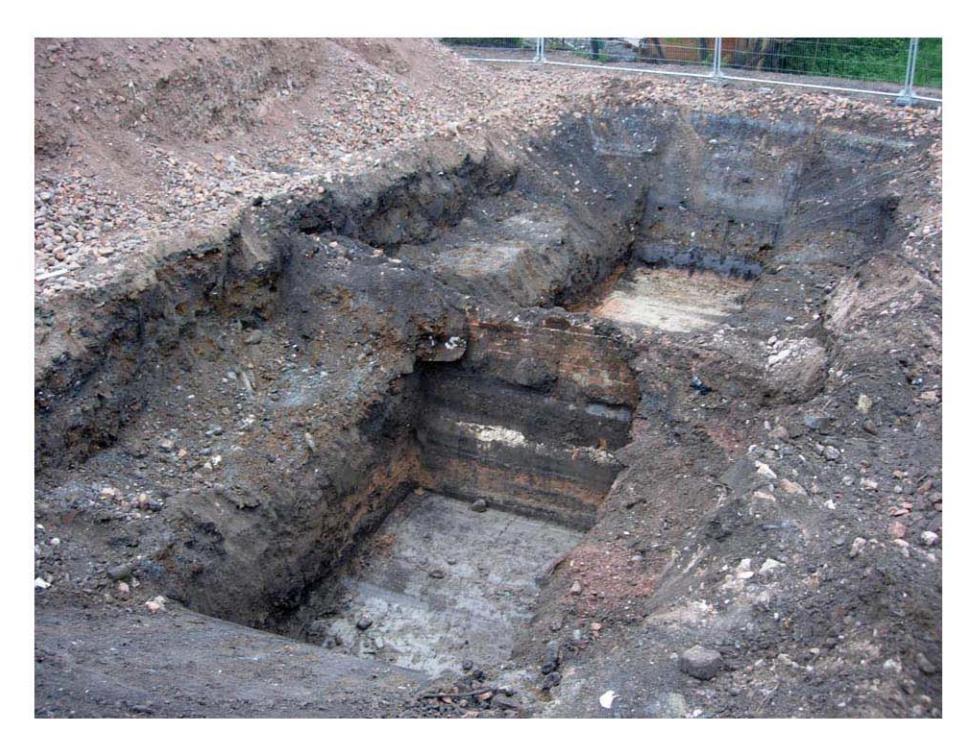
Plate 1

The natural clay was identified at the northwestern end of the trench this was located 2.23m below current ground surface (85.2m AOD), this was cut by the northern edge of a palaeochannel. The upper fill of the channel (1005) consisted of compact grey clay and silt, this lay 2.77m below the ground surface (84.69m AOD), but for safety reasons could not be excavated. Overlying this deposit, at the south end of the trench, was a layer of dark grey silt (1004) 0.25m deep. This was sealed by a layer of orange alluvial sandy silt (1003) also 0.25m deep. This deposit was a layer of dark grey clay rich silt (1002) 0.35m deep. This

was overlain by a modern levelling layer comprising loose soil and clinker (1001) that contained quantities of glass bottles and ceramic vessels, mostly whole, and animal bone, this had a depth of 1.6m. A layer of crushed rubble (1000) sealed the area of the trench.

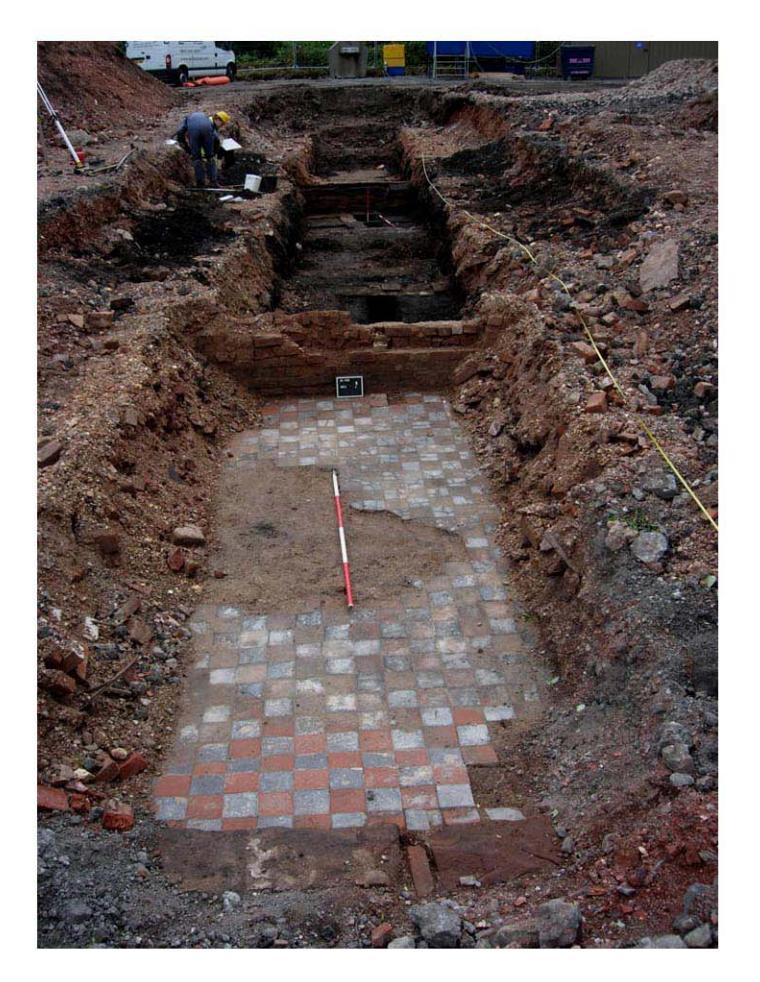
Plate 2

Overlying the tanning complex, across the whole of the trench, was a levelling layer (2001) primarily consisting of crushed rubble, roof tile, mortar and concrete. It was deepest at the northern end of the trench where it was 1.5m deep. At the southern end of the trench the continuation of 1001 identified in Trench 1 was identified (2016). A narrow layer of broken brick rubble (2000) sealed the area of the trench.

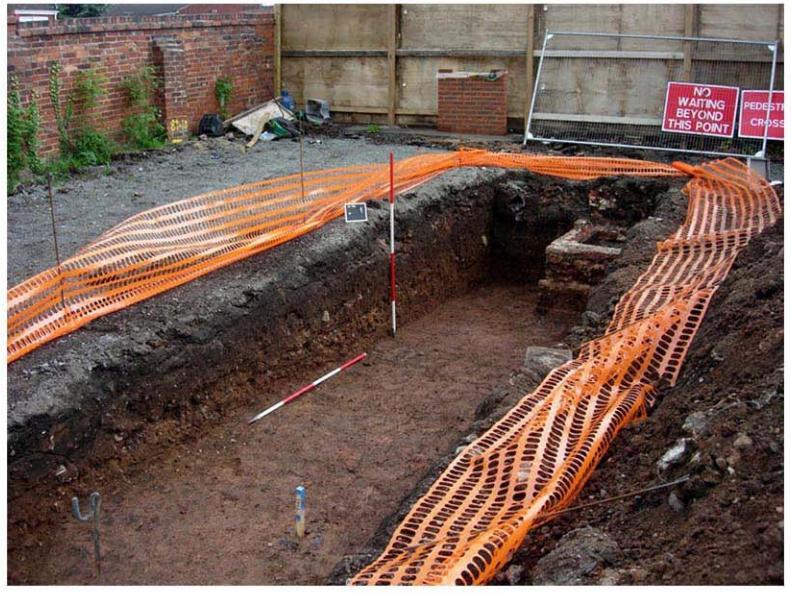
Plate 5

The natural sand and clay (3010) was identified at the eastern end of the trench, 1.5m below the current ground surface (87.37m AOD), and the overlying stratigraphy became shallower towards the west. Overlying the natural subsoil was a layer of mixed sand and gravel (3006), which was around 0.5m deep. This in turn was overlain by a series of buried garden soils (3003, 3004 and 3005) that had evidently built up over time in the area of the backplots to the rear of the properties fronting the main street. A lens in these soils (3009) produced a sherd of pottery dating to the 18th century. The only feature present in the trench cut the garden soils, this was a small brick built coal-bunker (3012). This trench was once again sealed by a layer of crushed rubble and hardcore (3002).
