Archaeological Geophysical Survey on land at the former Cranfield University campus, Silsoe Bedfordshire

Heather Smith Report 11/68 March 2011

ARCHAEOLOGICAL GEOPHYSICAL SURVEY ON LAND AT THE FORMER CRANFIELD UNIVERSITY CAMPUS, SILSOE, BEDFORDSHIRE FEBRUARY 2011

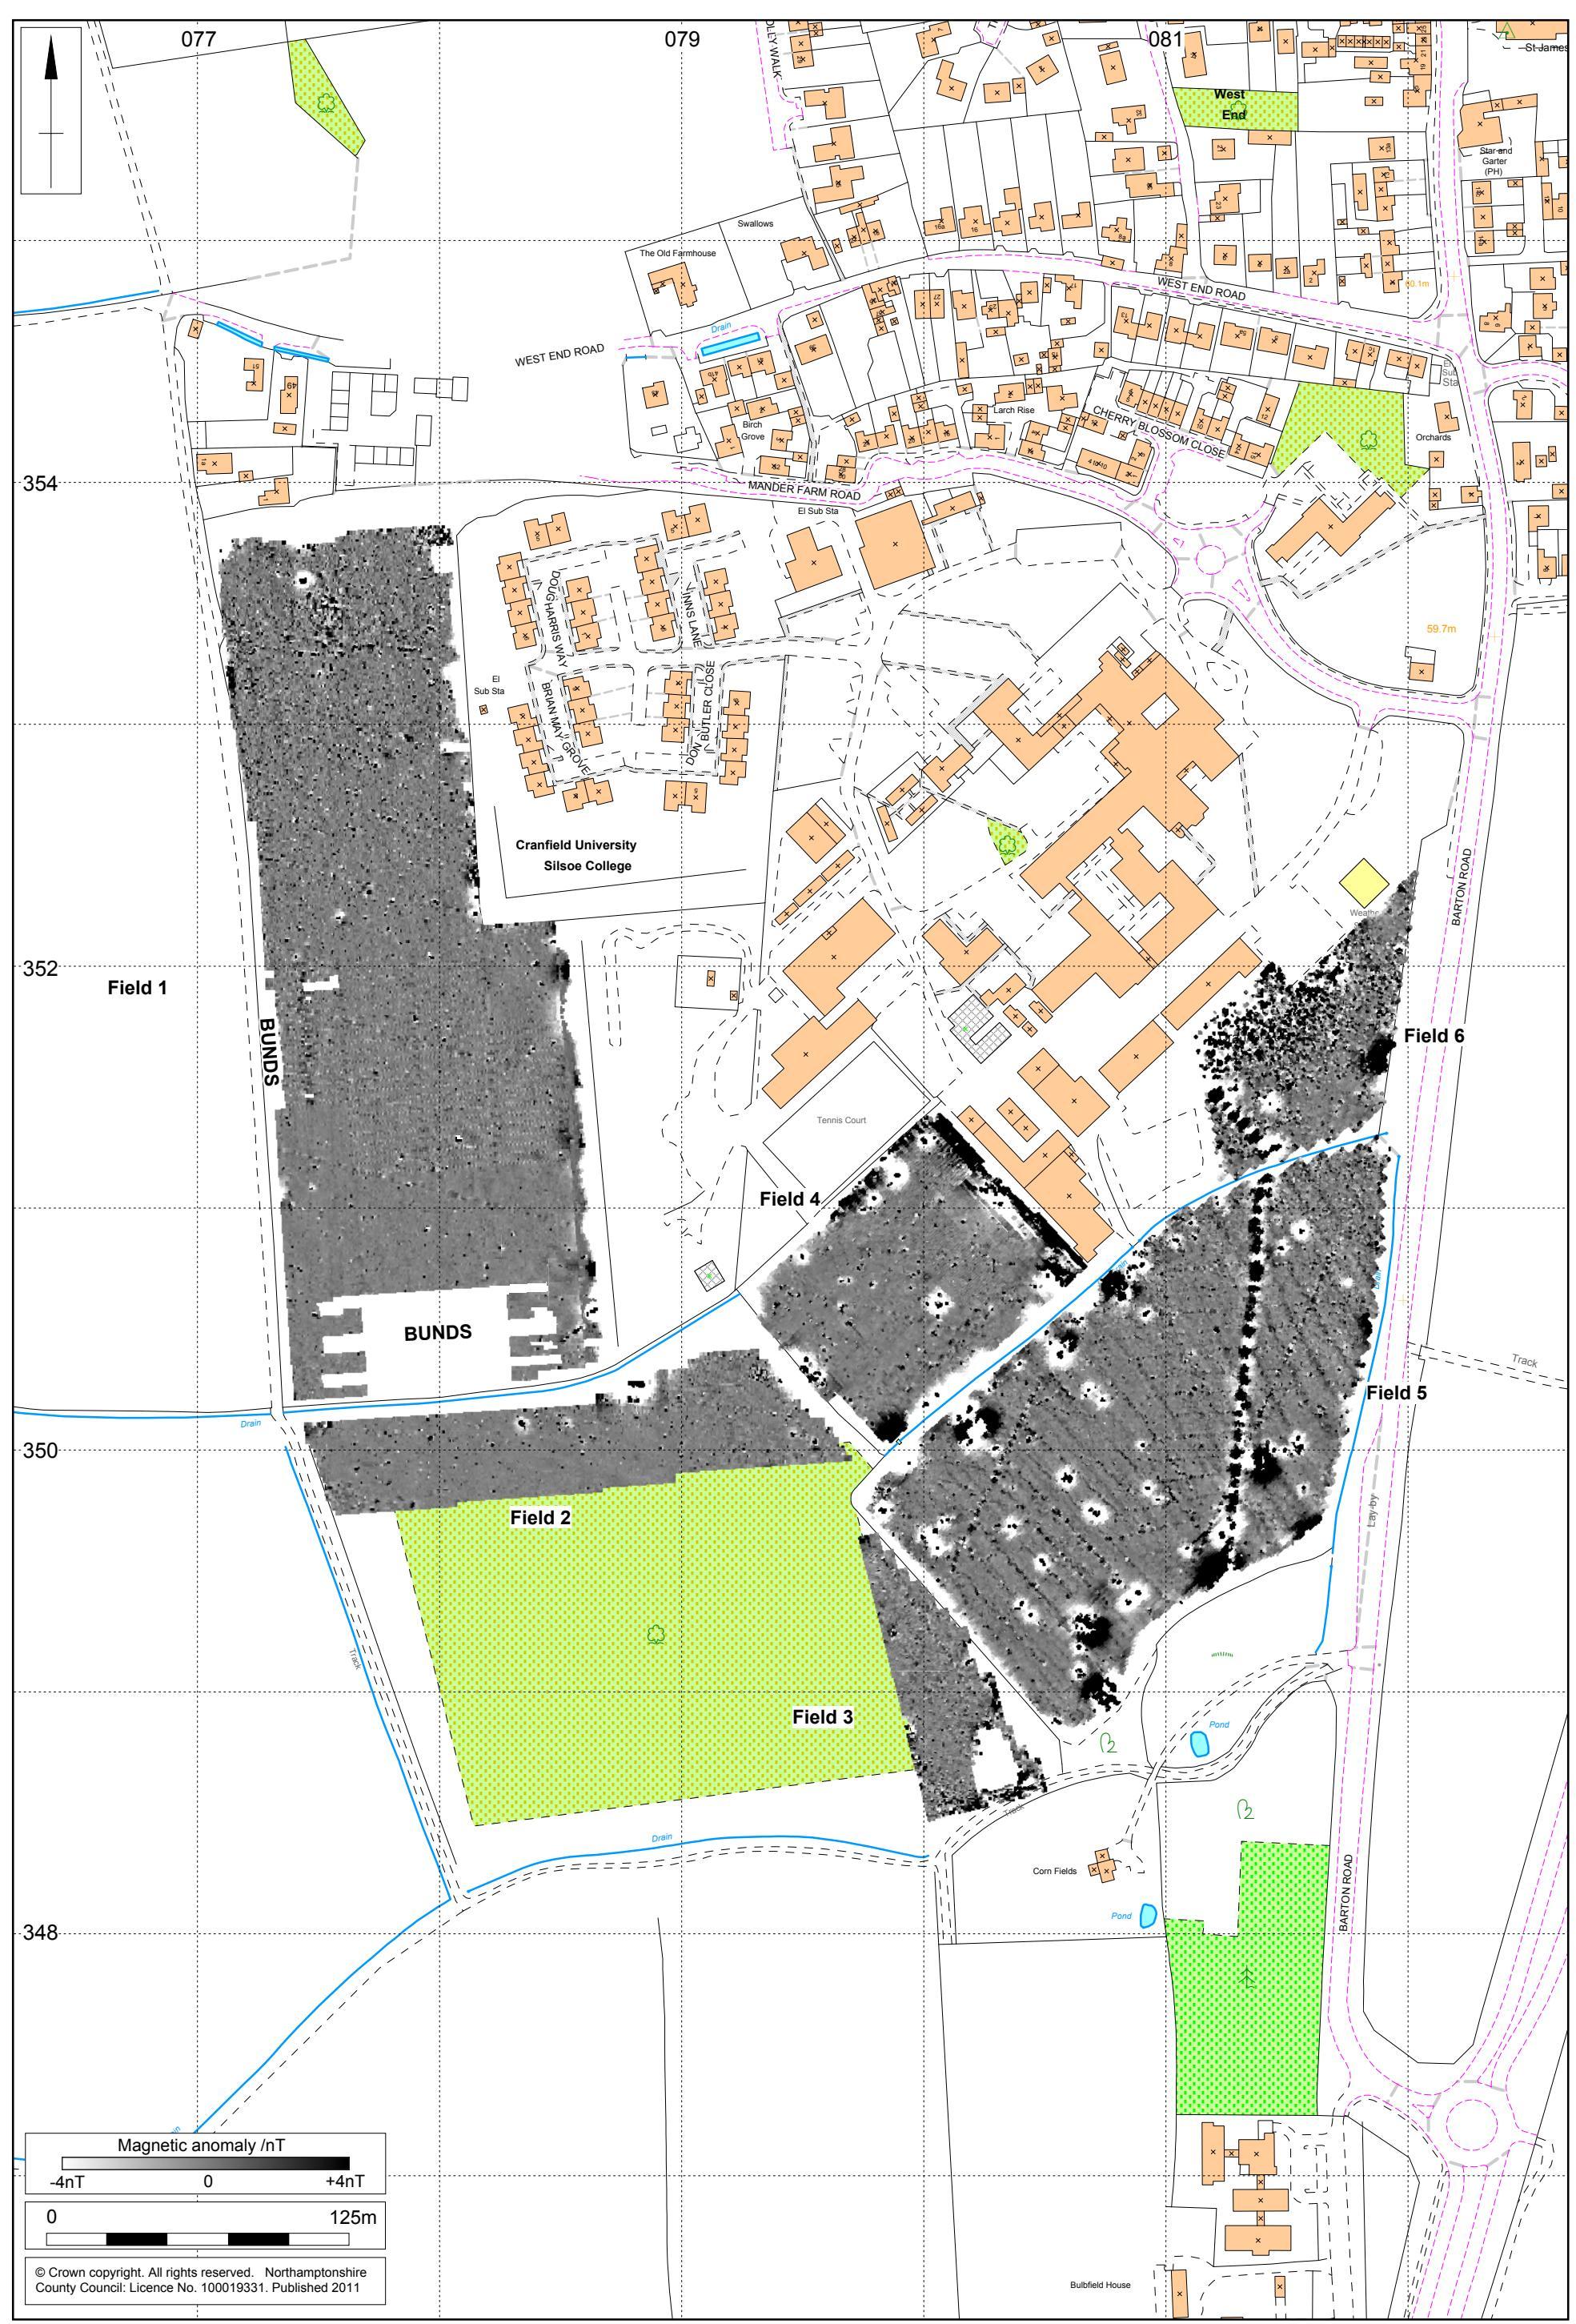
Magnetometer Survey Results Fig 2

The processed data are presented in this report in the form of greyscale plots (scale $\pm 4nT$ to -4nT black ~ white) which have been scaled, rotated and resampled (georectified) for display against the Ordnance Survey base mapping (Fig 2). An interpretative plot has been produced and is shown overlain onto the data in Figure 3. It is to these two figures that the following results refer.

The survey area covered six small areas comprising fields and sports fields (Fields 1-6, Fig 2), around the west, south and east edges of the former Cranfield University campus, which is located to the south of Silsoe. The site is bounded by agricultural land to the west and a house and gardens and scrub to the south. In the south-west corner is a woodland plantation. The east of the entire site runs alongside the Barton Road.

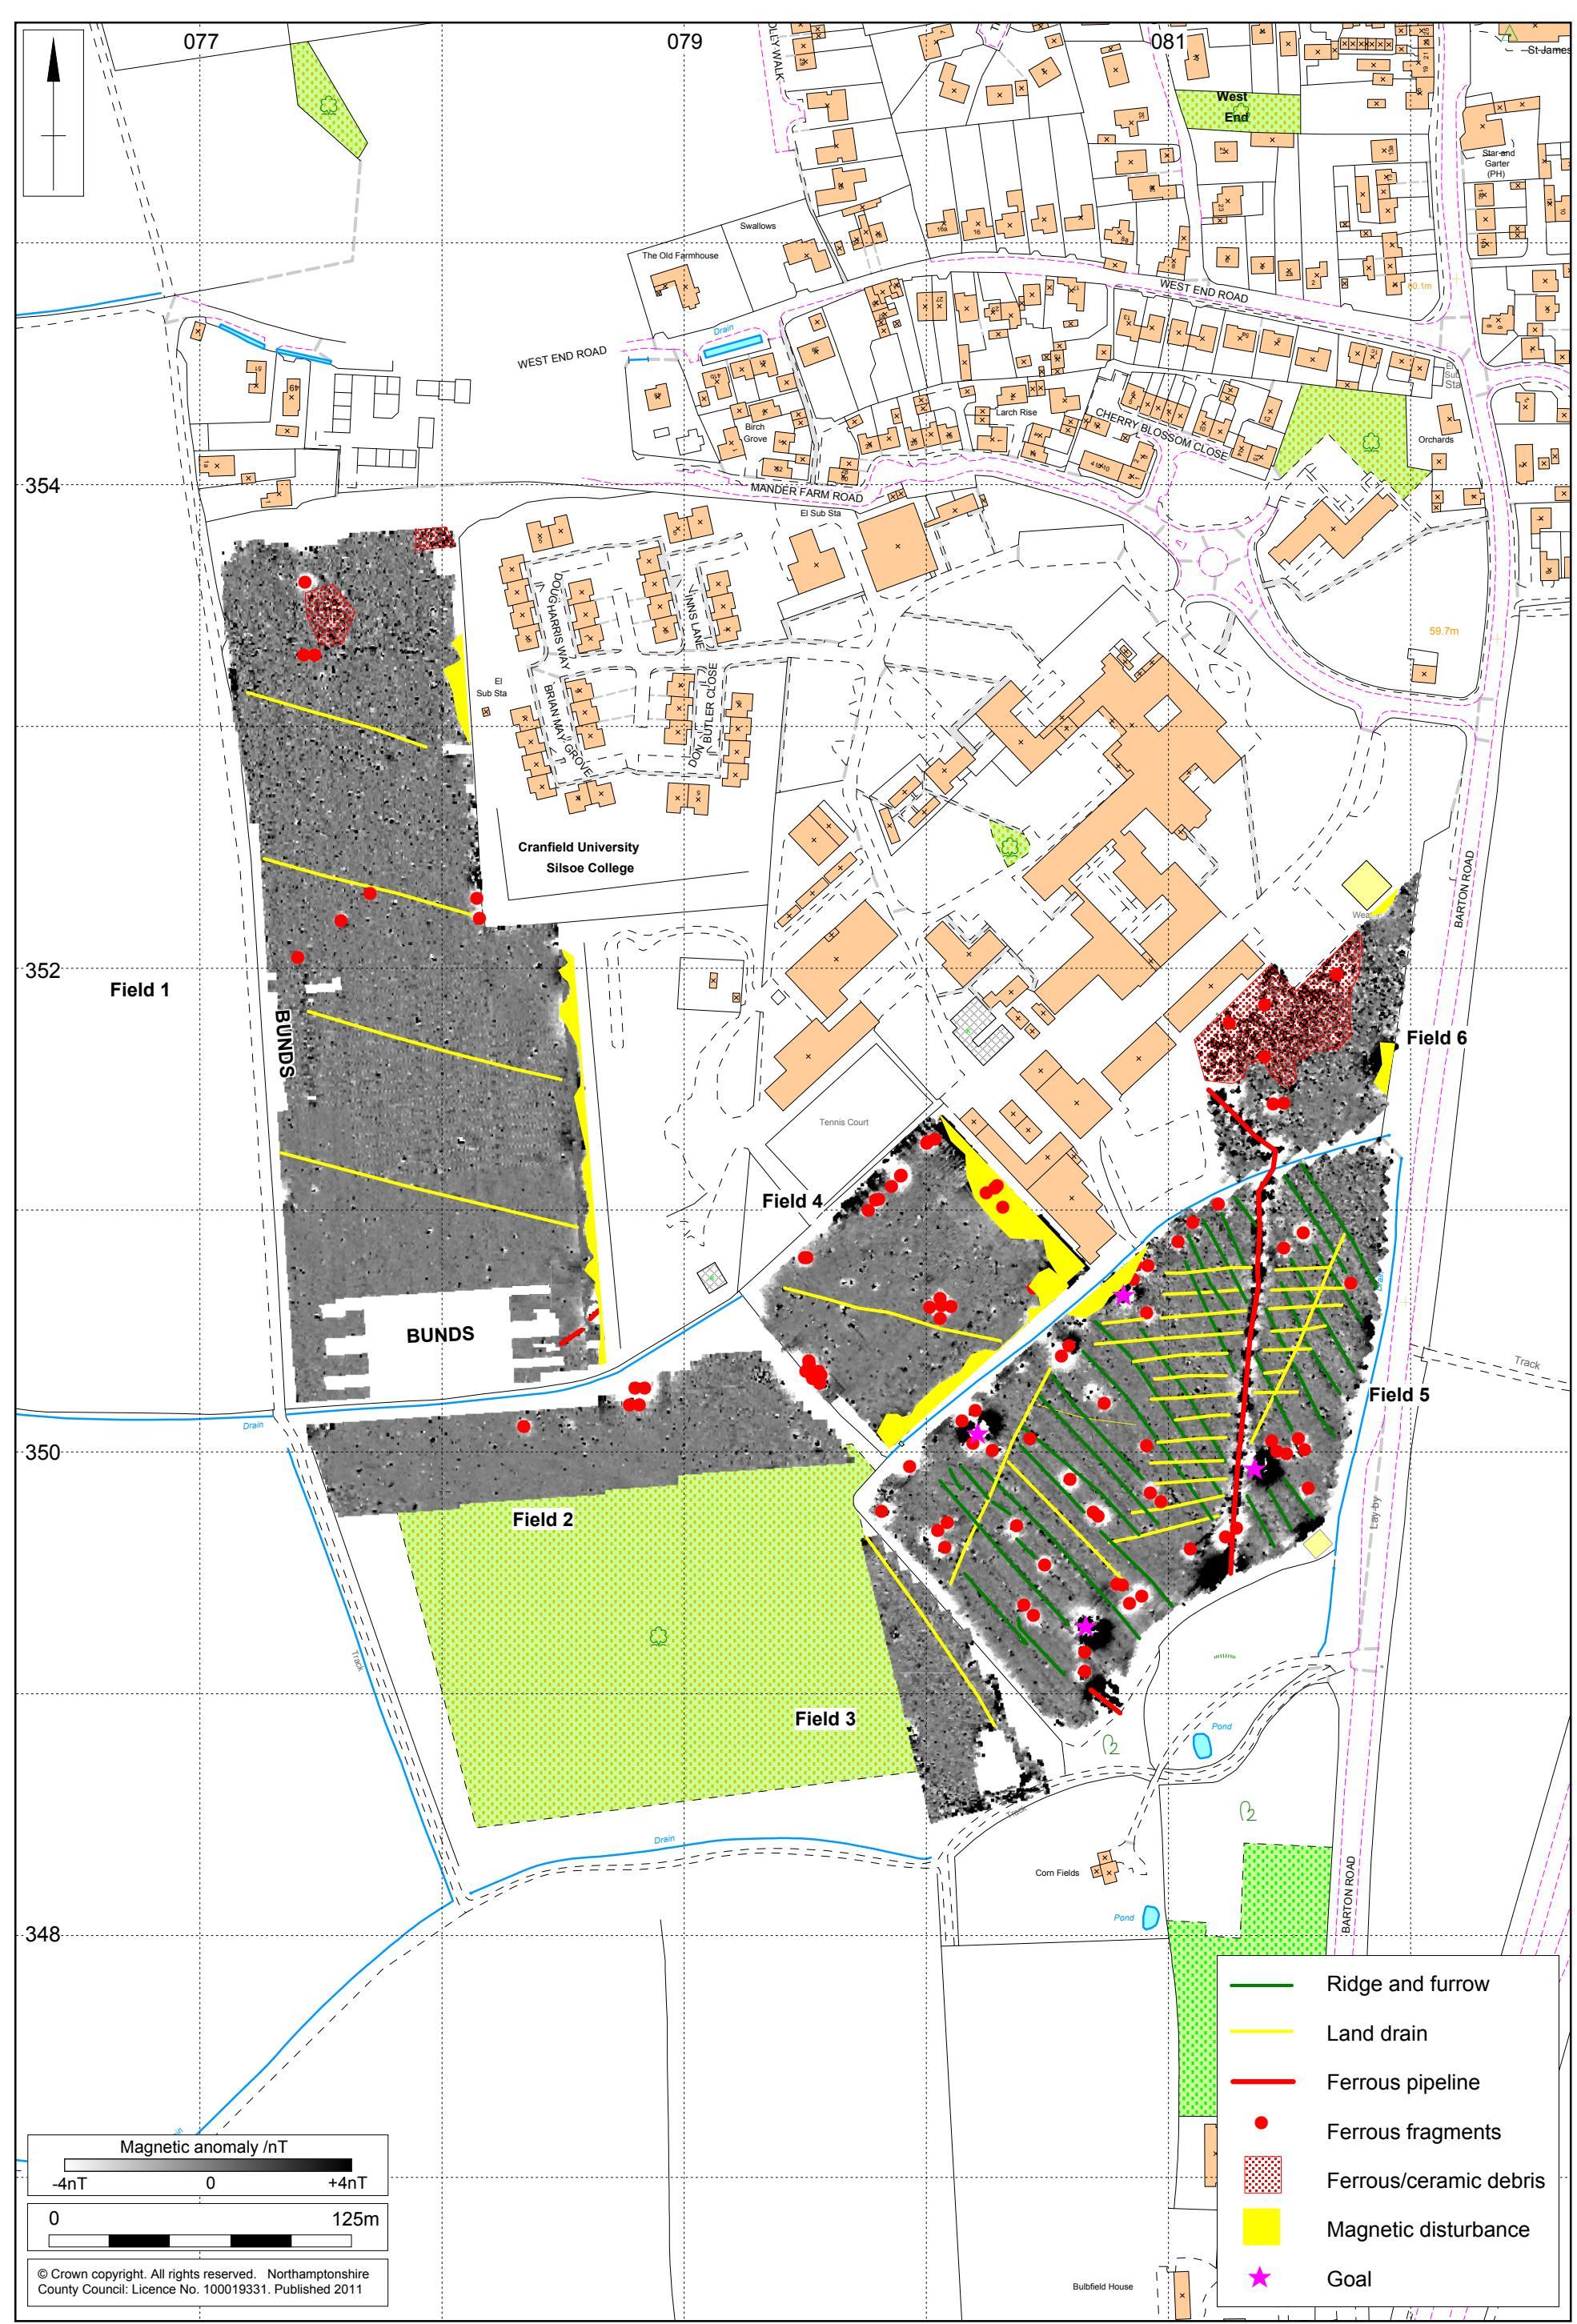
Magnetometer Survey Interpretation Fig 3

The data indicates several linear chains of paired positive and negative (dipolar) anomalies, which cross the field aligned north-west to south east. These are likely to represent ceramic land drains. Along the southern half of the eastern boundary is an area of magnetic disturbance. This could have been caused by a ferrous metal pipe which was lying above the ground surface along the edge of the neighbouring piece of land. Another area of magnetic disturbance was detected near the middle of the northern part of the eastern boundary, which runs up to the lawns at the back of the university housing. This magnetic disturbance could be caused by a deposit of ceramic waste (brick/tile) in the plough soil.

Across the field are several dipolar magnetic anomalies, these are likely to indicate pieces of ferrous debris in the plough soil. A stronger dipolar anomaly near the north of the field probably reflects a larger piece of ferrous material. Near to this item are two areas of magnetic noise (many positive and negative anomalies), which could represent areas of ferrous or ceramic debris.

In the south-east corner of the field a patchy linear anomaly probably indicates a ferrous pipe.

A dipolar anomaly detected in the middle of the field is likely to represent a piece of ferrous debris. A group of dipolar anomalies are similarly likely to represent ferrous debris near the entrance to Field 1.

A linear chain of dipolar anomalies is aligned north-west to south-east; this is likely to be caused by a ceramic land drain.

Areas of magnetic disturbance occur along the east and south sides of the field. The disturbance on the east is probably related to the buildings. The disturbance along the south side is probably related to some apparently derelict electrical installations, while the strong positive anomaly in the south-west corner could be related to the footbridge.

A linear chain of dipolar anomalies aligned north-west to south-east, is likely to indicate another ceramic land drain.

Several strong dipolar anomalies occur in the results for this field. As previously mentioned these are likely to represent ferrous objects. One in the south-east corner was probably caused by a lawn roller, another one along the eastern side was a metal sheet covering a void. Others may represent post sockets for goal posts.

Parallel linear positive anomalies aligned north-west to south-east were located across the whole field. These are typical of the response of medieval or post-medieval ridge and furrow cultivation patterns.

Other linear anomalies aligned west to east in the middle of the field, are likely once again to be land drains. Slightly stronger linear anomalies aligned south-west to north-east are also likely to be land drains, perhaps main spinal drains fed by the smaller drains.

A linear feature consisting of strong dipolar anomalies aligned almost north to south indicates the presence of a ferrous pipeline.

Many intense dipolar anomalies occur across the field, probably reflecting ferrous objects, perhaps sporting equipment. A number of them were caused by goal posts standing in the field at the time of the survey, as depicted on Figure 3.

An area of magnetic disturbance along the middle of the northern side is probably linked to the adjacent drain, footbridge and building. Another area of magnetic disturbance, in the south-east corner is probably caused by the small gas installation building there.

A short stretch of strong dipolar anomalies in the south-west corner perhaps indicate another ferrous pipeline and seem to coincide with the location of two concrete slabs on the ground.

This field is a grassed area within the campus grounds. Much of the field is covered by an area of magnetic noise, likely to be caused by ferrous or ceramic debris, with some stronger dipolar anomalies representing larger ferrous objects. The area of magnetic disturbance to the north of the field is probably related to ferrous installations in the weather station. Another area of magnetic disturbance occurs to the east of the field perhaps indicating some ferrous object in the ditch.

A linear feature consisting of strong dipolar anomalies aligned north-west to southeast in the south-east corner indicates a ferrous pipeline, which appears to turn towards the south and continue into Field 5.

The magnetometer survey results did not show any anomalies that represent obvious archaeological features. However, medieval or post-medieval ridge and furrow cultivation patterns were detected in the south-eastern field (Field 5). Other magnetic anomalies were revealed which probably indicate ceramic land drains and ferrous pipelines. There were several areas of magnetic disturbance mainly reflecting standing buildings, fences, electrical installations and an above ground pipe. Several areas of magnetic noise indicate spreads of ferrous or ceramic debris in the soil. While many discrete dipolar anomalies reflect ferrous debris or larger ferrous objects, especially on the two sports fields.
