# NORTH PENNINES ARCHAEOLOGY LTD

# Client Reports No. CP/775/08

David Jackson BA (Hons) North Pennines Archaeology Ltd Nenthead Mines Heritage Centre Nenthead Alston Cumbria CA9 3PD Tel: (01434) 382045 Fax: (01434) 382043 November 2008

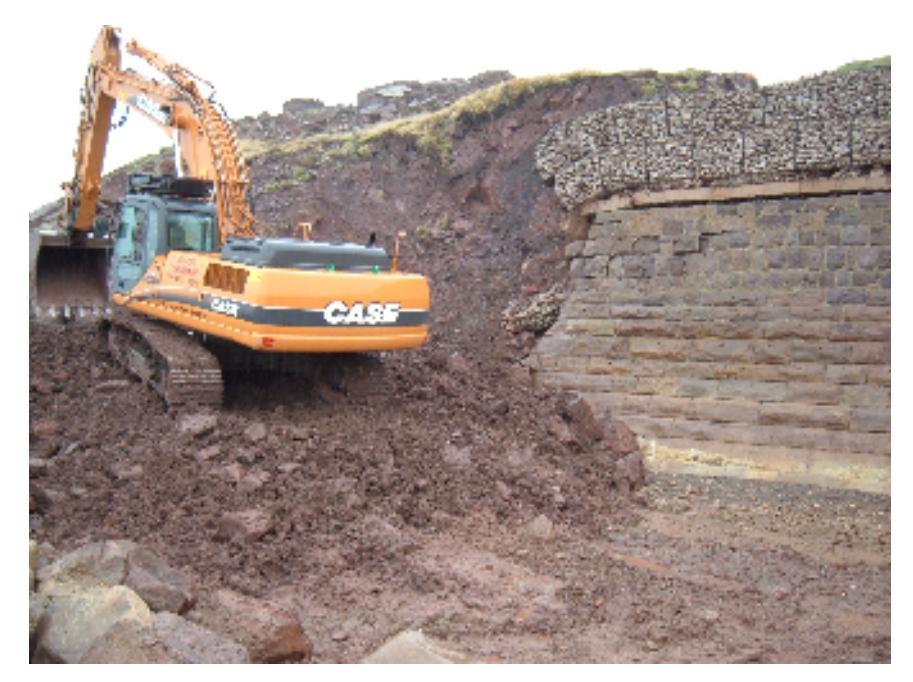
4.2.1 The first phase of groundworks took place at the north end of the surviving sea wall with the removal of hill wash material resulting from cliff erosion, with a CX 330 excavator (Plate 1). As this hill wash material had caused the partial destruction of the north end of the sea wall and subsequently buried any possible remains, the machine operator was informed to proceed with extreme caution within the area. The hill wash material (**102**) was made up of red/pink sandy clay mixed with frequent large red sandstone boulders, which had eroded out from the sandstone outcrop known as Fairy Rock above. This deposit formed a c.9 metre-high mound immediately to the north-northeast of the surviving sea wall and was covered by c.0.2 metres of turf and topsoil (**100**).

Plate 1: Excavation of eroded material north of sea wall

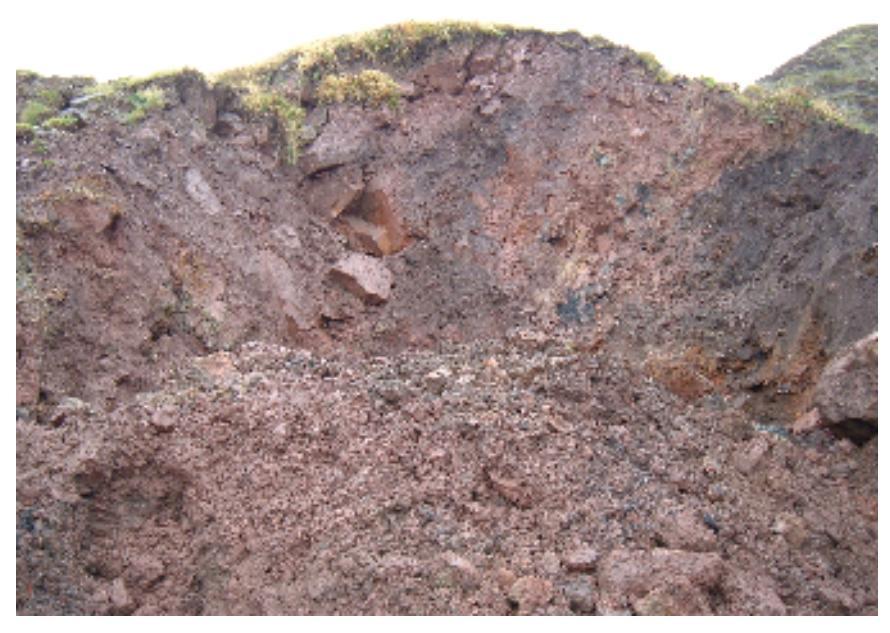
4.2.2 It became apparent as the excavation continued east into the mound that this deposit (102) was partially overlaying a deposit of dark brown silty clay mixed with industrial waste. This silty clay/industrial waste deposit (103) gradually increased at a gradient of  $c.45^{\circ}$  reaching a height of c.2.5 metres until it levelled out south of the mound (102) (Plate 2). As this deposit (103) comprised the upper c.2.5 metres of ground east of the sea wall, it is likely that it was used as backfill to raise the ground level when the site was in use and prior to the cliff erosion which led to the deposition of the mound (102). During this phase of the excavation, several gabions had to be removed from the top of the north end of the sea wall in order to provide safer conditions for people working below.

Plate 2: West facing section of deposits (102) and (103)

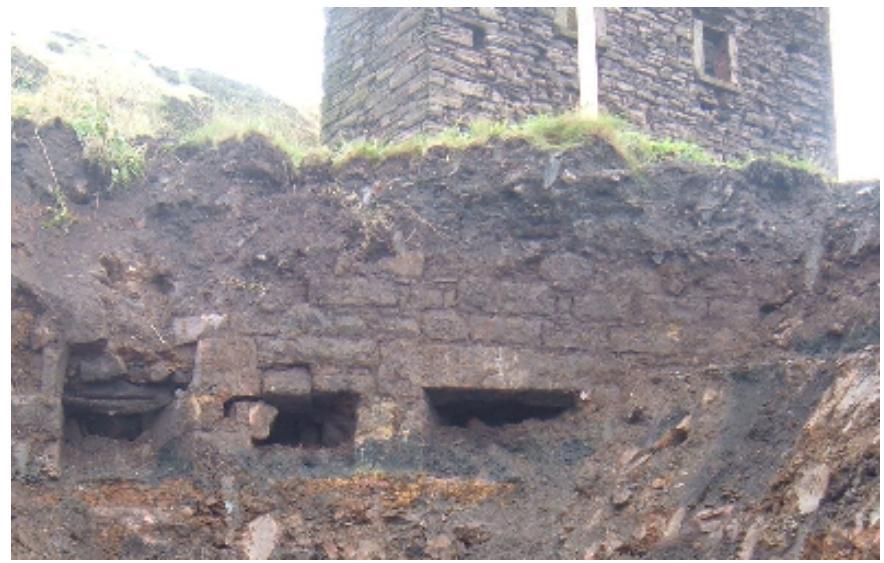
As the excavation continued further east of the surviving sea wall, the northwest 4.2.3 elevation of a structure was exposed in the section of the excavated area c.1 metre below topsoil (100) and backfill (103) (Plate 3) (Figure 4). The structure (104) survived to a height of c.1.45 metres and a width of c.5.3 metres. However, severe damage had occurred to the north-eastern end of the structure, possibly as a result of land movement, the structure also continued further southwest past the limit of the excavation for an unknown distance. The structure (104) was constructed from variable sized square-cut sandstone blocks and displayed three square-rectangular openings within the northwest face. The three openings were relatively irregular in comparison, varying in size from c.0.7m x 0.6m (north-east), c.0.64m x 0.5m (central), c.1.07m x 0.5m (south-west). However, all three chamfered inwards, decreasing in width as they continued further into the super-structure. It was also clear that all three had suffered severe damage through collapse. Two separate deposits filled the three openings. The upper deposit (105) measured c.0.25 metres in thickness and was probably deposited within the openings when the area was backfilled by deposit (103), as both deposits were very similar in both colour and texture. The lower deposit (106) was a compact black coal waste material that measured c.0.2 metres in thickness and had adhered to the base of the openings to a certain degree. The coal waste material (106) was probably deposited whilst the mine was still in use and could be a strong indicator to the possible function of the structure (104), suggesting that the openings may have served as vents for waste material. As no truncation was apparent, it is probable that the exposed section revealed the north-western limit of the structure (104), which appeared to continue in a south-easterly direction towards the surviving engine winding house.

- 4.2.4 Although the structure (**104**) and the engine winding house were initially believed to be directly associated, a drawing produced by Marshall and Davies-Shiel (1977: 113) of the Saltom Pit site in 1864 clearly shows a range of different buildings immediately north and northwest of the winding house including two additional engine houses, boiler sheds and a coal depot. These buildings have long since disappeared but they can be seen in a relatively detailed plan of 1852 (David Cranstone *pers. comm.*).

Plate 3: Northwest elevation of structure (104) (engine winding house in background)

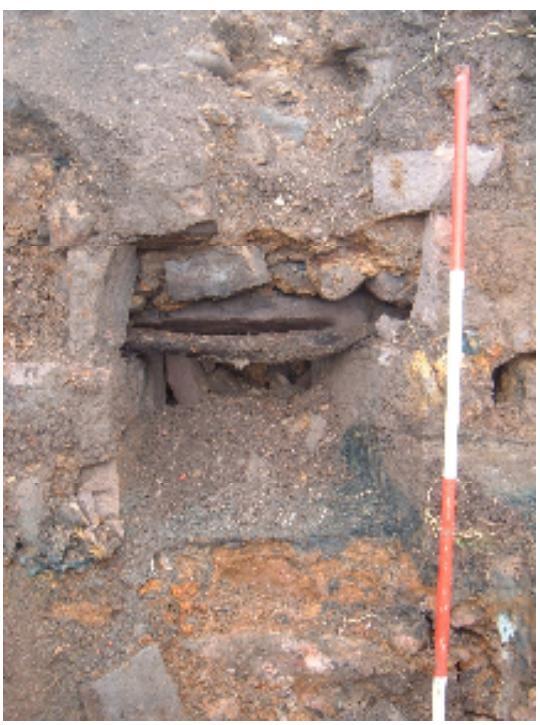
- 4.2.5 Interestingly, the 1852 plan displays a narrow curvilinear feature heading in a westerly direction from the southwest corner of one of the buildings (noted as being the coal depot by Marshall and Davies-Shiel), and abutting the eastern face of the sea wall. Furthermore, this feature is labelled on the 1852 plan as being a 'covered passage for conveying the ashes', strongly suggesting that it served as a type of flue for waste material. Whilst the structure (104) certainly has the overall appearance of a possible flue for venting waste material, especially when the coal waste (106) and openings are considered, its general alignment and location appear to be different. However, if the structure (104) is not the aforementioned feature on the 1852 plan, then it appears likely that it served a similar function further to the north. The top of a 19<sup>th</sup> century ceramic bottle was recovered from the upper fill (105) within the south-western most vent of structure (104), whilst the north-eastern most vent still had the remains of an *in-situ* wooden support beam (Plate 4).

Plate 4: North-eastern vent of structure (104)

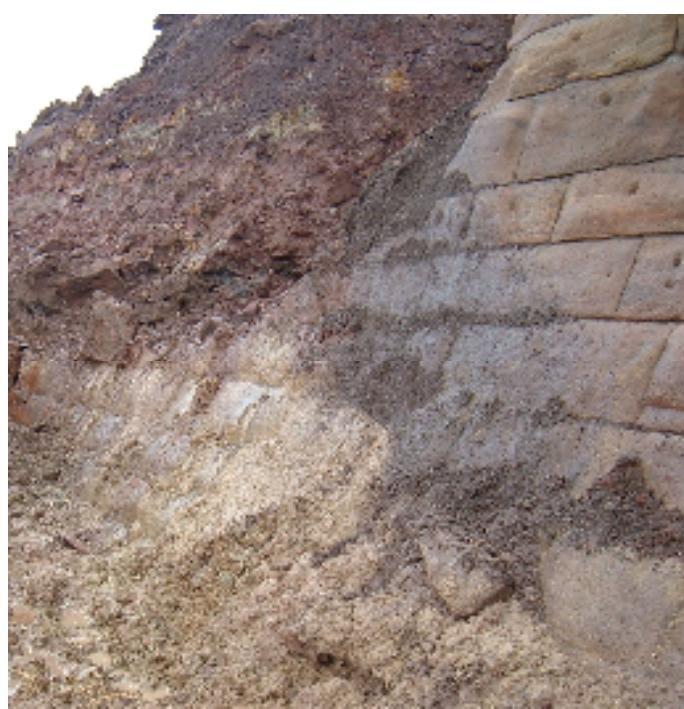
- 4.2.7 The bedrock only continued at its present level as far west as the line of the sea wall at which point, the bedrock 'dropped off' and it was revealed that the sea wall continued further north than was previously realised, abutting the western edge of the bedrock. However, it is unclear whether the bedrock falls away naturally at this point or whether it has been 'artificially' cut away to facilitate the construction of the sea wall. Once the newly exposed section of the sea wall had been cleared of all debris, it was revealed that at least five lower courses of the wall survived to a height of c.1.8 metres (Plate 5), which almost certainly survived as a result of its proximity to the natural bedrock. This section of the wall was constructed from square cut sandstone blocks (average size c.0.75 m x 0.35 m), two courses wide at a width of c.1.8 metres and continued north for c.8 metres past the limit of the excavated area for an unknown distance.

Plate 5: *Excavated area showing continuation north of sea wall (west face)*

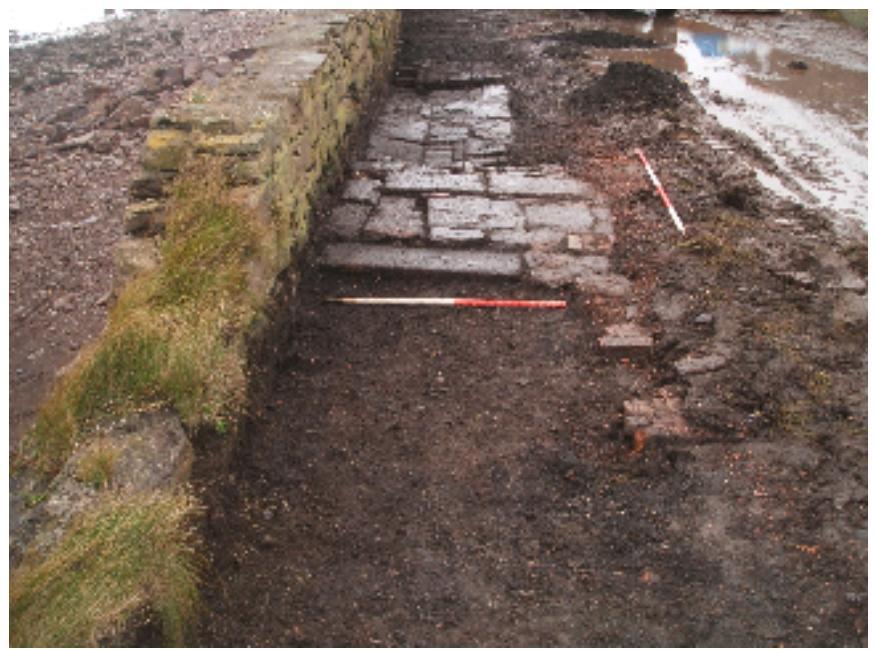
- 4.3.2 The first feature (109) was a floor surface located c.3.5m north of the south corner of the sea wall, measuring c.8.6m in length and spanning the entire width of the excavated area (1.6m) (Plates 6 and 7). This feature (109) was comprised of large red sandstone flags ( $c.0.6m \ge 0.6m = 0.6m$ ), interlaced with areas of red brick ( $c.0.23m \ge 0.6m$ ) 0.1m x 0.08m) which retained several small areas of mortar suggesting that parts of the surface may have once had a mortar covering. The surface also retained a north – south aligned, c.0.28m wide drainage channel which led into a ceramic pipe with a cast iron grate covering, and out through the west face of the sea wall (Plate 8). Surface (109) was largely damaged in places with many flags and bricked areas either smashed or completely missing. Several large depressions had also formed creating an uneven surface, although it is likely that the central section of the feature was always intended to form a low point for drainage purposes. It is probable that this feature (109) once formed the floor surface of a larger structure, as both the Second and Third Edition Ordnance Survey maps (1899 and 1925 respectively) clearly show several buildings within the same general location. The potential for further survival of feature (109) east of the exposed area is significantly high.

Plate 6: View north across floor surface (109)

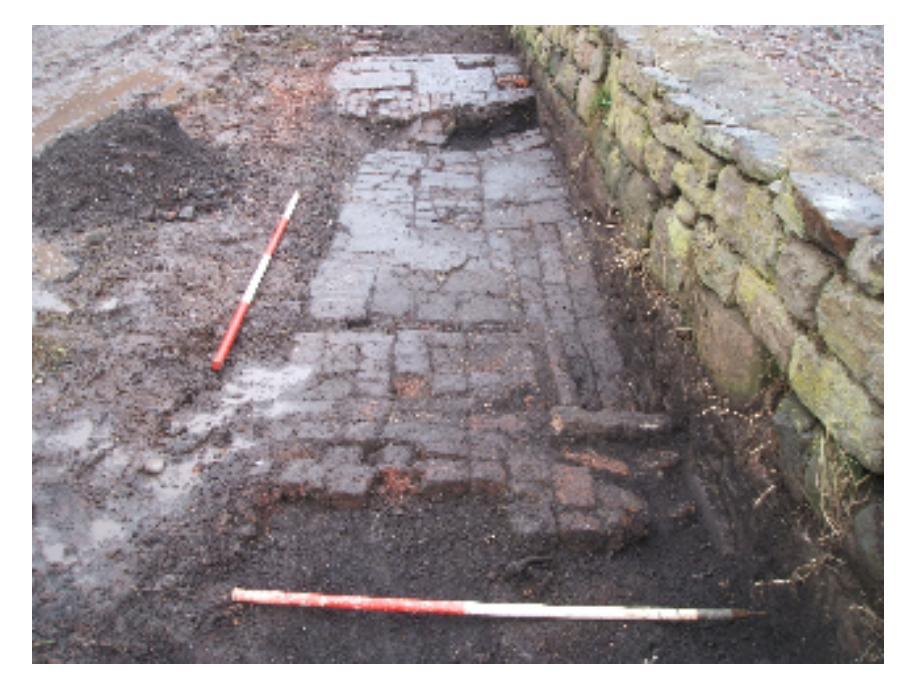
Plate 7: View south across floor surface (109)

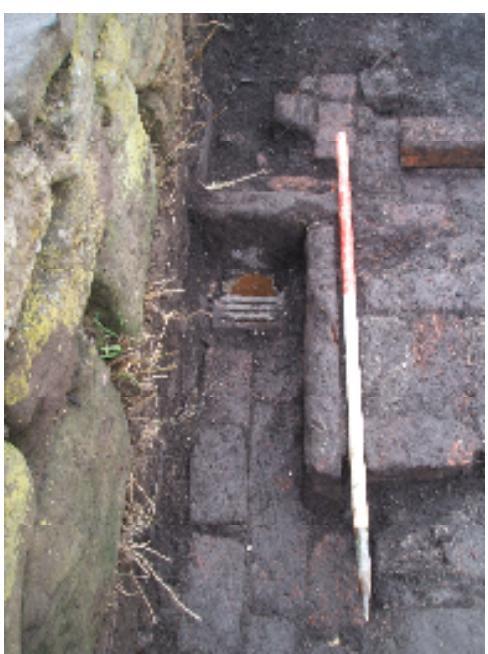
Plate 8: View north of drainage channel within floor surface (109)

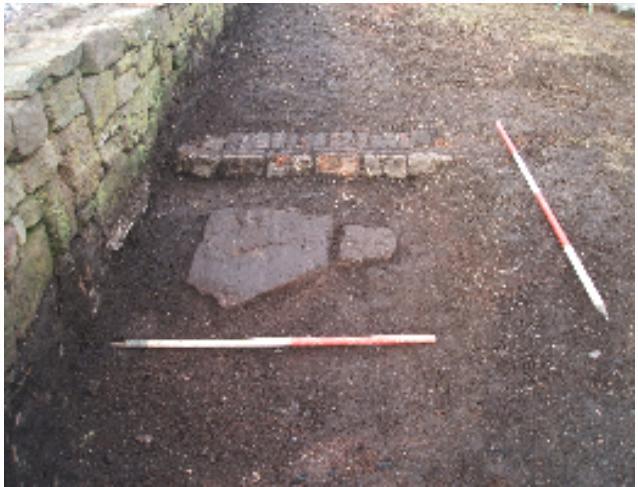
4.3.3 The second feature (110) identified was located c.7.4m north of the floor surface (109) and measured c.0.38m in width and 1.6m in length on an east – west alignment between the eastern face of the sea wall and continuing east past the edge of the excavated area. This feature (110) comprised a single course of red brick (0.22m x  $0.1m \ge 0.07m$ ) in three rows, two of which were aligned east – west with the northern most row aligned north – south (Plate 9). Two *in-situ* sandstone flags were also noted c.0.4m south of feature (110) (Plate 9). This feature (110) probably formed part of a larger structure, as the Third Edition Ordnance Survey map of 1925 shows several small buildings within the same area. However, these buildings are not present on the Second Edition Ordnance Survey map of 1899 suggesting that feature (110) was constructed after feature (109).

Plate 9: View north of feature (110) with sandstone flags in foreground

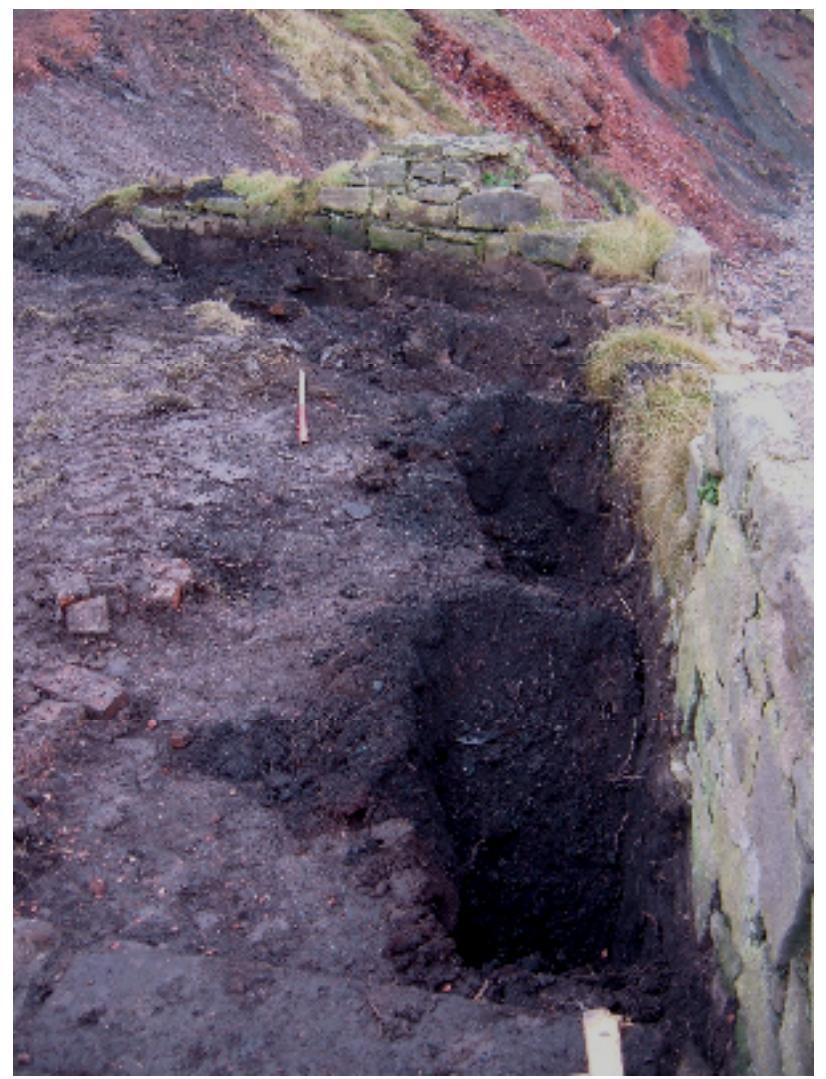
4.3.4 Further work immediately east of the sea wall included the excavation of eleven postholes in advance of the installation of fence posts. Six of the post-holes were located at the southern end of the sea wall, immediately south of the floor surface (109) and spaced approximately 2m apart adjacent to the sea wall's eastern and north-eastern face (Plate 10). The remaining five post-holes were located further north, immediately south of the area of gabions and were more randomly spaced on a northeast – southwest alignment between the east face of the sea wall and the wire fence north of the engine winding house. All of the post-holes measured  $c.0.9m \times c.0.6m$  and were excavated to a depth of c.0.5m exposing industrial waste/soil backfill (103) below the topsoil (100). No archaeological features or finds were noted during the excavation of the post-holes.

Plate 10: View south across southern series of post-holes
