# MONITORING AND RECORDING OF ARCHAEOLOGICAL TEST PITS:

# LONG BARN FARM, HIGH STREET, KETTON, RUTLAND

Planning References: FUL/2005/0606/CC and FUL/2007/0068 NGR: TF 34061 42118 AAL Site Code: KELB 10 OASIS Reference Number: allenarc1-73306

By Allen Archaeology Limited Report Number 2010010

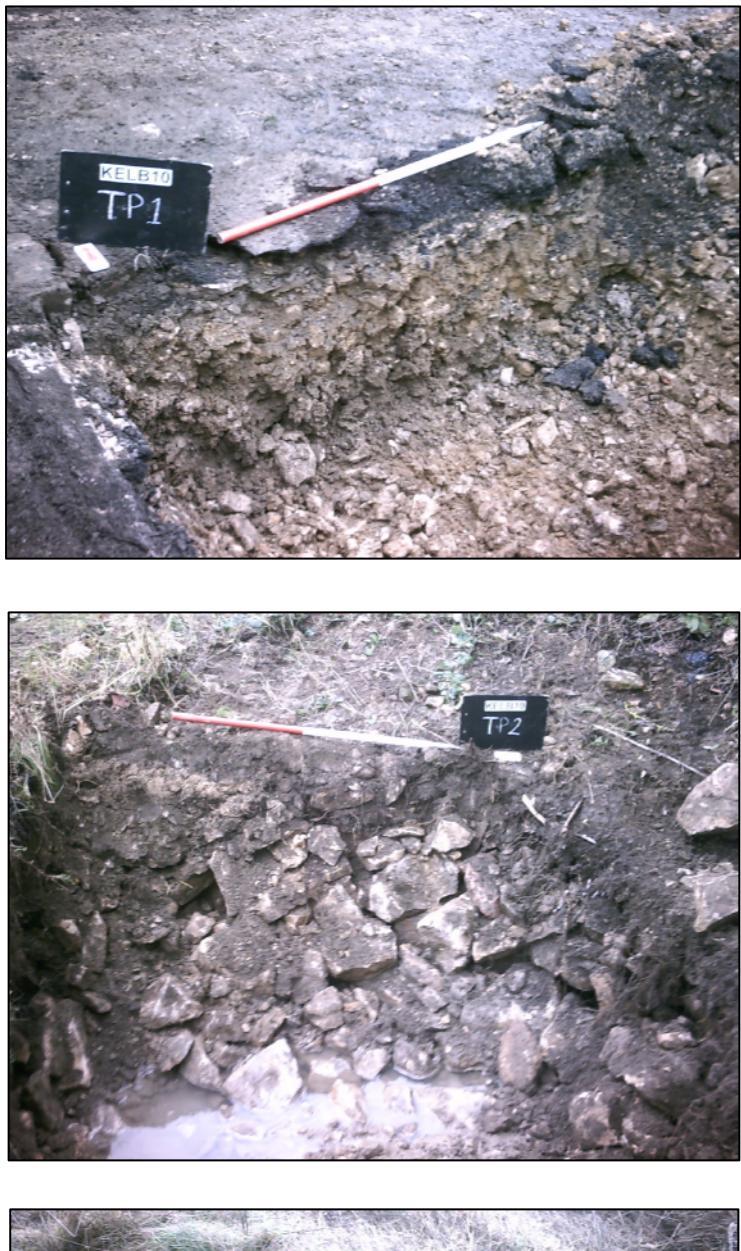
**Plate 1:** South-facing representative section of Test Pit 1, looking north-north-east

Context	Туре	Description	Interpretation	Thickness			
No.		-	-				
100	Layer	Tarmac, seals 101	Tarmac surface	0.1m			
101	Layer	Mid brown/yellow sandy clay, frequent sub-angular limestone. Sealed by 100	Natural limestone brash	>0.55m
