LAND AT THE BUTCHERS' ARMS, MAIN STREET, LANEHAM, NOTTINGHAMSHIRE

SCHEME OF ARCHAEOLOGICAL MONITORING AND RECORDING

April 2012

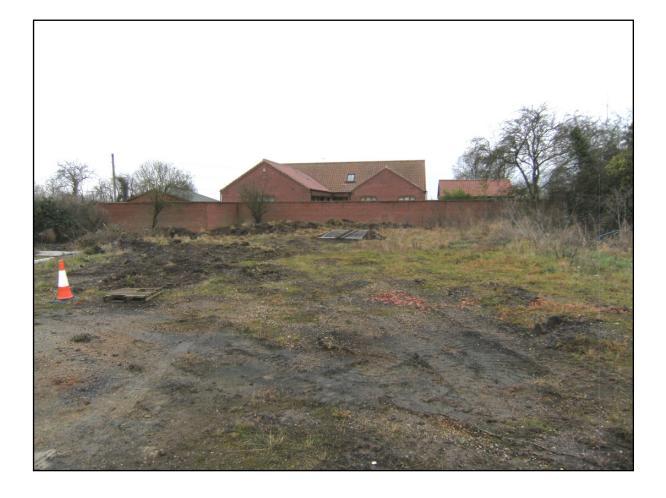
Plate 1: General view of location of southern plots, looking south.

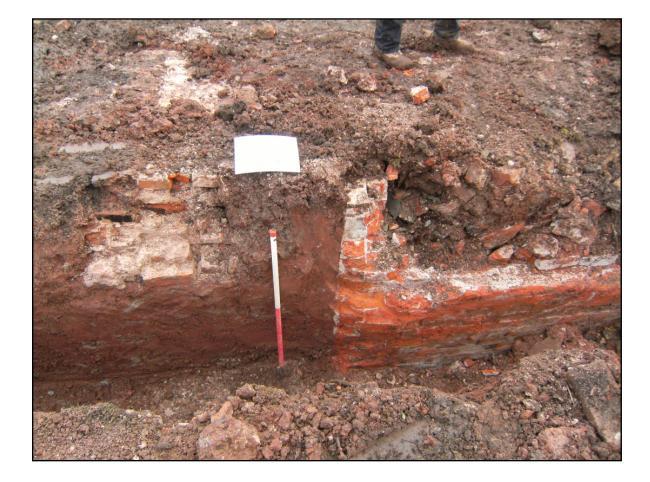
The wall of a large brick soakaway (108) was revealed adjacent to wall (106) towards the eastern extent of this plot. Assumed to be square in plan, (108) was contained within cut [112], approximately 1.5m in depth and 2.6m+ in length and subsequently backfilled with rubble and clay (111) which yielded two glass bottles dated between 1874 to 1969, one of which carried the embossed text "OWBRIDGE'S" "LUNG TONIC" "HULL".

Plate 3: South-west facing section of wall footing (106) and soakaway (108) within northern plot.

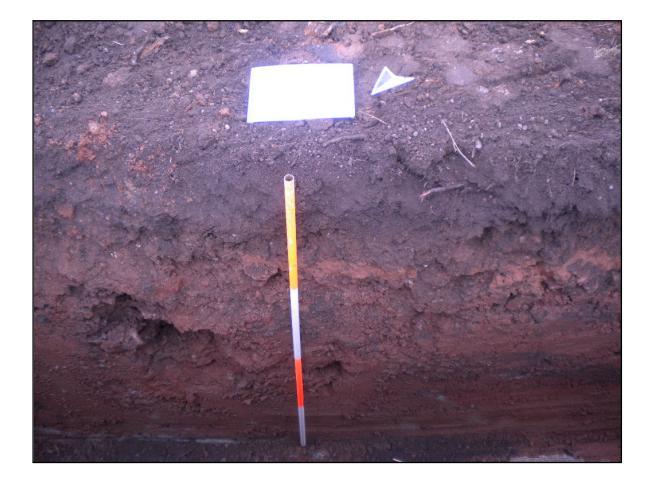
The earliest deposit encountered was natural clay (107) above which was a pale orange sand (116), probably associated with (117), a mid grey brown sandy silt which formed a levelling horizon for an asphalt layer (118), part of the former public house car park. These deposits were sealed by topsoil (101), which together with a concrete decorative edging, formed a boundary between the car park and a possible garden area.

Plate 5: South-east facing representative section showing natural red clay (107) within southern plot footings.

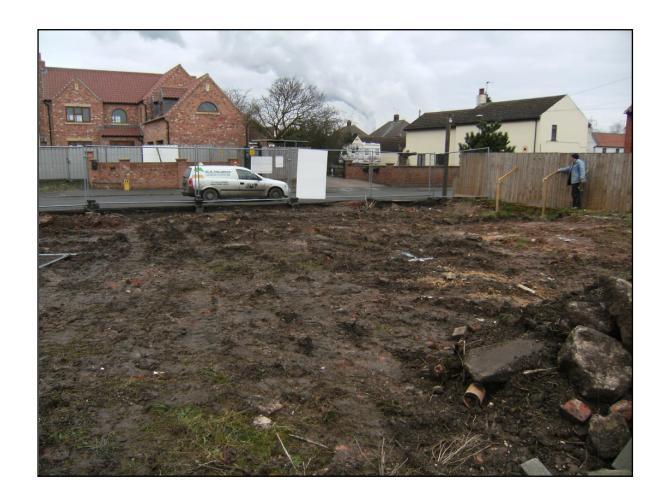
Plate 2: General view of location of northern plots, looking north.

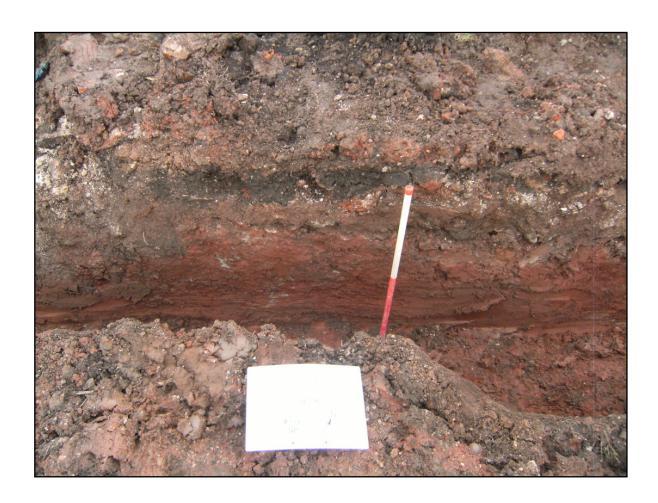
As with the previous test pits, the earliest deposit comprised natural red brown clay (107), covered in part by a sandy subsoil (102) = (113).

Plate 4: South facing representative section showing natural red clay (107) within northern plot footings.

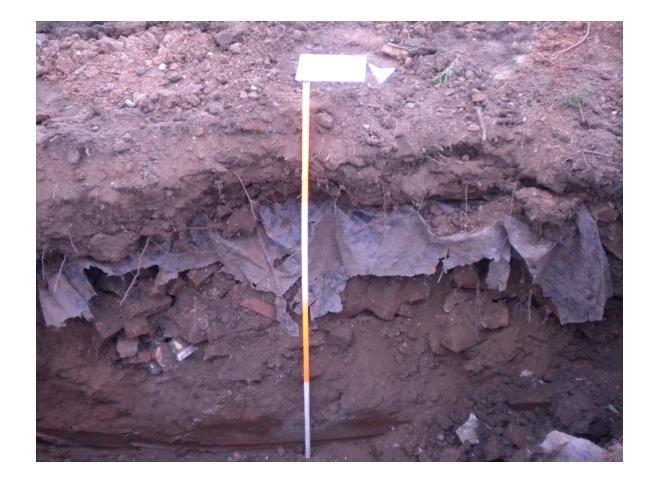
The area investigated for the garage plots revealed a sandy subsoil (102) above natural clay (107). The only feature present [121] was a large rubbish pit, 3m+ wide and 1.5m in depth, filled with mid grey-brown silty sand containing frequent brick, concrete and metal work, old buckets etc. This deposit had in turn been sealed by a plastic membrane upon which topsoil had been laid.

Plate 6: North facing section of modern rubbish pit [121] within garage plot.

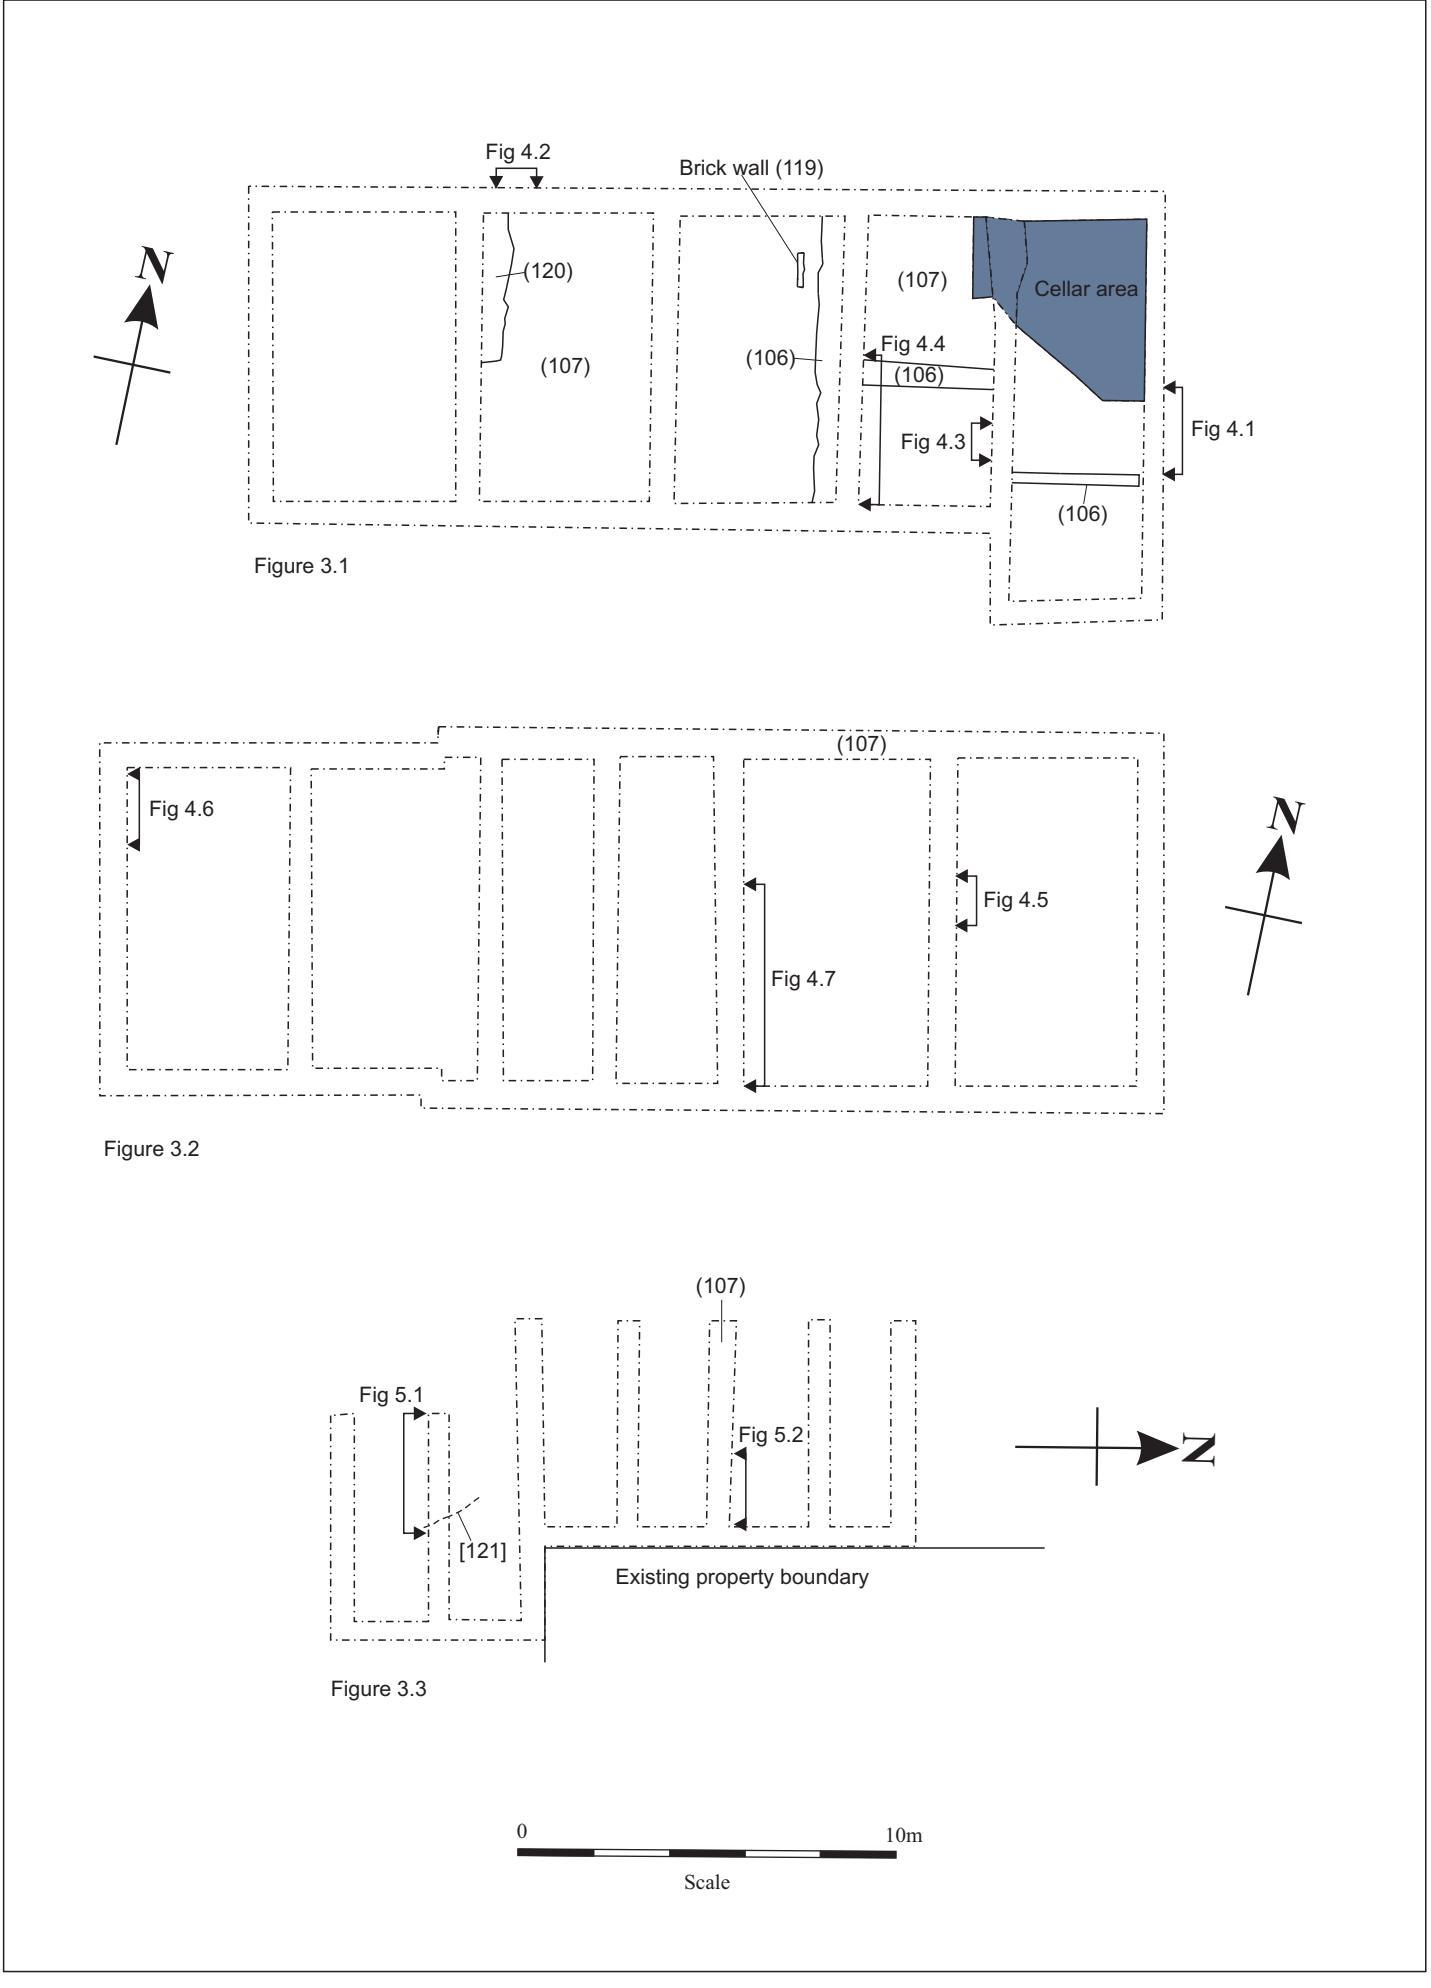
Figure 3: Plan of northern/southern plots & garages.

The following contexts formed structural elements of the Butchers Arms pub: construction cut [109] contained brick remnants of the internal and external walls of the public house (106), also to include (119) and (120). These were in turn backfilled by (110), a dirty, mixed clay and silt deposit.

At the eastern extent of the site was a deposit of topsoil/garden soil (101), present within the west facing section of the footings. This had been truncated in part by cut [103] for the pub cellar previously investigated during the test pit phase of operations. This had been backfilled with loose brick rubble, concrete and clay silt (105) upon which and incorporated within were remains of the brick boundary wall (104) for the public house.

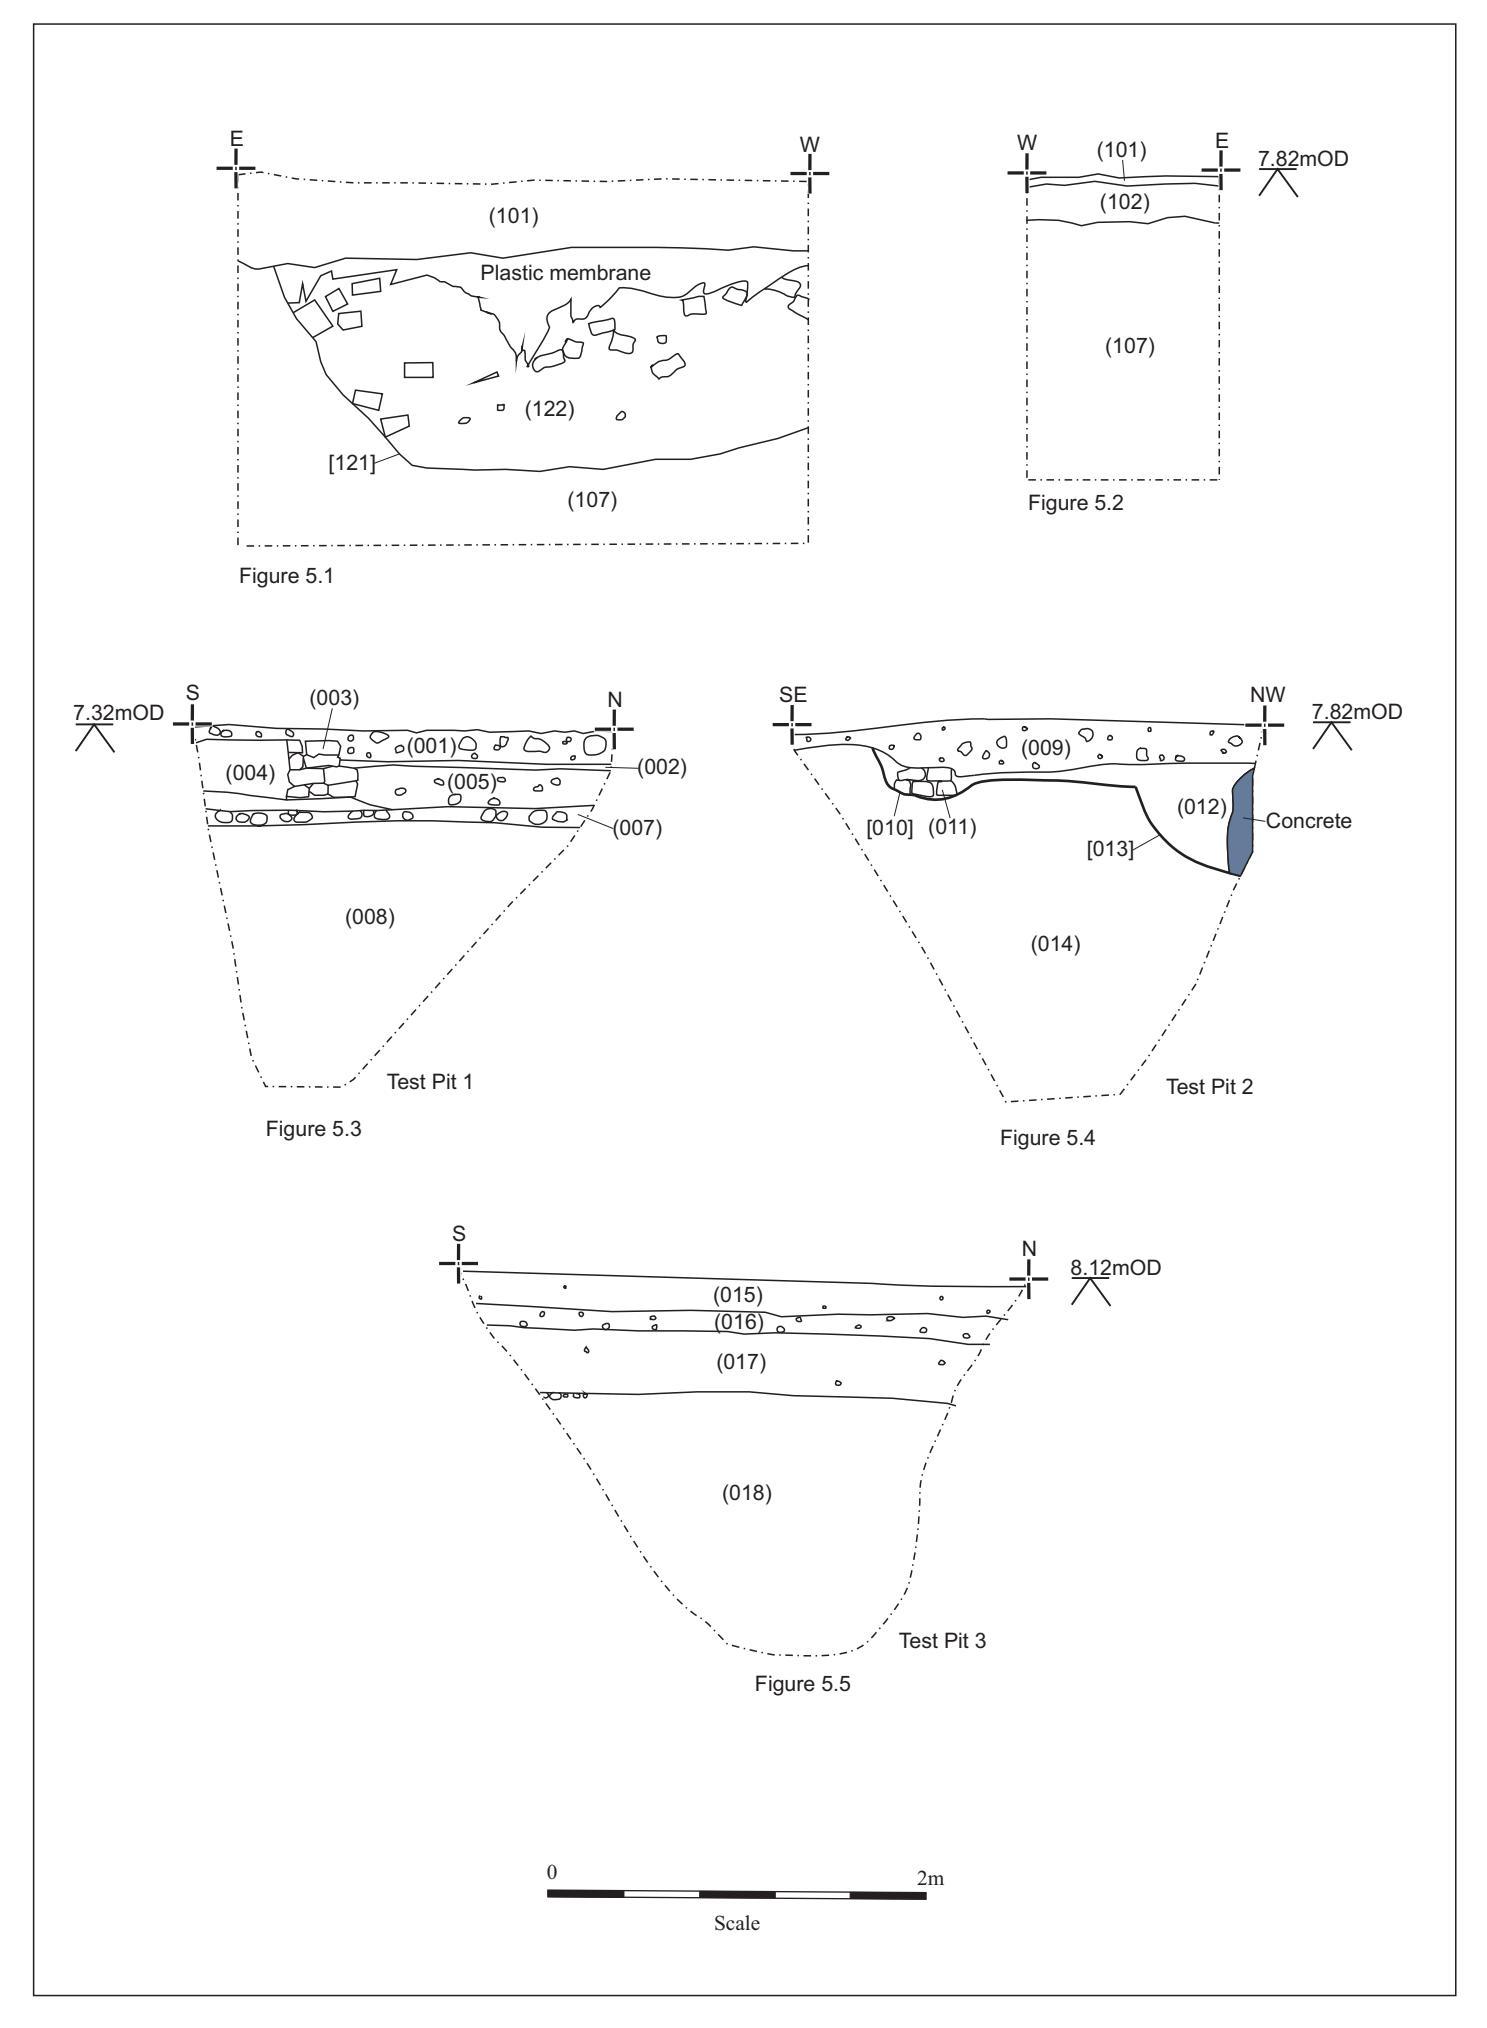
Figure 5: Representative sections through garage footings & Test pits.

The earliest deposit encountered within all three pits comprised mid orange / red blue clay with grey veining; (008), (014), (018).

Test pit 1 revealed a possible disturbed cobbled yard surface (007) approximately 0.08m thick above natural (008), upon which a sequence of modern levelling and construction for the former public house was laid. This sequence comprised contexts (004) and (005), a mid grey brown sand clay material, interpreted as former topsoil or made ground in which remnants of the rear wall of the Butchers Arms (003) was erected. A thin deposit of crushed lime (002), possibly a floor layer, was present to the immediate north of wall (003) sealed by a covering of recent demolition material (001).

Test pit 2, excavated within the footprint of the garages, was dominated by a large cut [013] containing a substantial concrete slab, possibly part of a septic tank? To the immediate south-east, remnants of a brick outhouse structure (011) were revealed, the cut for which merged with that of [013] and filled with red brown redeposited natural. All of the above was in turn covered by demolition deposit (009).

The third and final test pit appeared to be situated in an area which comprised the former car park to the Butchers Arms. A dense, 0.38m thick deposit of mid grey-brown sandy clay (017), interpreted as buried topsoil was covered by degraded cinder and asphalt, and subsequently sealed by topsoil (015).

It is apparent that, if any significant archaeology was once present, presumably along the frontage of Main Street, then it had subsequently been destroyed by the later construction of the Butchers' Arms public house. The only surviving evidence of earlier activity may tentatively be seen in deposit (007) (Figure 5.3), which comprised a disturbed cobble layer, probably Victorian/Edwardian in date.
