93 NETTLEHAM ROAD, LINCOLN

ARCHAEOLOGICAL INVESTIGATION REPORT

Report prepared for David Wilson Homes by

November 2006

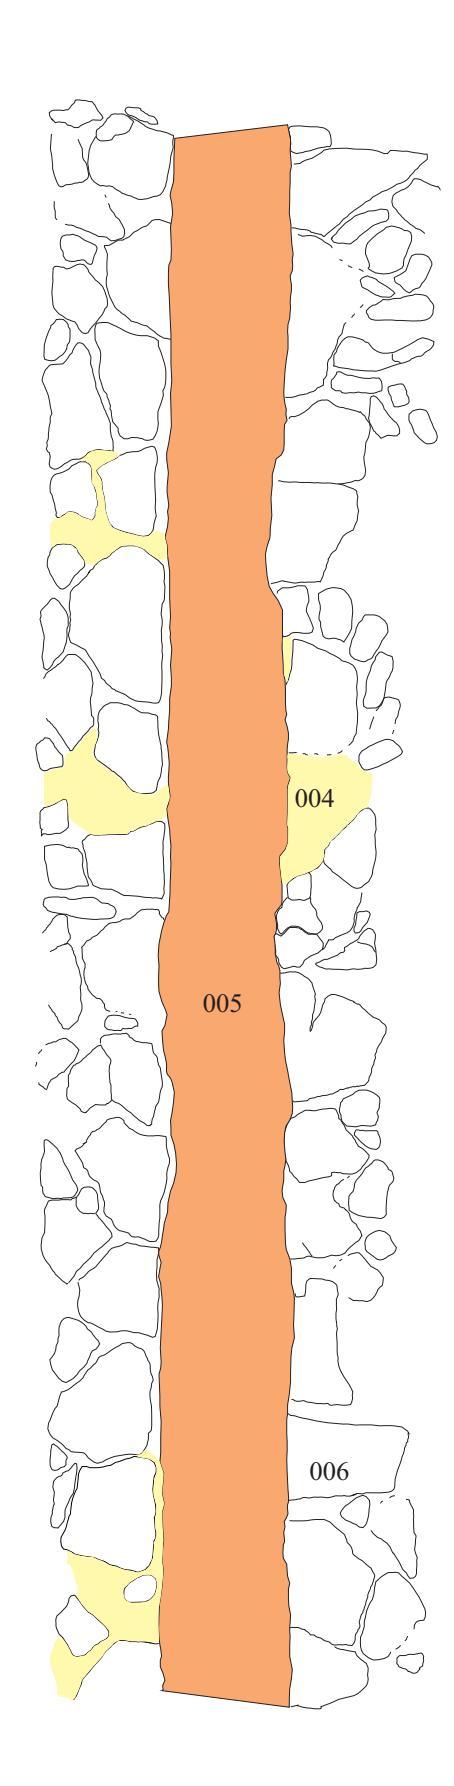
Detail of aqueduct

A section of the known Roman aqueduct was exposed towards the eastern limit of the site (Figs. 4, 6 & 7). A construction cut for this [012], measuring 1.00m in width and 0.33m in depth, truncated the natural limestone brash (008). The base of the cut was paved with un-worked Limestone slabs (011), which in turn were abutted by two parallel rows of un-worked stone blocks (006). These were laid in five courses to a maximum height of 0.40m and bedded together with a course mid orange sand (004) to form shuttering for the construction of the aqueduct.

The aqueduct pipe (007) was between 0.25-0.30m in diameter and fixed together with internal cylindrical terracotta collars which were similar in fabric to Roman tiles. These were joined together with mortar and finally encased in a jacket of Roman concrete *opus signinum* (005).

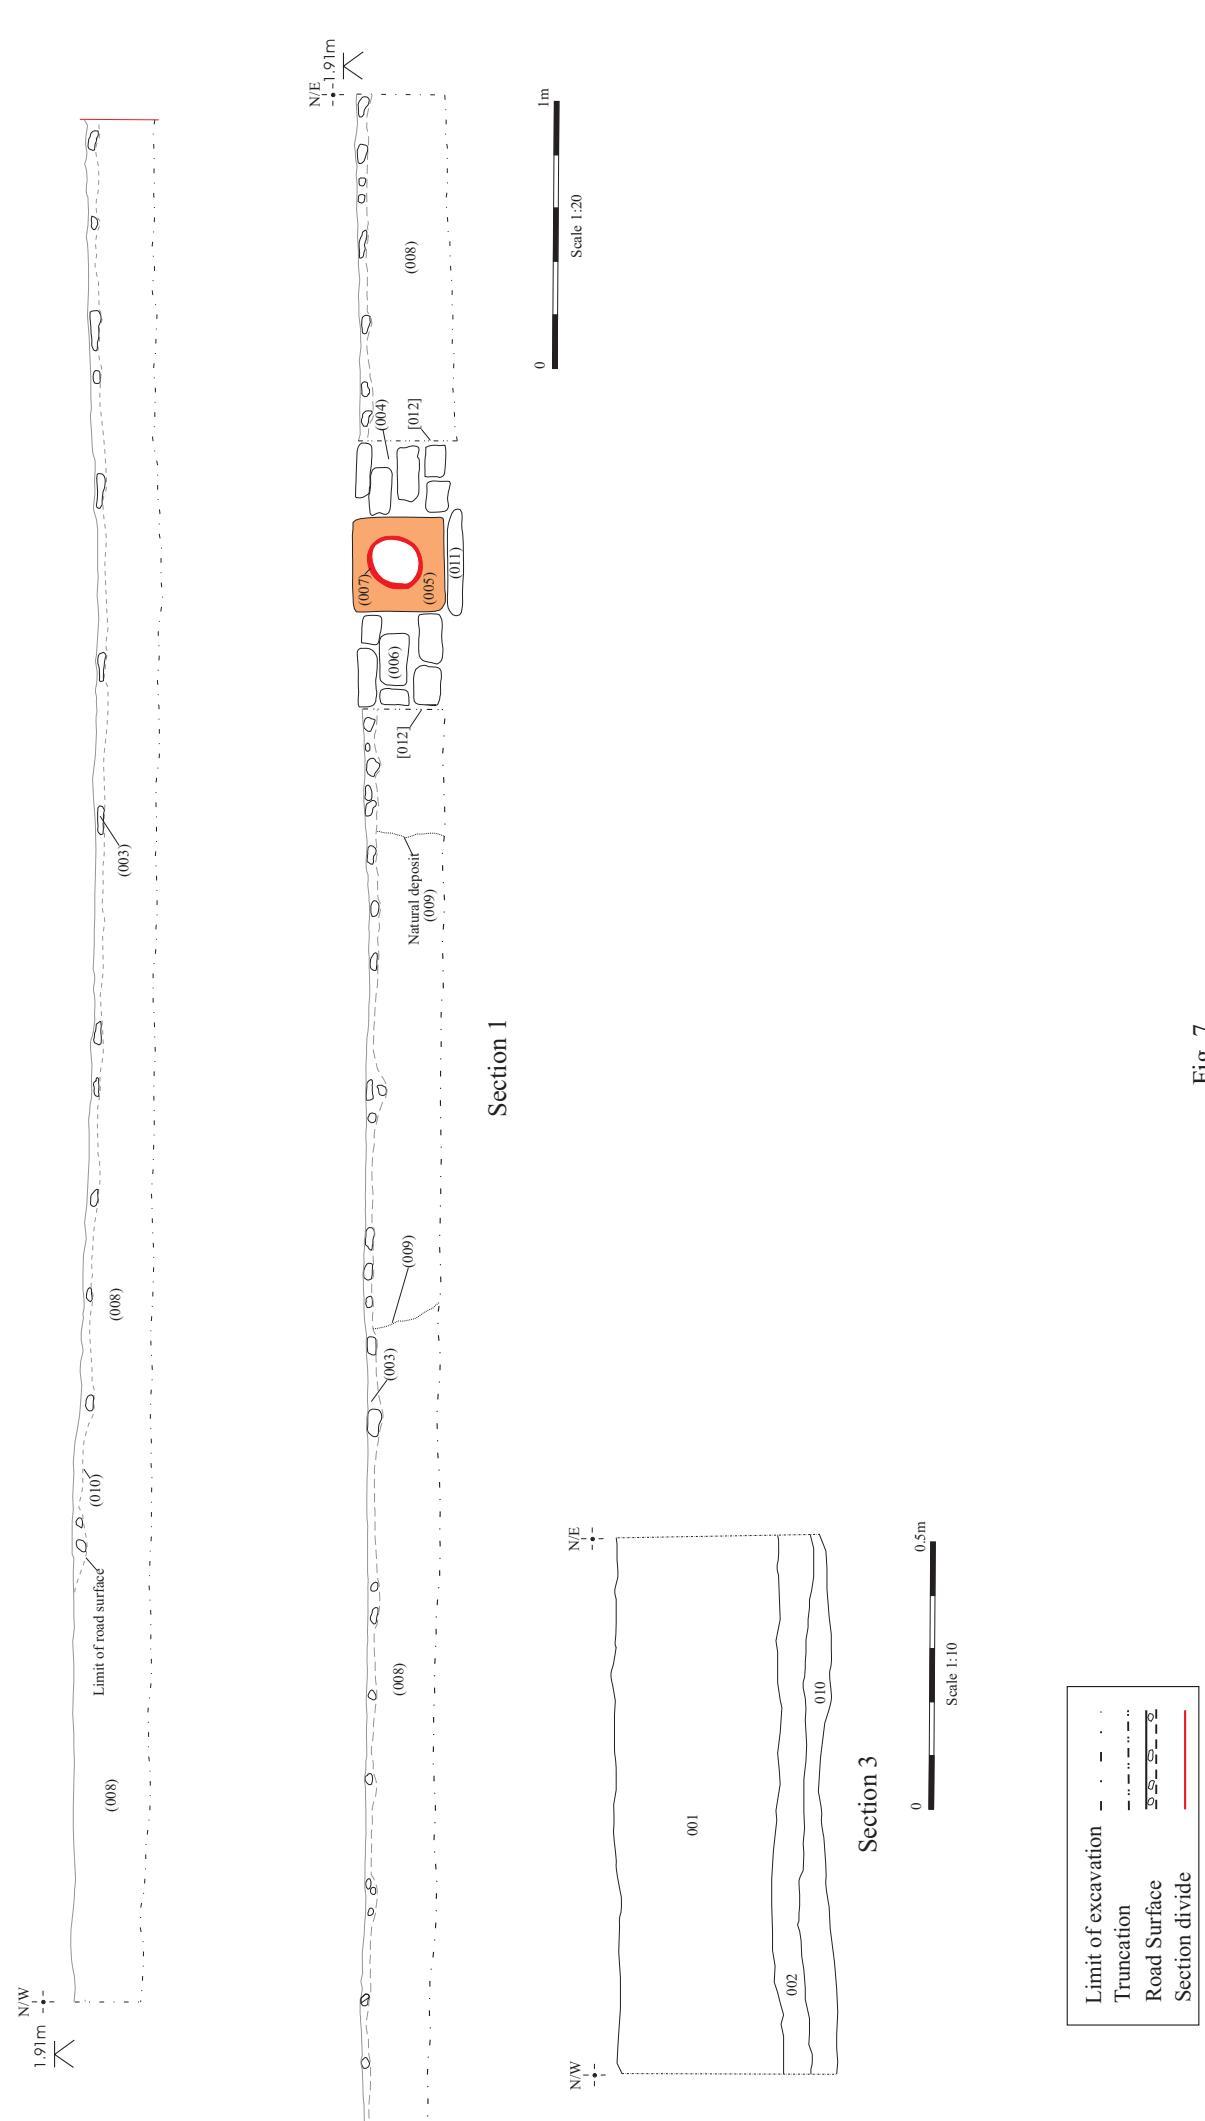
Fig. 7

Twelve archaeological contexts were recorded across the area of investigation (Figs. 2 & 3). The earliest was natural Limestone brash (008); this contained lenses of sand (009) within its matrix and was consistent across the site. The brash was overlain by (002), a silty clay sub-soil sealed by a mid brown/grey topsoil (001), (Fig. 7).

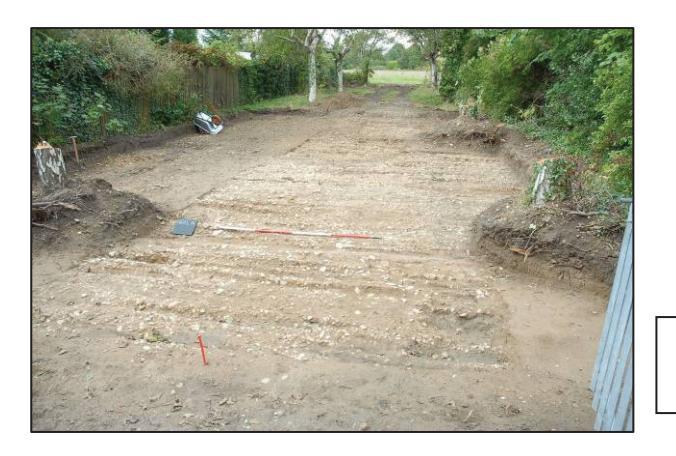
Plate 1: Site view, showing road surface looking north-west.

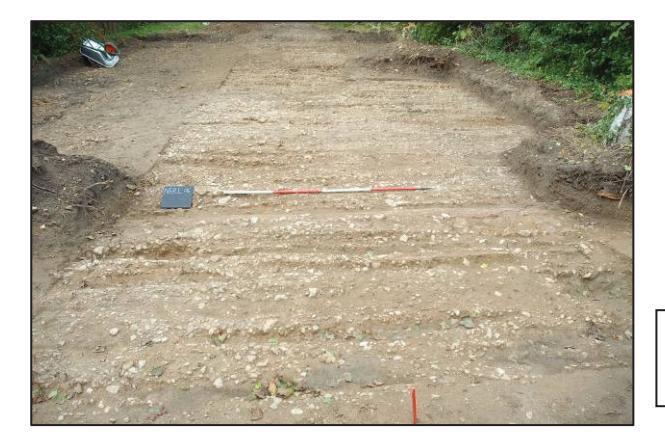
Plate 3: Road surface, looking north-west.

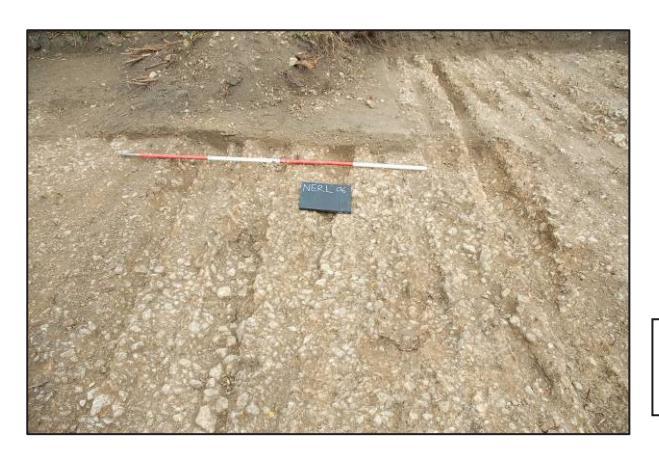
Plate 4: Road surface showing ruts, looking north-east.

A north-east to south-west aligned road surface (003) was exposed over much of the area. It consisted of re-deposited limestone brash approximately 0.04m in thickness, in excess of 15.00m wide and deeply rutted over most of its surface (Figs. 4 & 5). Overlying this was (010), a mid brown silty clay which predominately contained 17th-18th century pottery sherds, several sherds of 12th-13th and 19th pottery, copper alloy objects, iron nails and horseshoes of the post-medieval period. Construction and building material dating possibly from the Roman and/or post-medieval periods was also found (see Appendix 3 & 4).

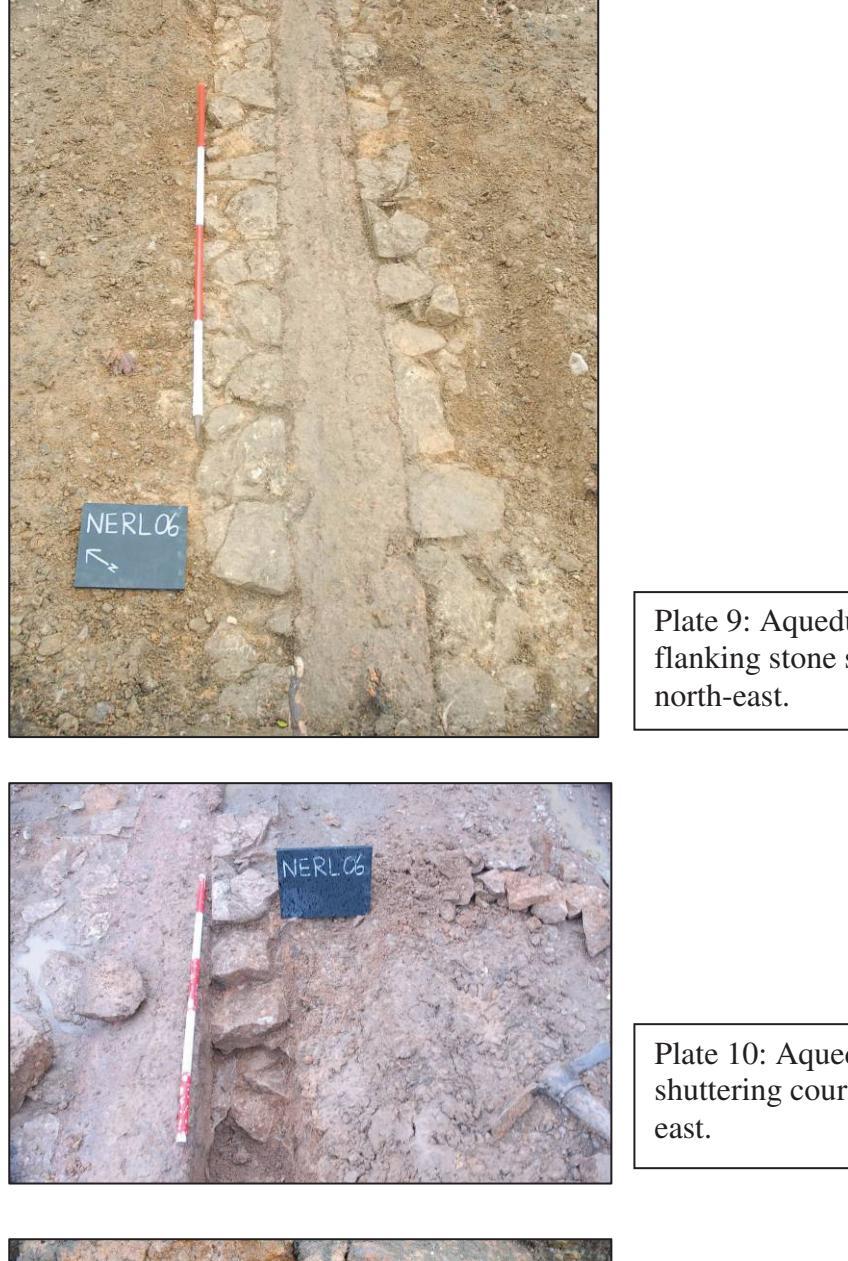
Plate 9: Aqueduct showing flanking stone shuttering, looking north-east.

Plate 10: Aqueduct showing shuttering courses, looking north-east.

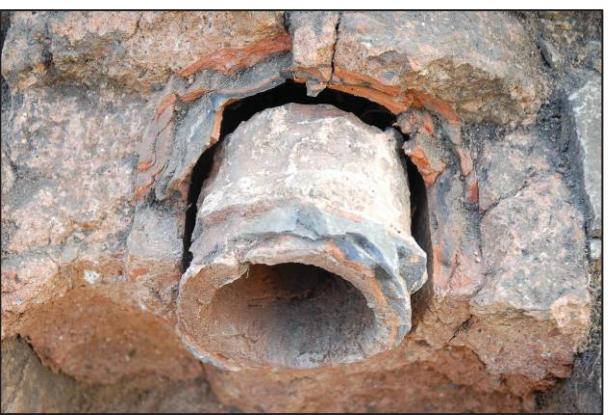
Plate 11: Aqueduct showing method of joining the sections of pipe together.

Before being cemented to the next pipe, the collar was roughly chipped at the end, removing c.5mm of clay. Presumably, this was because of an obstruction in the pipe it was to fit into. The collar was then coated in a mortar containing an aggregate composed of a mixture of coarse quartzose sand and tile chips, similar to that found in Opus Signinum.

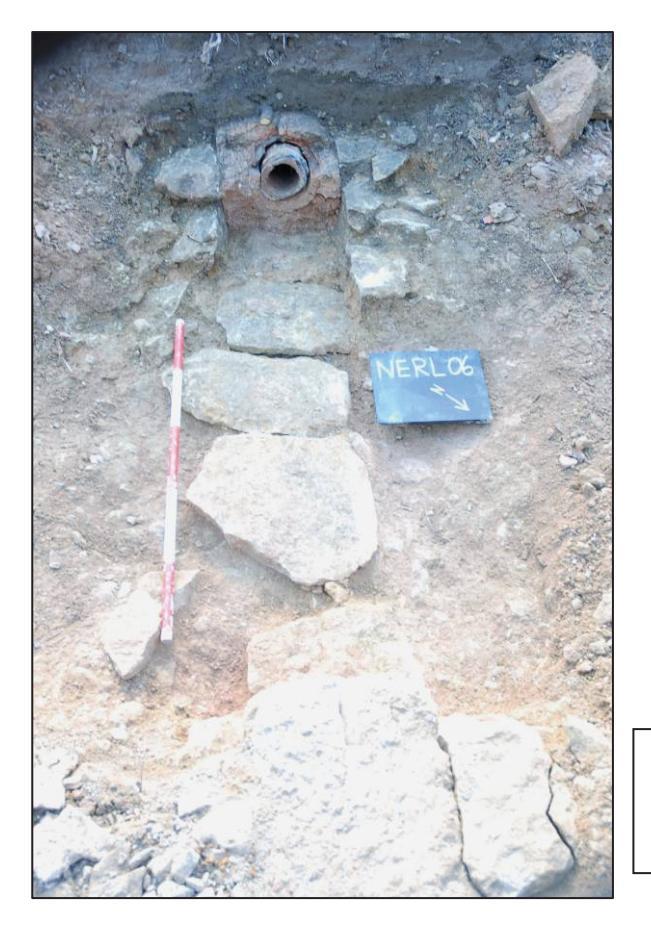
Plate 12: Aqueduct showing foundation layer, looking southwest.
