Howden House, Livingston: **Archaeological Test-Pit Evaluation**

Report No. 2083

Author	Gary Savory MA			
Illustrator	Shelly Werner BSc MPhil PhD			
Editor Bruce Glendinning Bsc PgDip MIfA				
Commissioned by	EMA Archiceture & Design Ltd (on behalf of Planview			
	Ltd)			
Date issued	August 2012			
Version	1			
Planning Ref No.	0403/LBC/06			
Grid Ref	NT 05212 67663

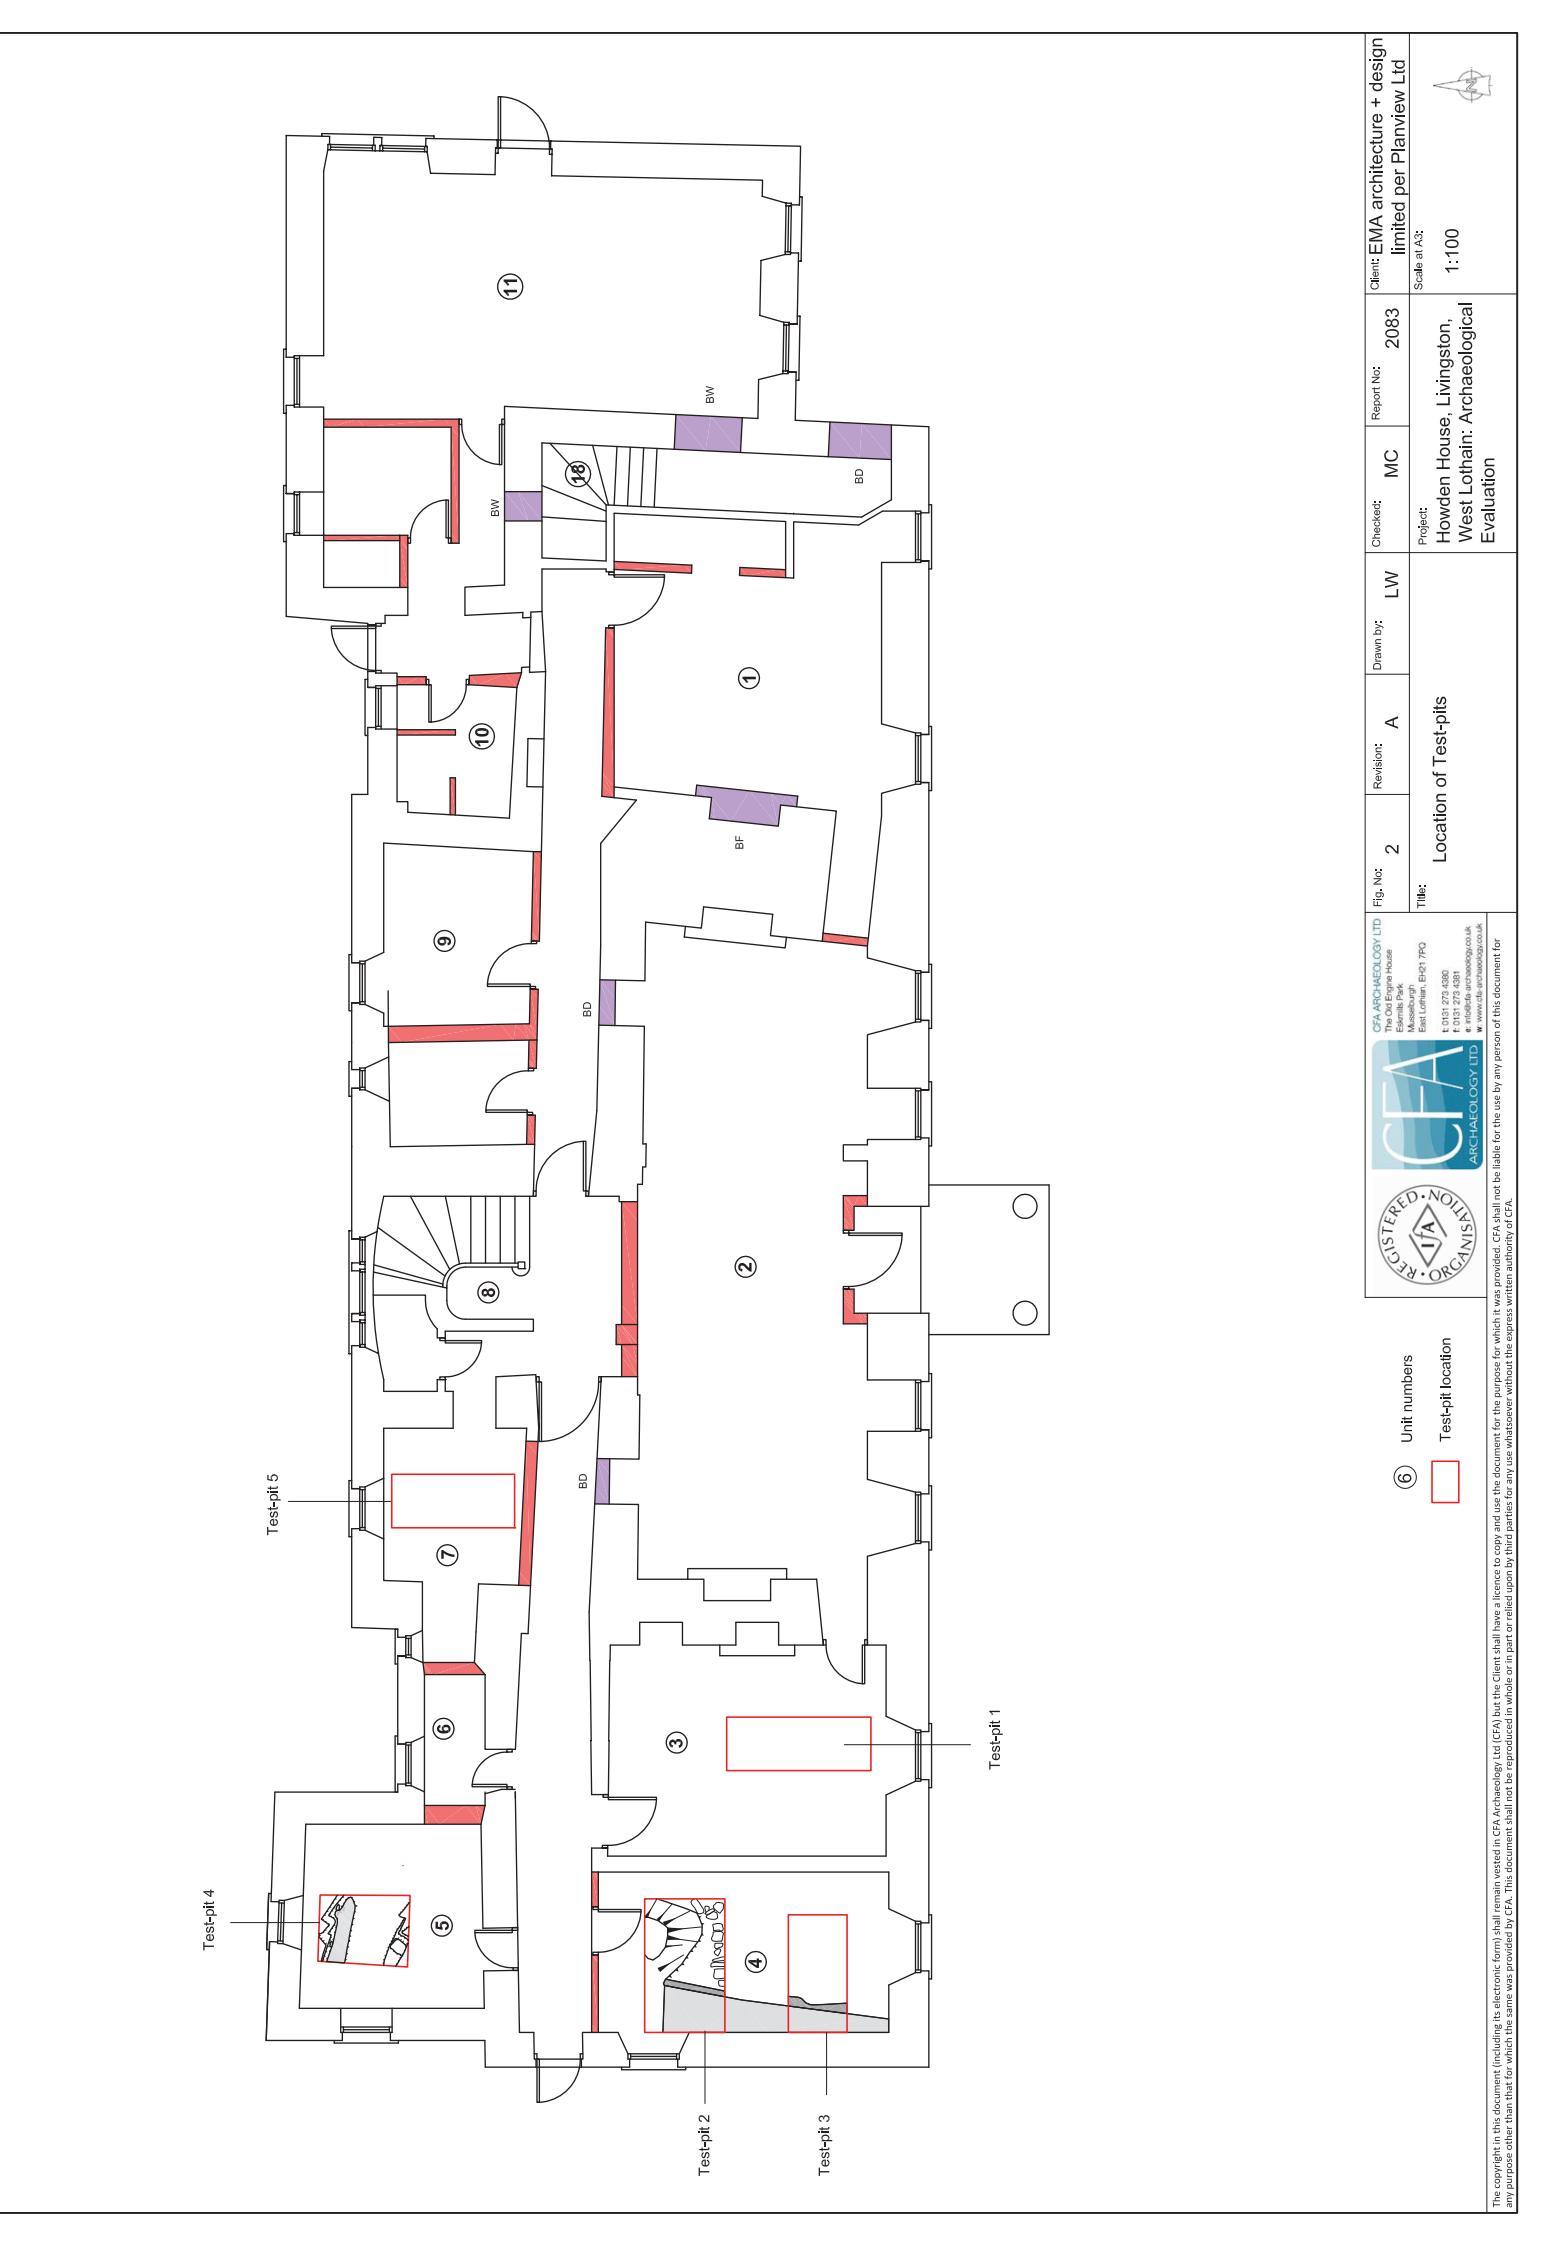
The method statement specified Four test-pits but in the end Five test-pits (1-5) were excavated by hand in Units 3, 4, 5 and 7 (Fig. 2). The method statement specified each of the test-pits were to measure 1.5m by 1.5m. However, due to certain constraints the test-pits varied in size. The dimensions of each test-pit are contained in Appendix 4. These targeted a number of locations within a variety of rooms in order to investigate the presence/absence of any earlier building remains.

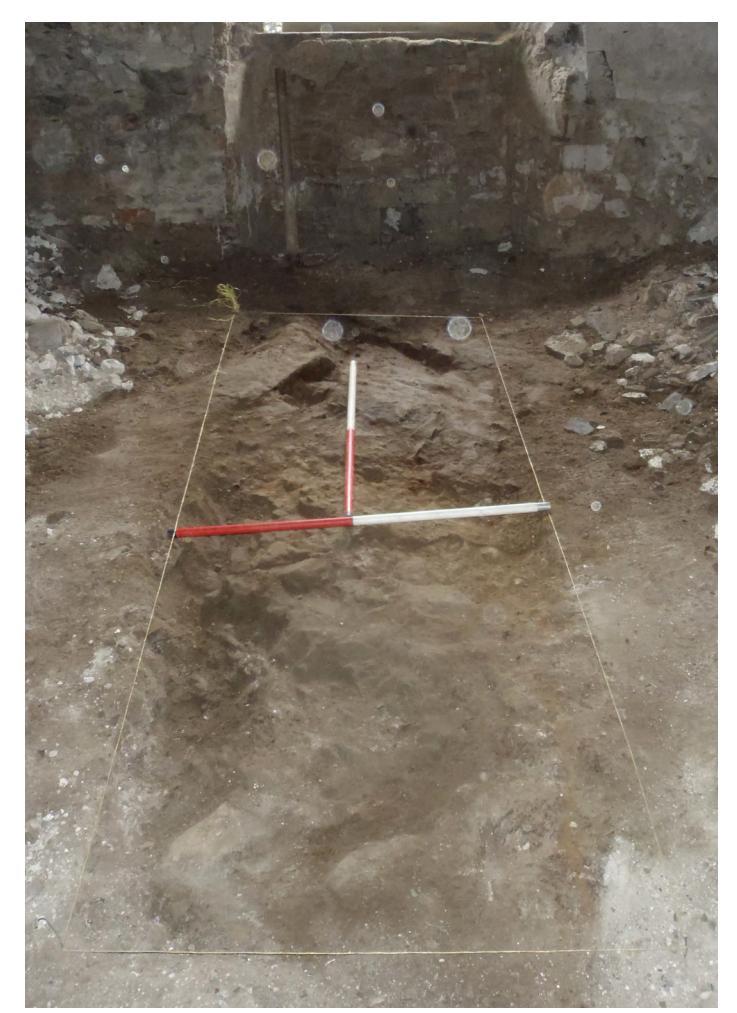
Fig 3 - Test-pit 1

A test-pit measuring 2.7m north to south by 1m wide (Fig. 3) and was excavated to a maximum depth of 0.2m. The deposit within the test-pit consisted of mortar and rubble (001) which overlay natural bedrock (000). There was no evidence of any structural remains or ghost wall lines on the natural bedrock.

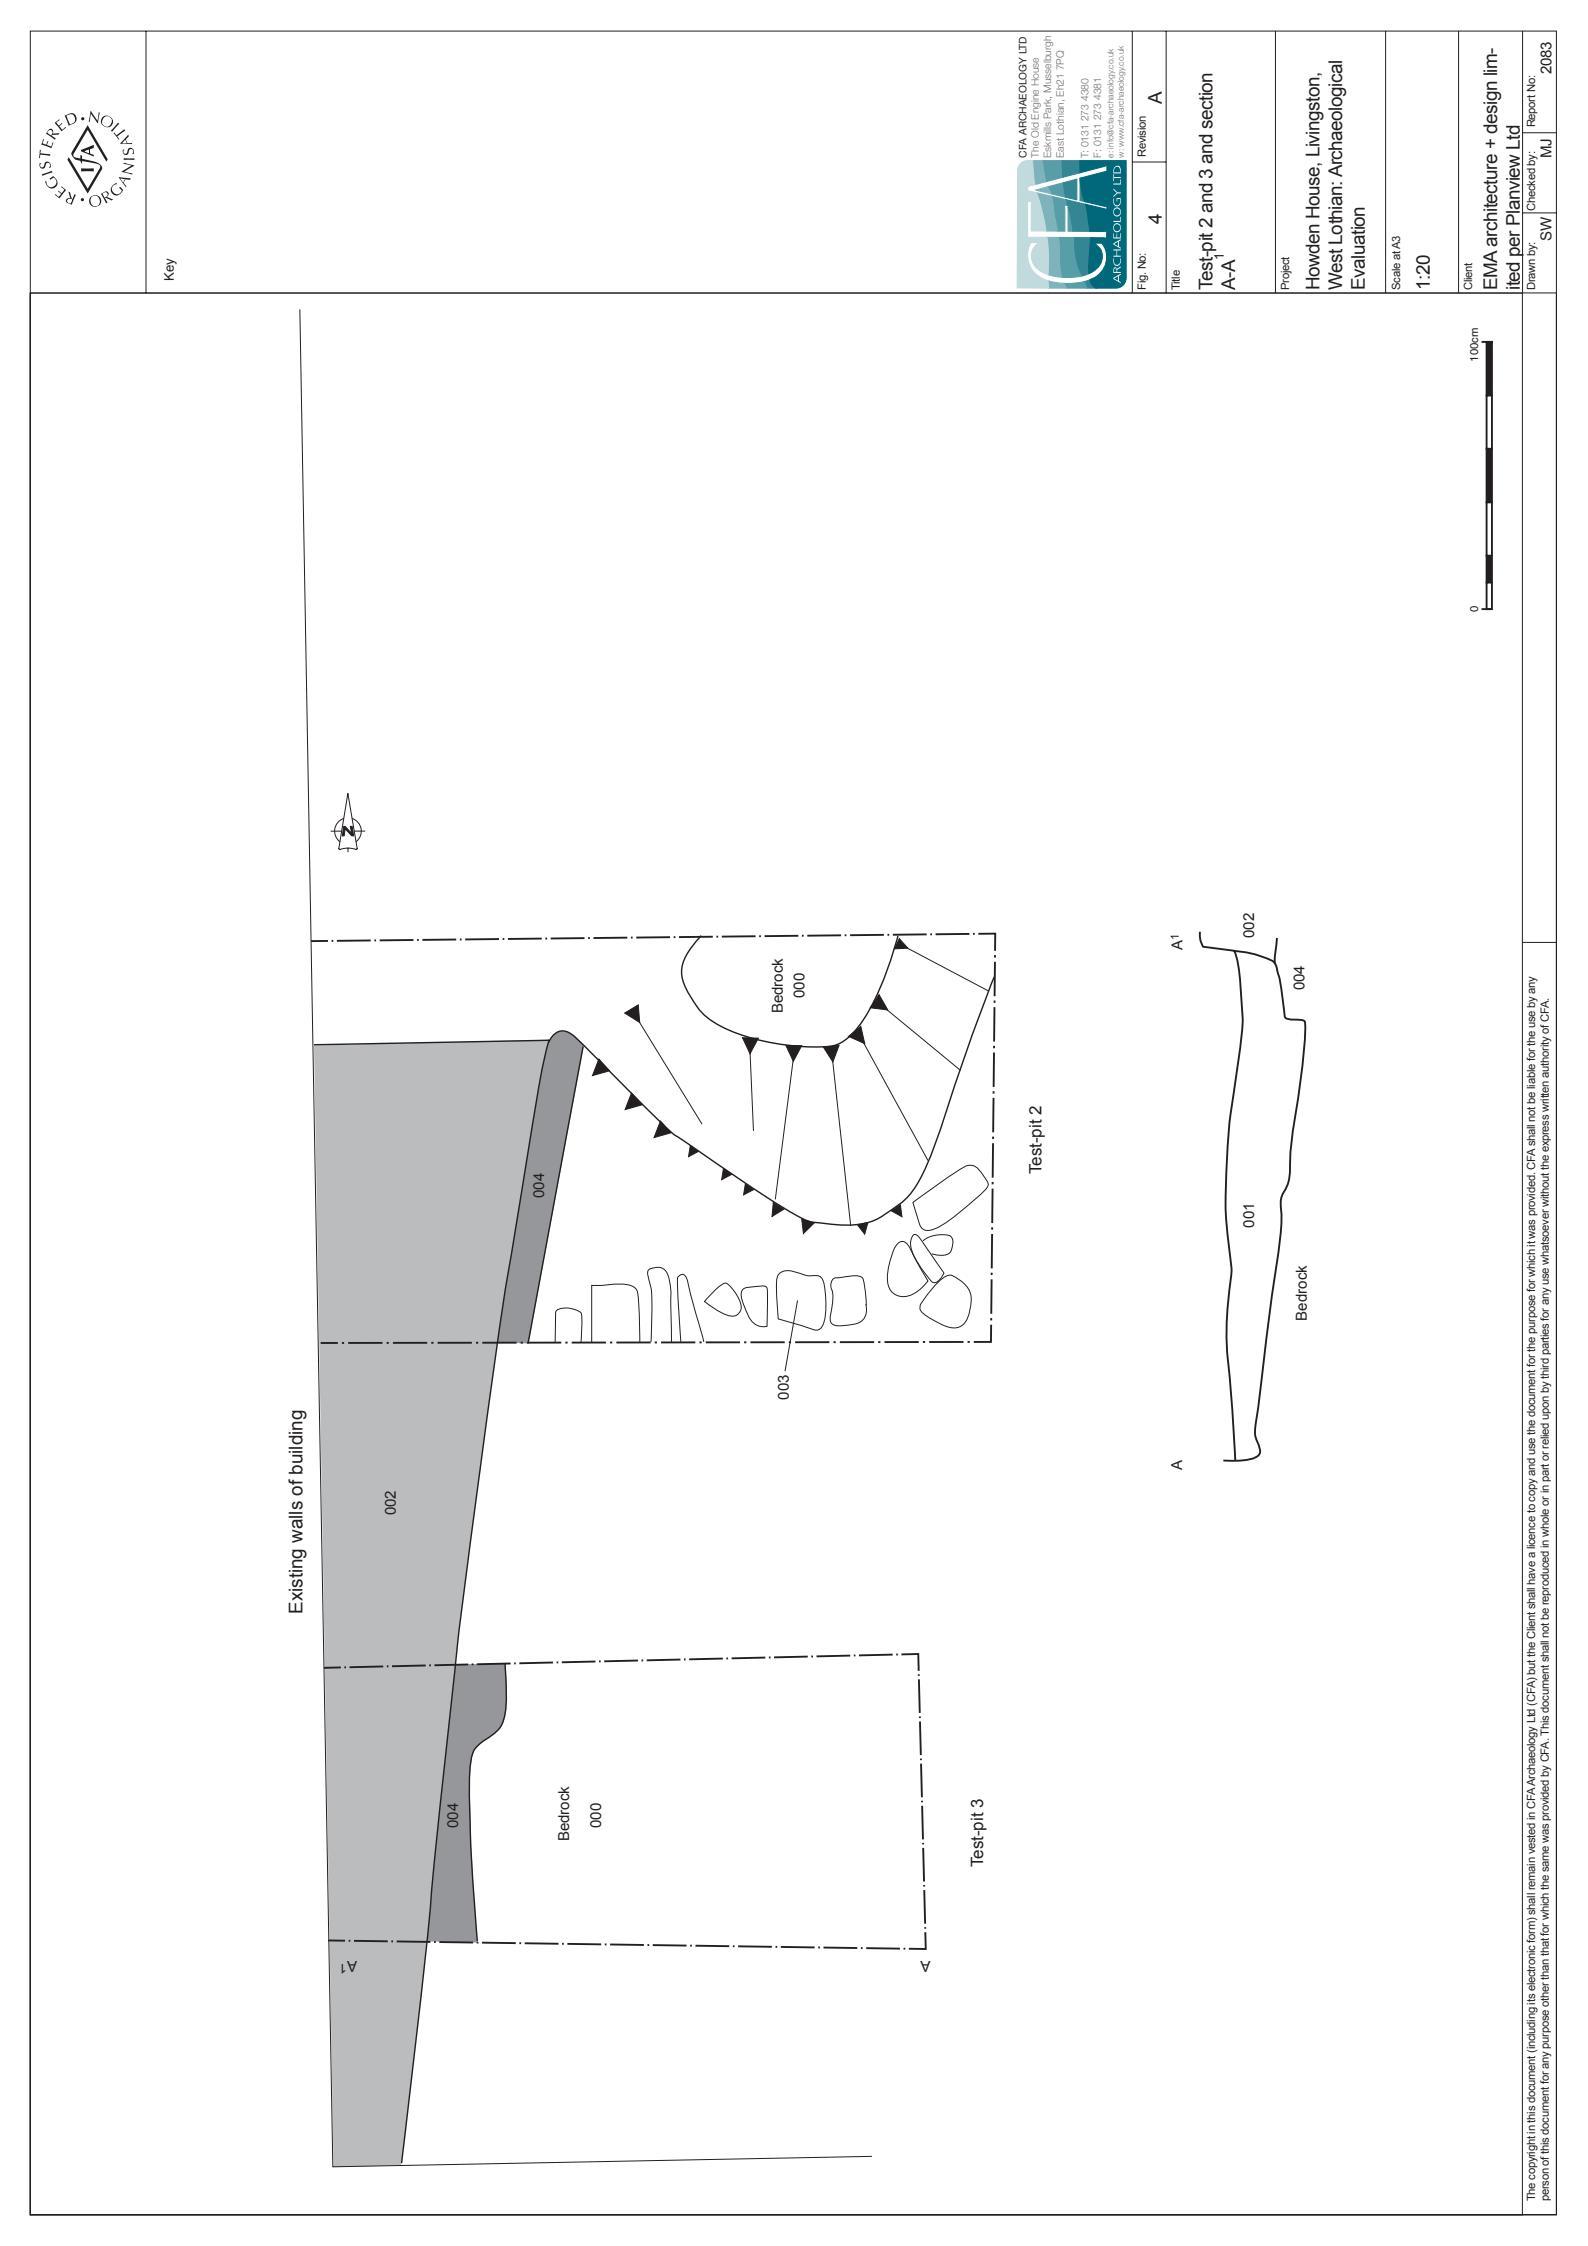
Two test-pits (Fig. 4) were excavated in Unit 4 where the remains of a wall (002) could be seen on the surface. This wall lay partially under the North – South orientated wall of the west wing of the existing house but was on a slightly different

alignment being more NNE –SSW orientated. It was considered possible that this wall may have represented the remains of an earlier structure beneath the footprint of the current house. The test pits were excavated against the wall to try and identify if any wall cut survived where stratified dateable material might be recovered from.

Test-pit evaluation was carried out at Howden House in order to ascertain the presence/absence of an earlier building on the site. In Unit 4 (Test-pits 2 & 3) a wall aligned approximately NNE–SSW and underlying the North – South aligned wall of the Western Wing of the house was identified. It was built directly on to the bedrock and terminated within the same Unit. It was not possible to determine categorically whether this was an earlier wall or part of the foundations of the current wall of the house but its slight divergence in alignment from the current wall does suggest it could have been earlier, but by how much is not known.

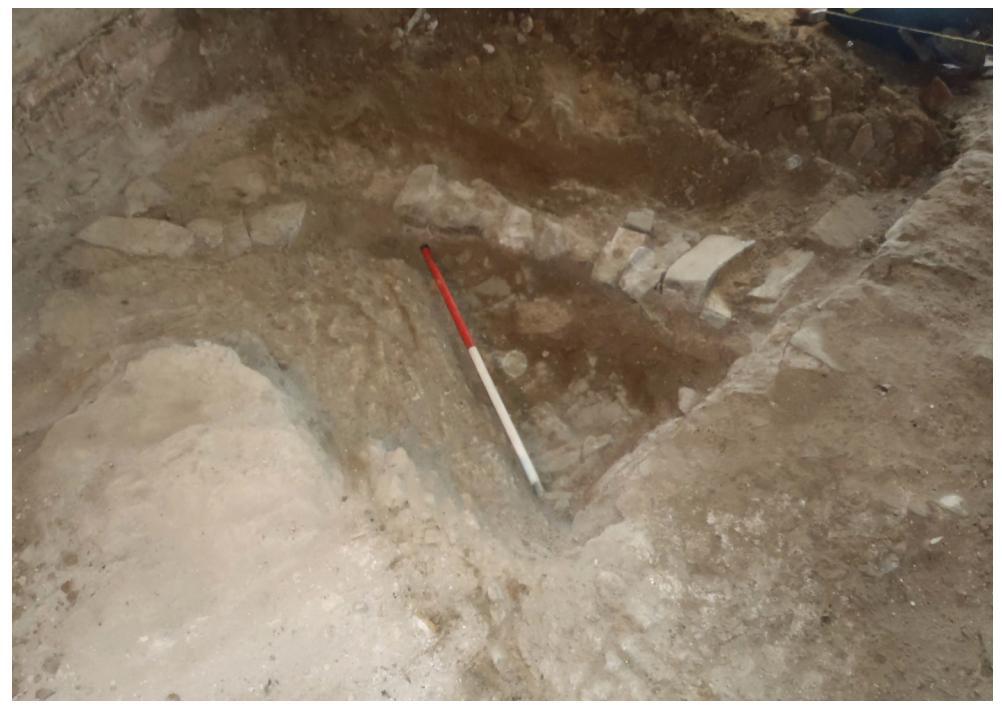
Fig 5 - Test-pit 2

Test-pit 2 (Figs. 4 & 5) measured 2.5m east to west by 1.5m wide and was excavated to a maximum depth of 0.15m. The deposits within the test-pit consisted of mortar and rubble (001), overlying bedrock (000) and a deposit of what is interpreted as levelling material (003). This consisted of flat, sub-rectangular blocks of stone mixed with rubble and mortar overlying bedrock. At the western end of the test-pit Wall (002) was identified. The wall survived to a height of 0.3m and sat on limestone mortar foundations (004), which had been built directly onto the bedrock (000). The north-east end of the section of wall abutted a raised area of bedrock where it ran out.

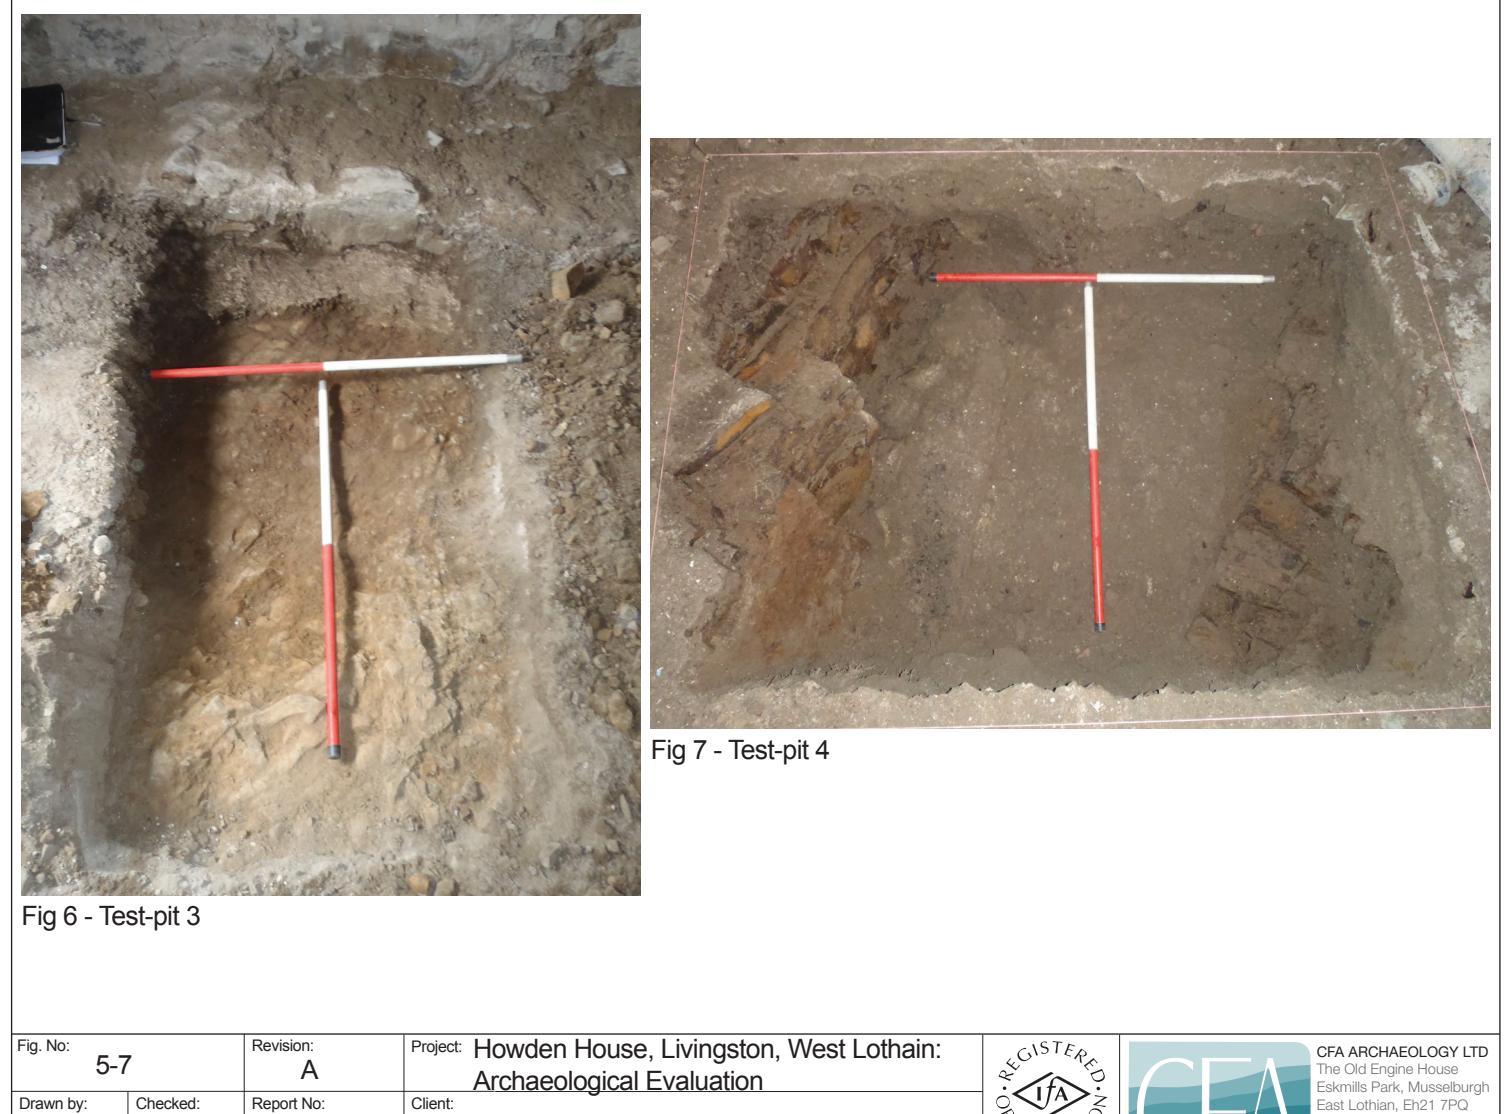
Test-pit 3 (Figs. 4 & 6) measured 2.2m east to west by 1.1m wide and was excavated to a maximum depth of 0.25m. Rubble and mortar (001) overlay bedrock (000) and the wall (002) and its foundations (004) were also identified as being built directly on top of bedrock. Like Test-pit 2 no wall foundation trench was present.

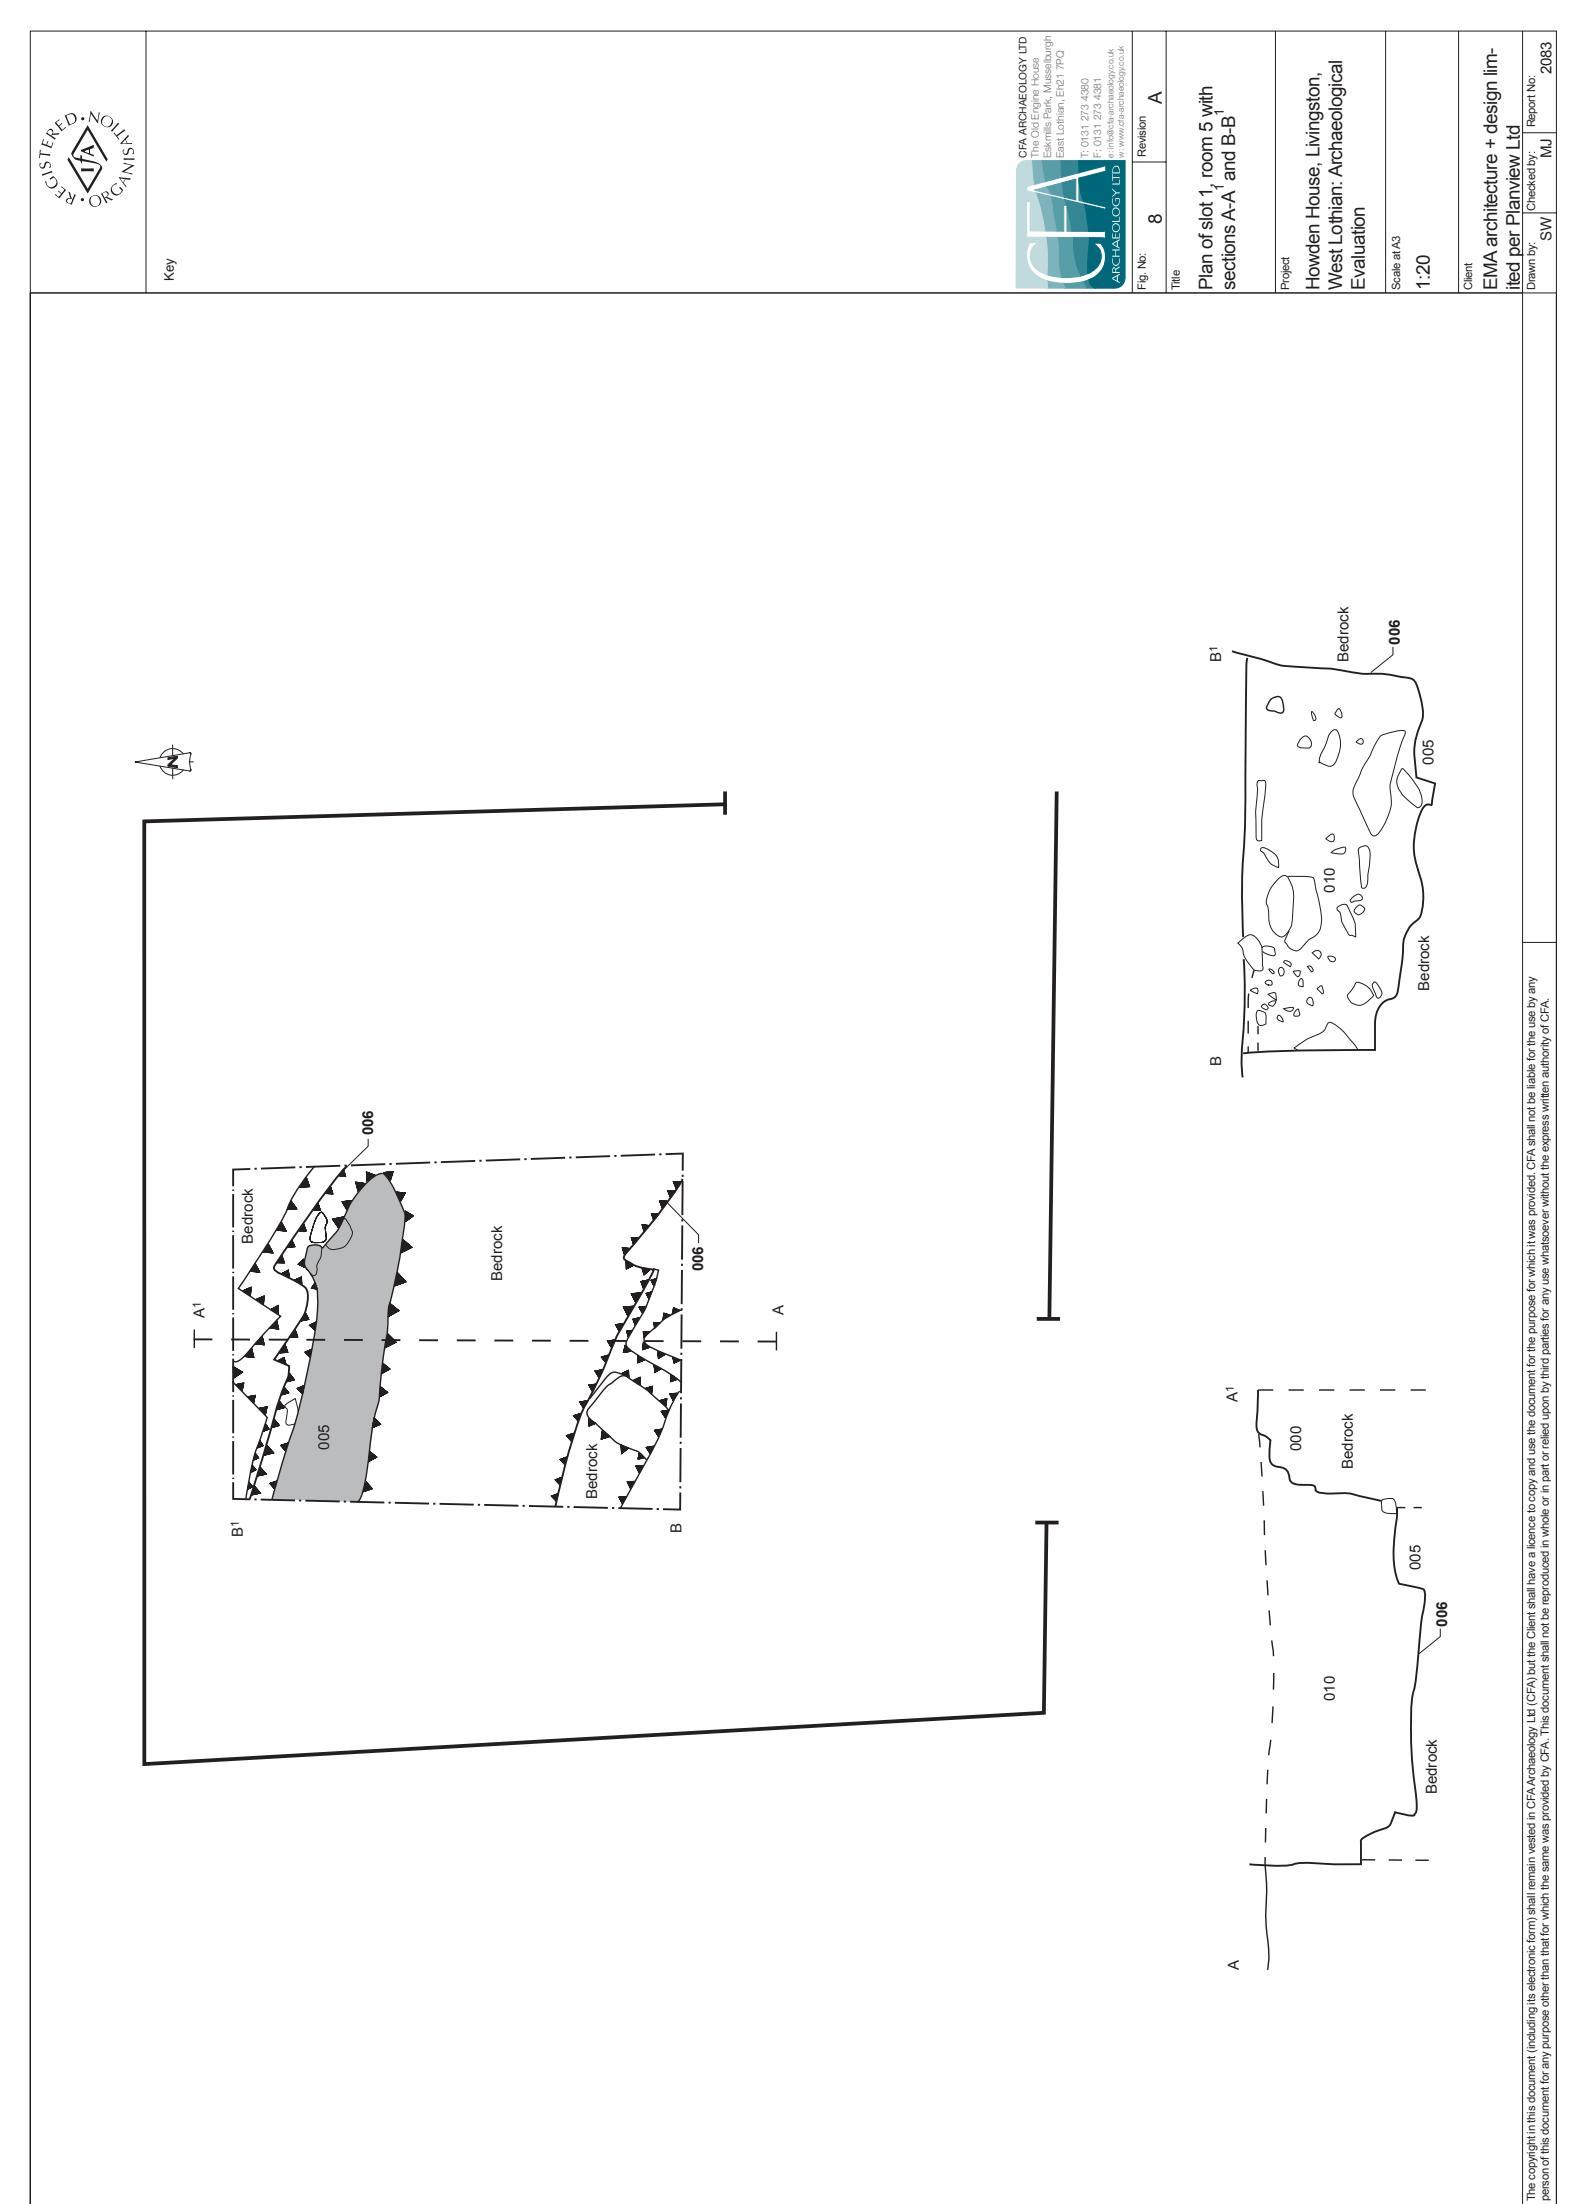
Test Pit 4 (Figs. 7 & 8) measured 1.7m by 1.3m, and 0.7m deep. A mortar and rubble deposit (010) overlay bedrock (000) and filled a cut in to the bedrock (006) that took up the majority of the test-pit. The cut was 1.4m wide and 0.7m deep and aligned roughly SSE-NNW. A possible length of wall foundation (005) survived along the northern side of the cut and was built directly on to the bedrock. The remains were very vestigial 0.25m wide x 0.1m high and consisted of a limestone mortar/stone mix. There was no evidence of any further construction within the cut.

A wide apparently linear cut in to the bedrock was identified in Unit 5 (Test-pit 4) which appeared to run on an approximately SSE-NNW alignment. Within this cut the vestigial traces of a stony mortar deposit were found along one edge. This was not a wall but may have been the mortar foundation for one. The alignment of this feature is intriguing as it would be almost right for a return wall based on the alignment of the wall in Unit 4. However, the identification of this feature as a possible wall foundation cut for an earlier structure such as is envisaged is difficult for a number of reasons:

- no other traces of potentially structural material (other than the thin band of stony mortar) were found in the cut;
- it makes no sense that a large wall would have been robbed so cleanly out of this cut;
- the obvious wall in Unit 4 was founded directly on the bedrock with no need for a foundation cut;
- If this was a wall foundation cut based on the alignment as observed in the Test-pit it should have appeared in Test-pit 5 which it did not.

It is more likely that the cut was not a foundation cut but a cut for some later feature associated with the current house like a pipe run as identified in Test-pit 5. Unit 5 did serve as a toilet so numerous soil and water connections would have been required as some point in time.

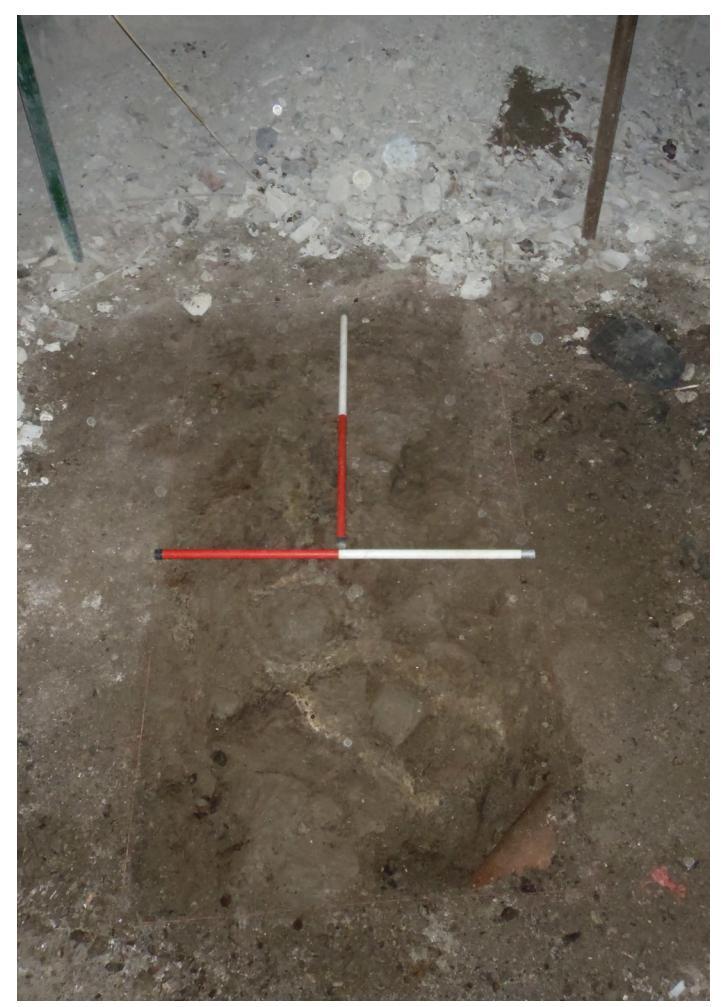
Fig 9 - Test-pit 5

Test-pit 5 (Fig 9) measured 2.3m by 1m and was excavated to a maximum 0.2m (Fig. 9). A thin layer of mortar and rubble (012) overly bedrock (000). At the north-west corner of the test-pit the bedrock had been cut [007] for a glazed ceramic pipe and backfilled with mortar (008). There was no evidence of any structural remains or ghost wall lines on the natural bedrock.
