## ARCHAEOLOGICAL EVALUATION OF THE ROUTE OF THE A4103 ROMAN ROAD IMPROVEMENTS, HEREFORDSHIRE

8th October 2002

Project 2231 Report 1000

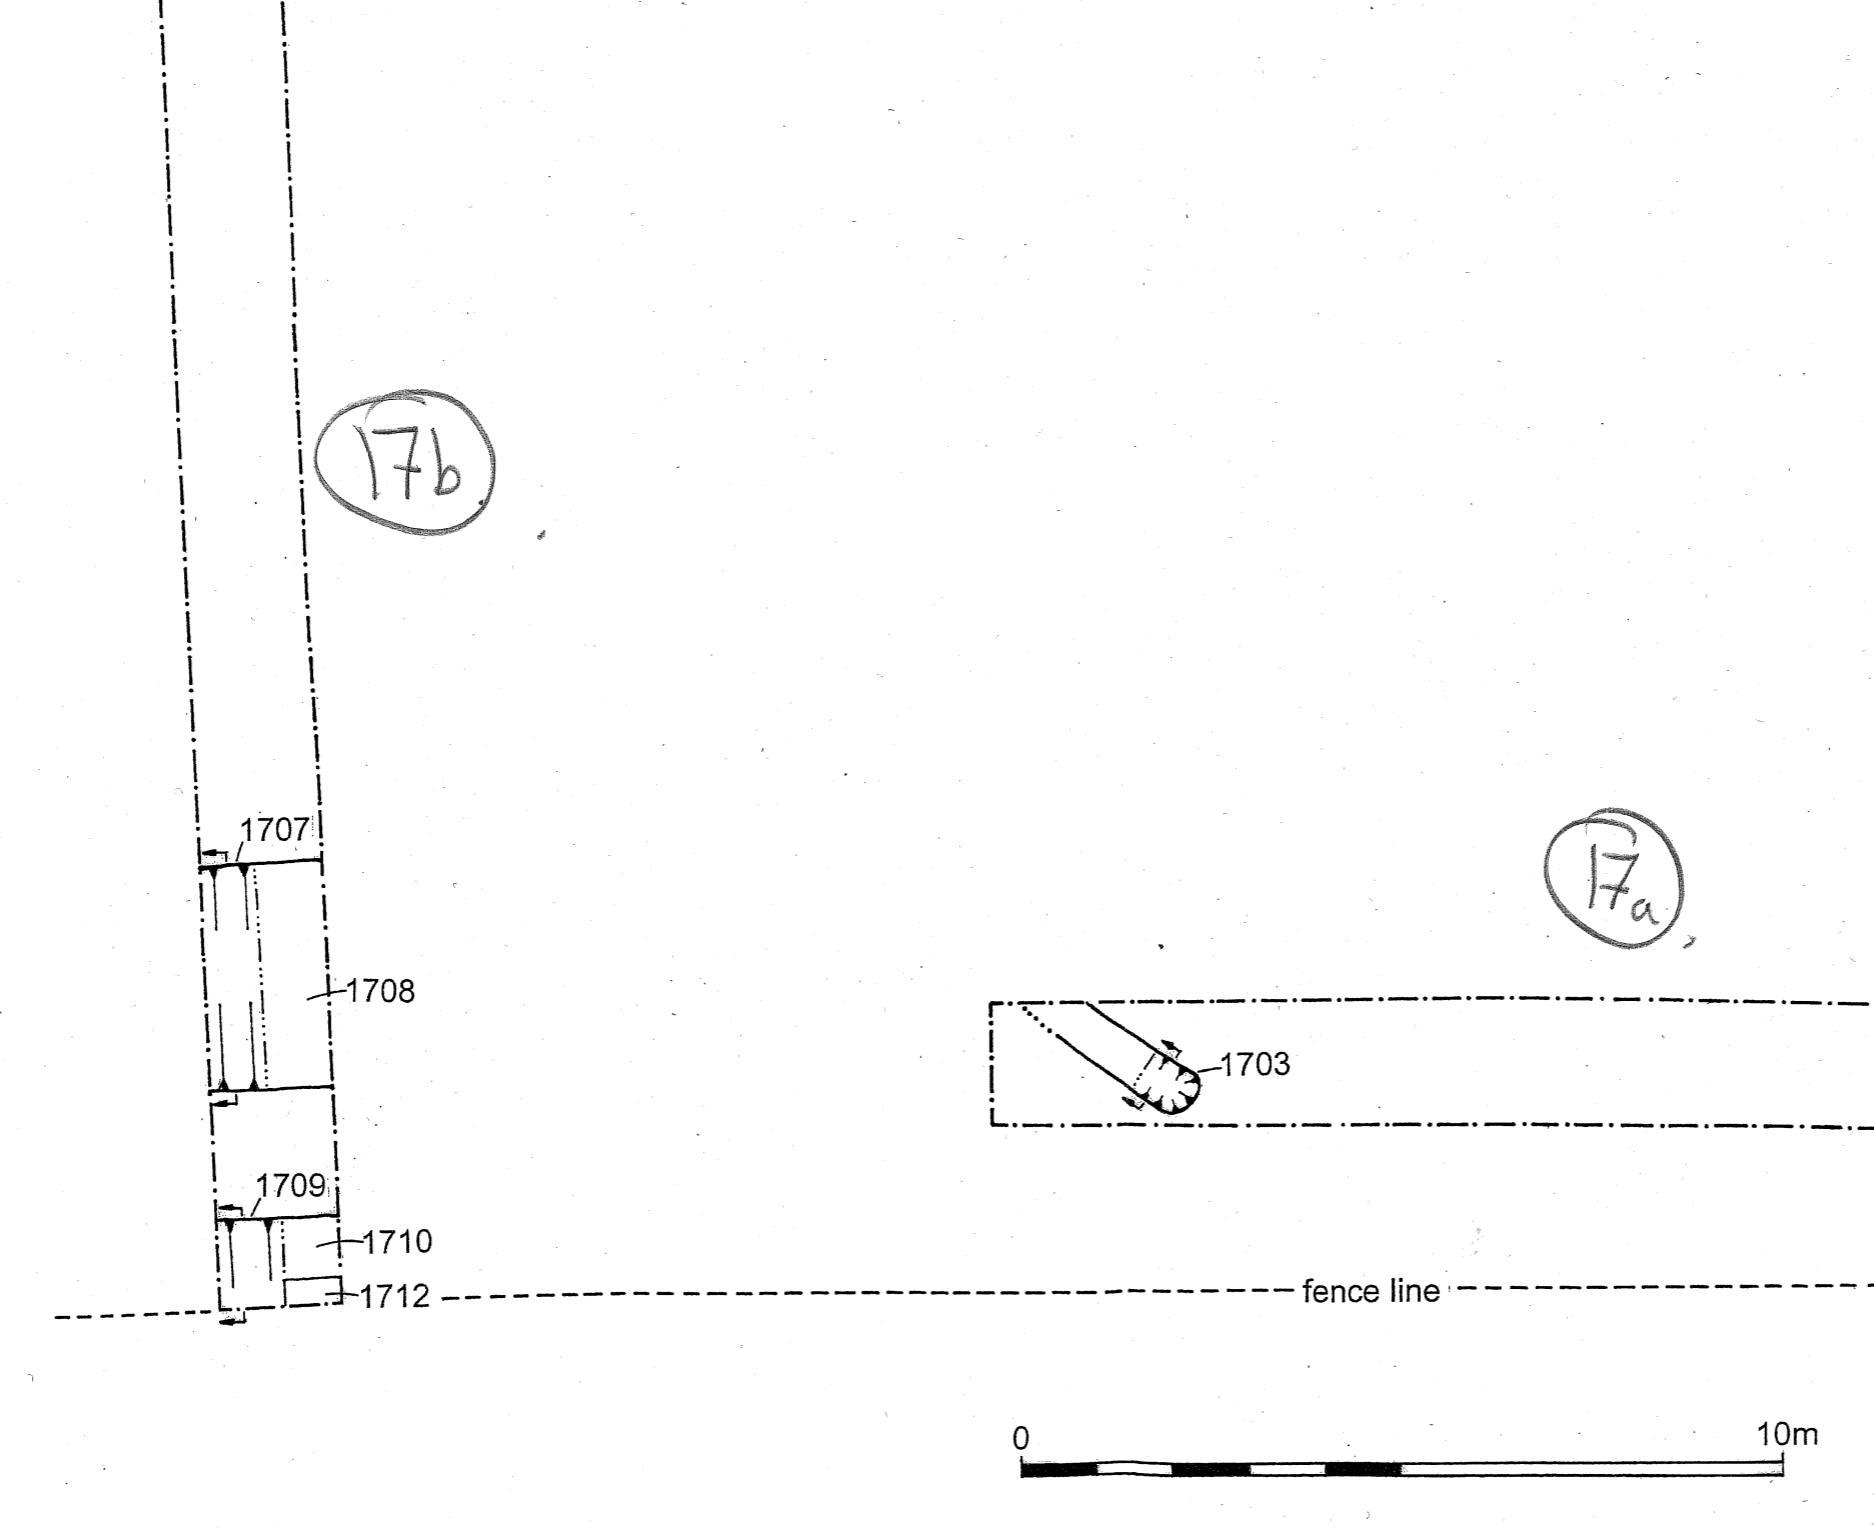
Figure 5: Trench 17, plan.

Trenches 17A and 17B were excavated in Field 7 to test the mound under the road, which was suggested to be of possible archaeological interest (Fig 5). Both trenches identified the remains of a road side ditch close to the present fence line which had been truncated by a later post-medieval ditch/pit (1705&1709, Fig 6) but in Trench 17B a second parallel ditch was found, aligned east-west, 3m north of the road (1707). The ditch was 3m wide and 0.6m deep with an obtuse v-shaped profile(Fig 6). No dating evidence was present. A second undated feature was found in Trench 17A, this was a terminal of a possibly curvilinear gully (1703) approximately aligned south-east to north-west. The feature measured 0.6m wide and 0.3m deep with sloping sides and a concave base (Fig 6). Ditch feature 1707 did not continue into neighbouring Trench 17A, nor was 1703 present in Trench17B.

The trenches excavated in Field 7 (Fig 5) to test the possible Prehistoric mound under the road found two undated features which were possibly of prehistoric origin; ditch feature 1707 in Trench 17B and linear gully terminal 1703 in Trench 17A. Feature 1707 was at first thought to be one of the roadside ditches for the Roman road and that with passage of time the alignment of the road had shifted towards the south leaving the ditch several metres to the north of the present road. This change in alignment would have left the Roman road in what is now Field 7 where it would have been ploughed away, leaving the ditch looking rather isolated. The radar survey, found no trace of an earlier round surface under the present road in Section 8 close to the mound. This was the only section where an earlier road was not discovered. However if it were a roadside ditch it would have been expected to have continued along the same alignment into Trench 17A, but the feature did not continue. The ditch must have either terminated or changed alignment, the profile and fill of the feature 1707 also seemed very different to the sections excavated through the ditch discovered in Field 5 on the south side of the road (Figs 6 and 9).

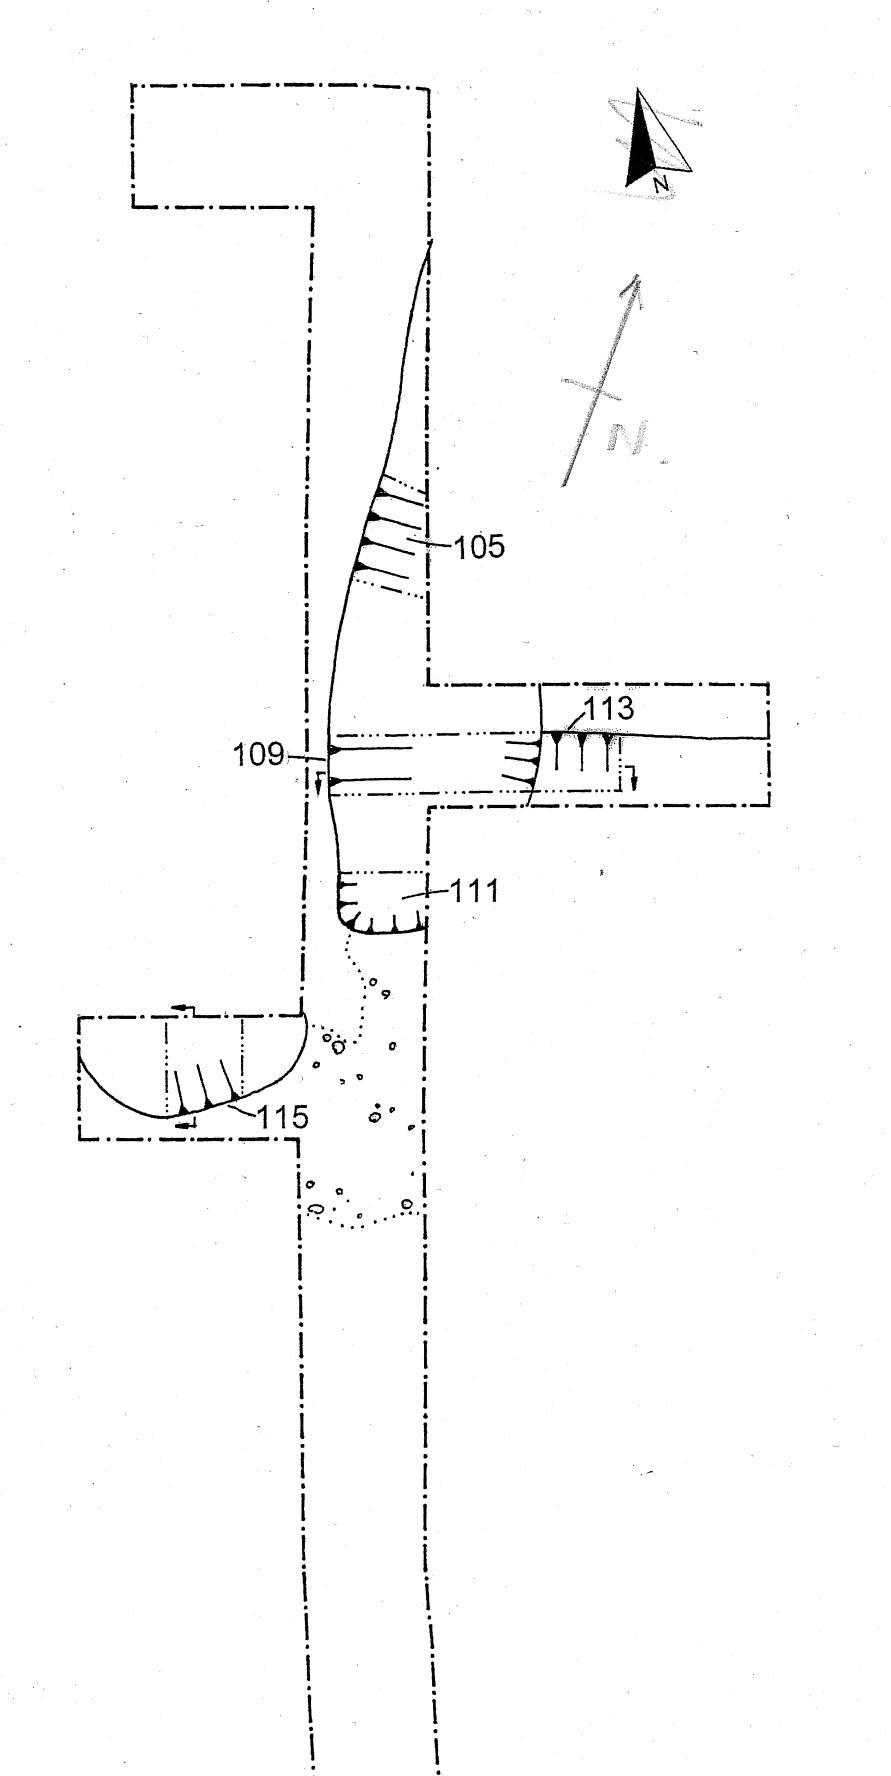
Figure 7: Trench 1, plan.

Roman features were found in Field 3, Trenches 1, 3 and Field 5,. Trenches 9, 10 and 11. Trench 1 (Fig 7) contained a large feature (109) that was thought to be either a shallow, elongated pit or the terminal of a shallow linear ditch. The feature was at least 9m long, 3m wide and 0.4m deep approximately north-south with gently sloping sides. The feature had three distinct bands of fill (Fig 8), The primary fill (112) was a mid-brown coloured clayey-sand with charcoal and burnt clay. This was overlain by a secondary fill (107) of light brown sandy clay with was then overlain by a dark grey coloured sandy fill containing coal and charcoal (106). All three fills contained large quantities of iron working slag with vitrified clay adhering to the surface and Roman pottery, principally Severn Valley wares. Feature 107 cut an earlier gully feature (113, Fig 7 and 8) to the east. The gully is aligned approximately east-west and measures at least 3m in length, 1m in width but only 0.2m deep, appearing to have been truncated from above. No pottery or iron working slag was present in the fill. A

short extension to the trench on its western side revealed a sub-circular pit (115, Figs 7 and 8). The pit measured 3m in diameter and 0.6m deep with sloping sides. It contained two fills, a primary fill of dark reddish-brown, clayey sand with gravel (116) and a medium reddish brown clayey-sand with small stones (117). Both fills contained Roman pottery and iron working slag.

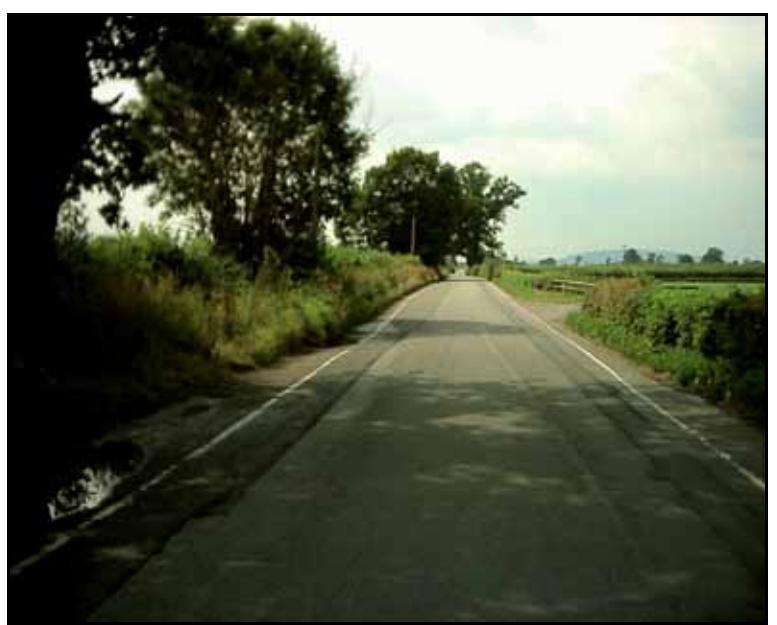
*View westwards of the road surveyed. In the foreground is section 6 with section 7 located in front of the entrance to the field on the right.*

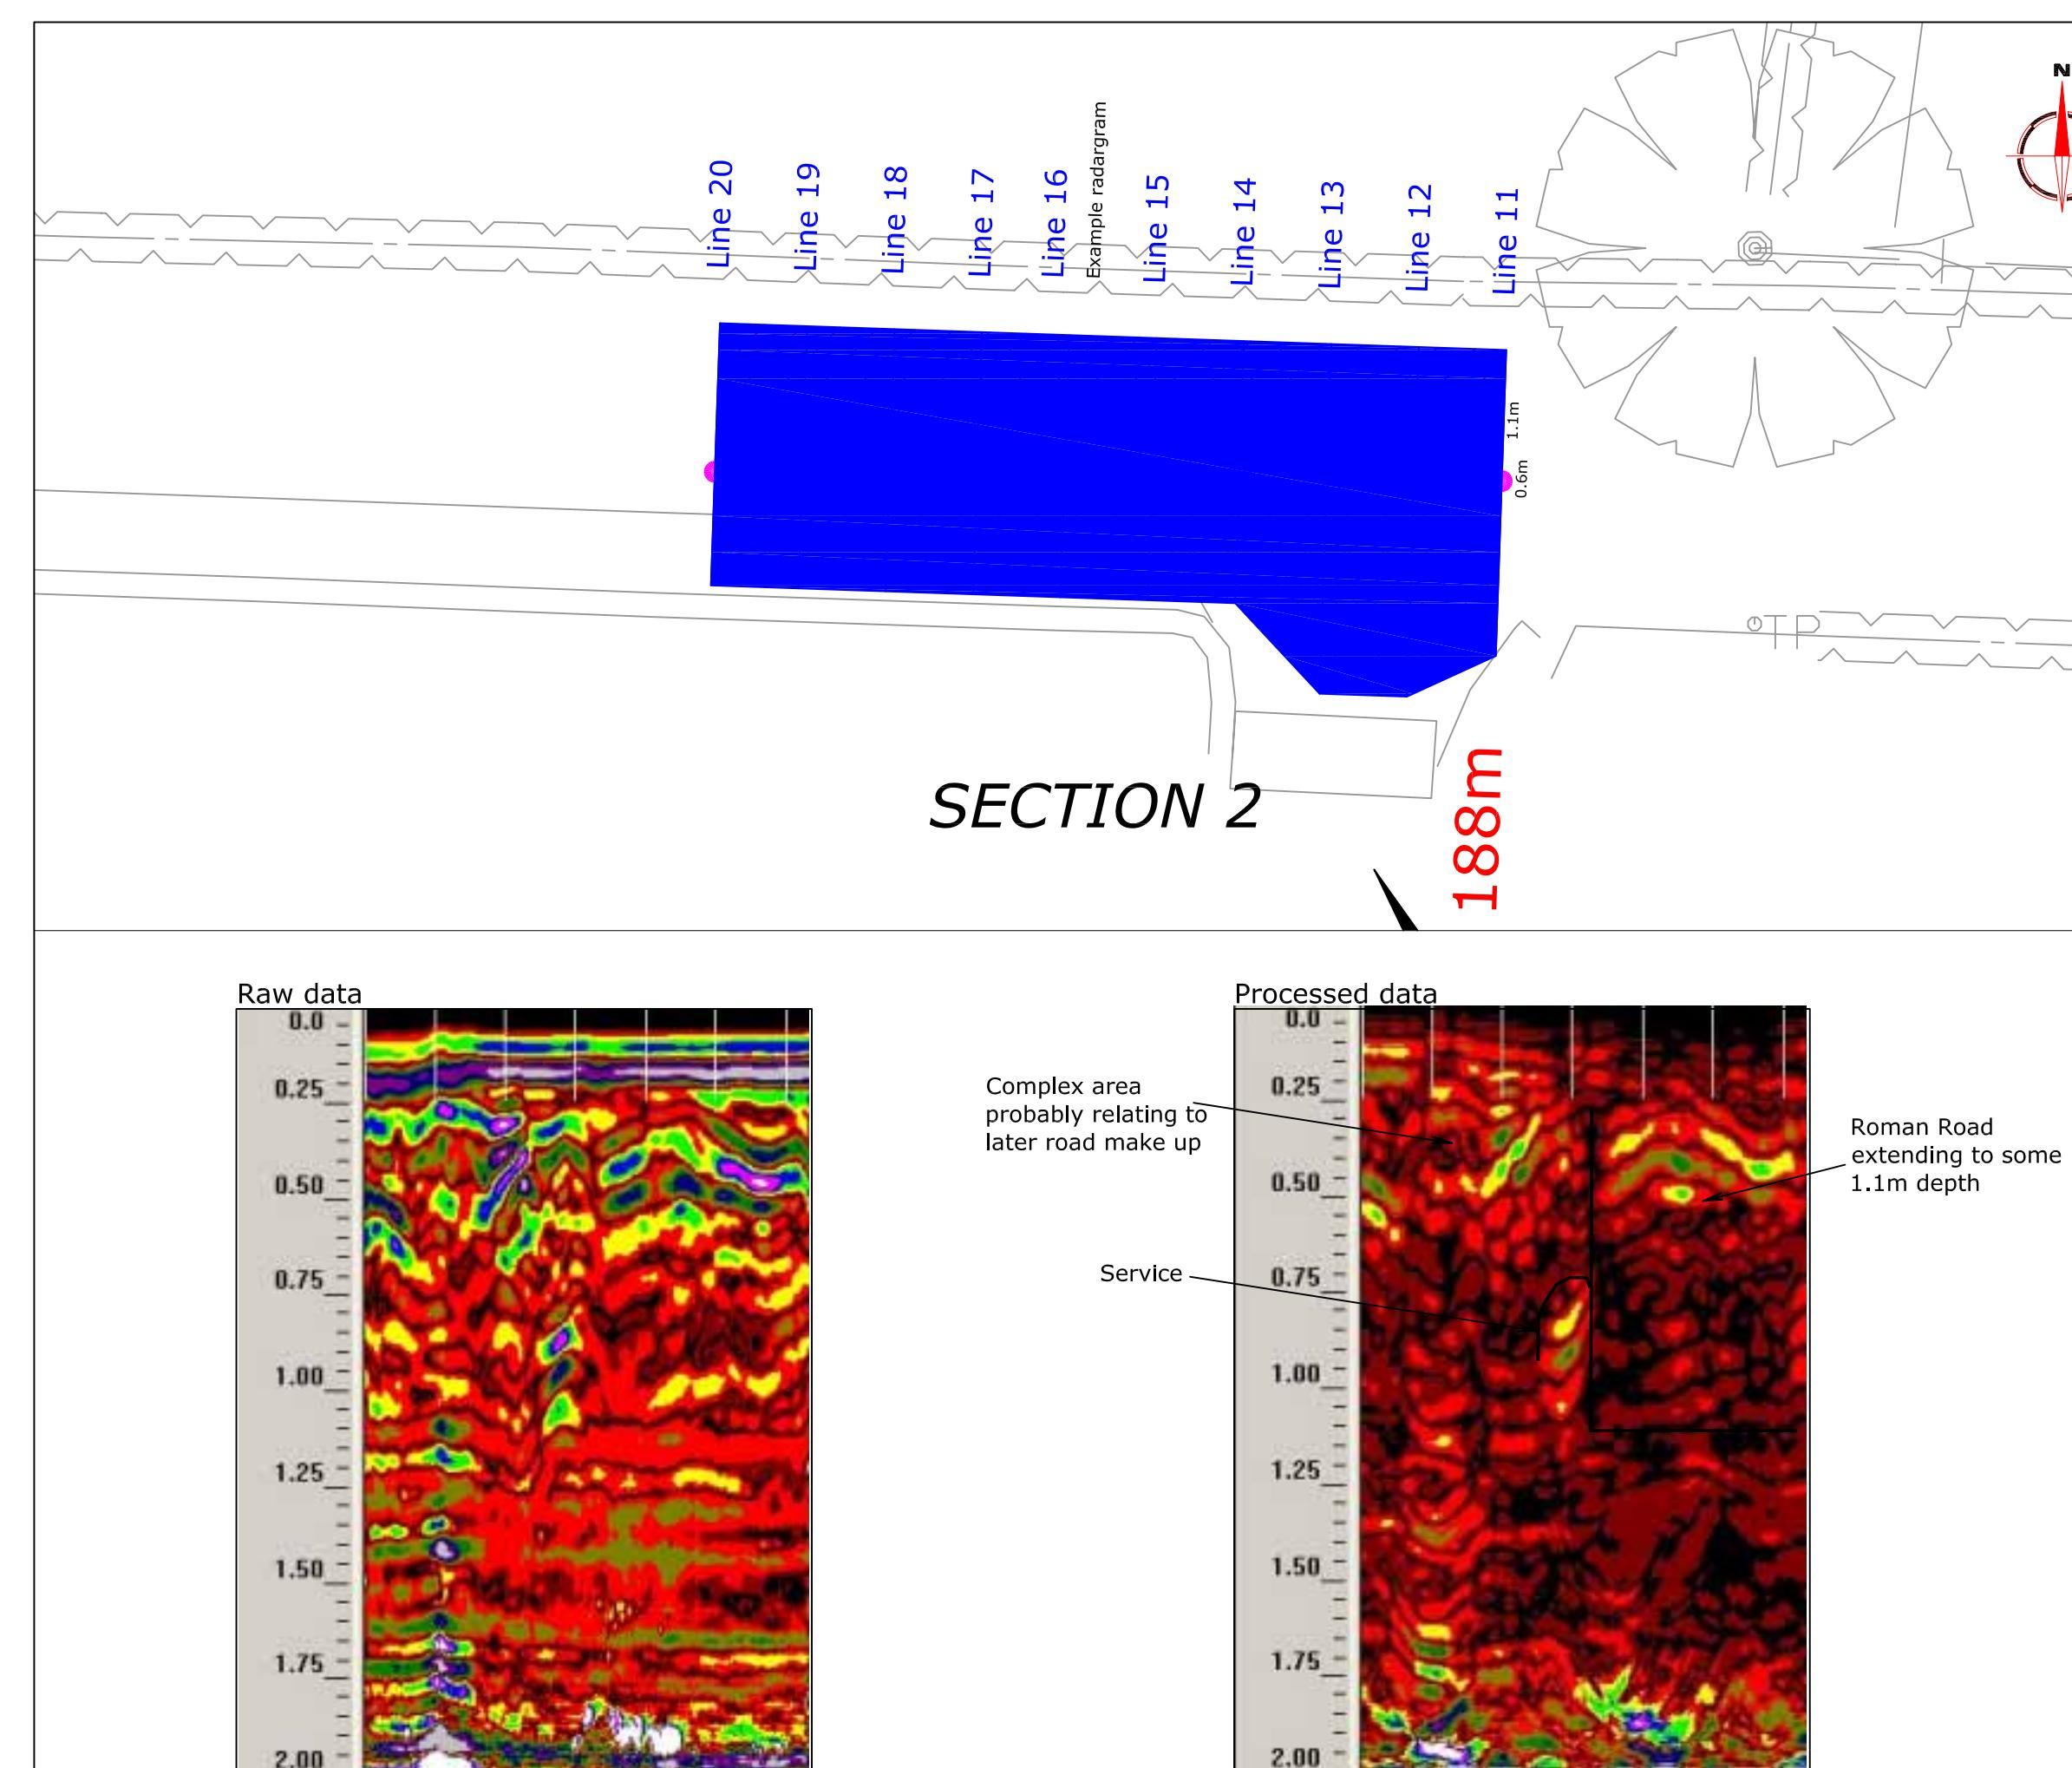
SECTION 2. LINE 16. EXAMPLE RADARGRAM

The example radargram in Figure 5 shows a clearly visible buried surface which can be observed down to a depth of 1.0-1.1m. As with section 1 this feature can be seen on the northern side of *Roman Road* and has been interpreted as the possible surface of the road of Roman date. No accompanying south flanking ditch was visible but this may be due to the disturbance from the service and from the construction of a later road surface, both of which have been plotted in Figure 5.

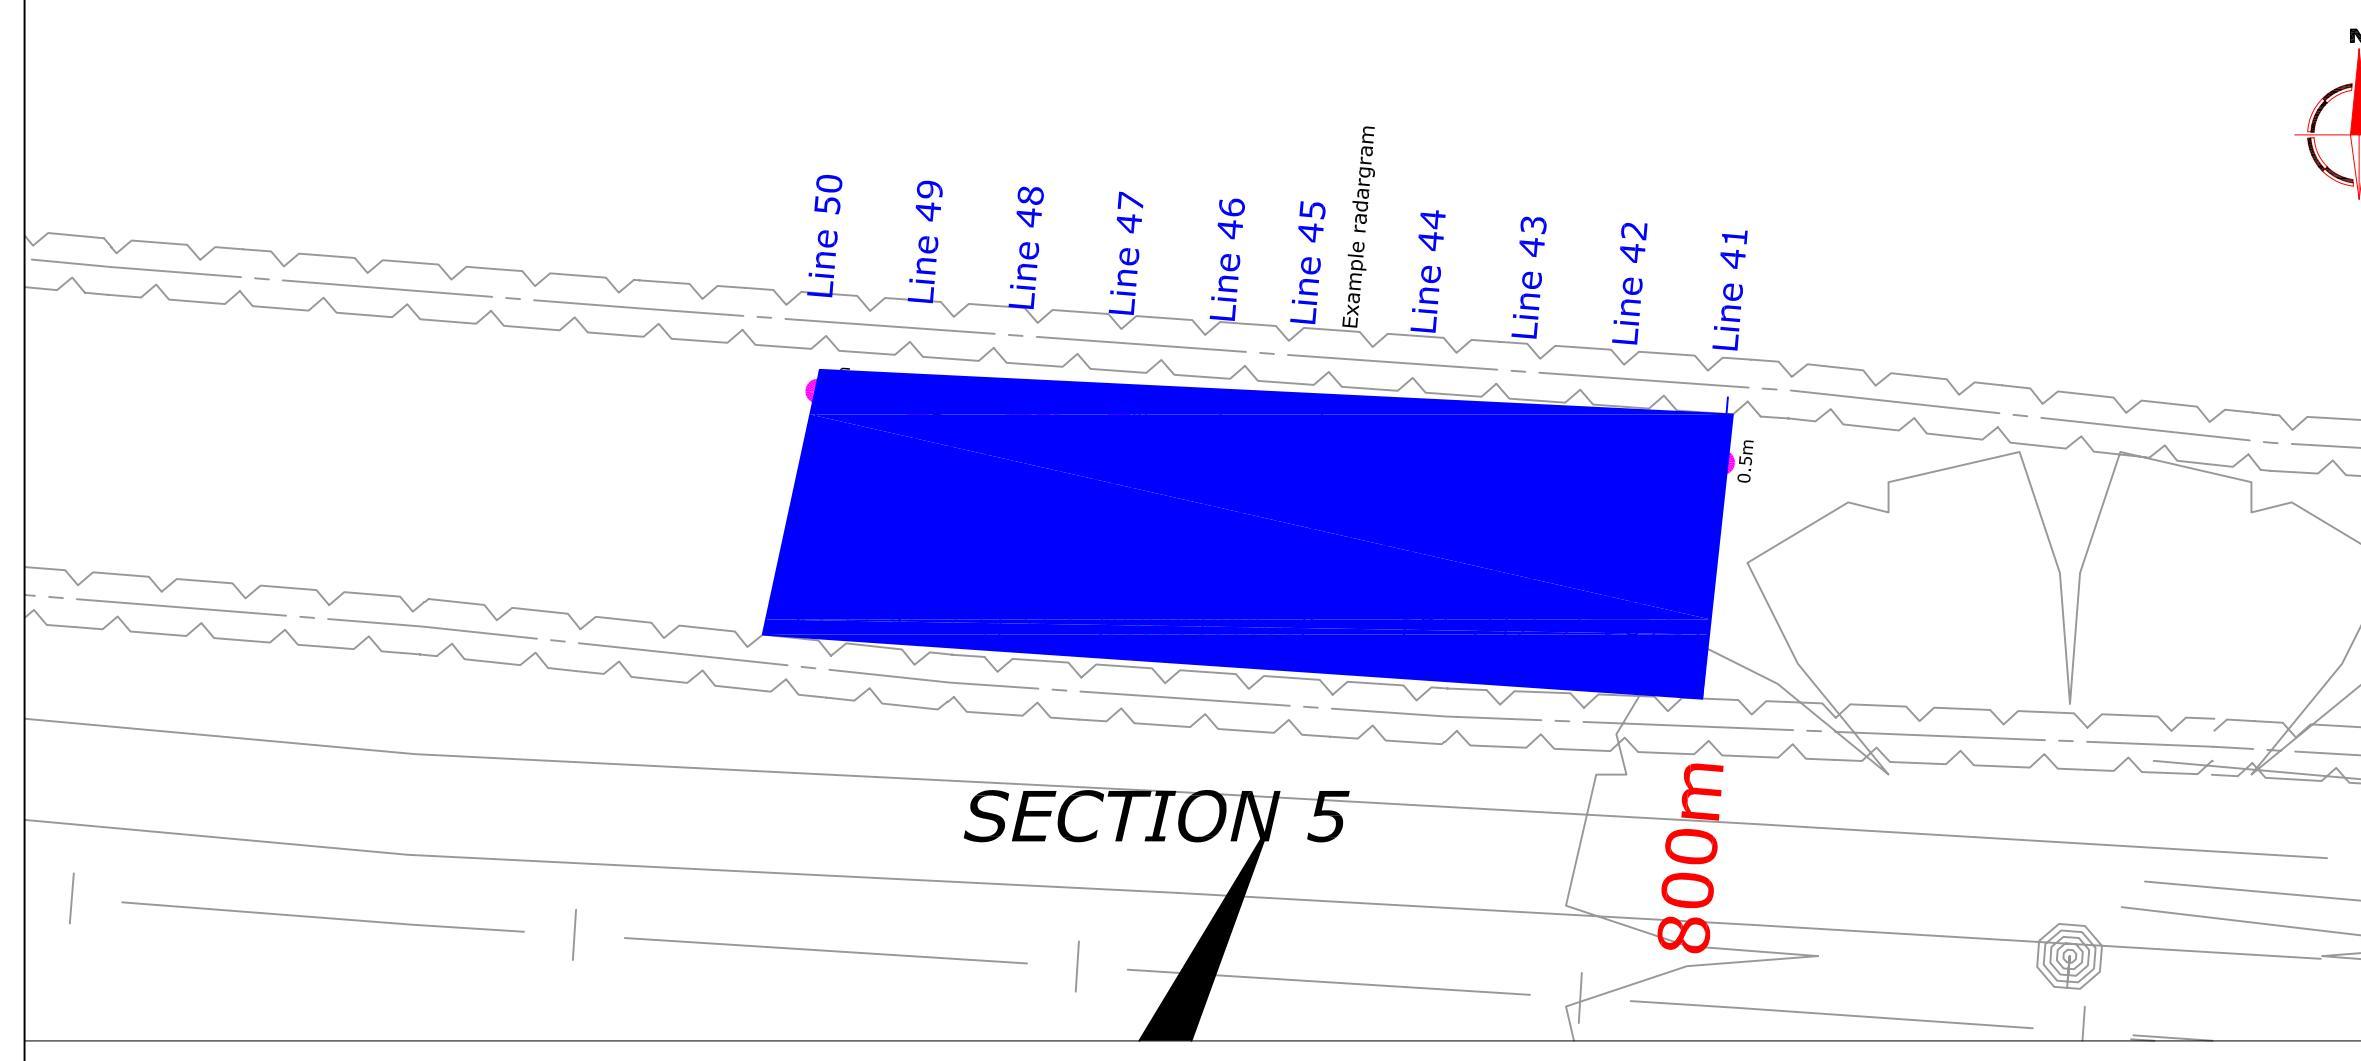
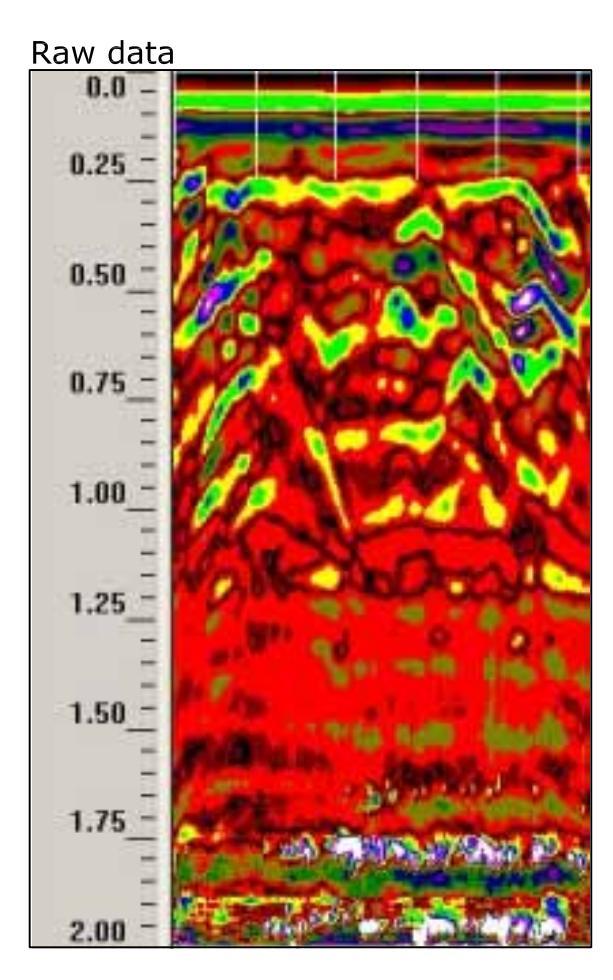
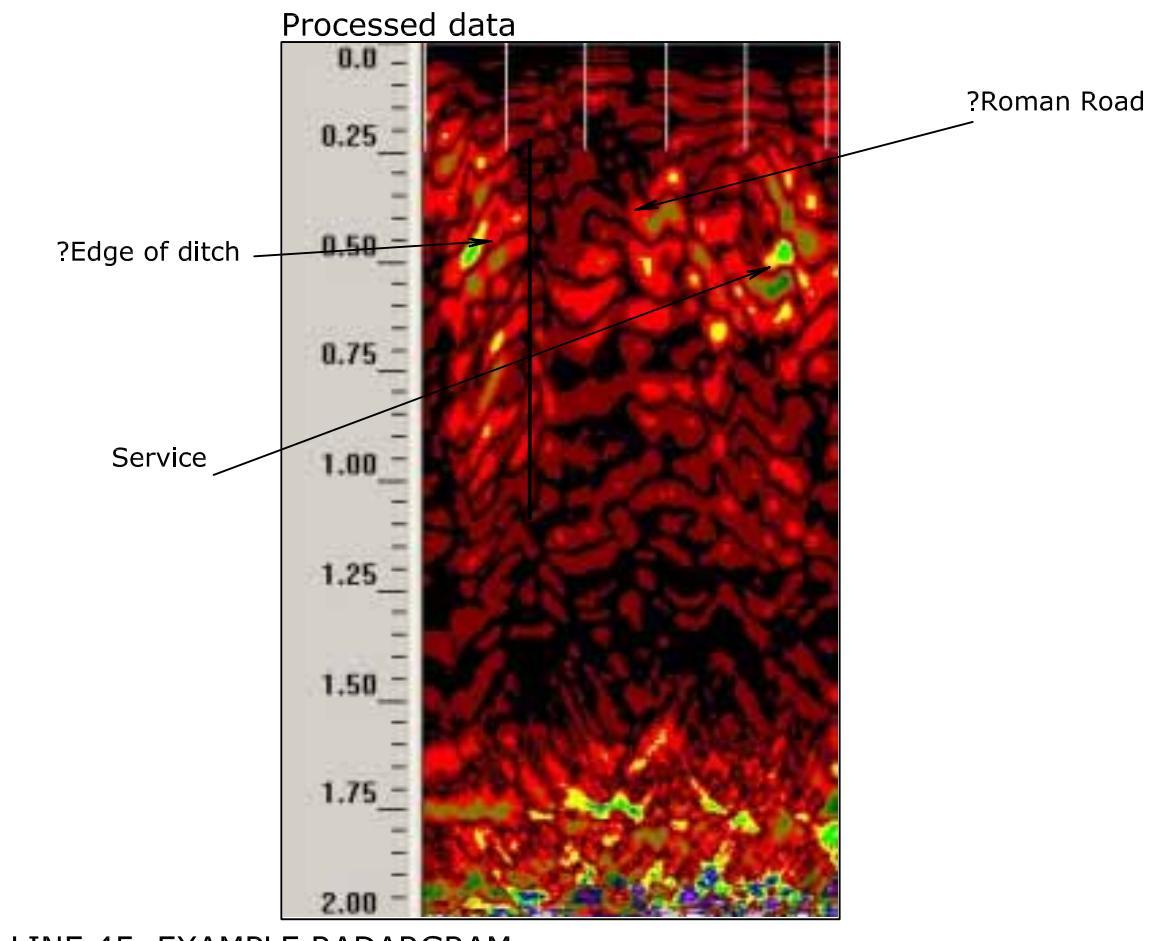
SECTION 5. LINE 45. EXAMPLE RADARGRAM

The data for section 5 shows a feature interpreted as possibly belonging to the Roman road and, as previously, banded between two services (Figure 8). However, the example radargram shows evidence of an inclining anomaly which is dipping southwards which can be observed on the very edge of the survey area. This may be related to partial remains of the south flanking ditch to the road of Roman date which seems to have been destroyed by modern disturbance to the west and east of section 5.
