Figure 3: Principal features of Butlins Camp, with the proposed development and earlier field boundaries superimposed

Figure 4: Itinerary of 2001 walkover survey, showing current land-use

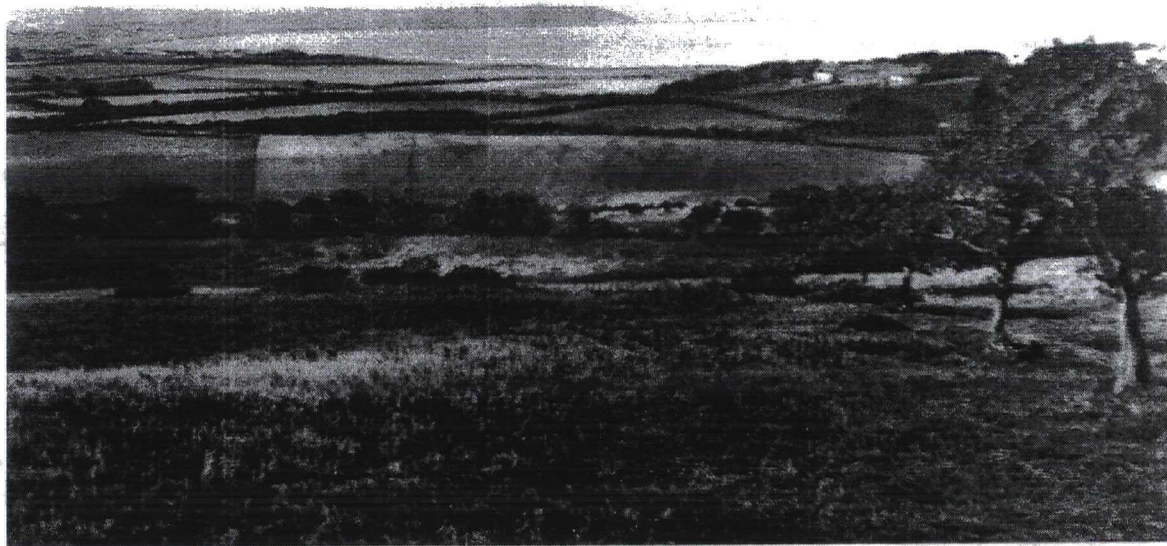
Plate 2 The site of the future Butlins Camp (centre rear) from Graffitoe Farm, c 1920, looking north-east towards Filey Brigg. The farm in the trees (centre right) is Moor Farm, near *Stir Heath Howe*. The rough pasture in the foreground are still-extant prehistoric earthworks, part of a series of mostly ploughed-out features on high ground overlooking the site area (Cecil Mowthorpe Collection)

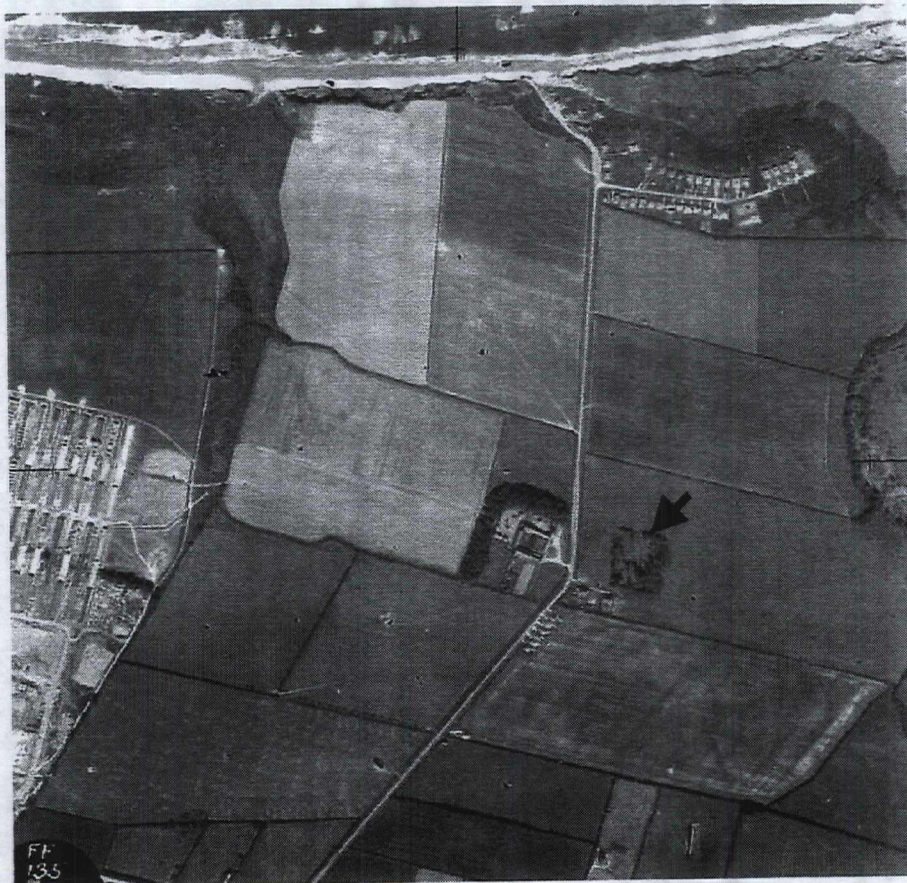
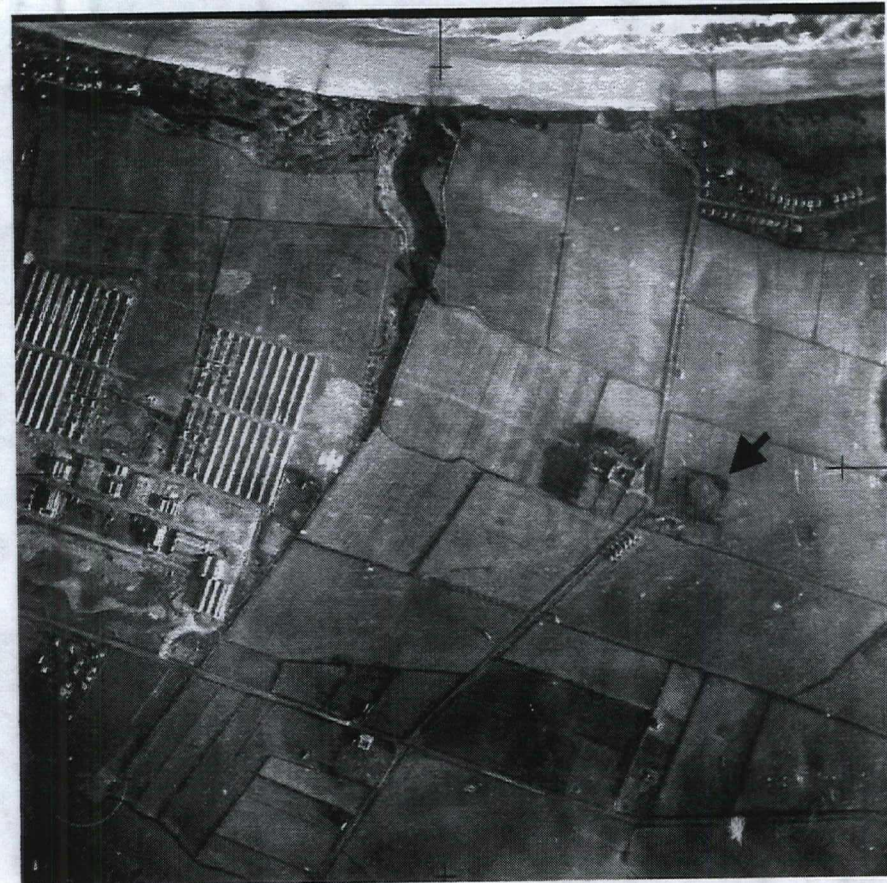
Plate 7 Aerial photographs taken to the south of the camp: (a) 1st August 1940. Enclosure period fields either side of Hunmanby Gap road to the south of RAF Hunmanby Moor (left). The small wood to the right of the road, opposite Moor Farm (arrowed) contains *Stir Heath Howe* burial mound, ploughed out by 1940, lay to the south (right) in the same field. The southern boundary of the camp is bounded by Flat Cliff Gill, leading to Butcher Haven; (b) 11th December 1940. Similar view, showing the straight main coast road (bottom), and the southern part of the camp still under construction (National Monuments Record)

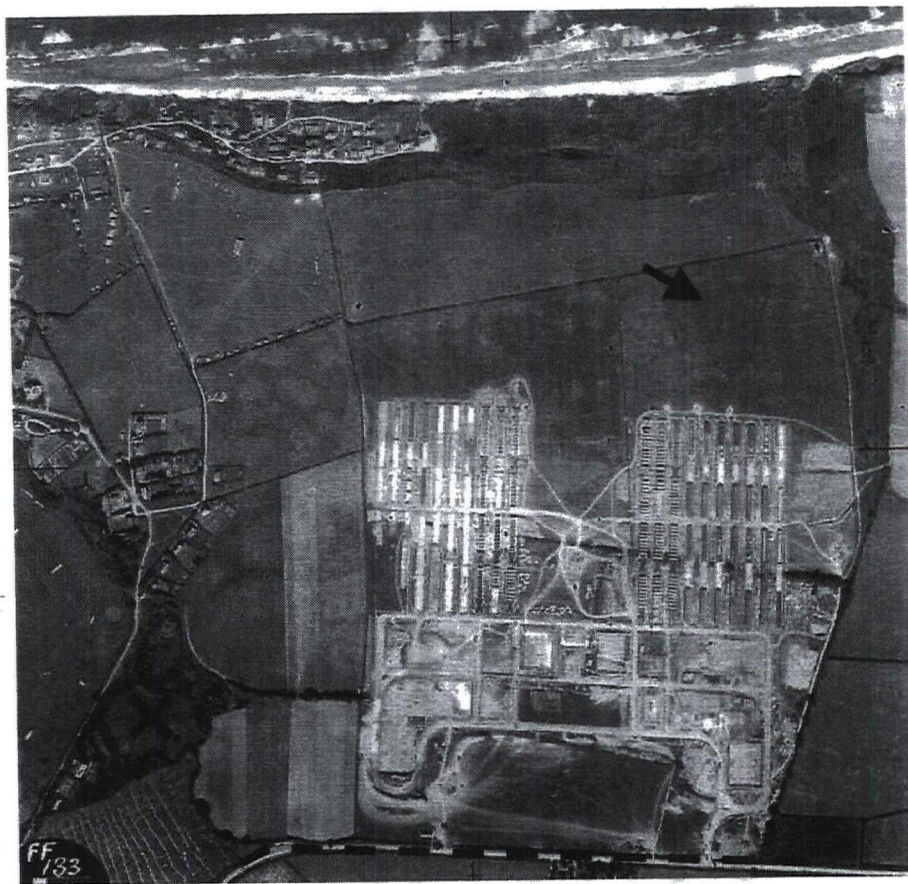
Plate 8 Aerial photographs of the camp: (a) 1st August 1940. RAF Hunmanby Moor under construction. A set of cropmarks (arrowed) shows faintly as thin lines on the former *Warren Hill*, an area covered by later self-catering chalets in 1969. Post-medieval ridge-and-furrow and hedgebanks still survives in the fields between the camp buildings and the cliff. To the left of the camp are old enclosures around the medieval township of *Fowthorpe* (marked by X). The main enclosure period road, c 1809 (dashed), changes direction where it meets these pre-existing features, although has been straightened in recent years. Within the camp, enclosure period field boundaries can still be seen; (b) 11th December 1940. A similar view, with the outline of the boating lake (wartime parade ground) more clearly developed (National Monuments Record)

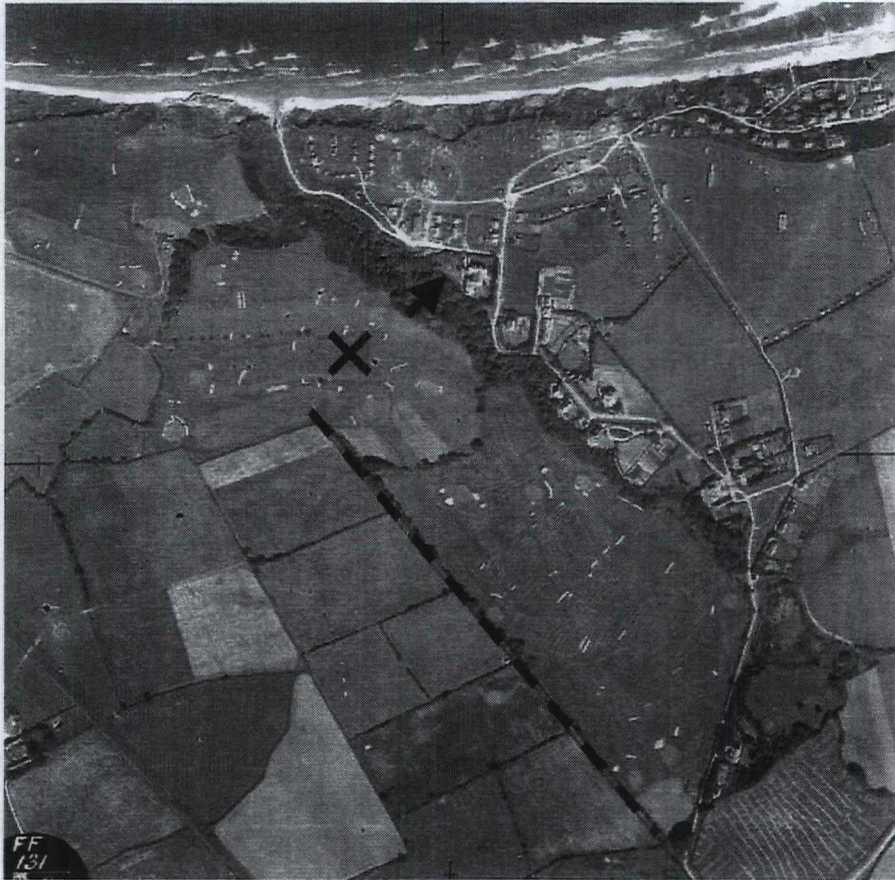
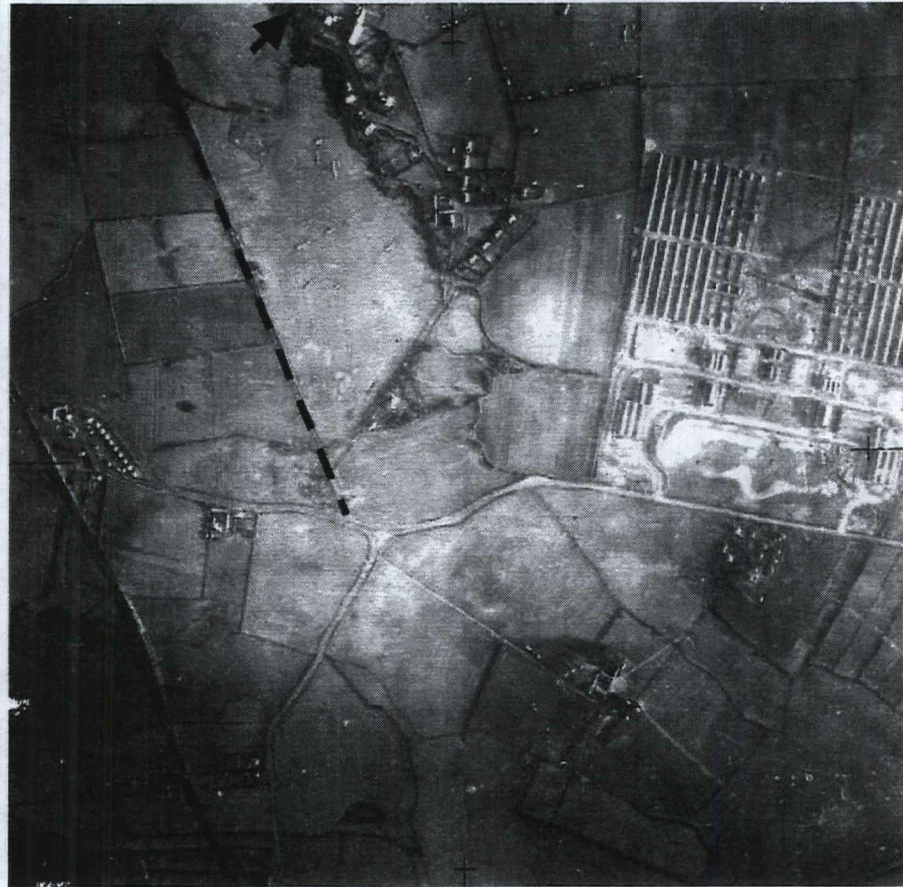
Plate 9 Aerial photographs to the north of the camp: (a) 1st August 1940. Mixed area of irregular old enclosures north of *Fowthorpe* township, on Fowthorpe Lane (dashed), partly replaced by fields dating to the 19th-century enclosure. The older enclosures (Fowthorpe Closes, already part of Filey golf course by 1940) show strong traces of what appear to be late medieval or early post-medieval ridge-and-furrow ploughmarks. This is the site of 'old walls' (marked X) found in the 19th century. To the south of the wooded area of Long Whin Gill (centre) is Primrose Valley Caravan Park, where late Roman pottery (arrowed) was found in the 1920s and 1930s during initial redevelopment; (b) 11th December 1940. Similar view, showing the junction of Fowthorpe Lane with the main coast road (National Monuments Record)

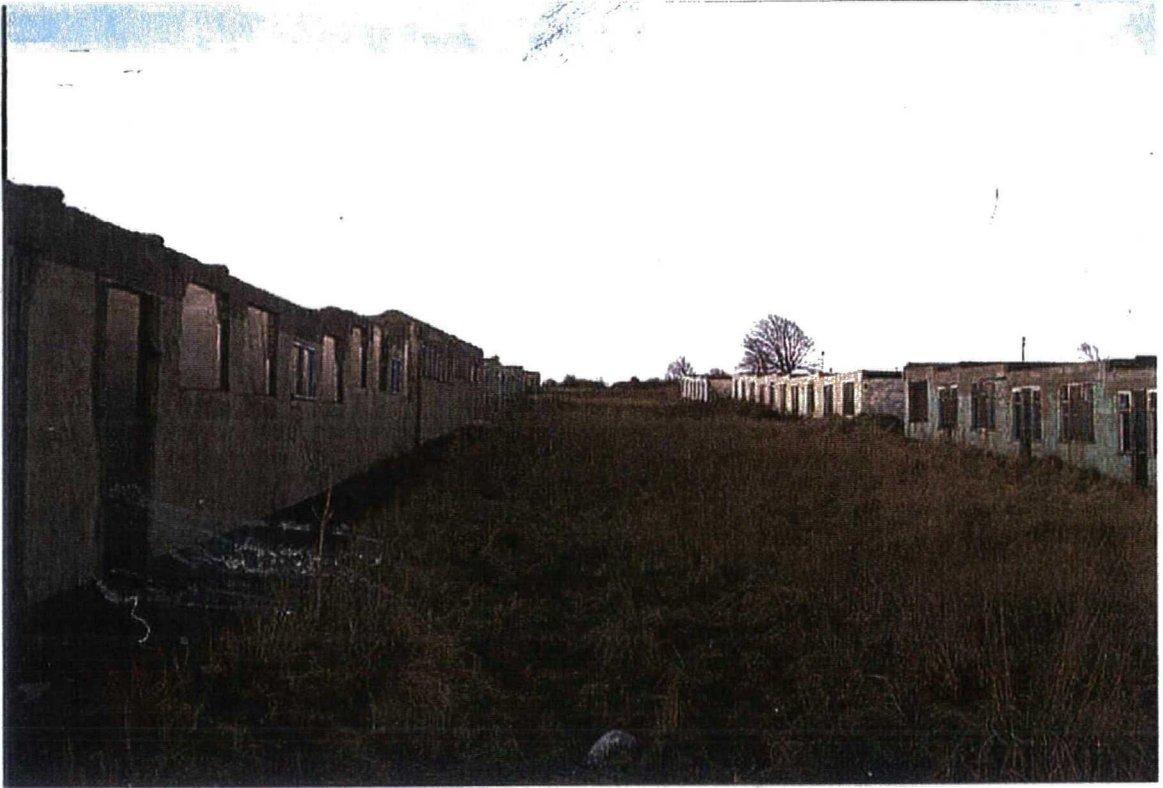
Plate 10 Roofless chalets in the north-east camp, with wide grassed strips surviving between, looking west

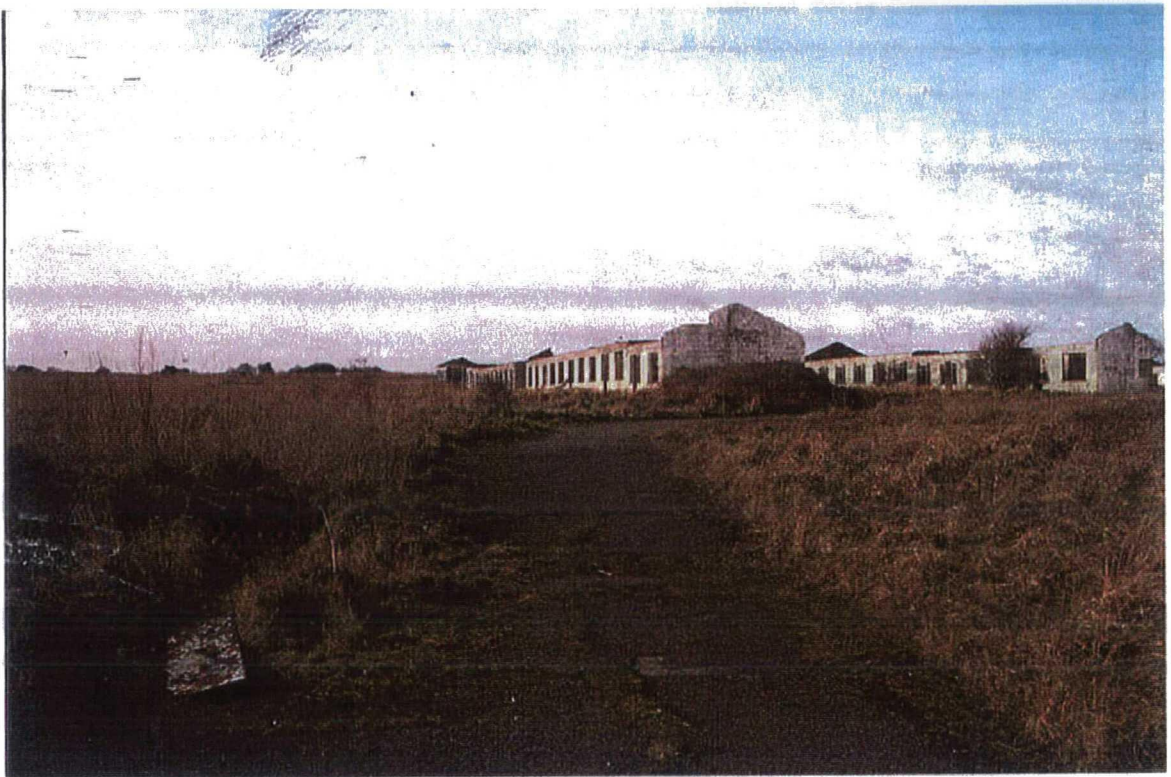
Plate 11 The north-east camp from the enclosure-period field on the clifftop, looking west

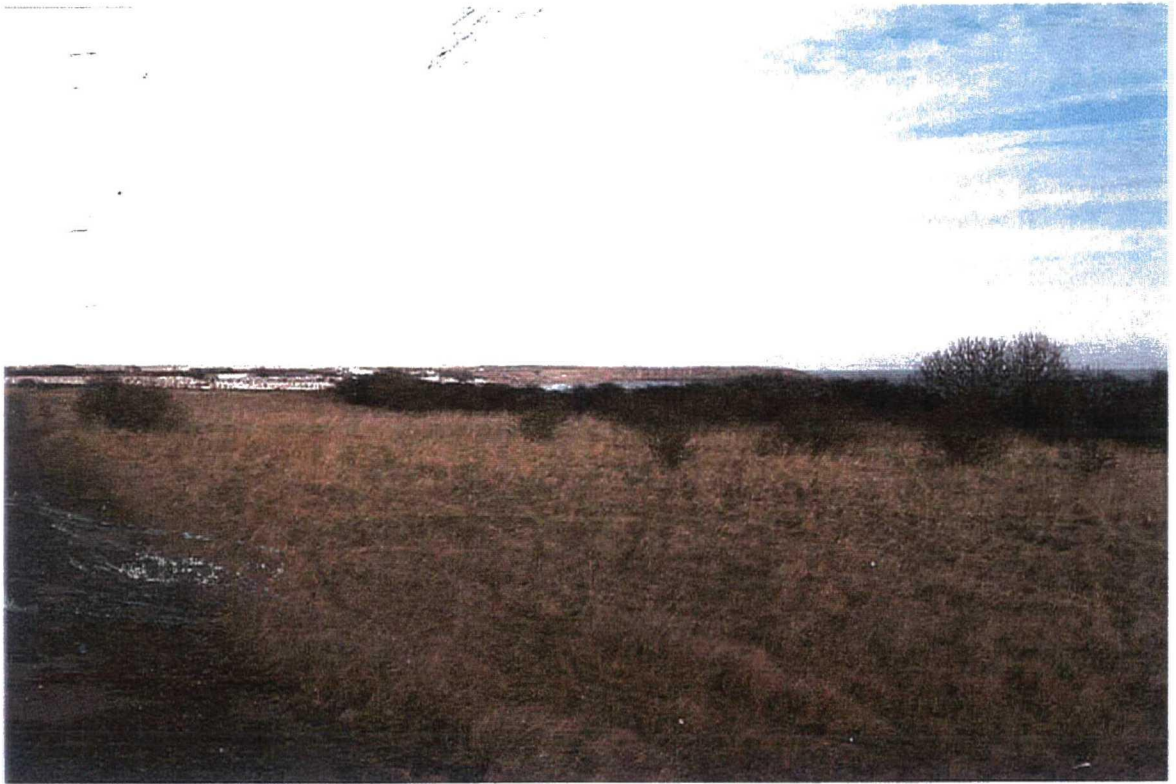
Plate 12 Enclosure-period hedgerow and fields to the east of the main camp, looking north-east towards Filey Brigg

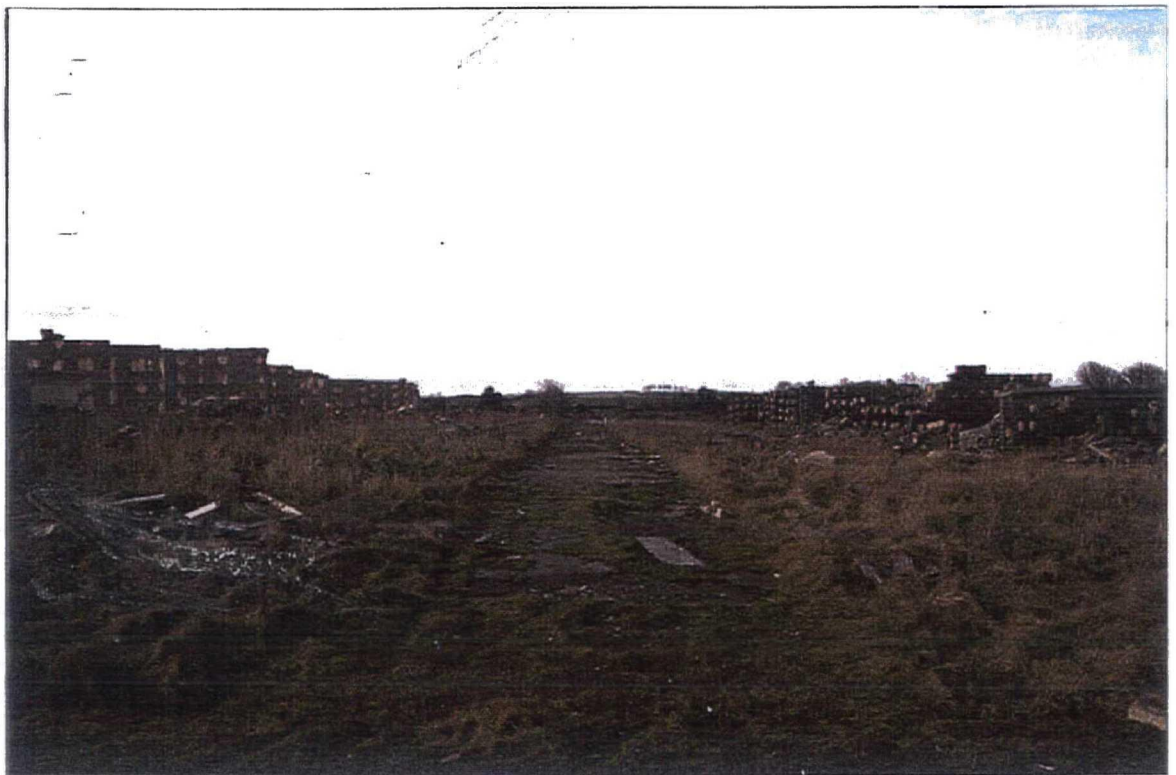
Plate 13 The 1969 self-catering chalets in the south-east camp, with wider spacing between, looking west. This is the area of *Warren Hill*, and features identified from the 1940 aerial survey

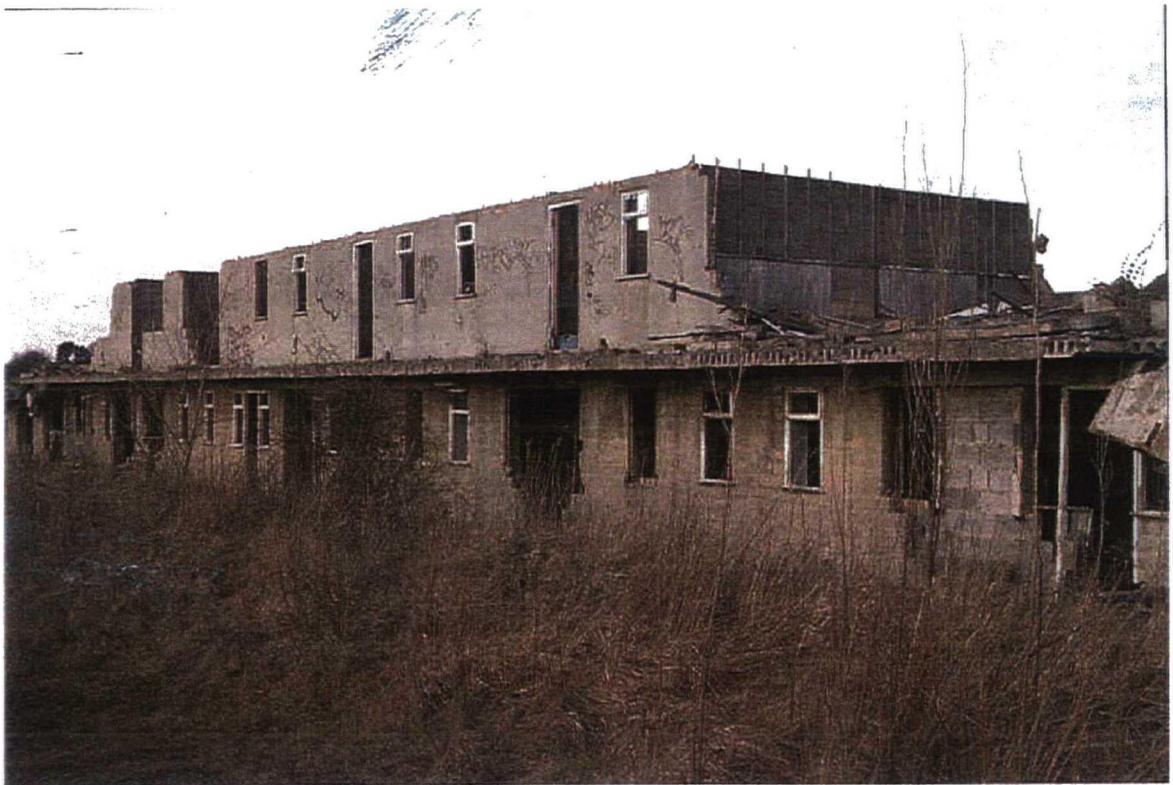
Plate 14 Example of two-storey self-catering chalets in the south-east camp, constructed on *Warren Hill* in 1969, looking north-west

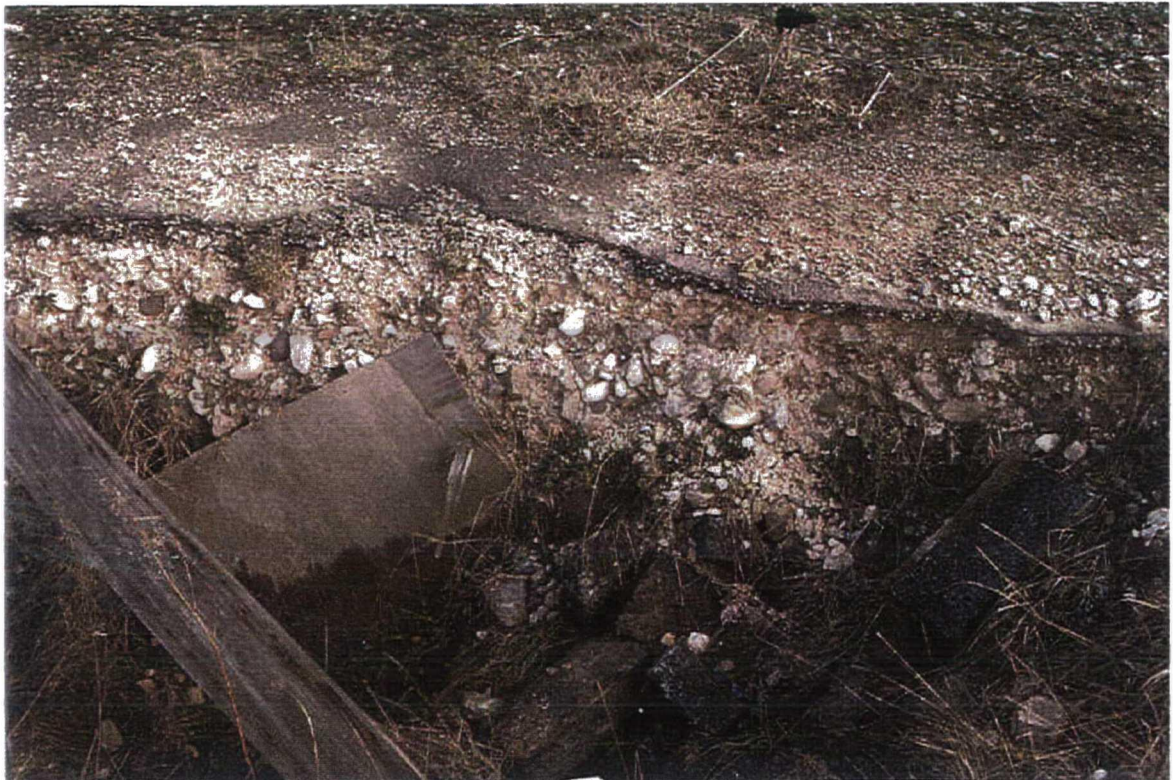
Plate 15 Excavated services in the south-east camp, showing what appears to be a considerable depth of made ground beneath the tarmac, although this could represent packing around the original service trench

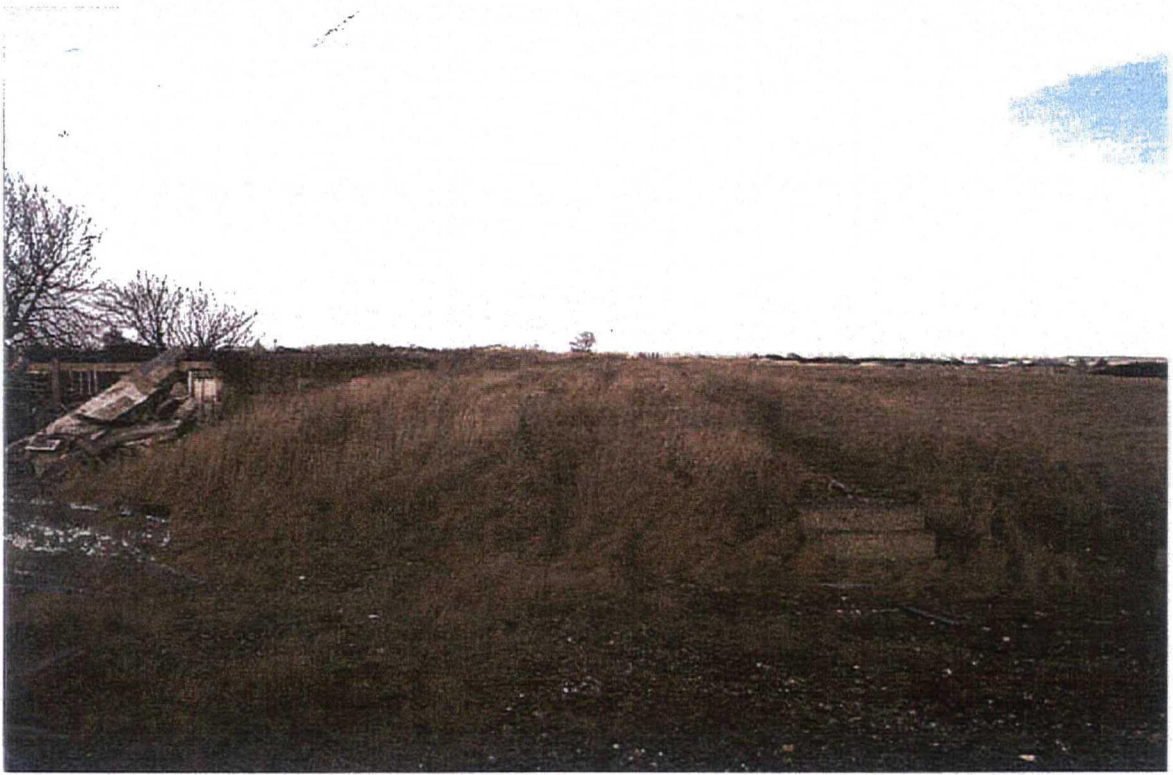
Plate 16 East-west artificial embankment leading between the original south-east camp (left) and 1969 chalets (right) towards the sports ground and undeveloped field in the distance, looking north. The unsurfaced track is reached by steps leading from the main track skirting the southern edge of the camp (foreground)

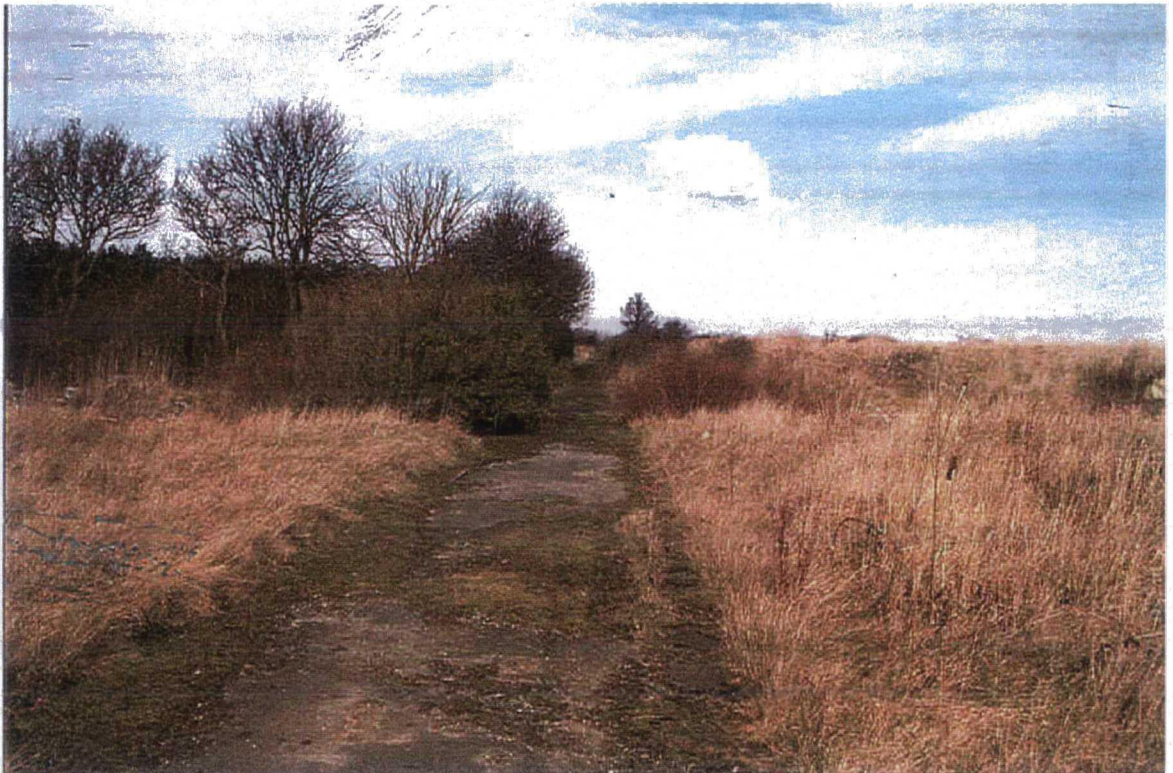
Plate 17 Surfaced east-west roadway between the south-east (right) and south-west (left) camps, looking north towards the sports field (right) and putting green (behind the tree line, left).

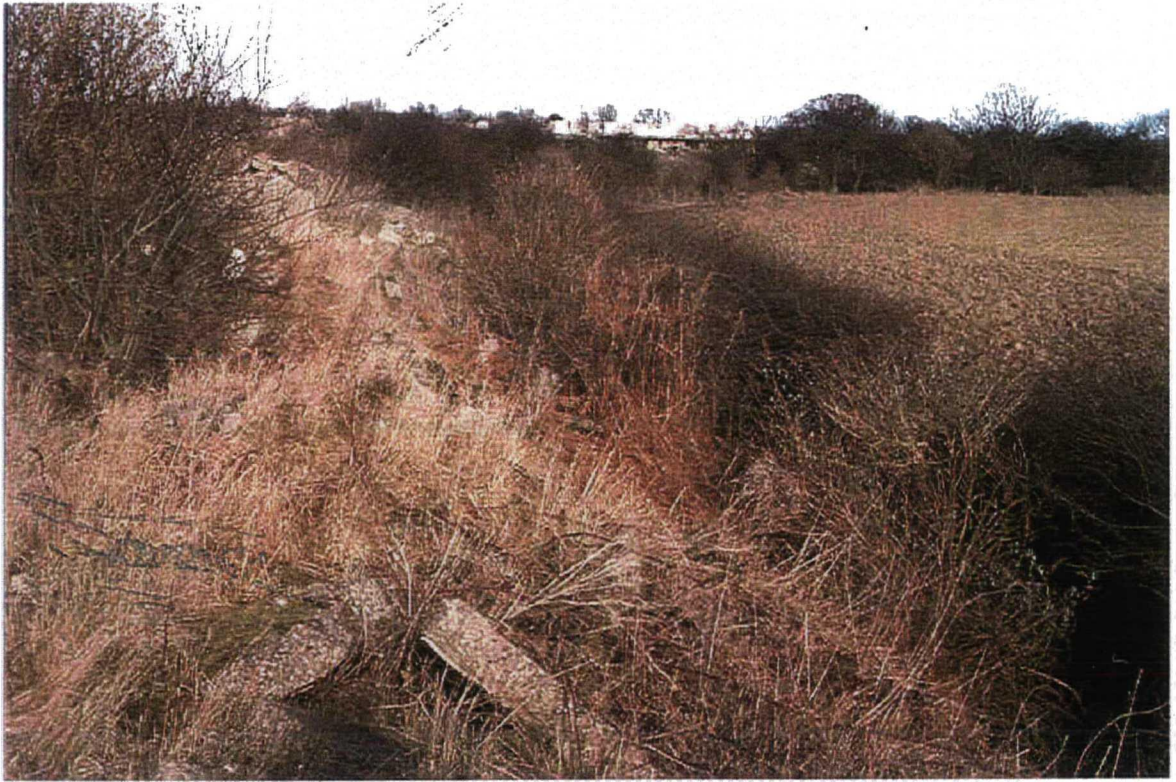
Plate 20 Thick rubble dumping east of the staff chalets (left), looking north. Below the rubble platform is the original hedgerow for the ploughed field behind Moor Farm (right)

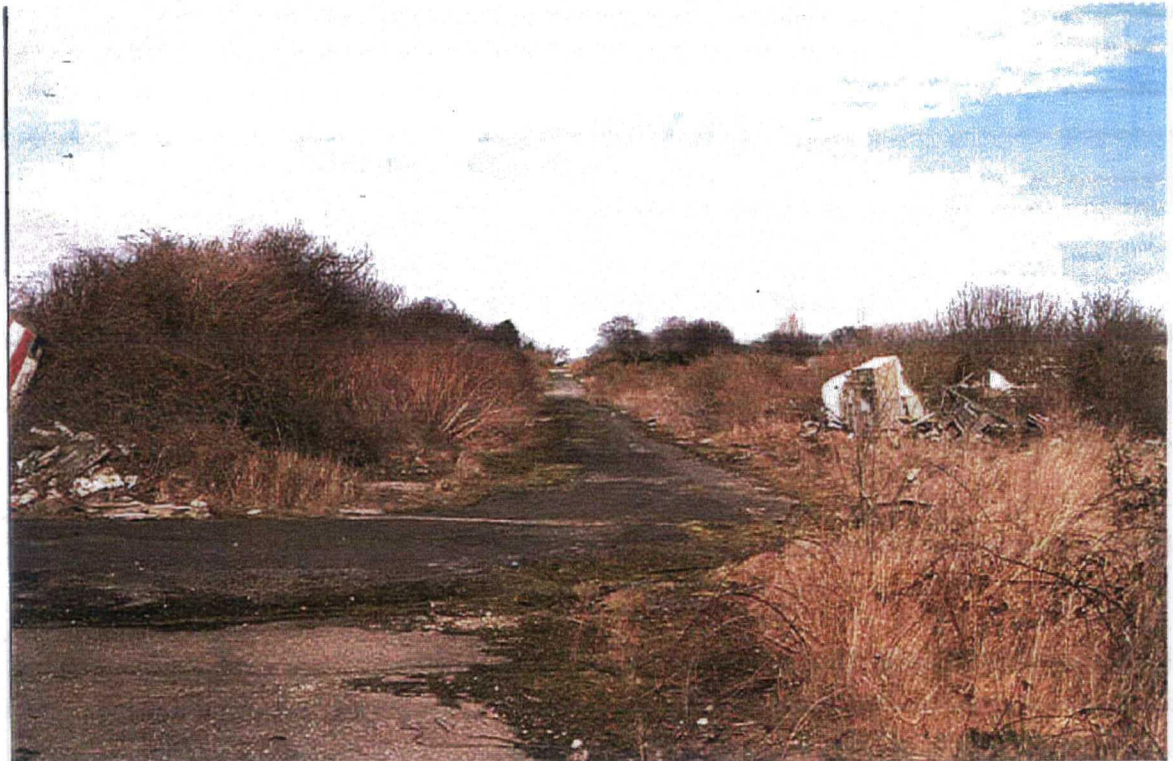
Plate 21 East-west roadway between the main entertainment blocks, looking north

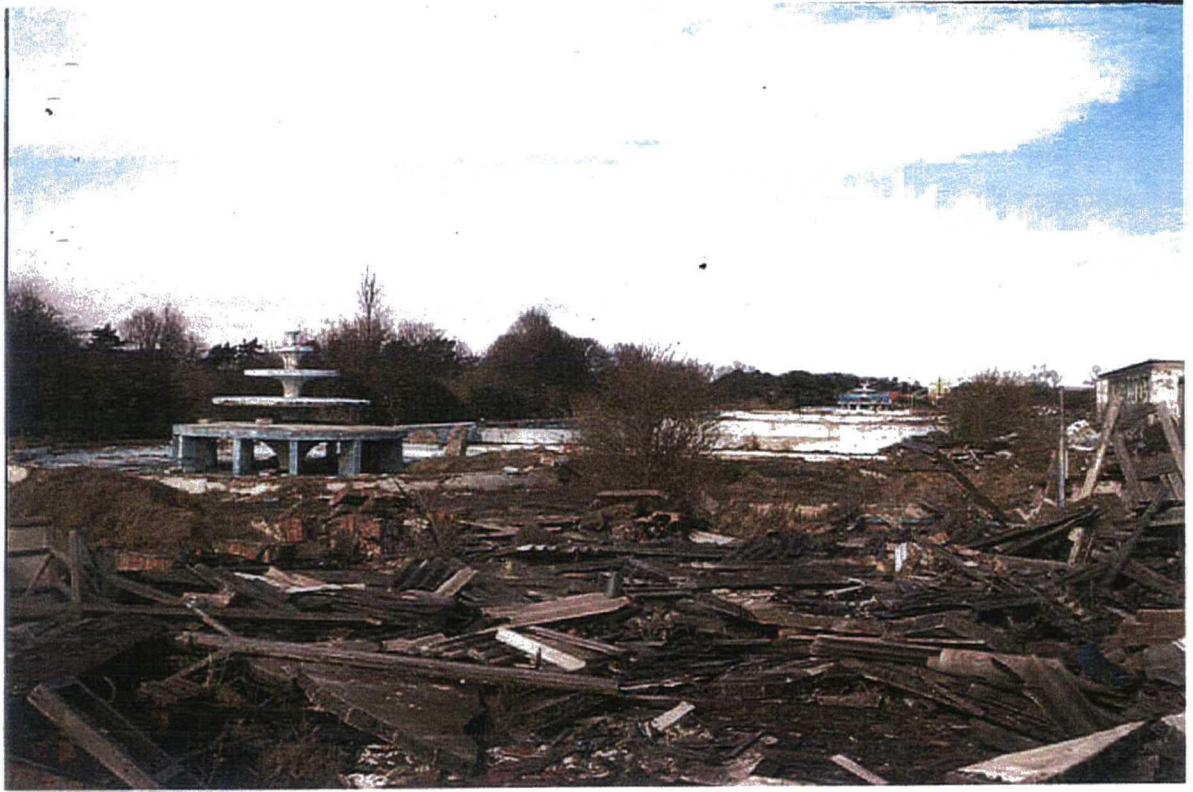
Plate 22 The outdoor swimming pool, looking north. The twin fountains were part of the original filtration system. The reinforced standing shell of the 1953 indoor swimming pool can be seen to the right

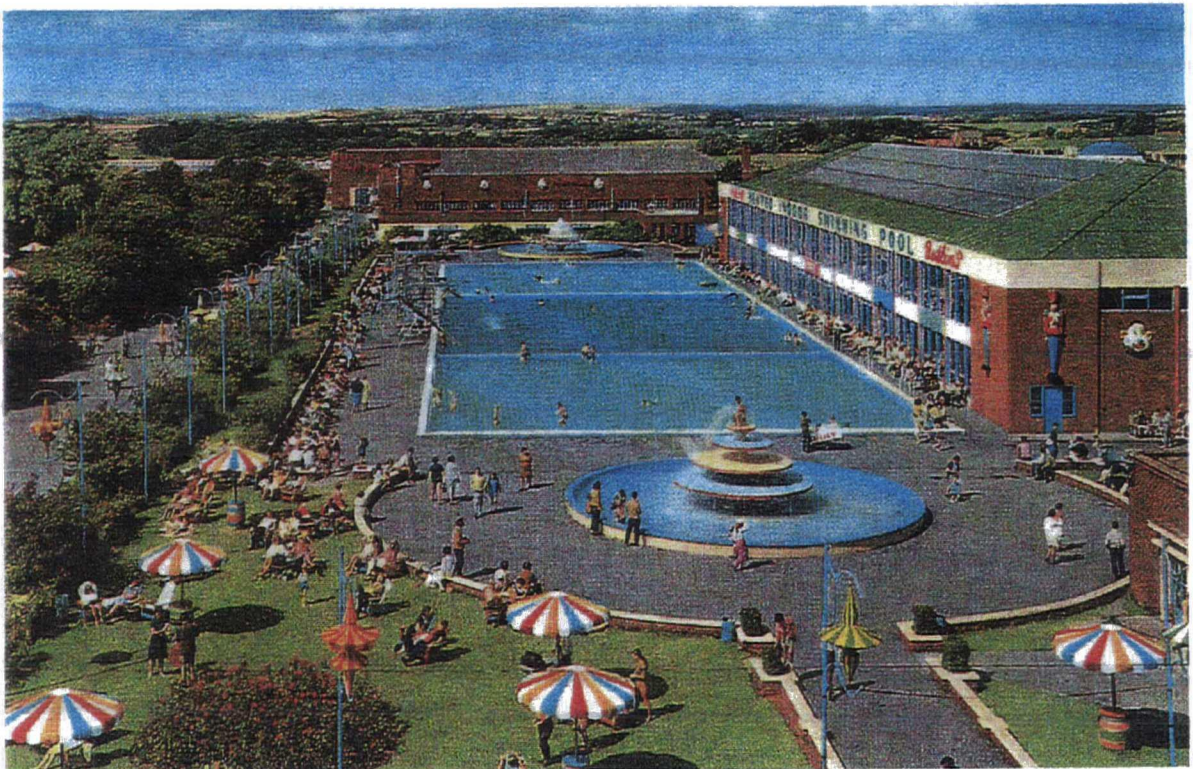
Plate 23 Rooftop view of the swimming pool and indoor pool during the 1950s heyday of the camp, looking north, with the Empire Theatre in the background. The boating lake is behind the roadway and tree line to the left (John Hinde Studios, Dublin)
