Alford Manor House Alford, Lincolnshire.

**Conservation Plan: Volume One
Cultural Significance: Issues & Policies
October 2006**

Alford Manor House Conservation Plan: Volume One

**Volume One:
Cultural Significance, Issues, and Policies**

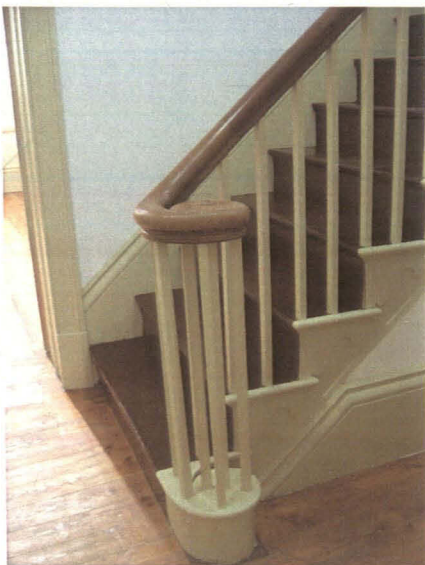
<p>The ground floor part of the staircase</p>

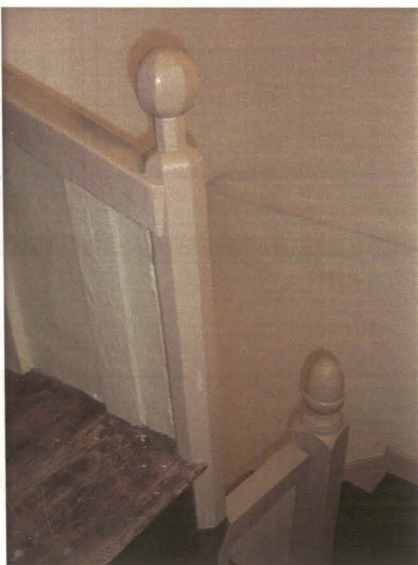
<p>The upper section of the staircase</p>
	<p>This staircase extends from the ground floor up to the attic. It is in the original staircase location in the eastern wing. The full flight to the first floor and the flight to the half landing on the upper level all date from the early 19th century. This is typical of the period with plain stick balusters and polished wreathed hardwood handrail. The upper flight dates from the late 17th century with its acorn finial and the top section with its faceted newel and oak finial is likely to date from 1611.</p>	
STATUS	Part of Grade II* building.	
SIGNIFICANCE	Considerable	
JUSTIFICATION	The position of the staircase is original and the phasing is of relevance and interest.	
POLICIES	RC2, RC4, RC5, RC6, RC7,

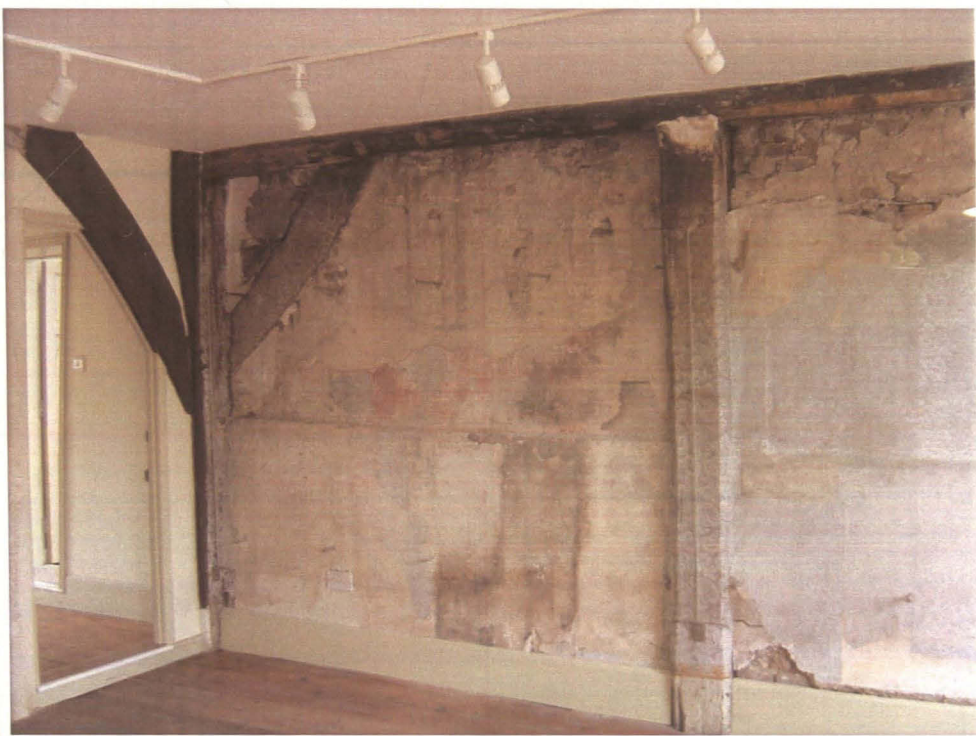
<p style="text-align: center;">East wall of F6</p> <p>This wall paper is hand blocked paper made from single sheets of paper joined in the traditional way to form a roll. It was then grounded with a grey distemper and printed in two colours from hand carved wooden blocks. The design is based on a floral motif. It has a separate fine foliate border strip at top and bottom, printed in six colours. The paper survives on areas of the east and north walls of F6. It has been expertly conserved by a wall paper specialist. It is likely that it related to the period when John Higgins occupied this part of the house. The east wall also shows various phases of construction of the house including timber posts and braces and a blocked early window opening.</p>
STATUS	Part of Grade II* listed building.
SIGNIFICANCE	Considerable
JUSTIFICATION	The wall paper expert believes that this is high quality paper and that a significant area has been found and conserved.

- This paper, found beneath later linings, is a considerable area of original early nineteenth century hand blocked paper with borders. It is high status paper that was probably chosen by former land agent John Higgins. It has been expertly conserved. (*local history; aesthetic qualities; conservation practice.*)

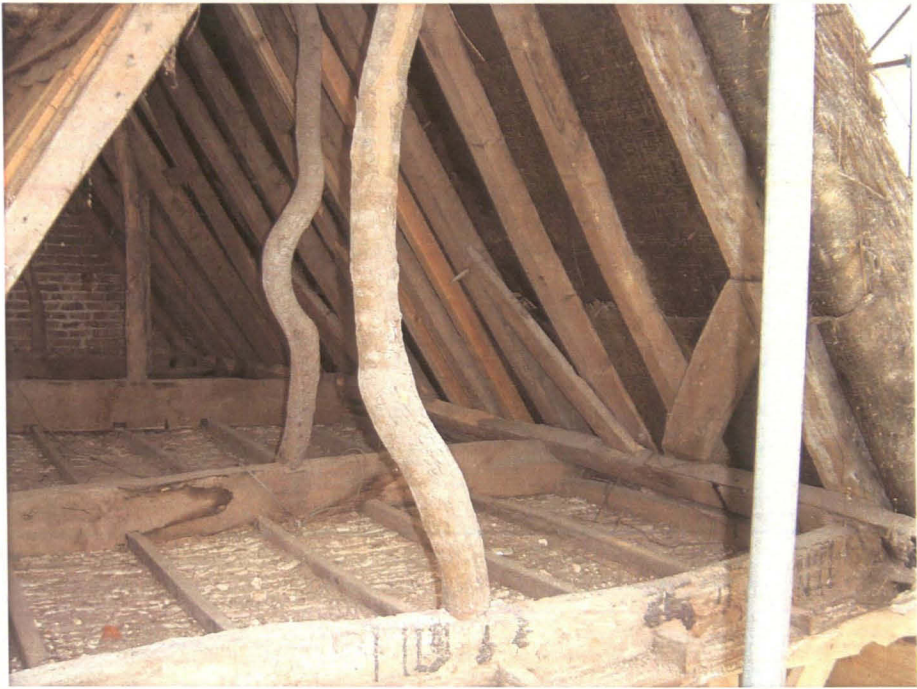
ELEMENT	ROOF AND FLOOR STRUCTURES
DATE	1611
DESCRIPTION	<p>Despite later alterations the roof form is retained across the whole of the original H plan with the best survival being in the eastern wing. The structure is oak with pegged A frames and collars, with morticed tenons and purlins. Rafters are numbered with five separate sequences of carpenter's marks. The first and attic floor structures also have carpenters marks in both Roman and Arabic numerals. Some of these floors also had an unusual form of construction with sub joists set on packing pieces on top of the main joists. All floors have been repaired and the historic floorboards replaced.</p>

<p>East wing roof</p>
STATUS	Part of grade II* listed building
SIGNIFICANCE	Considerable
JUSTIFICATION	The roof and floor structures are part of the original construction. They show interesting details of vernacular architectural construction and the sequences of carpenters marks are of particular archaeological interest.

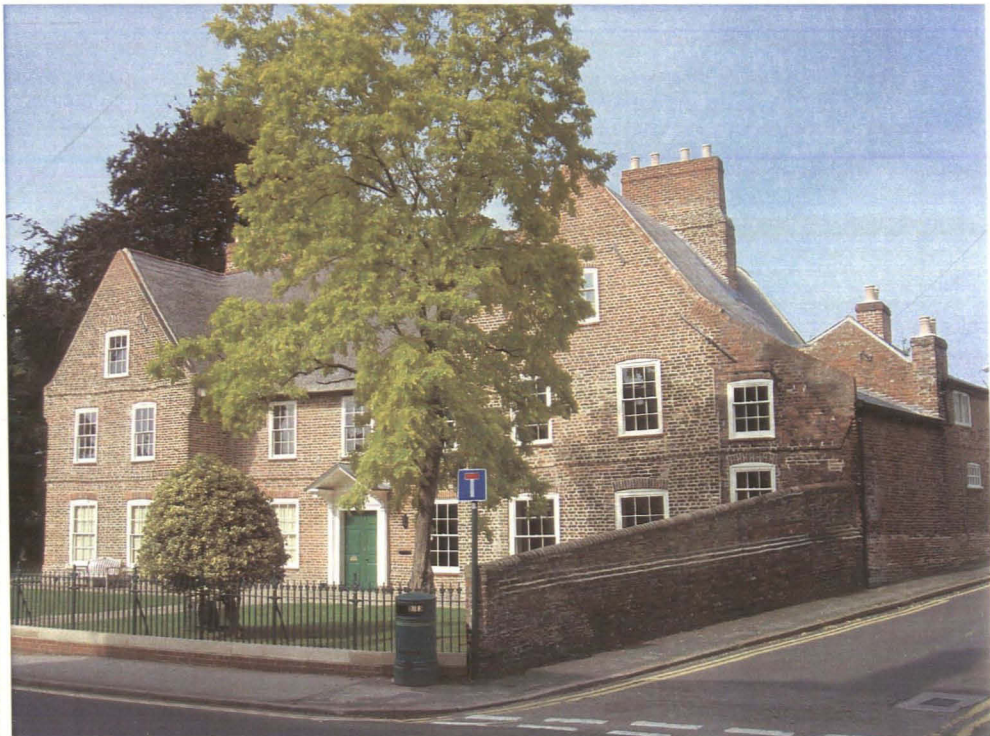
<p>The eastern extension is on the right.</p> <p>The original H plan house has the frontage aligned to West Street. Park Lane, on the east side is at an angle to West Street. This allowed room for a tapering extension to be constructed on that side, infilling the space between the Manor House and the frontage of the Lane. The front portion is one and a half stories high and under a slate lean-to roof. The northern half is a low two stories high and has a double pitched roof which gets wider from north to south. It has a lead valley gutter between it and the east wall of the Manor House. Internally it is an awkward plan form and has a very narrow winding stair to the attic of the south part and a steep rear stair to the two storey section.</p>

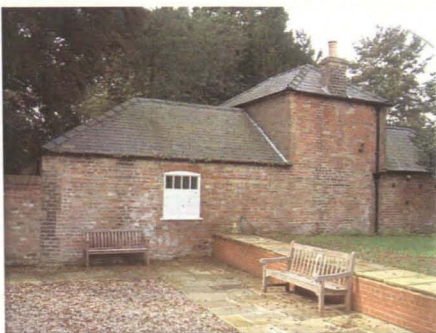
<p>The coach house from the garden</p>

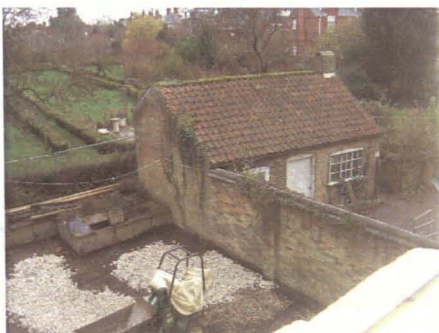
<p>The wash house seen from the first floor</p>
	<p>These buildings were added in the early nineteenth century and demonstrate the increased affluence of this period and the additional complexities of domestic life. Both are built in the local Farlesthorne buff brick. The coach house has been altered in the twentieth century but still retains much of its original character.</p>	
STATUS	Not listed in their own right but part of the curtilage of the principal listed building.	
SIGNIFICANCE	Moderate significance	
JUSTIFICATION	Typical additions of the period that form part of the character and history of the whole site	
POLICIES	D1, D2, D3, D4, RC1, RC2, RC3, RC5, RC6, RC8, AI1, AI3, M2, M3, M4, M5, M6, M7, M8	
SOURCES	Maps in Volume Two

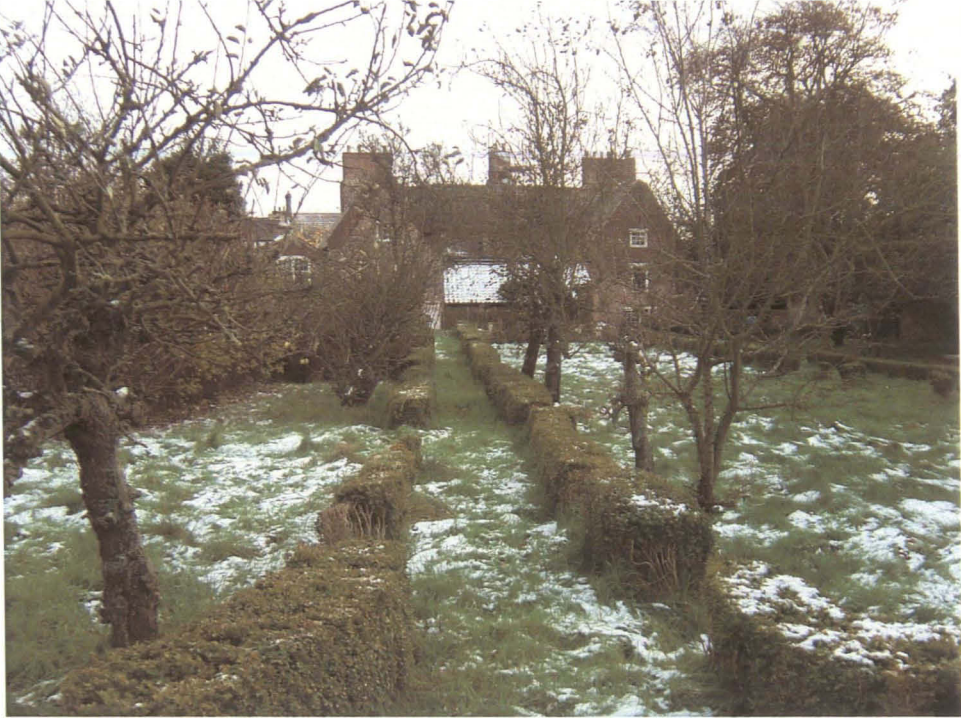
<p data-bbox="675 1129 1295 1158">Rear garden looking south towards the Manor House</p> <p data-bbox="505 1192 1471 1392">These comprise the rear garden area with its boundary wall, the front garden with its reconstructed front wall and railings and the western area between the house and the drain. The garden layout has box edgings around a plan form that is shown on the map of 1879. There may be evidence of earlier garden layouts and buried structures from earlier phases of building on the site. The front wall and railings were reconstructed in 2006 based on earlier photographic evidence.</p>
STATUS	Part of the listed building curtilage. In the Conservation Area. Some trees are covered by Tree Preservation Orders.
SIGNIFICANCE	Considerable Significance

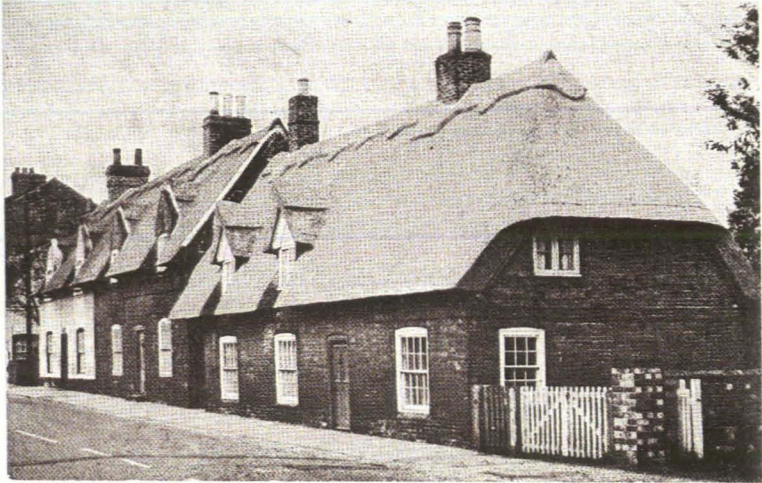
<p>Early twentieth century photograph of some of the thatched cottages that form part of the group of thatched buildings with the Manor House</p>

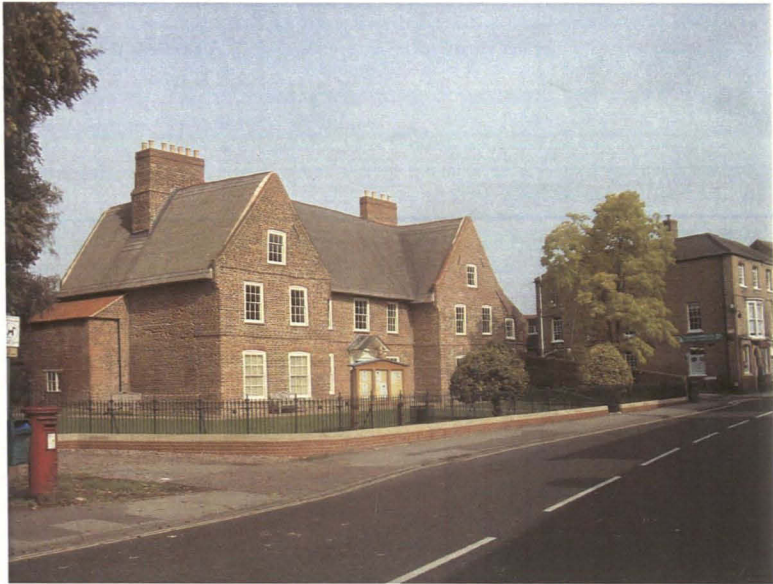
<p>The Manor House on West Street</p> <p>The wider setting is defined as both sides of West Street as far as the junction with Commercial Street, High Street, Park Lane to include the group of houses that back onto the site and the open land to the rear of the Manor House. It is on West Street that there is an important group of historic buildings with thatched roofs on both sides of the street.</p>
STATUS	The majority of this area is included in the Conservation Area apart from the area to the north of the site. Many buildings are listed grade II.
SIGNIFICANCE	Considerable significance
JUSTIFICATION	This wider context provides a positive contribution to the Alford manor House site and provides its historic, physical and visual context.
