Farming and Wildlife Advisory Group Project  
Archaeological Assessment  
South Hyde Farm, Mathon,  
Worcestershire, WR13 5PD

**Herefordshire Archaeology Report No. 262**  
**HSM 49269**

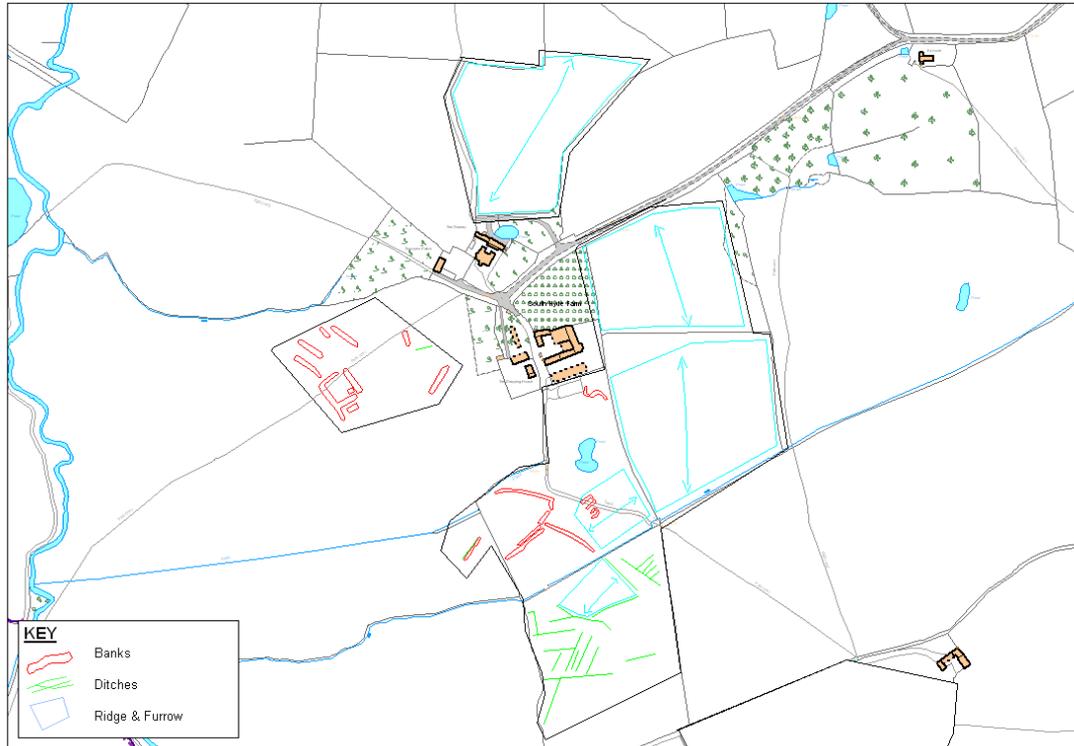
NMP Archaeological Features

Malvern Hills NMP was conducted in the late 1990s and recorded a number of sites on this landholding. These features were:

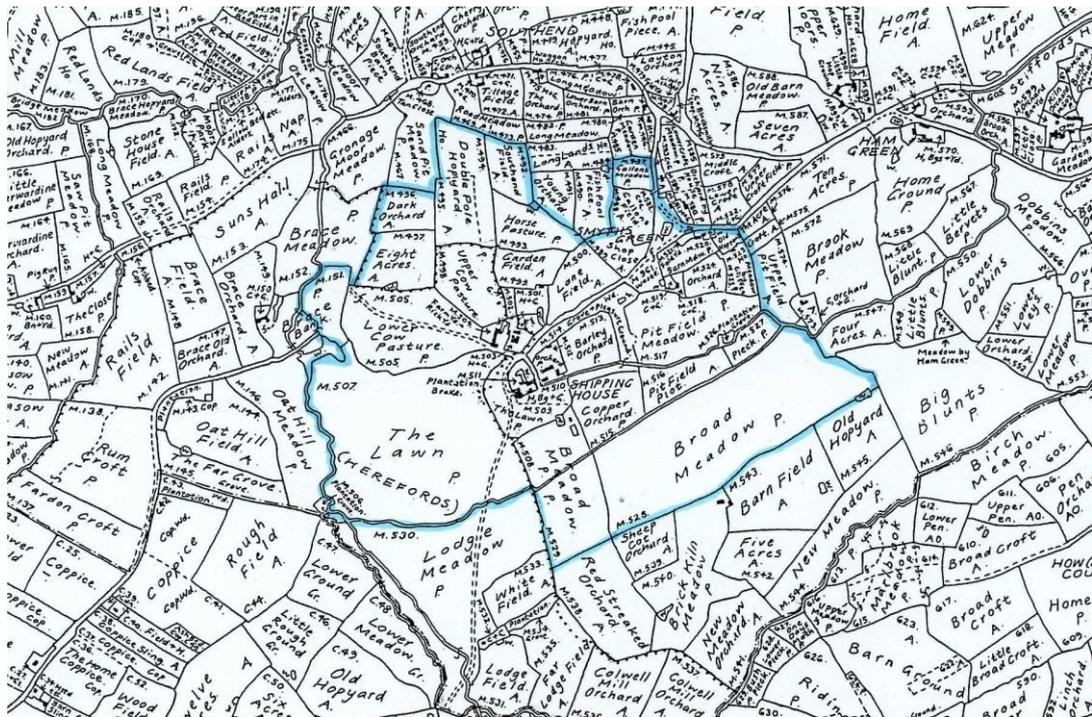
- ❖ Herefordshire 1086 Domesday map shows the county boundary running through the land holding of South Hyde, this is also seen on the 1840's Tithe Map for Mathon and Colwall and was noted as an earthwork on the ground during the site survey.
- ❖ 1840's Tithe map of Mathon and Colwall shows the location of the original Shipping House, formal gardens and pleasure grounds.

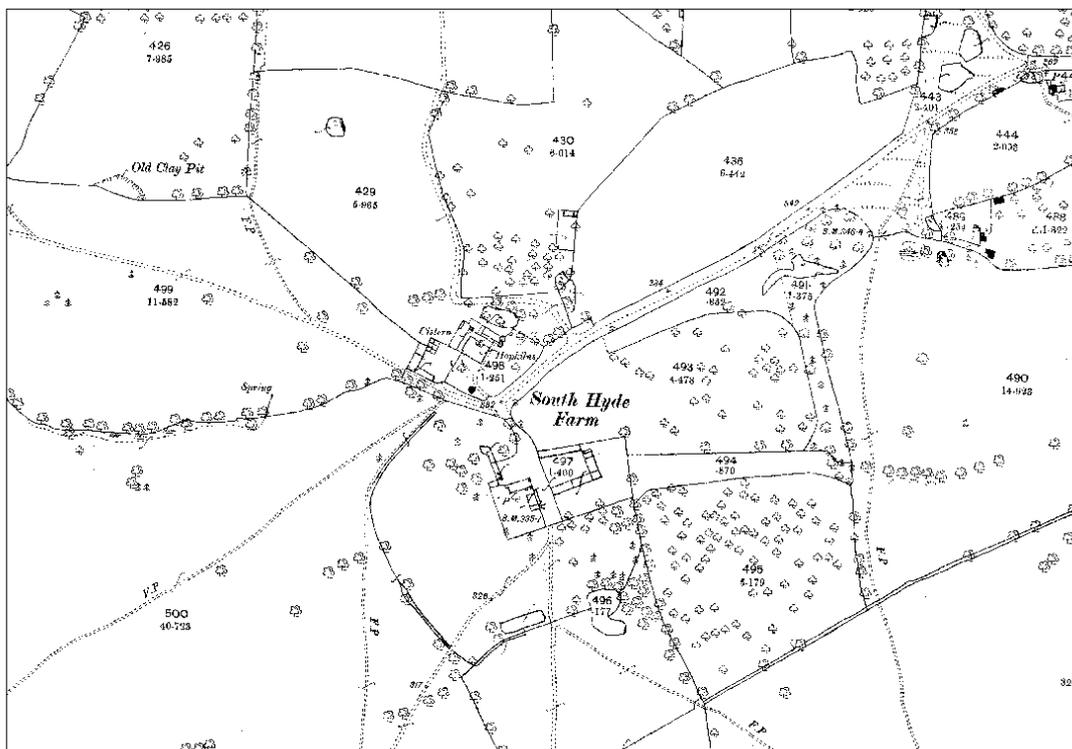
1890's 1<sup>st</sup> Edition OS Map

- ❖ 1890's 1<sup>st</sup> Edition Ordnance Survey map clearly shows the pleasure grounds previously associated with the Shipping House as a tree lined avenue with ornamental pool. The house is no longer standing by this date.

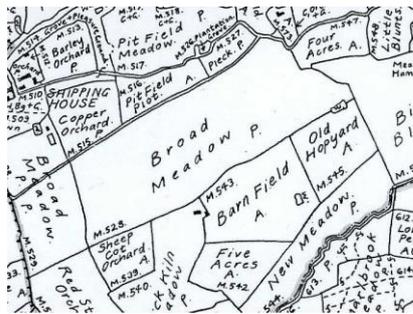
An area of prominent ridge and furrow is located north of the farm complex in what was previously named 'Garden field' and was once an orchard. The ridge and furrow pre dates the orchard as can be seen from the historic mapping where on the Tithe map of the 1840's the land is marked as arable; the 1<sup>st</sup> Edition 1890 showing the land under orchard. The date of the ridge and furrow is impossible to determine but it is likely to date from the Post Medieval period as the ridge size would indicate a later, smaller horse drawn technique.

**Description:** Prominent area of ridge and furrow measuring approximately 4-5m wide between ridges and occupying the northern part of the field.

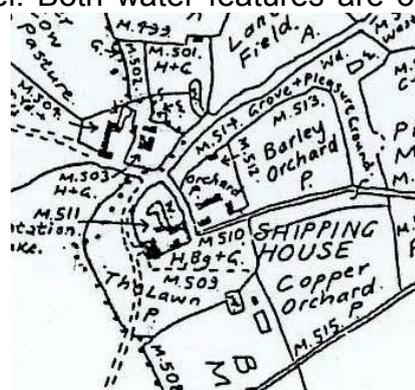
The historic mapping clearly shows that there was a deliberate move to create a formal designed landscape associated with the Shipping House. Features recorded during the field survey combine to recreate the ground plan of the Shipping House and its ornamental landscape. The earthworks recorded include a stepped building platform where the house would have once stood with surrounding landscape features such as the remnants of a Ha-ha for animal management, a pond and water channel. Both water features are of probable ornamental type and are located within a field previously called 'The Lawns', indicating an attempt at formal grounds. These features were possibly later used as water storage for animal management. Further to the north east of the building platforms is an area marked as pleasure grounds on the 1840's Tithe map; and is also still visible on the 1<sup>st</sup> Edition OS map of 1890. There is little evidence left on the ground but mapping indicates that there was a tree lined circular route promenade, a grove and wilderness area with ornamental pool.
