Cow Tag **206** Function Code **P13-1 C**

Brief Description: [timber element, p/s, condition, fragments]  
Aft Scarf Fragment of P13-1 - modern cut for dendro?

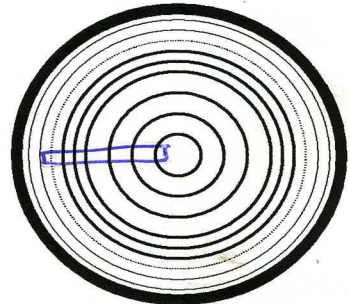
Wood Science: [rings, ARW, knots, sapwood, conversion]  
Radial, pith beyond upper edge  
C110H+SS. ARW = 197 / 115  
SS  
115 Total Rings Sapwood 5

Recommended action: [samples, additional photos, moulding, queries and problems]  
Check for dendro.
