DB29/2/08

Cow Tag 342	Function Code S31.325
----------------	--------------------------

Brief Description: [timber element, p/s, condition, fragments]
AFT END OF PLANK

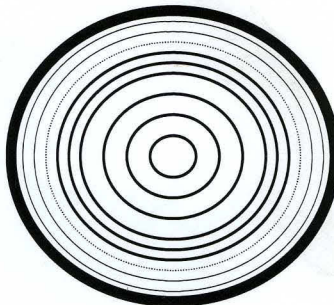
LARGE CRACK OB, PREV. COVERED BY TINGLE 344
DOUBLE TREENAILS; ALSO SOME TREENAILS LARGER THAN NORMAL? VAGUE TYPE 3
ALSO VERTICAL LINES INSCRIBED AT END OF CRACKS
1/2 soft surface + remnants of unscribed line
Type 1 next to middle treenail

- didn't see any ins. lines during recording - MS.

Radius ~ 100H. ARW = 2.15mm
P.H. beyond upper edge.

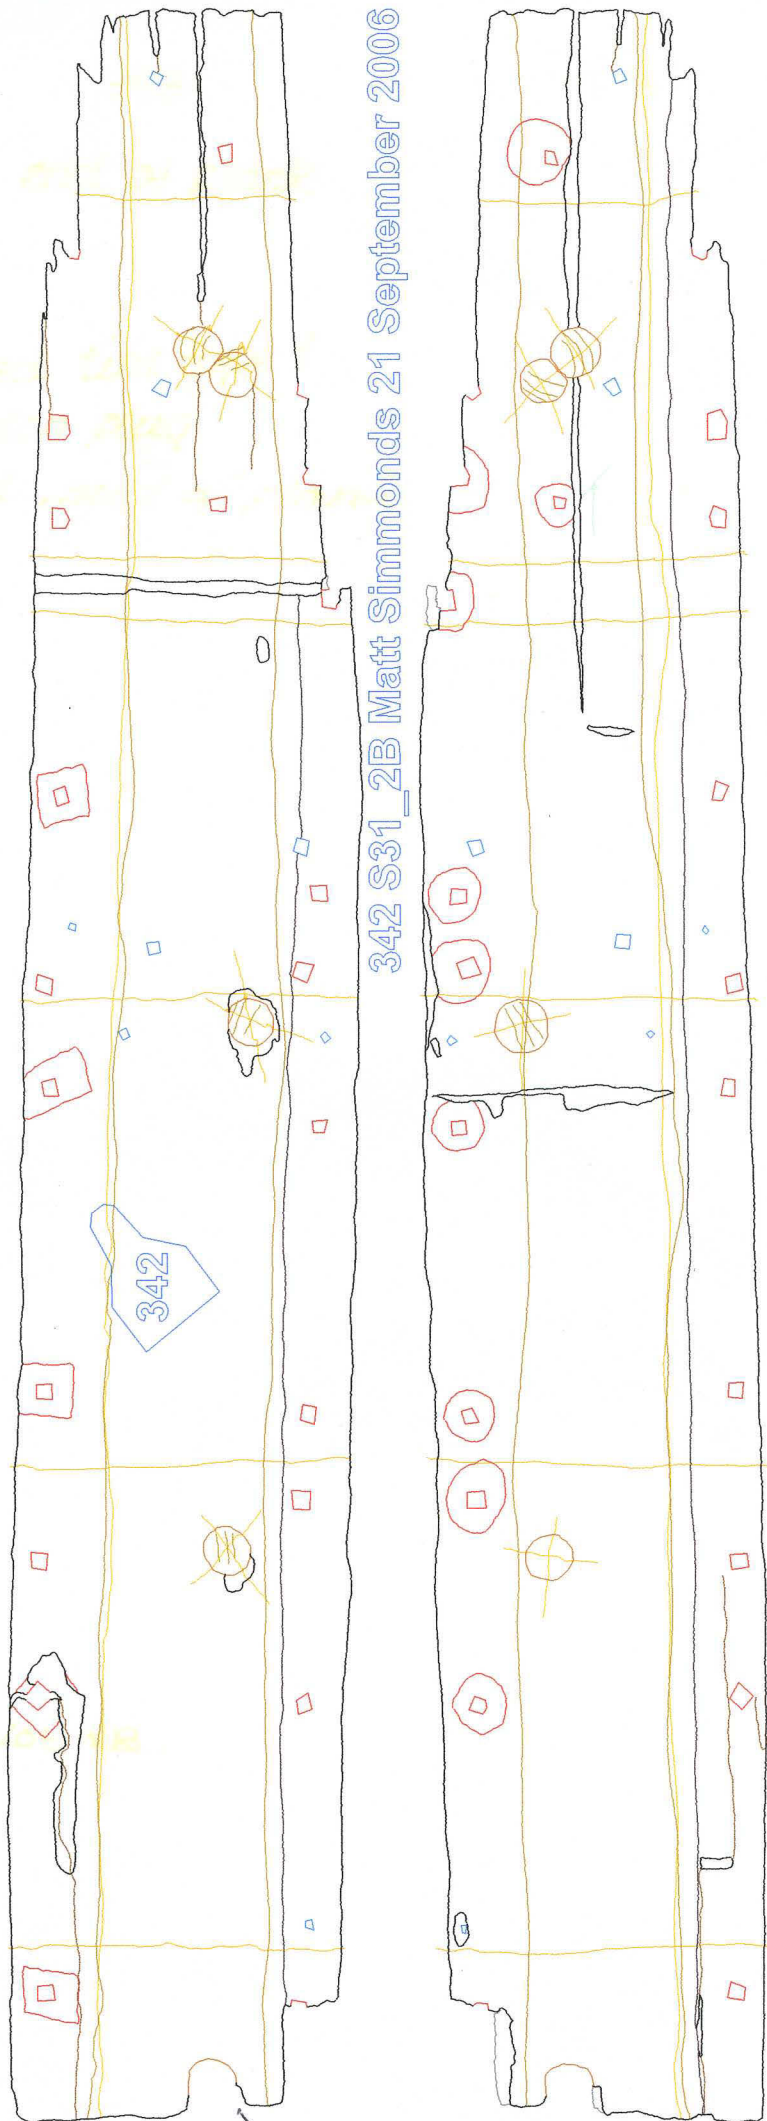
342 S31_2B Matt Simmonds 21 September 2006

cut in anticipation
