Cow Tag 344 Function Code 331.2-323
TINBLE 342-343

Brief Description: [timber element, p/s, condition, fragments]
OB Tangle

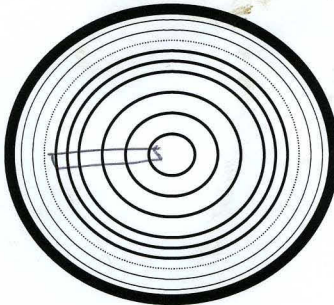
Wood Science: [rings, ARW, knots, sapwood, conversion]

Radial. Pith beyond upper edge
~90H ARW = 170/90

Recommended action: [samples, additional photos, moulding, queries and problems]
DEND.
LBB 26/10/07
--> Relec.
