Cow Tag **453** Function Code **Misc Timber - Treenail**

Brief Description: [timber element, p/s, condition, fragments]
Near complete treenail **Scan 28/6/10**

TREENAIL

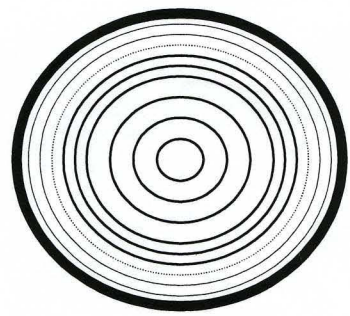
Notable Features: [tool marks, scribed lines, decoration, repairs] POINTS TO LOOK OUT FOR WHEN RECORDING
 27mm in diameter at head. 350mm in length. ~~Appears~~ to be wedged at the head (not certainly)
 Circular in section. 105mm from the end the treenail is worked flat on two surfaces. Tool marks suggest it was worked down-wards toward end of treenail.
 Head doesn't appear to be faceted. Some concretion exists on head.

Oak
