Cow Tag 461		Function Code S15.1
Brief Description: [timber element, p/s, condition, fragments] GOOD CONDITION PLANK, TRUNCATED AT FORE END		
Notable Features: [tool marks, scribed lines, decoration, repairs] POINTS TO LOOK OUT FOR WHEN RECORDING ufos IMPRESSIONS: - LINES IMMEDIATELY FORE OF V OF COWTAG - = "V" Type 1 IB. Clamp impression IB. Aftboard

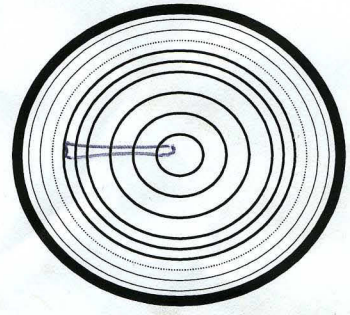
Wood Science: [rings, ARW, knots, sapwood, conversion] Some knots + tears. Radial 85H at aftboard. Pith insertion.

Recommended action: [samples, additional photos, moulding, queries and problems] forward end is cut in antiquity		
Cleaned: MS/VT 12/06/06	Recorded: DV 14/6/6	Photos:
Checked: [corrections needed]		Initials & Date: NN 14/6/6
Corrections Done [desktop, Faro Arm?]:		Initials & Date:

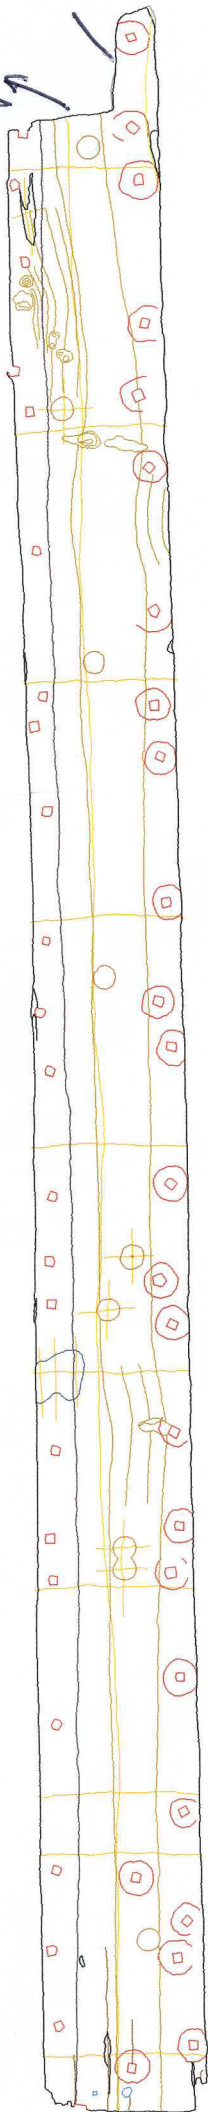
481 S15_1 Yardent Worst 14 June 2006

cut Est.
 out of party
 Tom
