Cow Tag 470		Function Code S 11.4	
Brief Description: [timber element, p/s, condition, fragments] GOOD CONDITION PLANK			
Notable Features: [tool marks, scribed lines, decoration, repairs] POINTS TO LOOK OUT FOR WHEN RECORDING ufos INBOARD:-

470 S11_4 Yardeni Vorst 13 June 2006

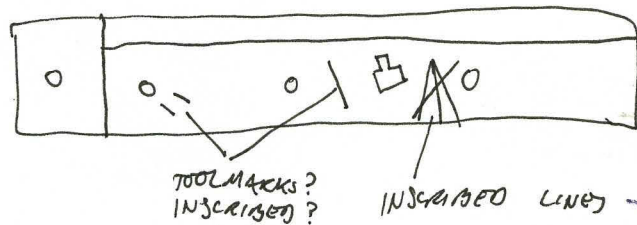
<p>TOOL MARKS? INSCRIBED? INSCRIBED LINES</p> <p>When aboard upper edge between frames Numerous wooden nails along lower edge. Type 1.</p> OUTBOARD:-

Recommended action: [samples, additional photos, moulding, queries and problems] inscribed lines inboard: one type 2 line near cow tackle + type 2 lines outboard; don't think they are tool mark - lines - wooden nail with clear visible grain & shape on outboard, forward end. <p>photo</p>			
Cleaned: 07/06/06	3J KMN MS LB	Recorded: 13-6-06 D.V.	Photos:
Checked: [corrections needed] ✓		Initials & Date: NW 14/6/06.

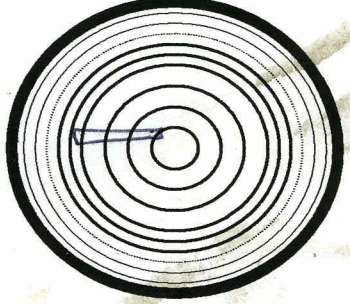
<p>TOOL MARKS?</p>			
Wood Science: [rings, ARW, knots, sapwood, conversion] Off radial at aft scarf, c 55H, Pith uncertain ARW = 235/55.

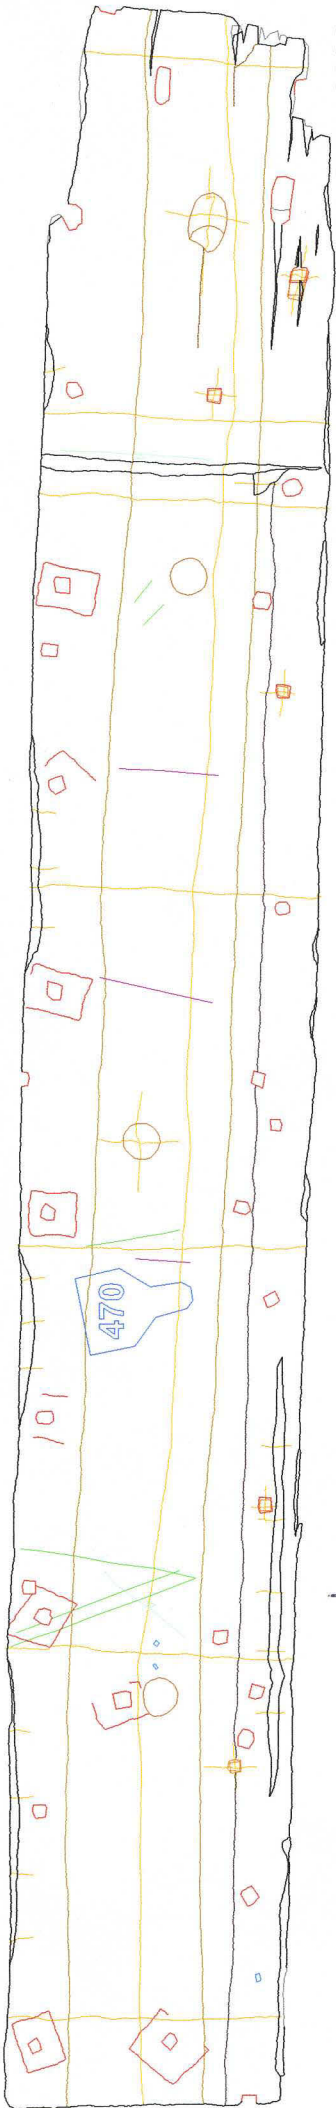
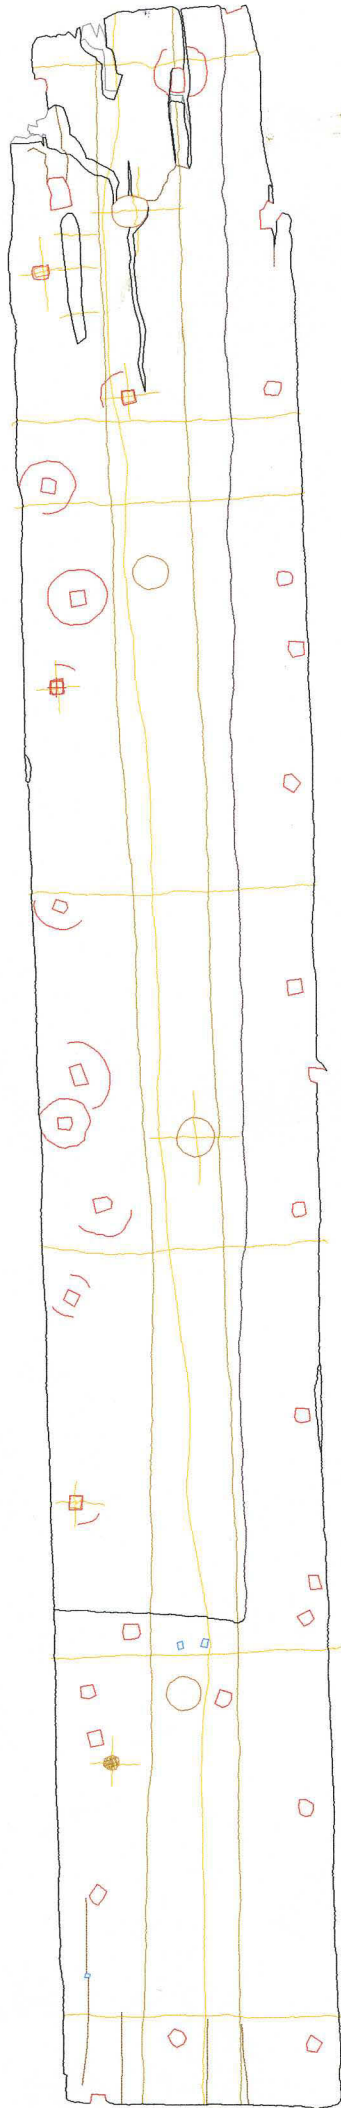
type 1
