Cow Tag	472	Function Code	510-1
---------	-----	---------------	-------

Brief Description: [timber element, p/s, condition, fragments]  
 Starboard Plank - Damaged on forward end

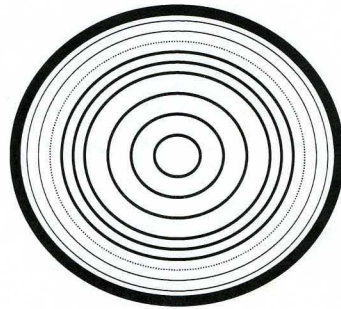
Wood Science: [rings, ARW, knots, sapwood, conversion]  
 c100H Radial. P.H. beyond lower edge on growth trail.  
 ARW = 185/100

Recommended action: [samples, additional photos, moulding, queries and problems]  
 Unknown Recorder - Recorded approximately on 28 April 2005, possibly by TNJ?  
 Probably needs re-recording as look like Degees curves.
