Cow Tag 504 504	Function Code S12.2	
Brief Description: [timber element, p/s, condition, fragments] GOOD CONDITION - LARGE NUMBER OF CRACKS		
Notable Features: [tool marks, scribed lines, decoration, repairs] POINTS TO LOOK OUT FOR WHEN RECORDING ufos INBOARD:- OUTBOARD:- POSSIBLE INSCRIBED DIAMOND (V. FANT!) C. 60cm FROM AFT END, AT TERMINUS OF LARGE CRACK ALONG MIDDLE OF BOARD, WEDGE IN FIRST TRUNNEL FROM AFT END, TOOL MARKS (RIDGES) ON LOWER EDGE OF PLANK, BETWEEN 3RD + 4th TRUNNEL FROM AFT END,		
Wood Science: [rings, ARW, knots, sapwood, conversion] - Diamonds 57H + 2S at aft scarf radial Pith beyond lower edge upper edge ARW = 185 / 59

504 S12_2 Yardeni Veret 6 June 2006

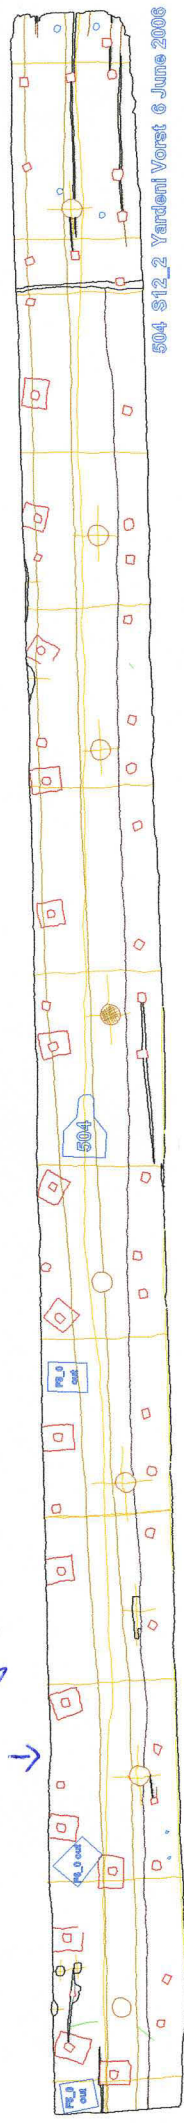
missing number
↓

Recommended action: [samples, additional photos, moulding, queries and problems] - diamonds & inscribed lines on outboard. - nice big additional nubs with nailheads at aft end outboard photo Missing nail hole to add		
Cleaned: BJ 1/06/06	Recorded: D.V 6/6/06	Photos:

Checked: [corrections needed] ✓ Missing nail hole - see photo pane	Initials & Date: NM 21/1/6	
Corrections Done [desktop, Faro Arm?]:	Initials & Date:
