508 S27\_3A Yardeni Vorst 24 August 2006

Brief Description: [timber element, p/s, condition, fragments]

FOCUSSED SECTION of 527.3 - see also 1732

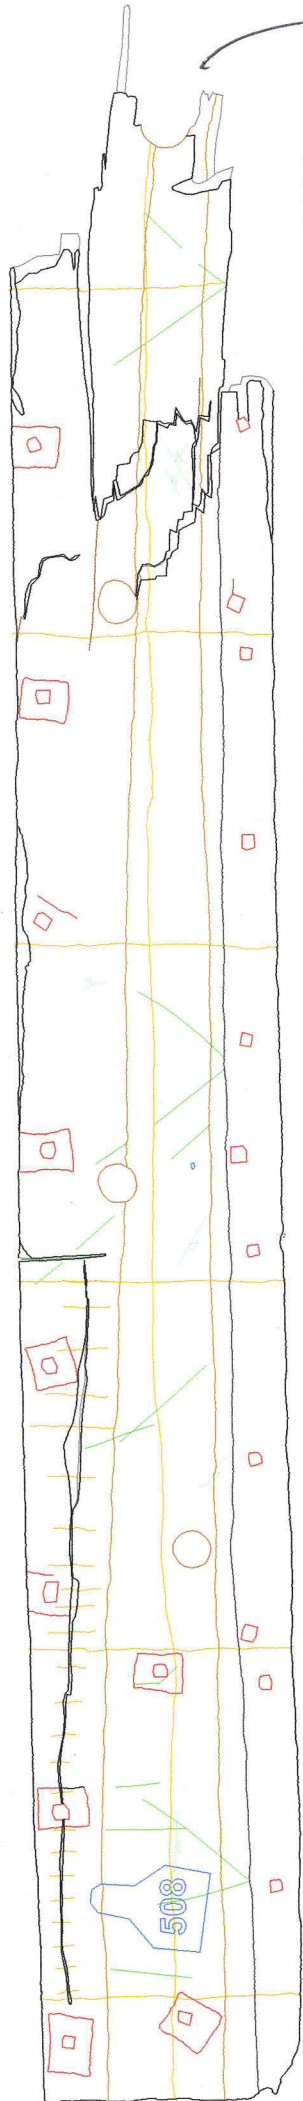
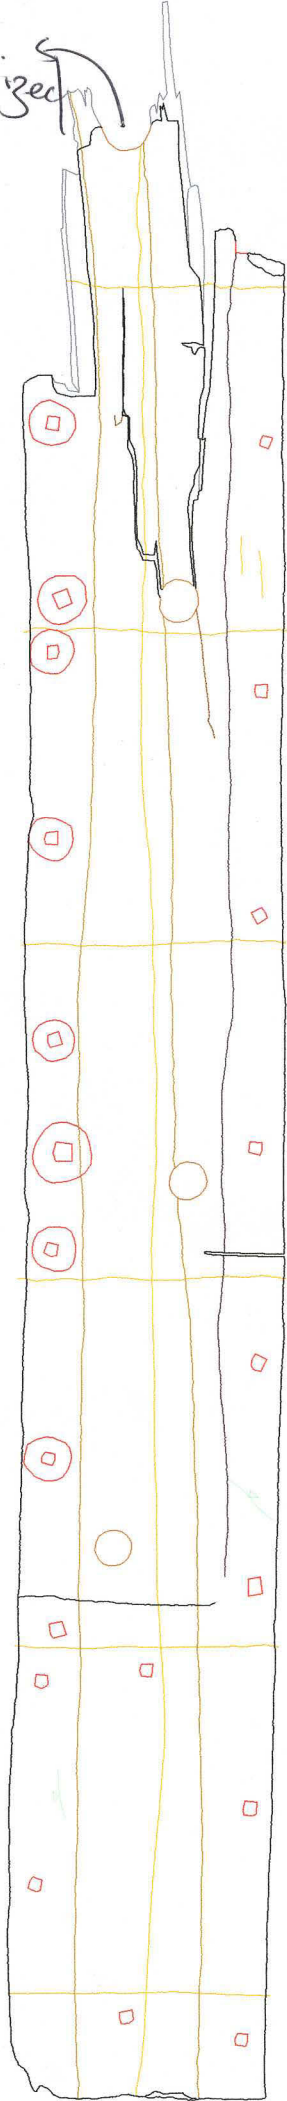
i.b. - 4 x T.1 lines along length  
3 x vertical parallel lines at far end,  
either side of convex

O.b. - Surface v. soft

inboard: - upper rim of land sampled = (no. 2555) looks like plant material  
- large keener hole aft end ?!

Just off radial - Diff to count.  
70W??
