Cow Tag 519 Function Code ~~SIA~~

519 S14_7 Monika Maleszka-Ritchie 19 June 2006

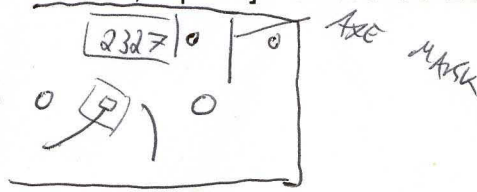
Brief Description: [timber element, p/s, condition, fragments]
GOOD CONDITION PLANK, Complete
Numerous interesting features

Notable Features: [tool marks, scribed lines, decoration, repairs] POINTS TO LOOK OUT FOR WHEN RECORDING ufos
INBOARD: - INSCRIBED LINES
BELOW SAMPLE 2327
STEP ON LAND ADJACENT TO COWTAG
INSCRIBED LINE C.O.D.5m AFT OF COWTAG, CURVES ALONG WIDTH OF PLANK.
outboard - dipsles on all transverse
Type 2 (4 lines) inscribed lines not plank
iron nail - possible good for sample - couldn't remove. t.

Recommended action: [samples, additional photos, moulding, queries and problems]
Photos as indicated
Then metallurgical sample of nail.

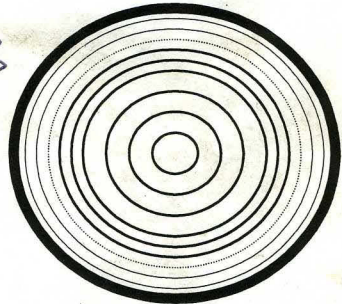
Wood Science: [rings, ARW, knots, sapwood, conversion]
2 major knots on plank, large tears
Pith beyond lower edge? - one on aft scarf
Radial
c60 H ARW = 205/60
