**THE CHURCH OF ST MICHAEL AND ST LAWRENCE  
FEWSTON  
NORTH YORKSHIRE**

**ARCHAEOLOGICAL DESK-BASED ASSESSMENT**

JB Archaeological Services

September 2008

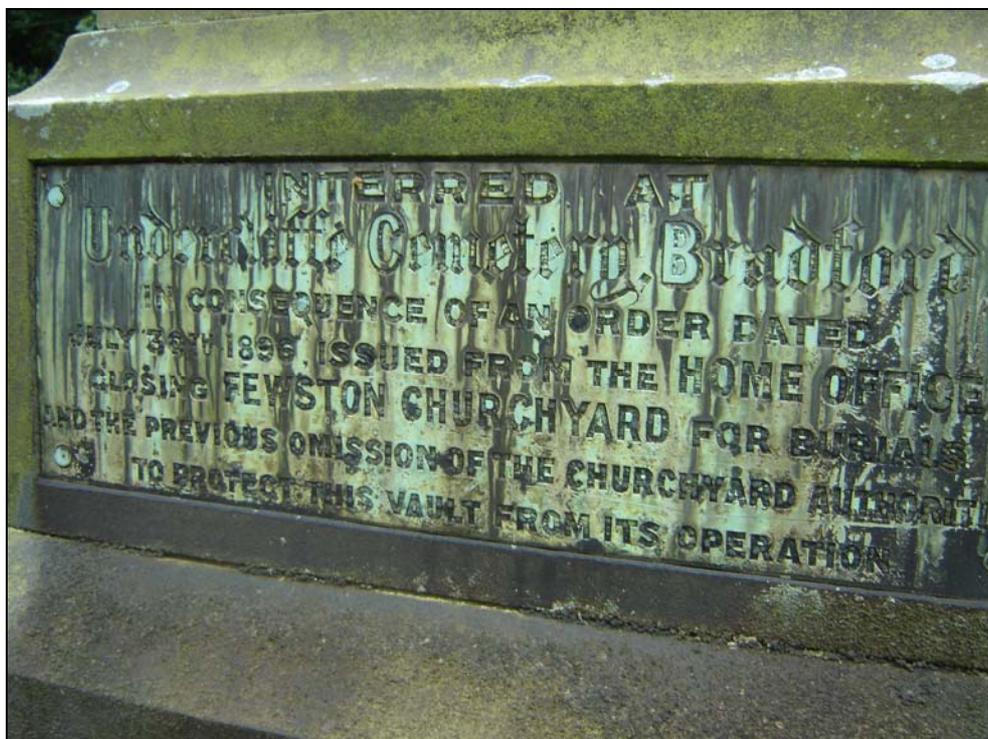
graveyard was closed in 1896 (Plate 1). In association with the burials there are a wide range of size and style of grave markers, mostly dating from the 19<sup>th</sup> century (Plate 2).

Plate 1. Plaque noting closure of graveyard.

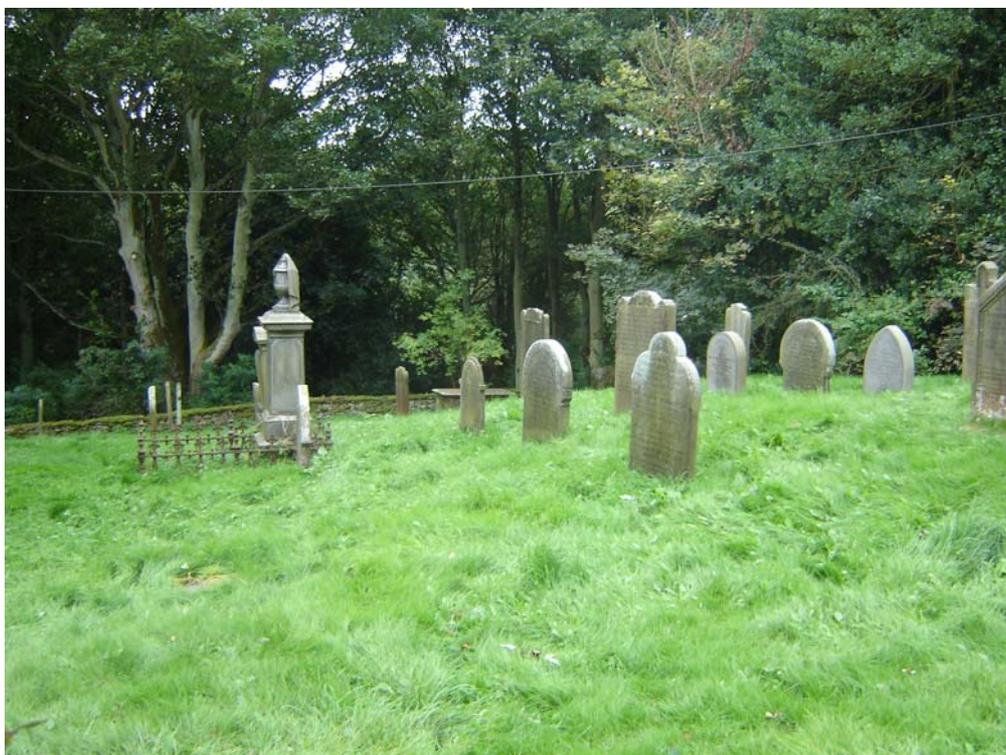
Plate 2. Proposed area showing range of grave markers. Looking south-west.

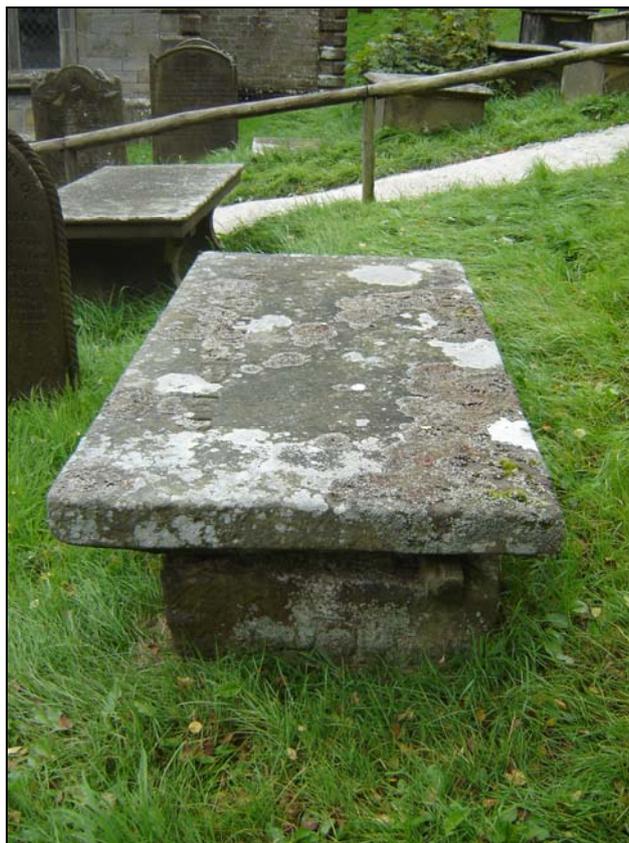
- 4.16 The graveyard of the church contains two Listed Buildings, a chest tomb of 17<sup>th</sup> century date (Site 30, Plate 3) and an 18<sup>th</sup> century sundial (Site 31, Plate 4) (see Appendix I for details). The 17<sup>th</sup> century tomb appears to be the only survival from that era and shows that the cemetery has been heavily reused over at least 300 years and almost undoubtedly since its first inception. This means that there is a high likelihood of encountering earlier graves which have been re-cut by later burials across most if not all of the graveyard. Work in other cemeteries has shown that the density of burials in long established graveyards can be between 100 and 700 graves per 100m<sup>2</sup> (English Heritage, 2005, 37), and potentially here these could date back to the 14<sup>th</sup> century church or earlier.

Plate 3. 17<sup>th</sup> Century chest tomb (Grade II Listed Building), Looking west.

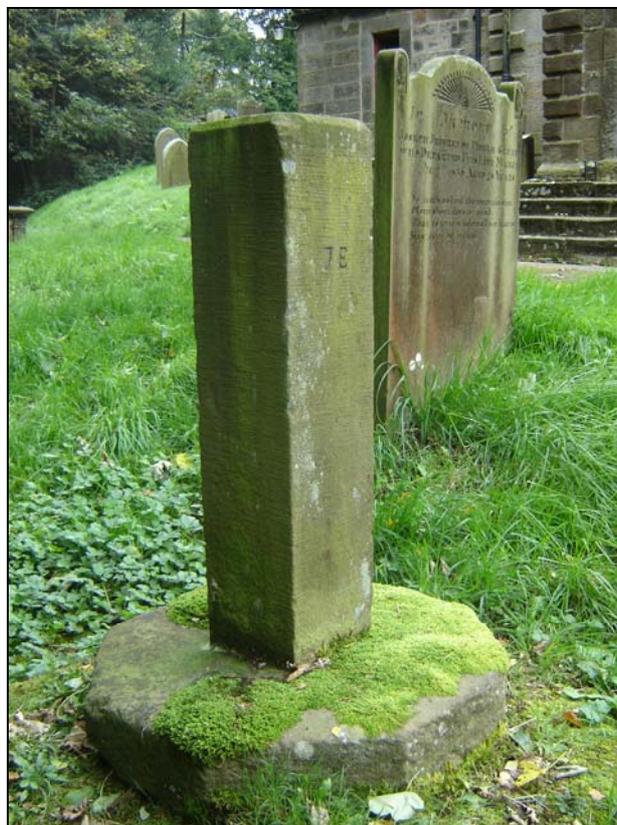
Plate 4. 17<sup>th</sup> Sundial (Grade II Listed Building). Looking north-west

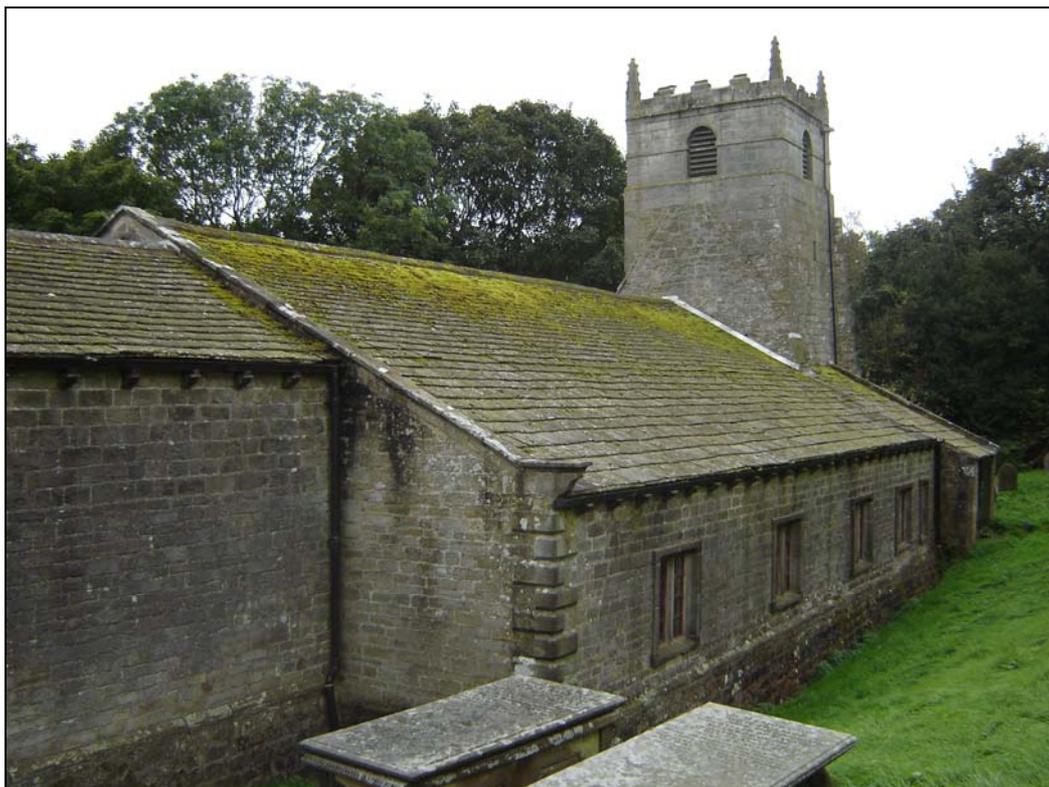
- 5.2 An examination of the location of the church showed that it had been built on a terrace which had been cut into the slope of the hillside (Plate 5). Its location probably took advantage of a naturally slightly more level area of ground which was then enhanced to create the platform seen today. The effort involved in both levelling the site and then building the church would seem to indicate that the structure was of some significance and importance to the community and that once the site had been created it would have been reused as the need arose – for instance the rebuilding after the 1696 fire – rather than starting again at a new location.

Plate 5. Church cut into hillside on its terrace. Looking south-west.

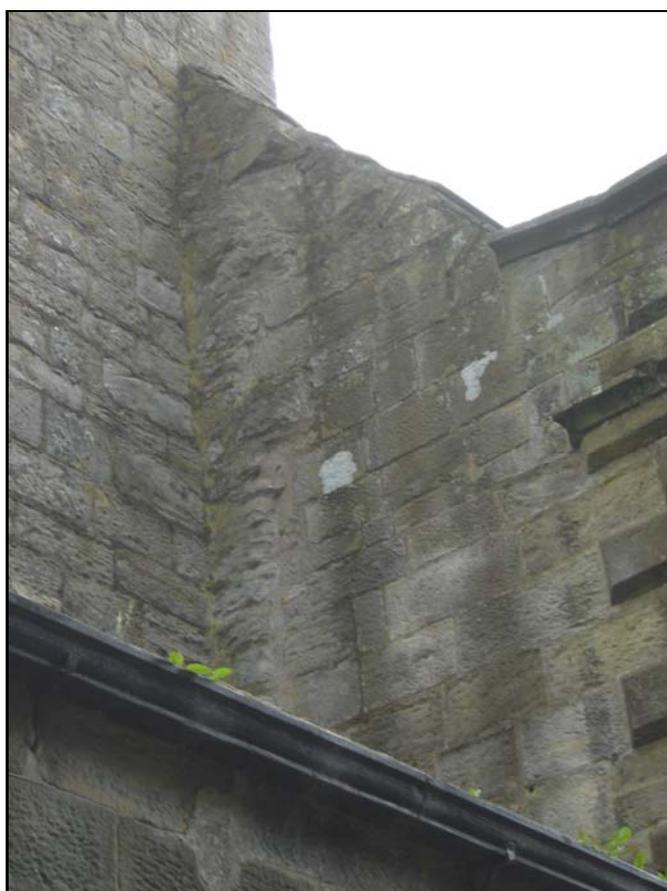
- 5.3 Several features survive on the church tower which show the presence of at least part of the earlier medieval building. On the southern side of the tower some of the earlier, less well dressed stone work could be seen where it had been joined to the 17<sup>th</sup> century rebuild (Plate 6). Also on the tower but this time on its eastern side, the scar of the line of the earlier thatch roof could be clearly seen (Plates 7 & 8).

Plate 6. South side of tower showing join between 14<sup>th</sup> and 17<sup>th</sup> century stonework.

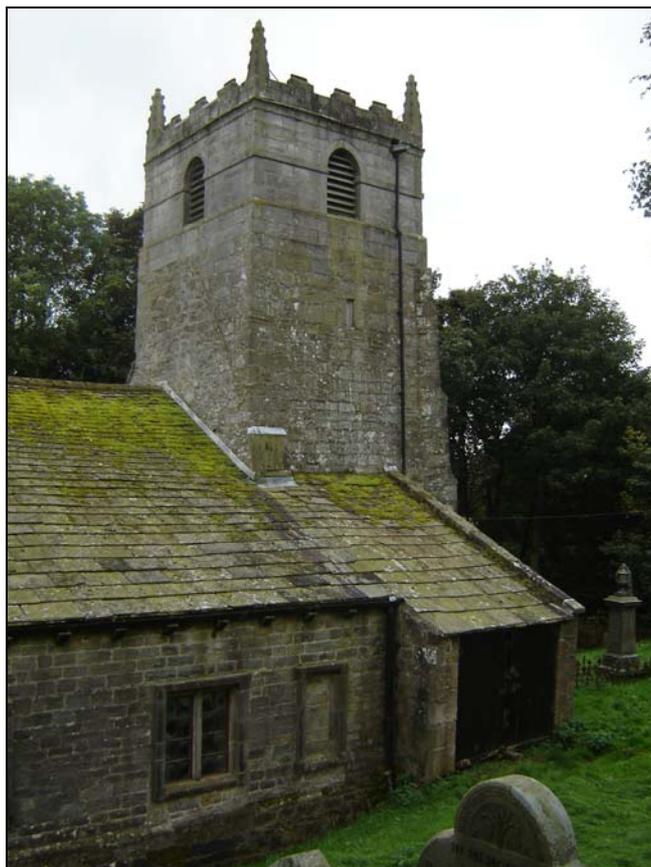
Plate 7. Earlier roofline on east side of the tower and C17<sup>th</sup> addition to top of tower.

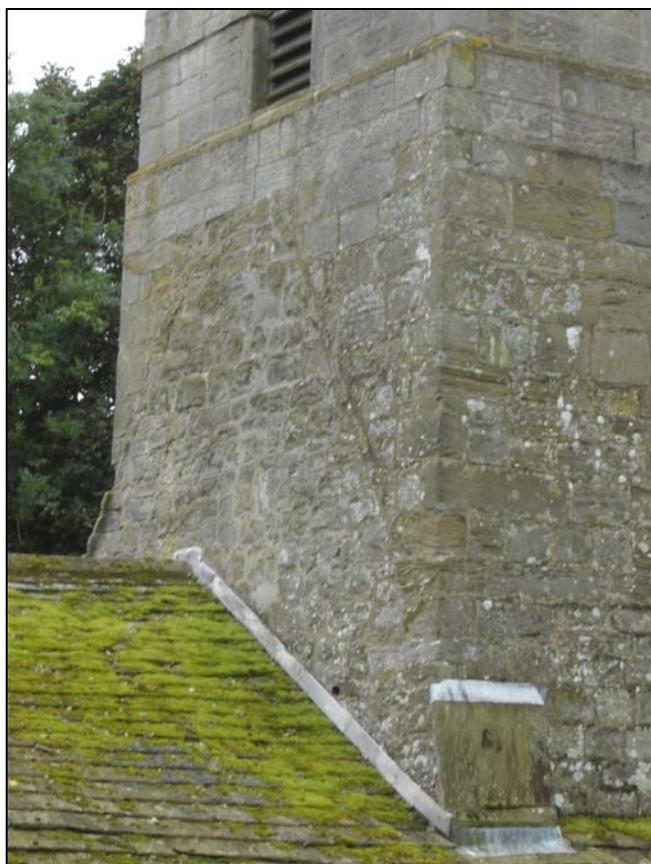
Plate 8. Scar from earlier thatch roof on side of tower.

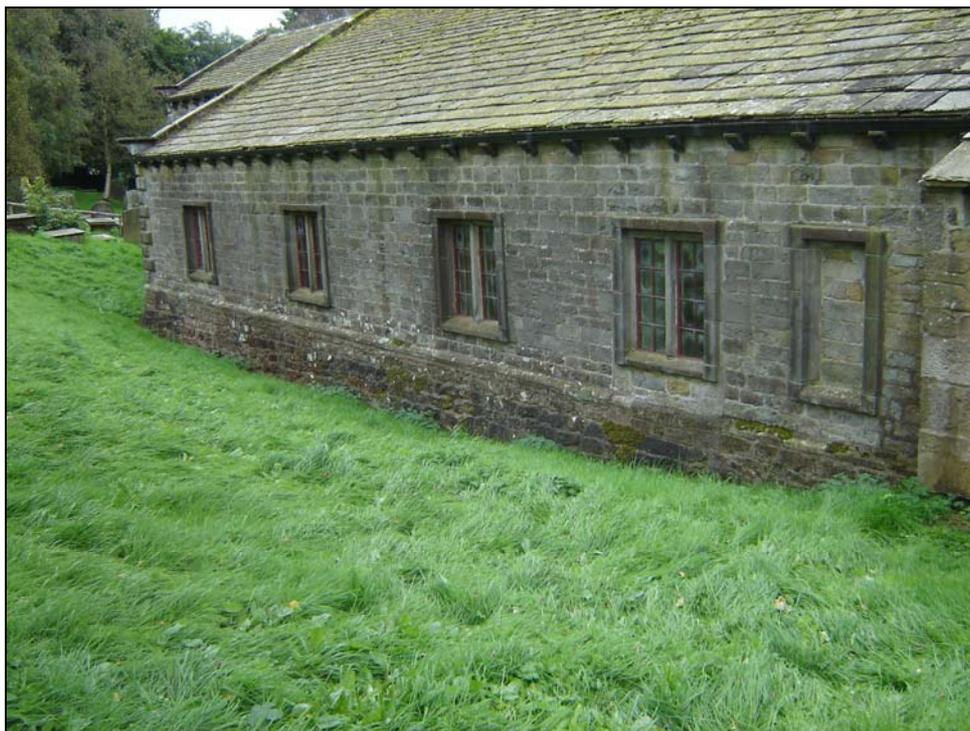
- 5.4 A further possible survival of the earlier church could be the less well dressed stone work visible below the sills of the windows on the northern side of the building (Plate 9). It is possible that any surviving stone work from the fire was reused with the later building erected on top. It is equally possible though that as the northern side was less visible, rougher cheaper stone was used.

- 5.5 Whilst both of these features may well relate to the earlier, medieval, phase of the church they could equally well relate to various other stages of repair and rebuild. The fact that further work had to be carried out in the 19<sup>th</sup> century, presumably on the 17<sup>th</sup> century rebuild, is attested to in surviving documentary sources (Appendix II).

Plate 9. North side of the church showing possible earlier stonework below windows.

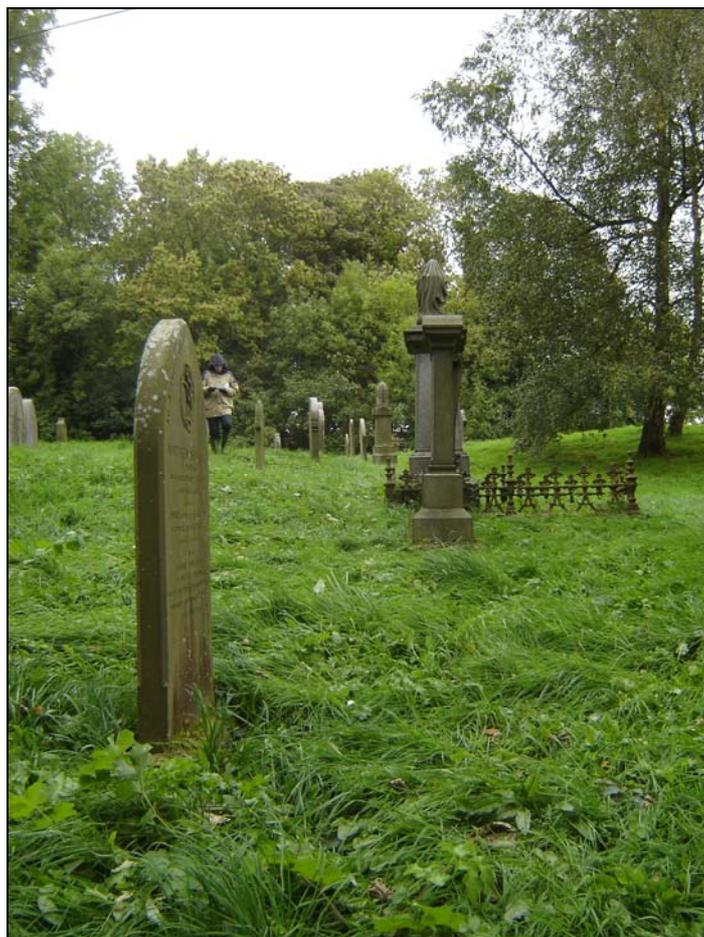
- 5.8 Observation of the topography of the site noted that towards the northern end of the site there was a small area of more level ground with no obvious grave markers (Plate 10). Given that there were burials on the more sloping ground but not here there are three possible explanations for the lack of grave stones. Firstly that there are burials here and the gravestones have been removed and the more level ground is due to the settling of the graves. Secondly that there are burials here but in a vault of some form, a situation which is alluded to by the memorial located to the north of this area (Plate 11). Thirdly that there was some form of structure or feature here (a building for example) that meant that the area was not available for burials.

Plate 10. Area of level ground between iron railings and tree in distance.

- 8.1 Archaeological trial trenching/test pitting targeting the areas between known graves where on the current draft design there will be the need for foundations, services or ground reduction.

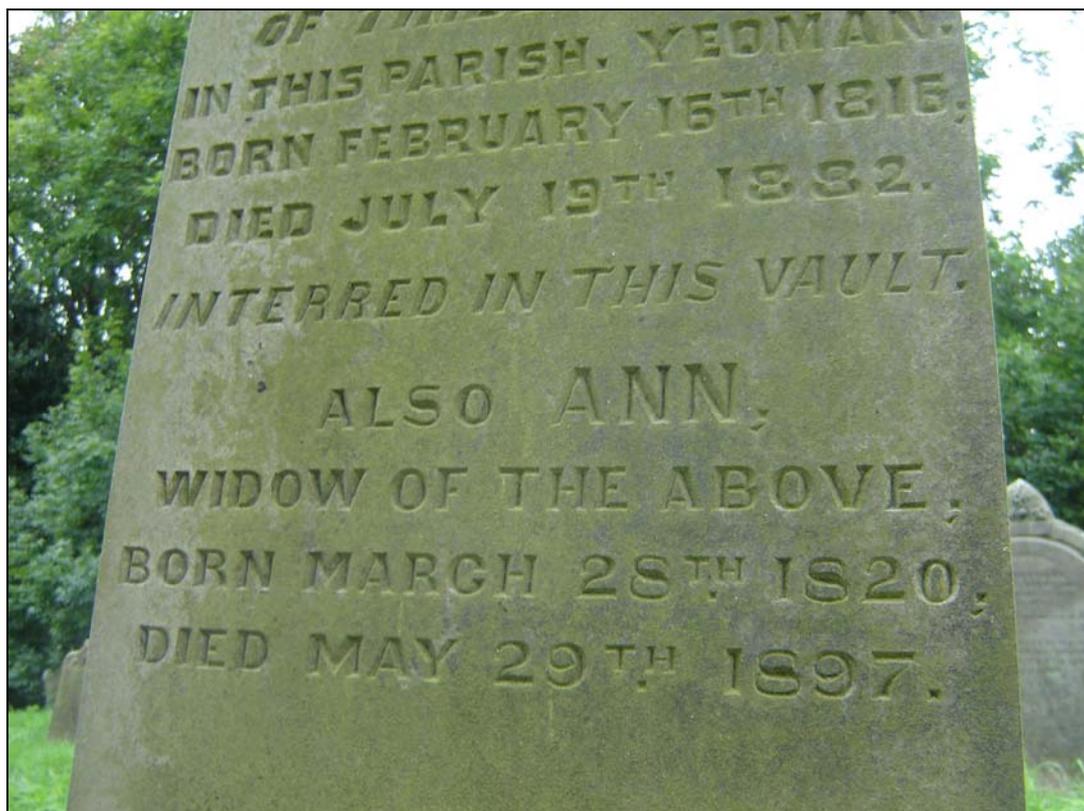
Plate 11. Reference to possible vault in area of level ground.

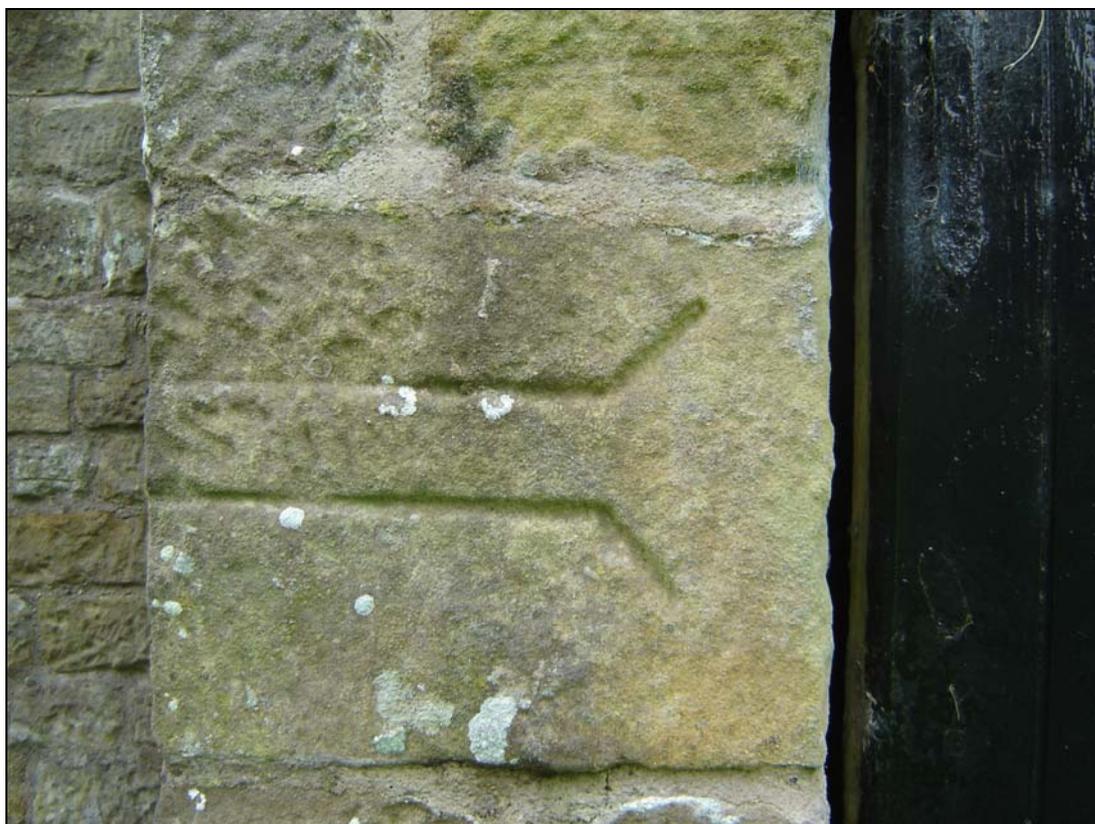
- 5.10 On a small single storey extension to the northern side of the tower a re-used stone with a Y shaped design was noted (Plate 12). The origin and meaning/significance of this is uncertain but it suggests that there are other possible buried remains around which have been subject to some reuse.

Plate 12. Y shaped marking on reused stone on small extension north side of tower.
