PROCEEDINGS  
OF THE  
CAMBRIDGE ANTIQUARIAN  
SOCIETY

## DOVECOTES OF SOUTH CAMBRIDGESHIRE

E. M. DAVIS

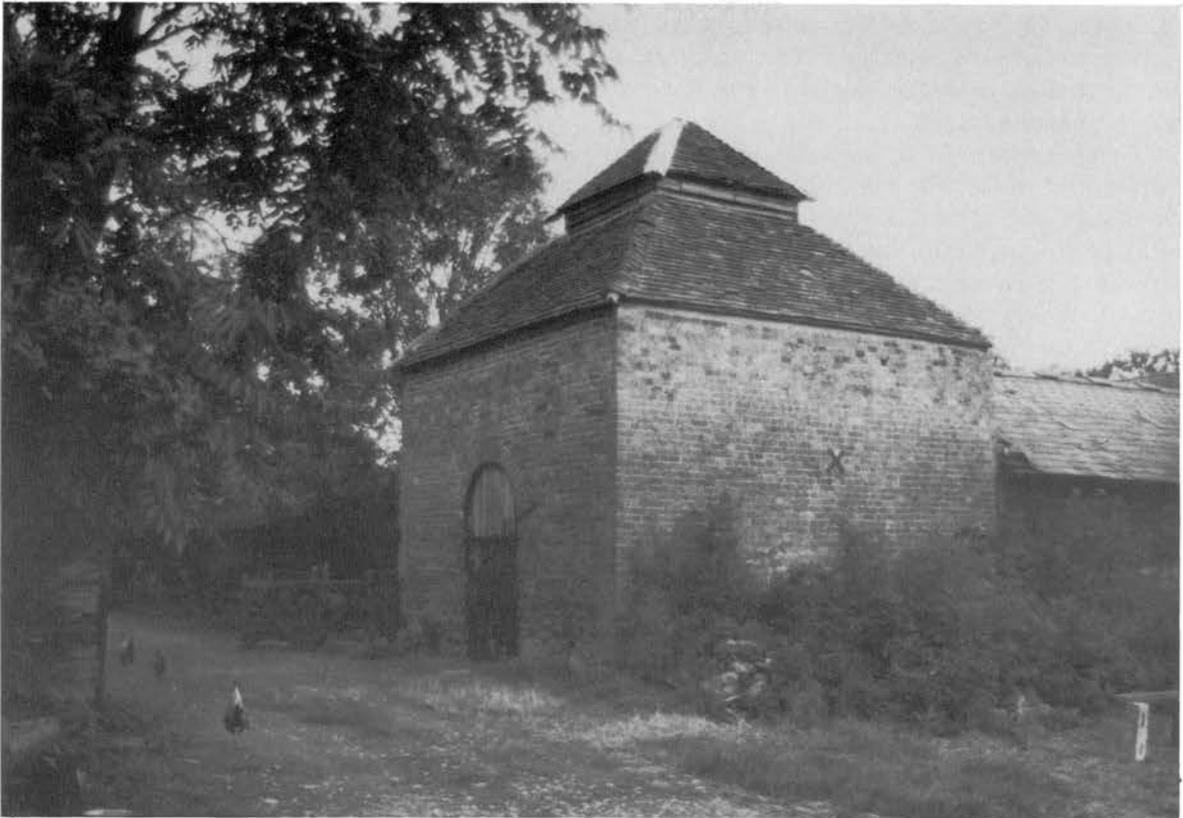
Fig 1. Clear Farm, South End, Bassingbourn-cum-Kneesworth.

1800. Now situated with later 19th century farm buildings of light red brick with a pyramidal plain tiled roof and large lantern. Single storeyed and square planned. The main entrance had a boarded door with an iron grill shaped to the round headed brick arch; a round window in the rear wall possibly also had a grill. The nesting boxes have been removed, they may have been of clay bat; the flight platform and chute can still be seen.

The single entrance doorway usually had a boarded door with a circular cat-hole at the bottom; the windows are mostly covered by lathes though the circular windows at Bassingbourn (Fig. 1) are an unusual 'Georgian' feature.

Some of the best examples of the late seventeenth and eighteenth centuries' brick, dark red and plum coloured, and coursed in various bonds, have chamfered plinths, plat bands and decorated eaves cornices. There are eight examples and the most outstanding is Haslingfield, No. 29 High Street (Fig. 7); Barton and Foxton are both examples built of local field bricks. Bassingbourn (Fig. 1) and Shudy Camps (Fig. 31) are later red brick buildings.

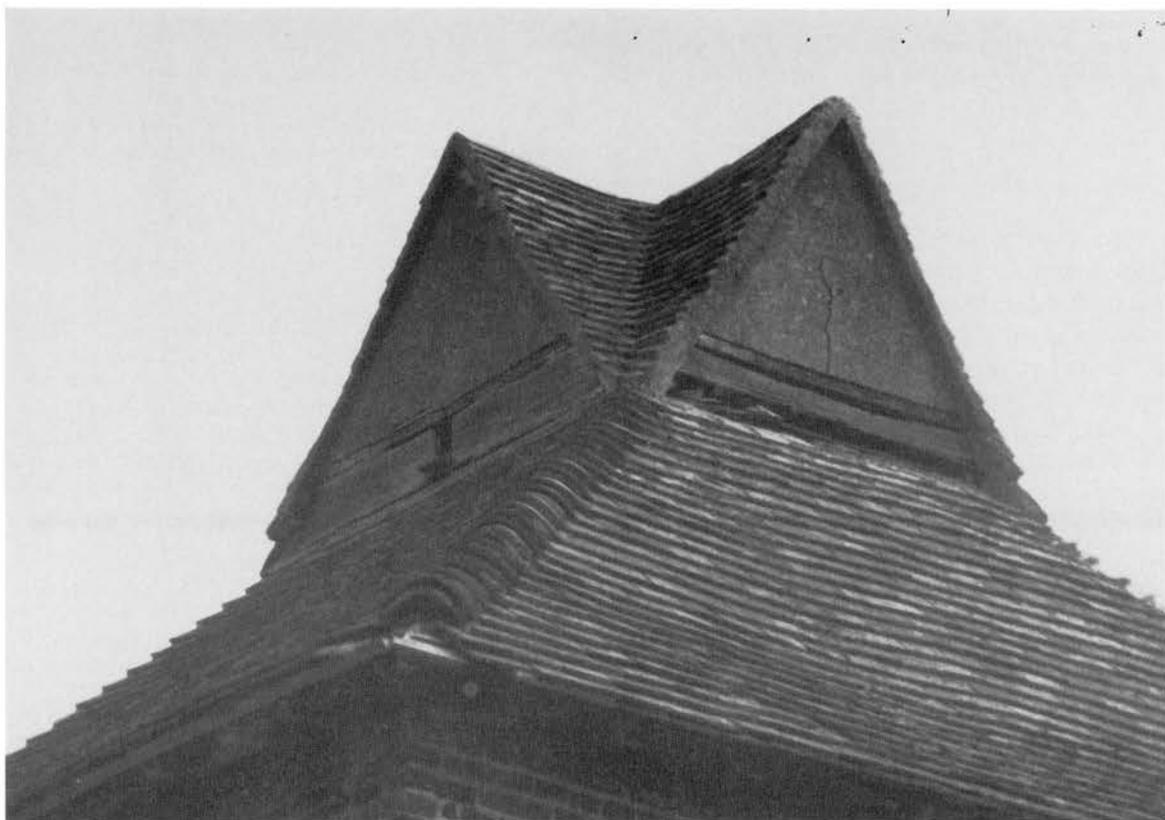
Fig 3. Flight hole and louvres.

The internal walls of the dovecote, lined with tiers of nesting boxes, were usually constructed independently of the external wall, though Whaddon (Fig. 20) and Gamlingay (Fig. 3) may be exceptions. Clay bat and daub and lath was commonly used and also brick with brick or tiled floors. Some brick nesting boxes have remains of clay linings, and these were perhaps the clay pan referred to by J. Moore in *Columbarium* (Moore, 1735), who also advises a 'straw basket' lining.

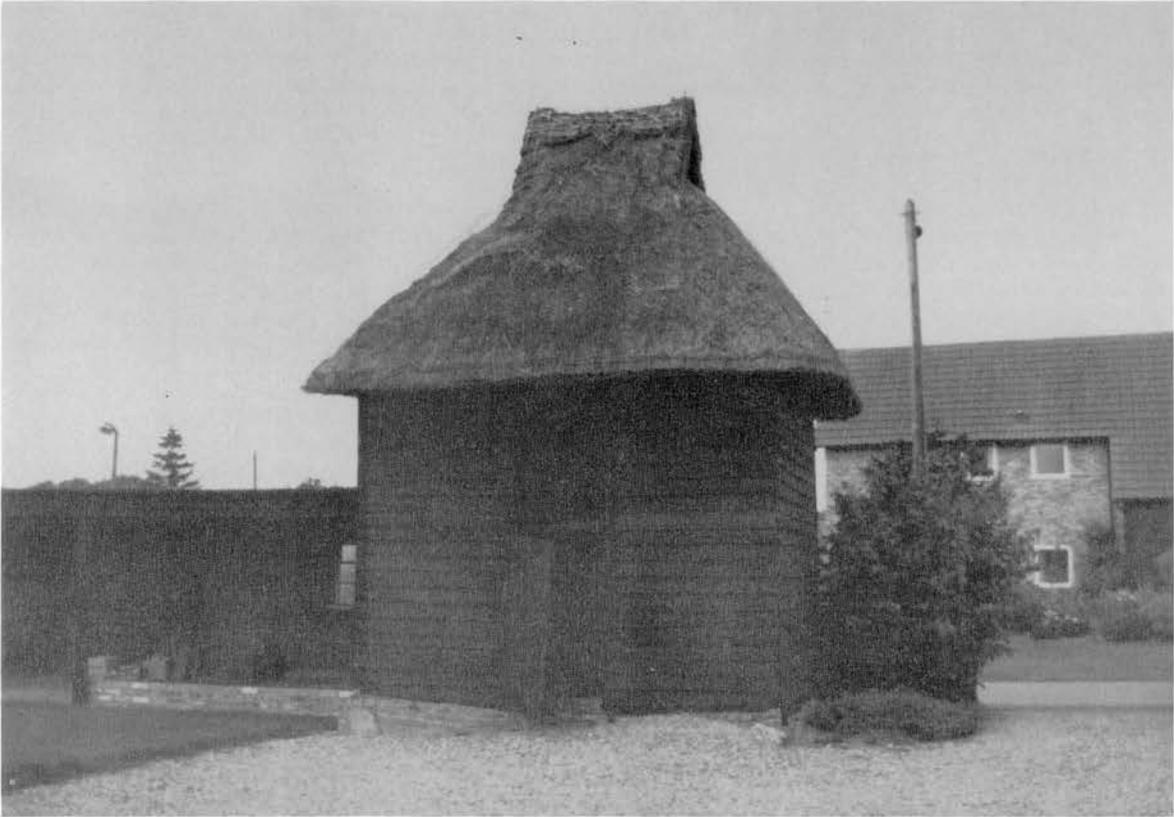
Fig 5. No. 27 Temple End. Gt. Wilbraham.

The dovecotes in the survey date from the seventeenth century and represent all the different vernacular building materials to be found in Cambridgeshire. There are 26 timber-framed examples, framed traditionally with lath or wattle infill sometimes plastered and weatherboarded. Some of these have rod holes regularly spaced across the studs suggesting the positions of the former nesting boxes (Great Wilbraham Fig. 5). The plinths are of

The roof coverings were of plain tiles with plastered or weatherboarded gablets: there are two long straw thatched examples at Elsworth (Fig. 24) and Great Wilbraham (Fig. 5). The more steeply pitched roofs date from the late seventeenth century.

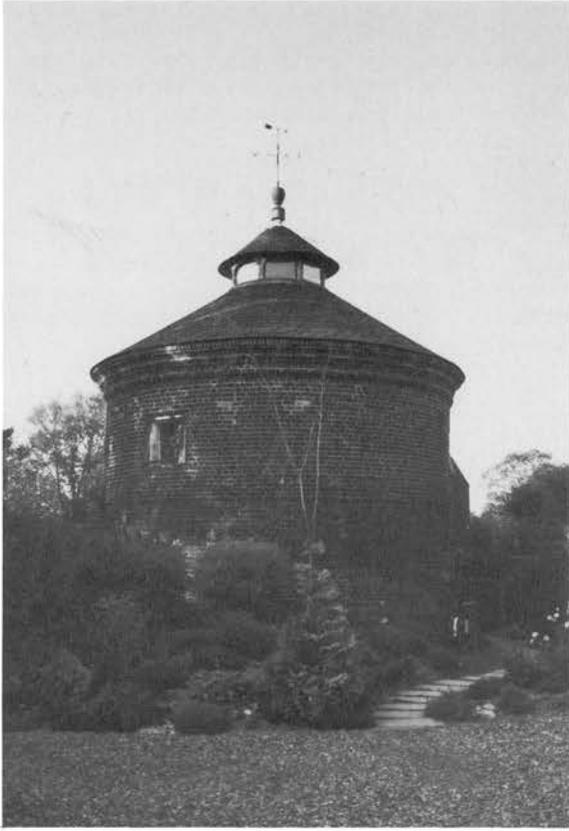
Fig 7. No. 29 The Dovecote, High Street, Gamlingay.

The earliest known plan form was round and of this type there are two eighteenth century examples (Newton, Home Farm Fig. 13, and Haslingfield, No. 29 High Street Fig. 7). By far the most common plan type is the square planned dovecote with a central doorway in one side (Swavesey Fig. 29, and Bassingbourn-cum-Kneesworth Fig. 1). Larger rectangular planned dovecotes are also found (Newton, Coach House Lane and Grantchester, Nos. 36 and 38, Millway). Both were subsequently converted to dwellings.

(Kingston, Church Lane Fig. 10) or by ladders secured to potences projecting from an arbre, a central rotating post (Haslingfield, Fig. 7 noted before being rebuilt, 1974).

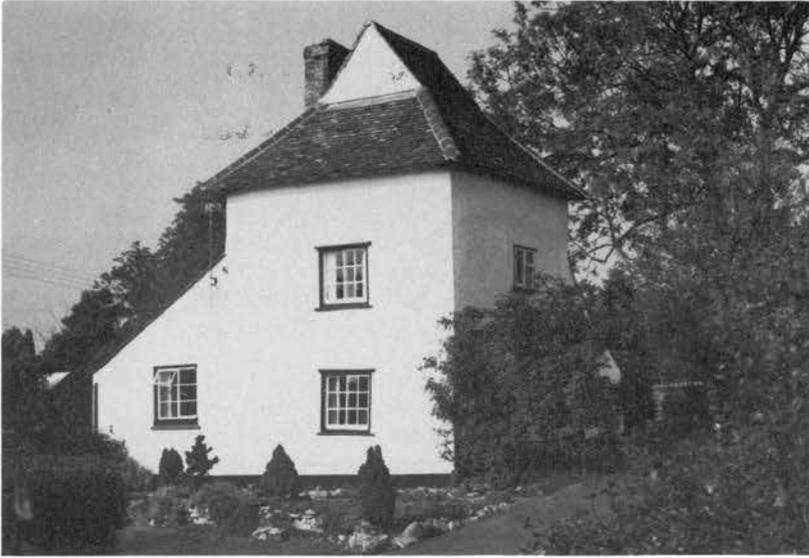
Fig 10. Dovecote, Church Lane,  
Kingston.

Some dovecotes were originally single storeyed and have remained so without alteration (Whaddon Fig. 20). Other first floor dovecotes were approached either by an internal or external staircase. The squabs (young pigeons) were collected by means of a ladder leaning against corner braces

To meet the increasing demand for homes in the nineteenth century many farmhouses were subdivided as labourers cottages, and so too were the larger dovecotes (Grantchester). The smaller dovecotes were extended by lean-tos (Kingston Fig. 10) or an additional cottage (Newton, Coach House Lane, and Sawston, Orchard Lane). Usually the conversion included the insertion of a floor or floors and a staircase and chimney stack(s). New windows were fitted to light the rooms generally with segmental headed arches and horizontal sliding sashes; the boarded entrance door was replaced by the ubiquitous panelled door.

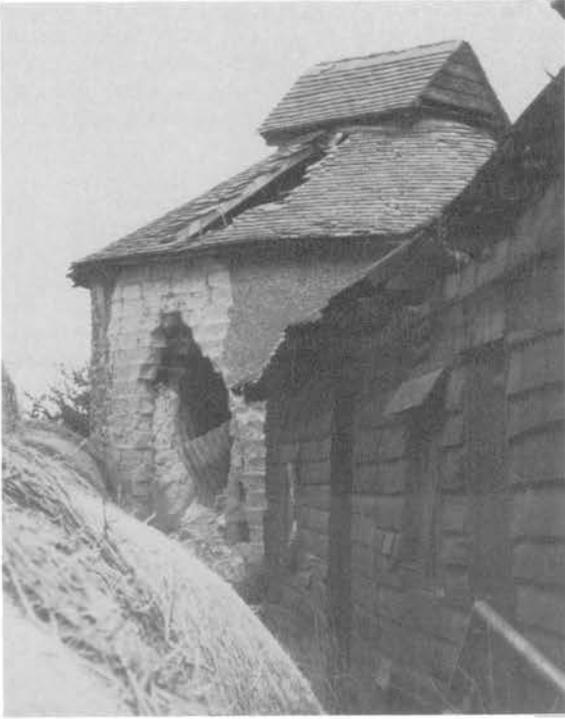
Fig 13. Home Farm, Town Street, Newton.

The nesting boxes, occasionally of two sizes (Newton, Home Farm Fig. 13), were arranged around the wall in tiers, each shaped to an L-plan with the entry hole to the right hand. At Haslingfield (Fig. 7) there are fifteen rows of nesting boxes, with fifty nests to each row. Some dovecotes housed as many as 1,500 birds, and 3,000 are said to have been housed in one at Grantchester.

The only example of a clunch dovecote is the round-planned building at Newton Home Farm (Fig. 13). The external wall is protected by a plaster render, but it may have originally been exposed. The nesting boxes are of lath and daub.

The husbandry of dove keeping is now a lost art. The dovecote at Home Farm, Town Street, Newton appears to have been the last to be used as such in South Cambridgeshire. Doves can be seen in the photograph of circa 1930. The most useful early source of information comes from *Columbarium*, by J. Moore. He was an apothecary and noted for his worming preparations. His book, published late in his life in 1735 was reprinted posthumously in 1765 and again by W. B. Tegetmeier in 1879. It was presumably a handbook much used at that time.

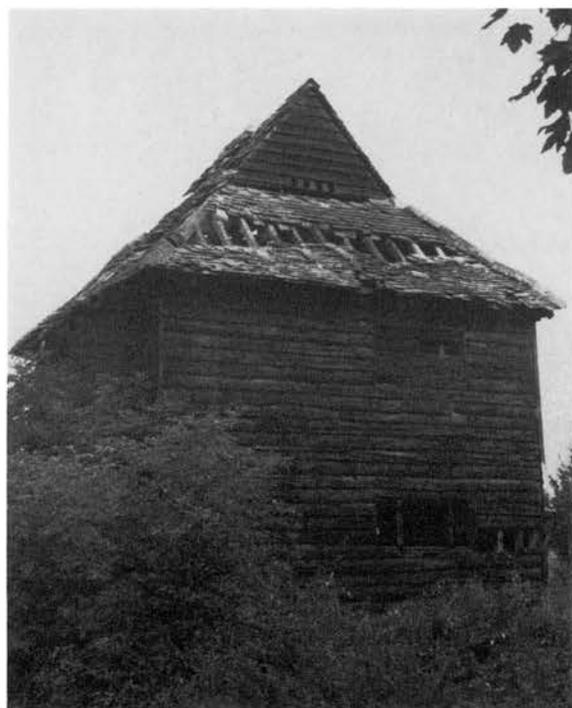
Fig 27. Malton Farmhouse, Malton Lane, Orwell.

verted into granaries, stables, or stores. Some still retain features from this conversion. The ground floor of one dovecote (Malton in Orwell Fig. 27) housed the pump used in washing coprolites.

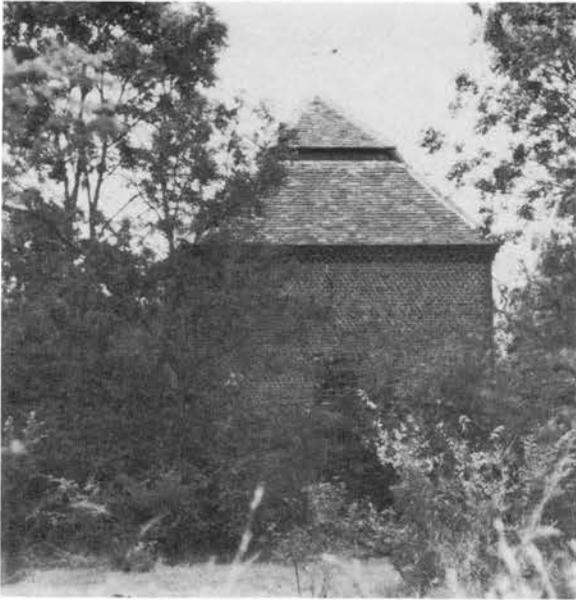
Fig 28. Manor House, Papworth St Agnes.

Circa 1700. Situated on the boundary of the garden enclosure. Red brick walls with double row of sawtooth bricks in the eaves cornice, plain tiled pyramidal roof with louvres breaking the roof pitch on two sides. Two storeys, square planned. The flight platform and chute are intact, the nesting boxes, possibly of clay bat or daub, have been removed.

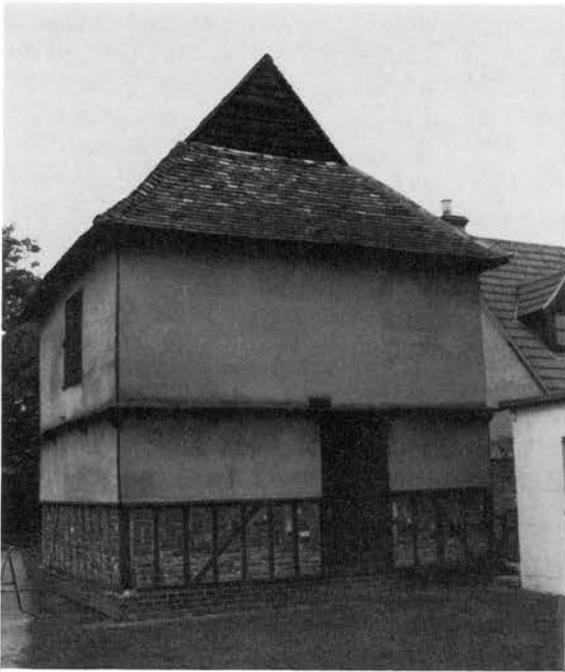
Fig 30. John Faulkner Primary School, Mill Lane, Sawston.

Most dovecotes had wooden floors suspended on brick piers at plinth height. In some timber-framed structures the lower level was nogged with brick to discourage rodents (Sawston, John Faulkner Fig. 30) and then weather boarded.

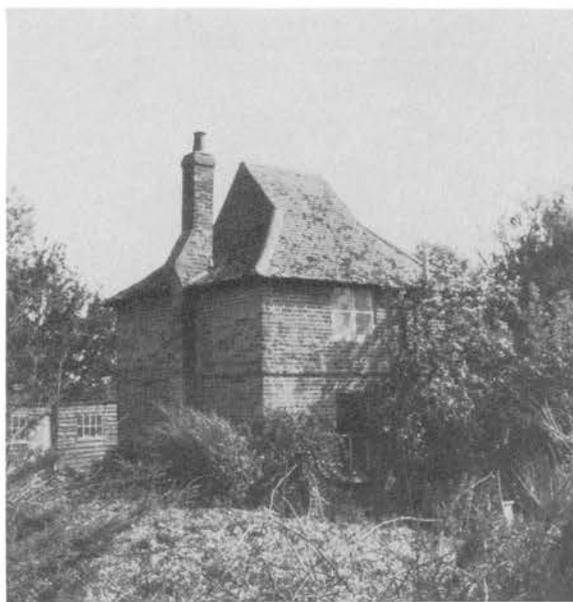
Fig 32. No. 12 Hines Lane, Comberton.

18th century. Possibly situated within a close, the dovecote is converted to a house. Red brick walls with three coursed brick band. Replacement plain tiled gablet roof. Side stack and inserted windows. Occupied.

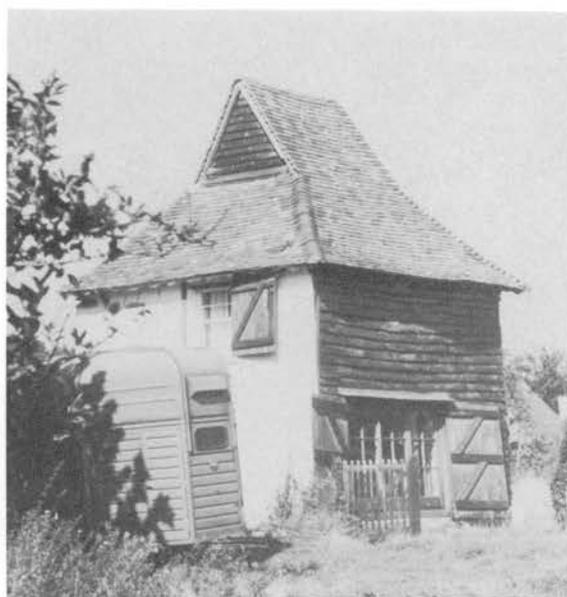
Fig 33. Cross Farm, Barton Rd. Comberton.

17th century. Situated near the farm and within a close, the dovecote was converted after 1942 to a house. Plastered timber-frame on a stone and brick plinth. One wall was cased in clay bat in the 19th century and another weatherboarded. Steep plain tiled gablet roof. Two storeys with an inserted floor, square planned. Occupied.
