## ***Friends Meeting House, Hertford***

*50 Railway Street, Hertford, Hertfordshire, SG14 1BA*

### ***Statement of Significance***

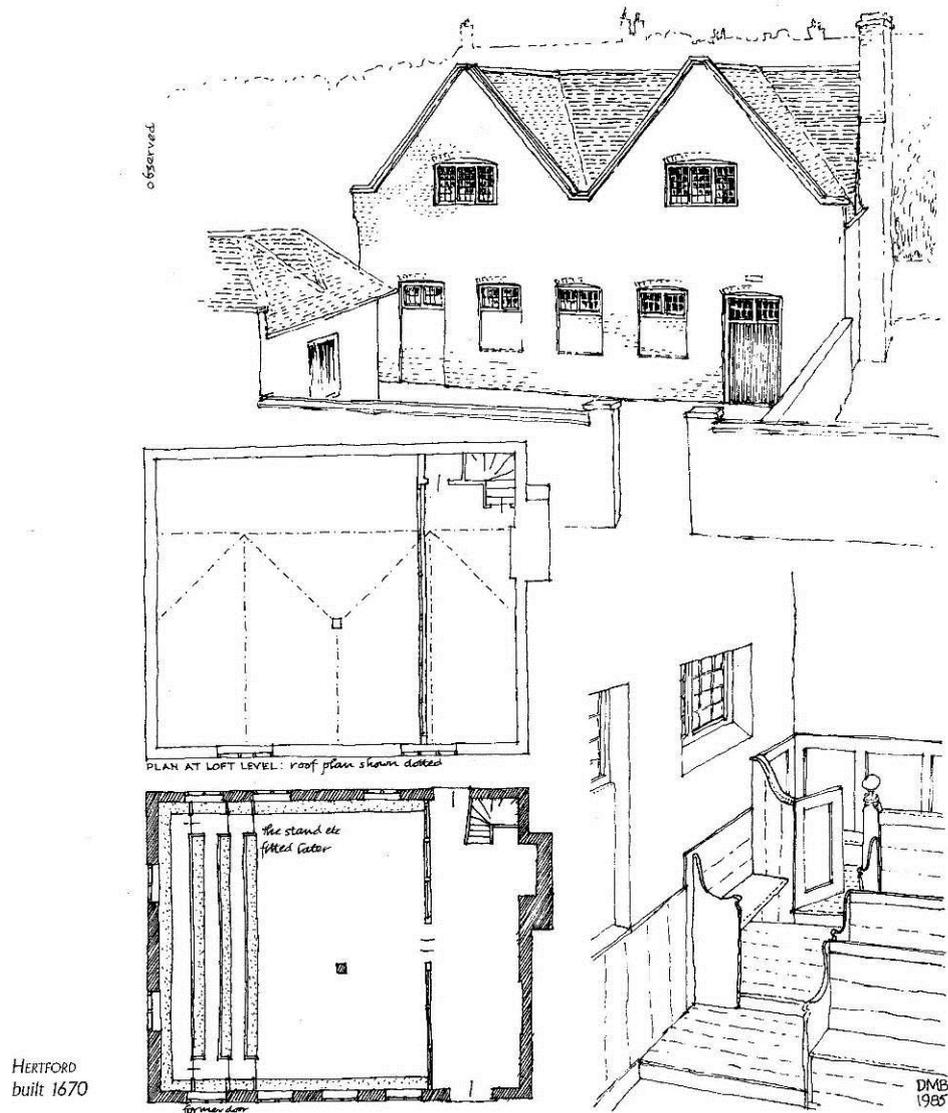
Figure 1: Plan, elevation and detail of elders' stand, from Butler, Vol. 1, p. 256 (north is at the bottom of the plan)

The interior is principally a single large full-height meeting room space, with a shuttered gallery across the west side and a shuttered lobby below. The meeting room has a timber boarded floor. Across the full width of the east side is a triple stand with doors and shaped ends to the benches. A substantial freestanding timber post in the centre of the room supports the wall plates of the roofs, and close to it in the floor is a stone slab marking the former location of a stove. Standing just proud of the walls on all sides are the vertical members of the steel frame inserted in 1980. The lobby has a stair in the south west corner with splat balusters. Both the lobby and the gallery above are heated by very substantial

hearths. The gallery is now divided into two smaller spaces, one of which contains the meeting house library. Both Butler and Stell suggest that the gallery arrangements have been altered and that the present shutters may have replaced a plastered partition.
