Friends Meeting House, Dorking

Butter Hill, South Street, Dorking, Surrey, RH4 2LE

Statement of Significance

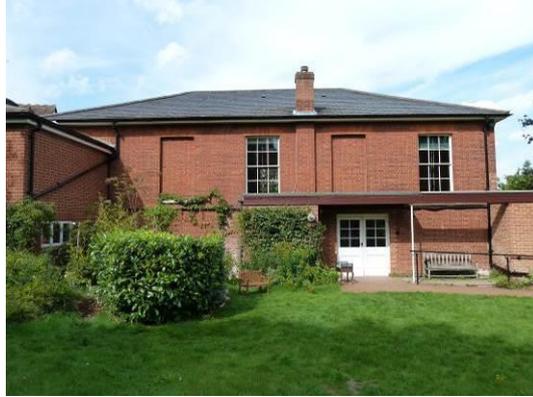
The three-bay porch has two 8-over-8 sashes on either side of the entrance with Tuscan columns in antis. (The porch's cornice, visible in an historic photo (figure 2), has been removed and replaced by a brick parapet.) The first floor of the main block has five 6-over-6 sash windows under rubbed and gauged flat arches. The toilet block to the east has frosted plate glass sashes, the block to the west has two 8-over-8 sashes. The rear elevation of the original building was also five bays wide, with a square brick stack off-centre. There are two 6-over-6 sashes to the first floor, which alternate with blind openings. The first-floor window at the far west is obscured by the cottage extension. On the ground floor, there is one modern double-leaf door in the second bay from the east, under a modern canopy which is a continuation of the east extension.

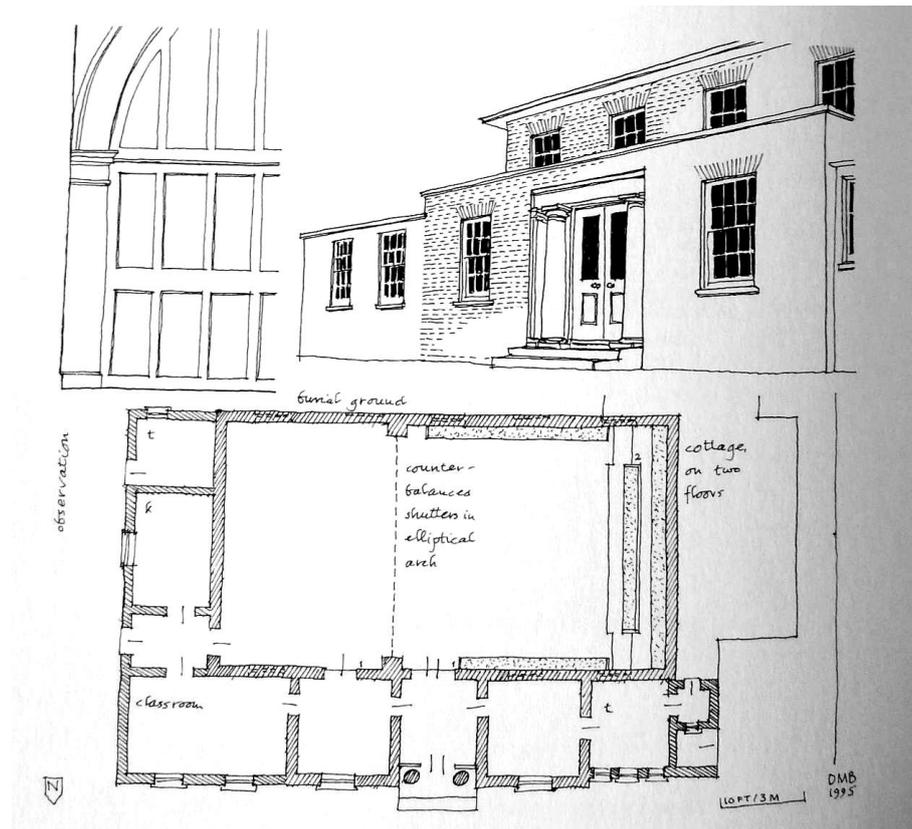
Figure 1: Plan, detail of shutter screen and perspective (north is roughly at the bottom of the plan; not to scale) (Butler, *The Quaker Meeting Houses of Britain*, 1999, vol. 2, p. 586)

The street elevation faces roughly north. The materials are red brick laid in Flemish bond (and stretcher bond for the later extensions). The main meeting house has an oblong plan and a hipped slate roof. The attached cottage is to the west. There is a flat-roofed extension to the front, flanked by hipped-roof extensions on either side. To the east is a flat-roofed extension (which is wider and longer than that shown on Butler's plan (figure 1), projecting further south than the rear elevation of the original building).

The entrance lobby leads into the information centre (a former classroom) to the left and an office to the right, with toilets beyond. The main building is divided into two rooms by a counter-balanced timber partition under a wide three-centred arch. The top half can be winched into the roof space, while the lower half simultaneously goes into a pit below the building. The winding mechanism is in the lobby and is still in working order. At the centre of the partition are back-to-back doors.

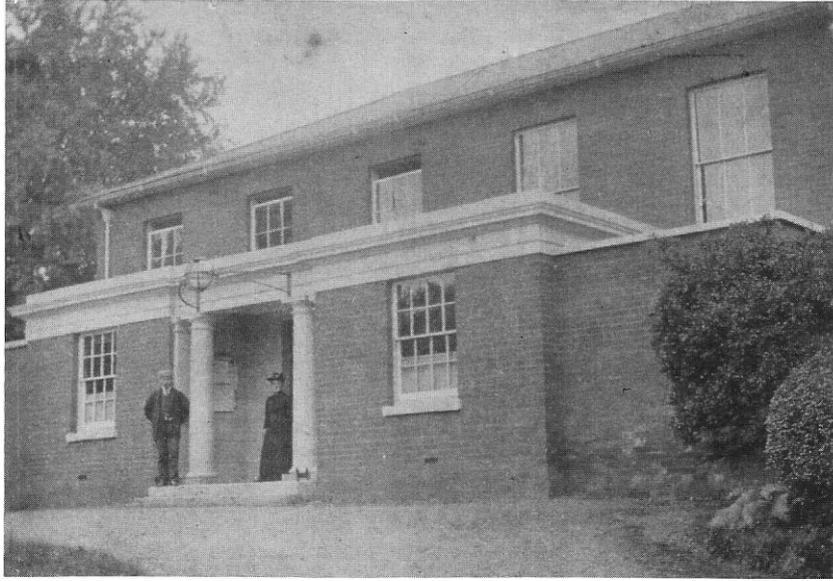
Figure 2: Undated photo of the meeting house ('Friends Meeting House, Dorking', leaflet)
