***Friends Meeting House, Bentham***

*Calf Cop, Burton Road, Low Bentham, LA2 7ET*

***Statement of Significance***

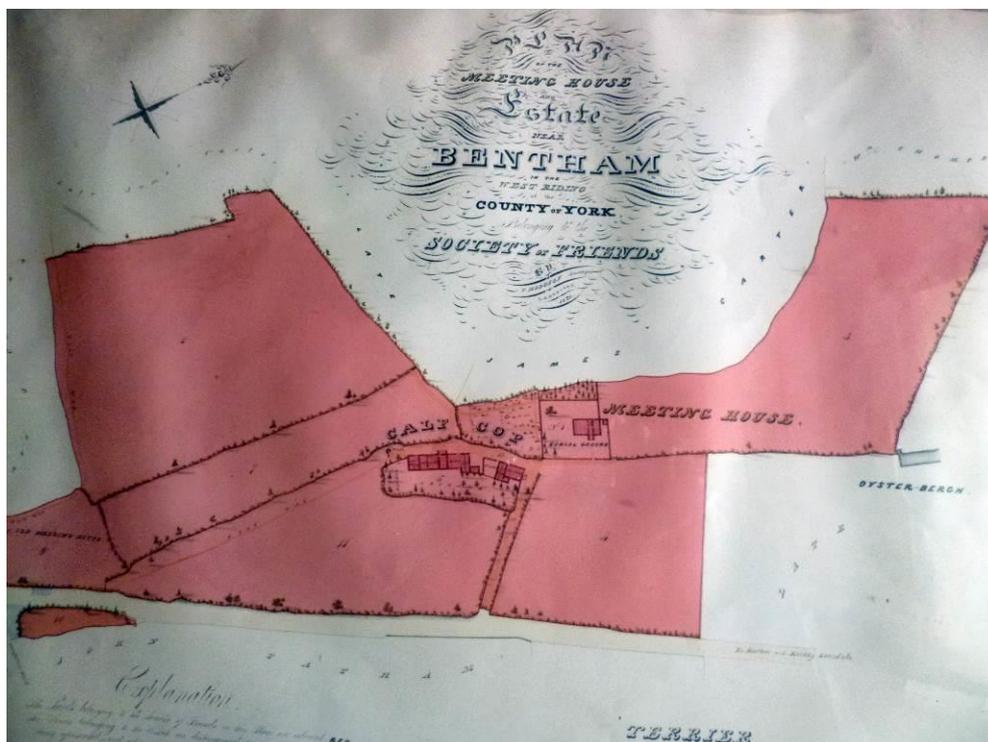
Fig.1: plan of land belonging to the Calf Cop Trust in 1850 (Bentham Meeting collection)

The meeting has an idyllic rural setting surrounded by fields, about a mile north of the village of Low Bentham. The approach from the lane is by a track that also serves a group of stone cottages that were historically a farm and the stables for the meeting house (marked on the plan in Fig.1 and now privately owned). From the parking area a path along the edge of the field leads through a gate into the walled burial ground. Iron estate railings divide the path from the field. The meeting still owns about 12 acres of fields around the meeting house. There are fine views north-east across the fields towards Ingleborough.

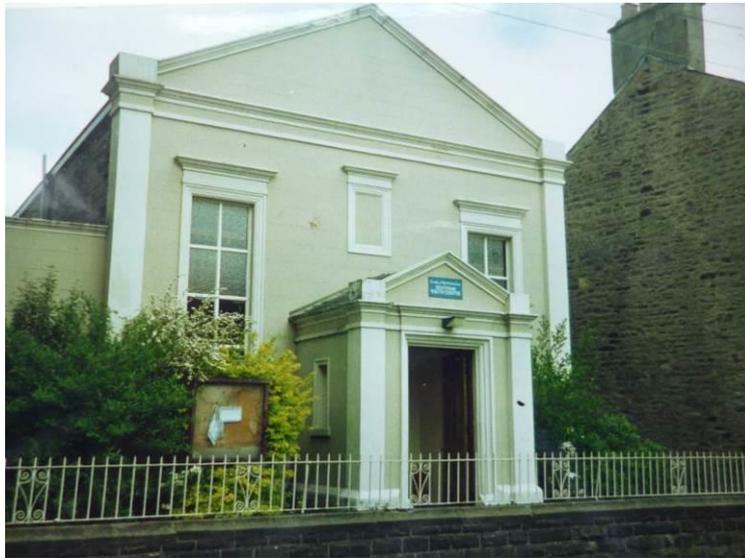
Fig.2: 1864 meeting house in High Bentham, closed in 1973

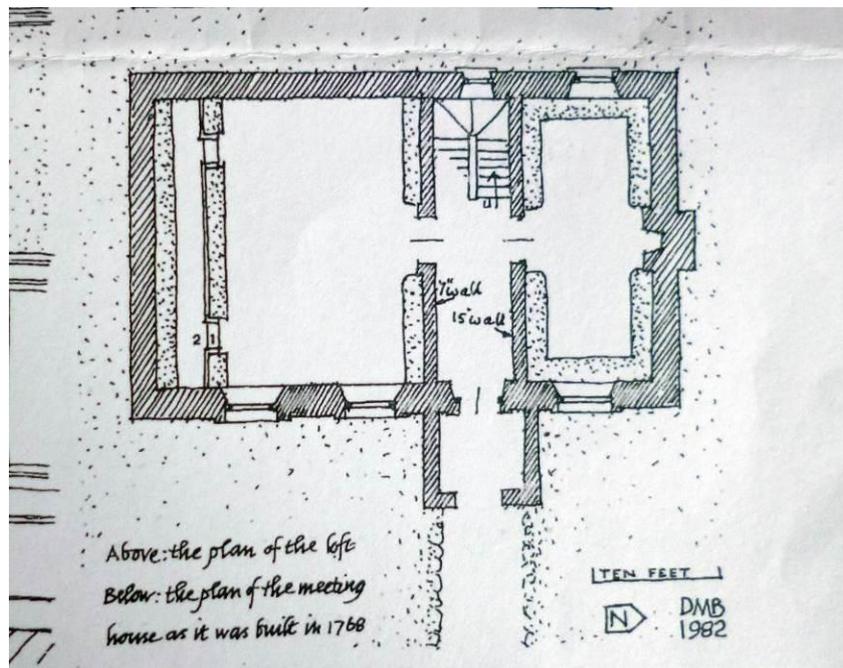
Fig.3: reconstructed ground plan from Butler, Vol 2, p778

The meeting built in 1798 is constructed of roughly coursed rubblestone (probably originally lime-rendered), with ashlar details, a stone slate roof with timber gutters on stone corbels, and a stone chimney stack to the north gable end. The building is aligned roughly north to south with an asymmetric plan; a cross passage is aligned with the east porch towards the north end and to its south is the large meeting room and to the north bay is the former women's meeting room, now sub-divided into small rooms. The front elevation faces east with two 24-pane sash windows to the large meeting room to the left of a gabled porch. The porch is probably an addition; built of ashlar with distinctive punched tooling, a plinth, impost band, pediment and ball finial, and has an open doorway and stone floor. Within the porch the inner doorway has the date 1718 inscribed on the lintel (re-used from the demolished meeting house to the south). To the right of the porch the 2-storey north bay of the building has one sash window to each floor; a nineteenth century 6-pane sash to the ground floor and a 16-pane sash to the first floor. The small-paned sashes are probably original. The north and south gable ends are blind, but there is a blocked window to the south and a projecting chimney stack to the north. The west elevation has a single 18-pane sash to the meeting room, a fixed light stair window and two small sashes matching those to the east, at the north end.

A 6-panelled door with iron latch leads into the stone-paved cross passage from the porch. The dogleg stone staircase at the west end of the passage has stick balusters, closed string, square newels and plain moulded handrail. Off the south side of the passage, a 6-panelled door leads through a solid masonry wall into the main meeting room (there are no shutters); the south face of the doorway has an architrave with fluted pilasters and a cornice. The meeting room walls have a dado with field panelling and plain plaster above. The floor is of wide pine boards. The pine tongue and grooved ceiling dates from 1973. The Elders' stand at the south end of the room has fielded panelling to the front bench and the back wall, with steps at either end. Fitted to the back of the front panelling, two wrought iron brackets relate to a missing hinged table. The gallery to the north side of the room has slender turned balusters to the front rail, and a sloping floor. On the north side of the passage, the former women's meeting room has been altered; the 6-panelled door to the centre now leads into a kitchen and at the east end the north passage wall has been removed to allow for WCs to be installed with new partitions and fittings.

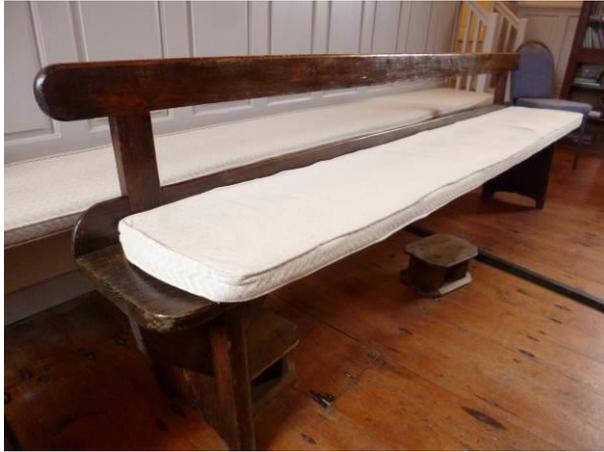
Fig.4: open-backed pine bench

The meeting house contains six open-backed pine benches of similar design and also two benches with solid bench ends (similar to those in Airton meeting house). The gate-leg table in the centre of the meeting room has legs of early eighteenth century date but the top is Victorian. There are also two eighteenth century oak chairs, with pierced splat backs, in the hall.

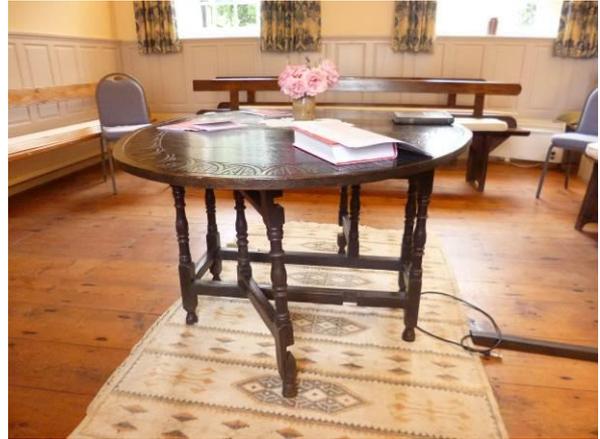
Fig.5: gate-leg table in meeting room

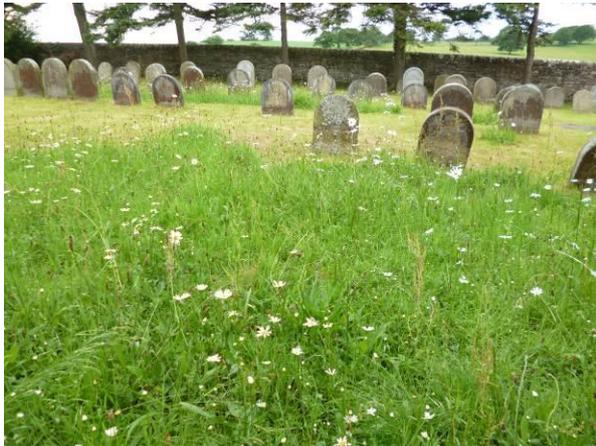
Fig.6: the burial ground from the east

The meeting house stands towards the north side of a large square burial ground, enclosed by well-built mortared stone walls with half-round copings. The walls are about 2 metres high, with tooled quoins forming gate piers to the main east entrance, aligned with the porch of the meeting house. The walls are separately listed Grade II. There is also a small (recent) gateway on the south wall giving access to the adjoining allotment gardens. The former outside men's toilets in the north-east corner were in a dilapidated state, but have been renovated to provide a tool shed for use by allotments holders. The burial ground is laid to grass with areas allowed to seed to encourage wildlife. Perimeter trees include mature yew trees and conifers. The burial ground records run from 1836 to the present day, and are kept at the meeting house. The plain semi-circular headed memorial stones are arranged in rows aligned north-south.

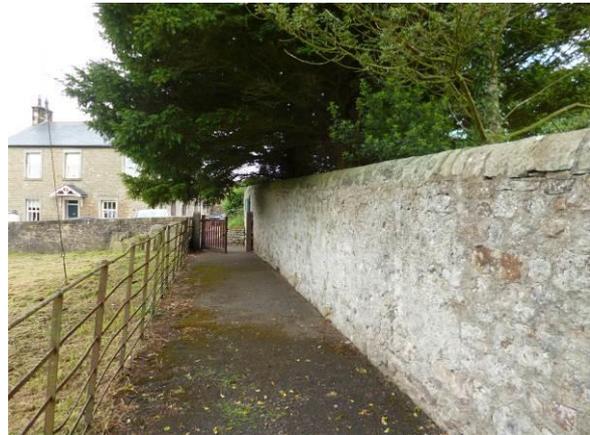
Fig.7: east wall to burial ground, from the north

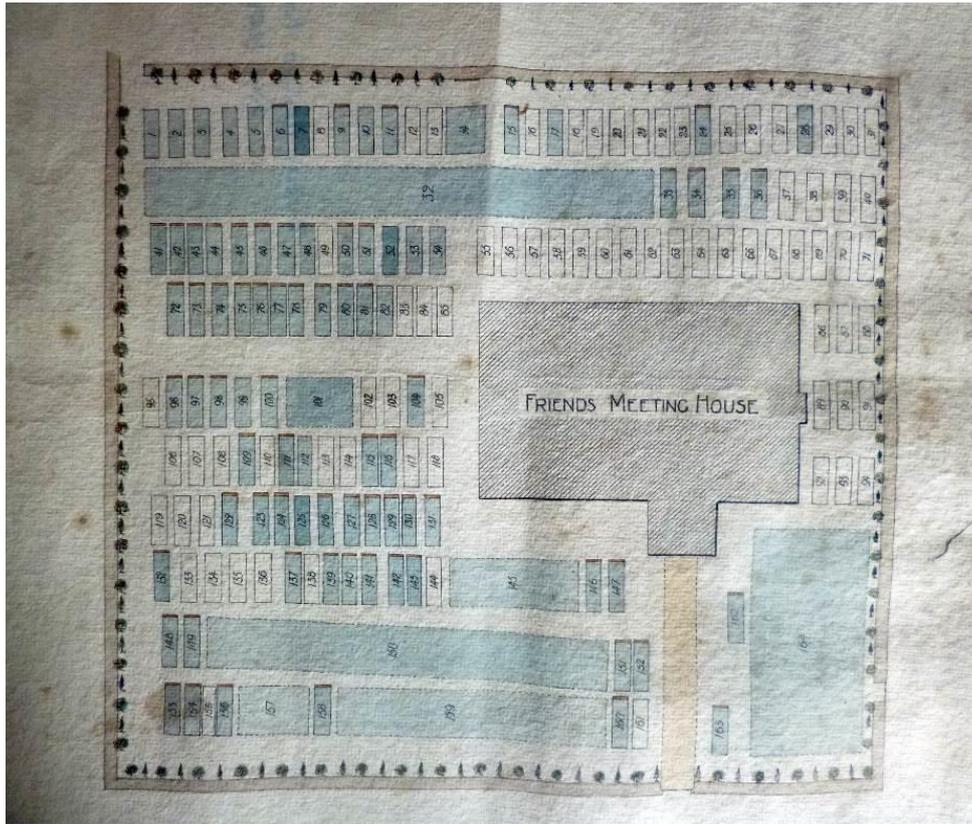
Fig.8: plan of the burial ground kept in the meeting house
