Rescue Excavations on the Old Custom House Site Part 2: — Roman

TIM TATTON-BROWN*

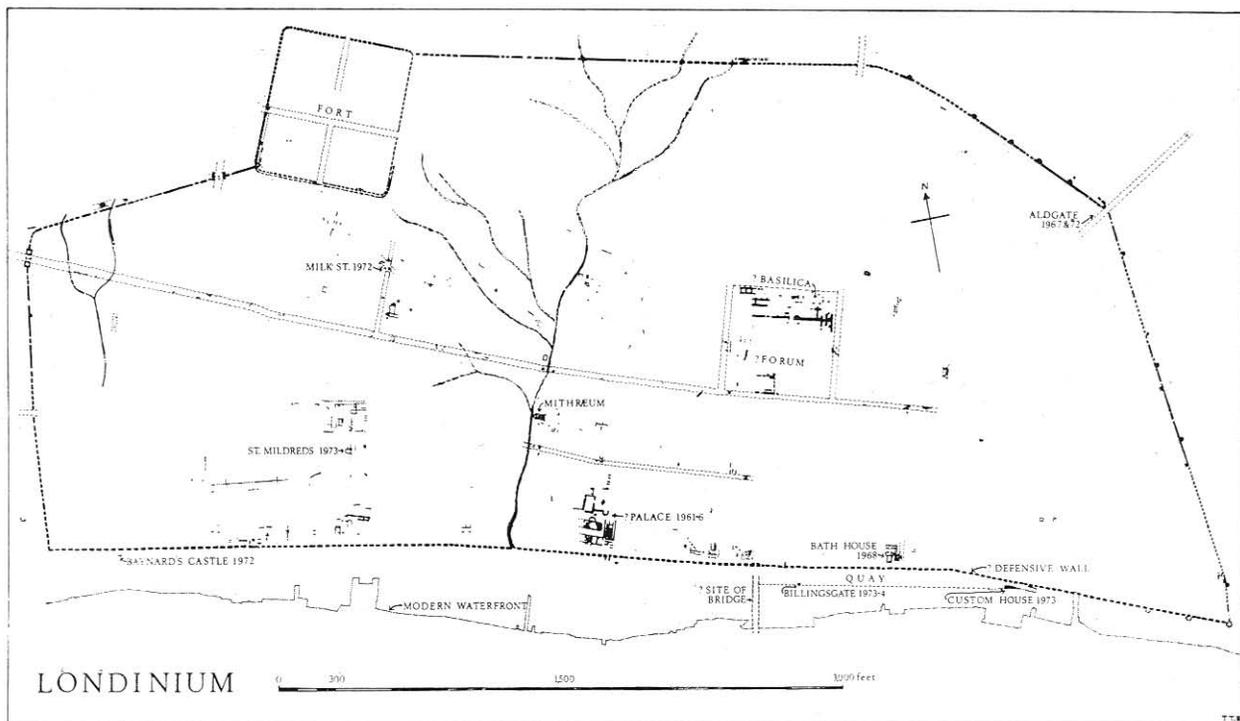
Fig. 1. Plan of Roman London showing its main features and the probable line of its riverside defensive wall and Roman timber quay.

In the second half of the 2nd century a new large timber quay was built on the site c. 20 feet further south. The western part of this quay was made as a rigid box structure (fig. 1 and 4) with large numbers of pre-fabricated timbers, all of standard size. The main vertical posts and cross-members were either c.20cm. square or 20 x 15cm. (i.e. roughly $\frac{2}{3}$ x $\frac{1}{2}$ of a Roman foot). The timber beams of the front of the quay were larger still with the biggest at the bottom and then becoming progressively smaller towards the top. The largest beam was c.45 x 30cm. (i.e. about $1\frac{1}{2}$ x 1 Roman foot). All the wood was joined together and held in place by the force of gravity; no nails were used. Large saws, planes and chisels were clearly used by the carpenters, and the whole job of constructing this waterfront must have been done officially. There were three main joints (fig. 5): (a) half-laps, which were used where beams crossed at right angles; (b) barefaced-dovetails, for joining the north-south beams into the huge front beams; and (c) false-tenons, for joining these beams vertically. Here small blocks of wood c. 5cm. wide by 13cm. long and 13cm. high fitted into mortice holes

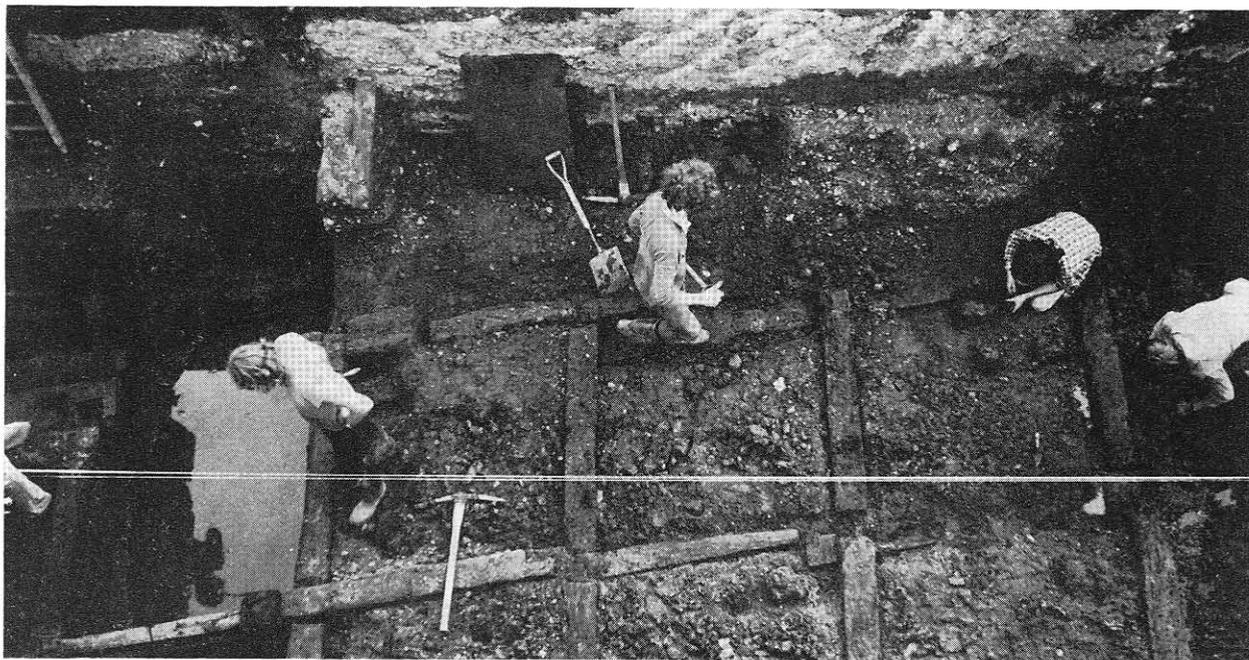
Fig. 3. Excavation in progress on the box structure of the Roman quay.
