PLATE 1. The Abbey Mill: line of standing (west) arches; facing east.

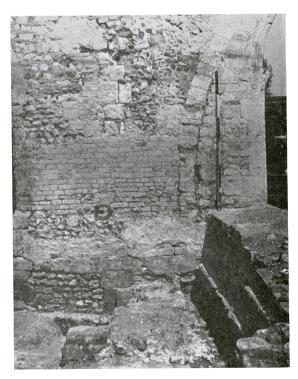
PLATE 2. The Abbey Mill: central arch, north side, west face.

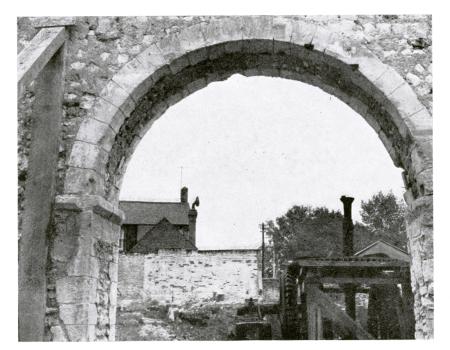
PLATE 3. The Abbey Mill: north arch, facing east.

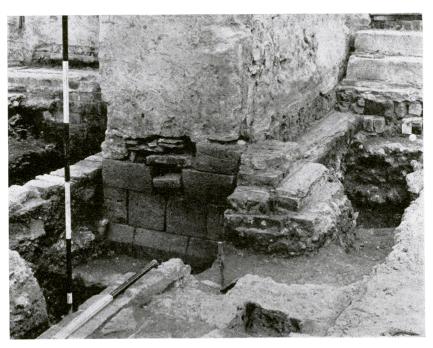
PLATE 4. The Abbey Mill: north arch, south face.

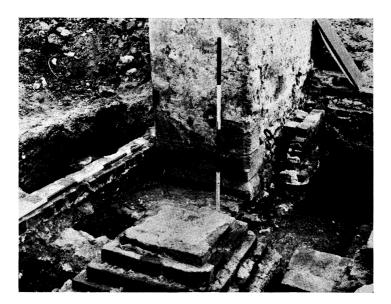
PLATE 5. The Abbey Mill: north arch, north face.

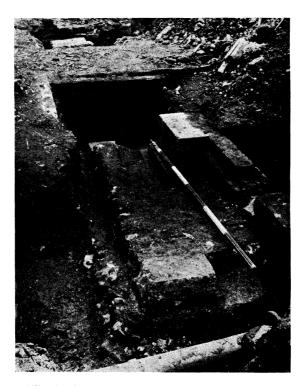
PLATE 6. The Abbey Mill: footings of central pier of destroyed east line of arches; facing south.

This would lie directly to the east of the northernmost pier shown in Plate 1.

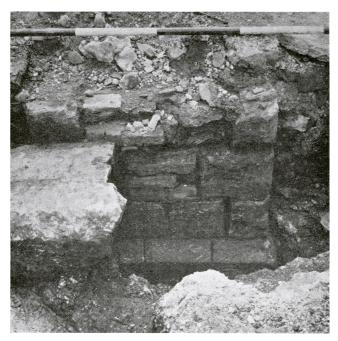
PLATE 7. The Abbey Mill: footings of south pier of eastern line of arches, north face.

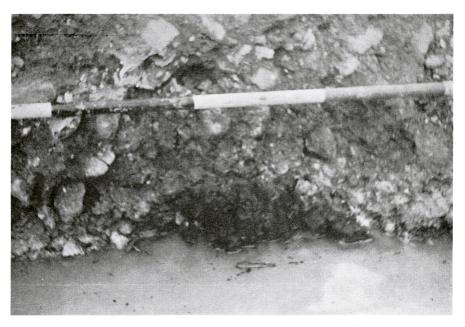
PLATE 8. The Abbey Mill: footings of south pier of eastern line of arches, base of east face showing timber.

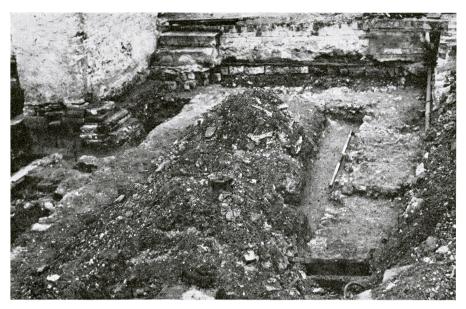
PLATE 9. The Abbey Mill: flint in mortar footings and poor ashlar wall to west of standing arches (area A), facing south.

PLATE 10. The Abbey Mill: central pier of standing arches, west face, showing junction of pier and flint in mortar footings (Plate 9).

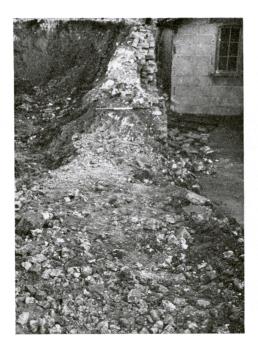
PLATE 11. Outer wall of Abbey to the east of the Abbey Mill, showing destruction.

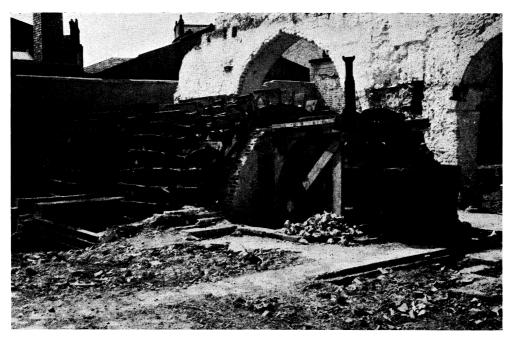
PLATE 14. The Abbey Mill: the latest mill machinery.

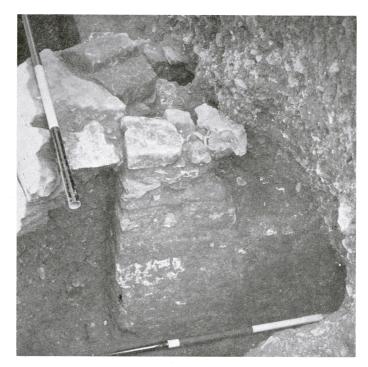
PLATE 15. Cloister Area: Trench I, showing junction of footings and drain.

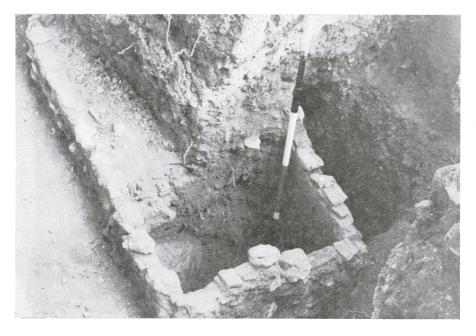
PLATE 16. Cloister Area: Trench II, showing soakaway(?).
