**Figure 1a.**  
**Roman Villa: earlier phase**

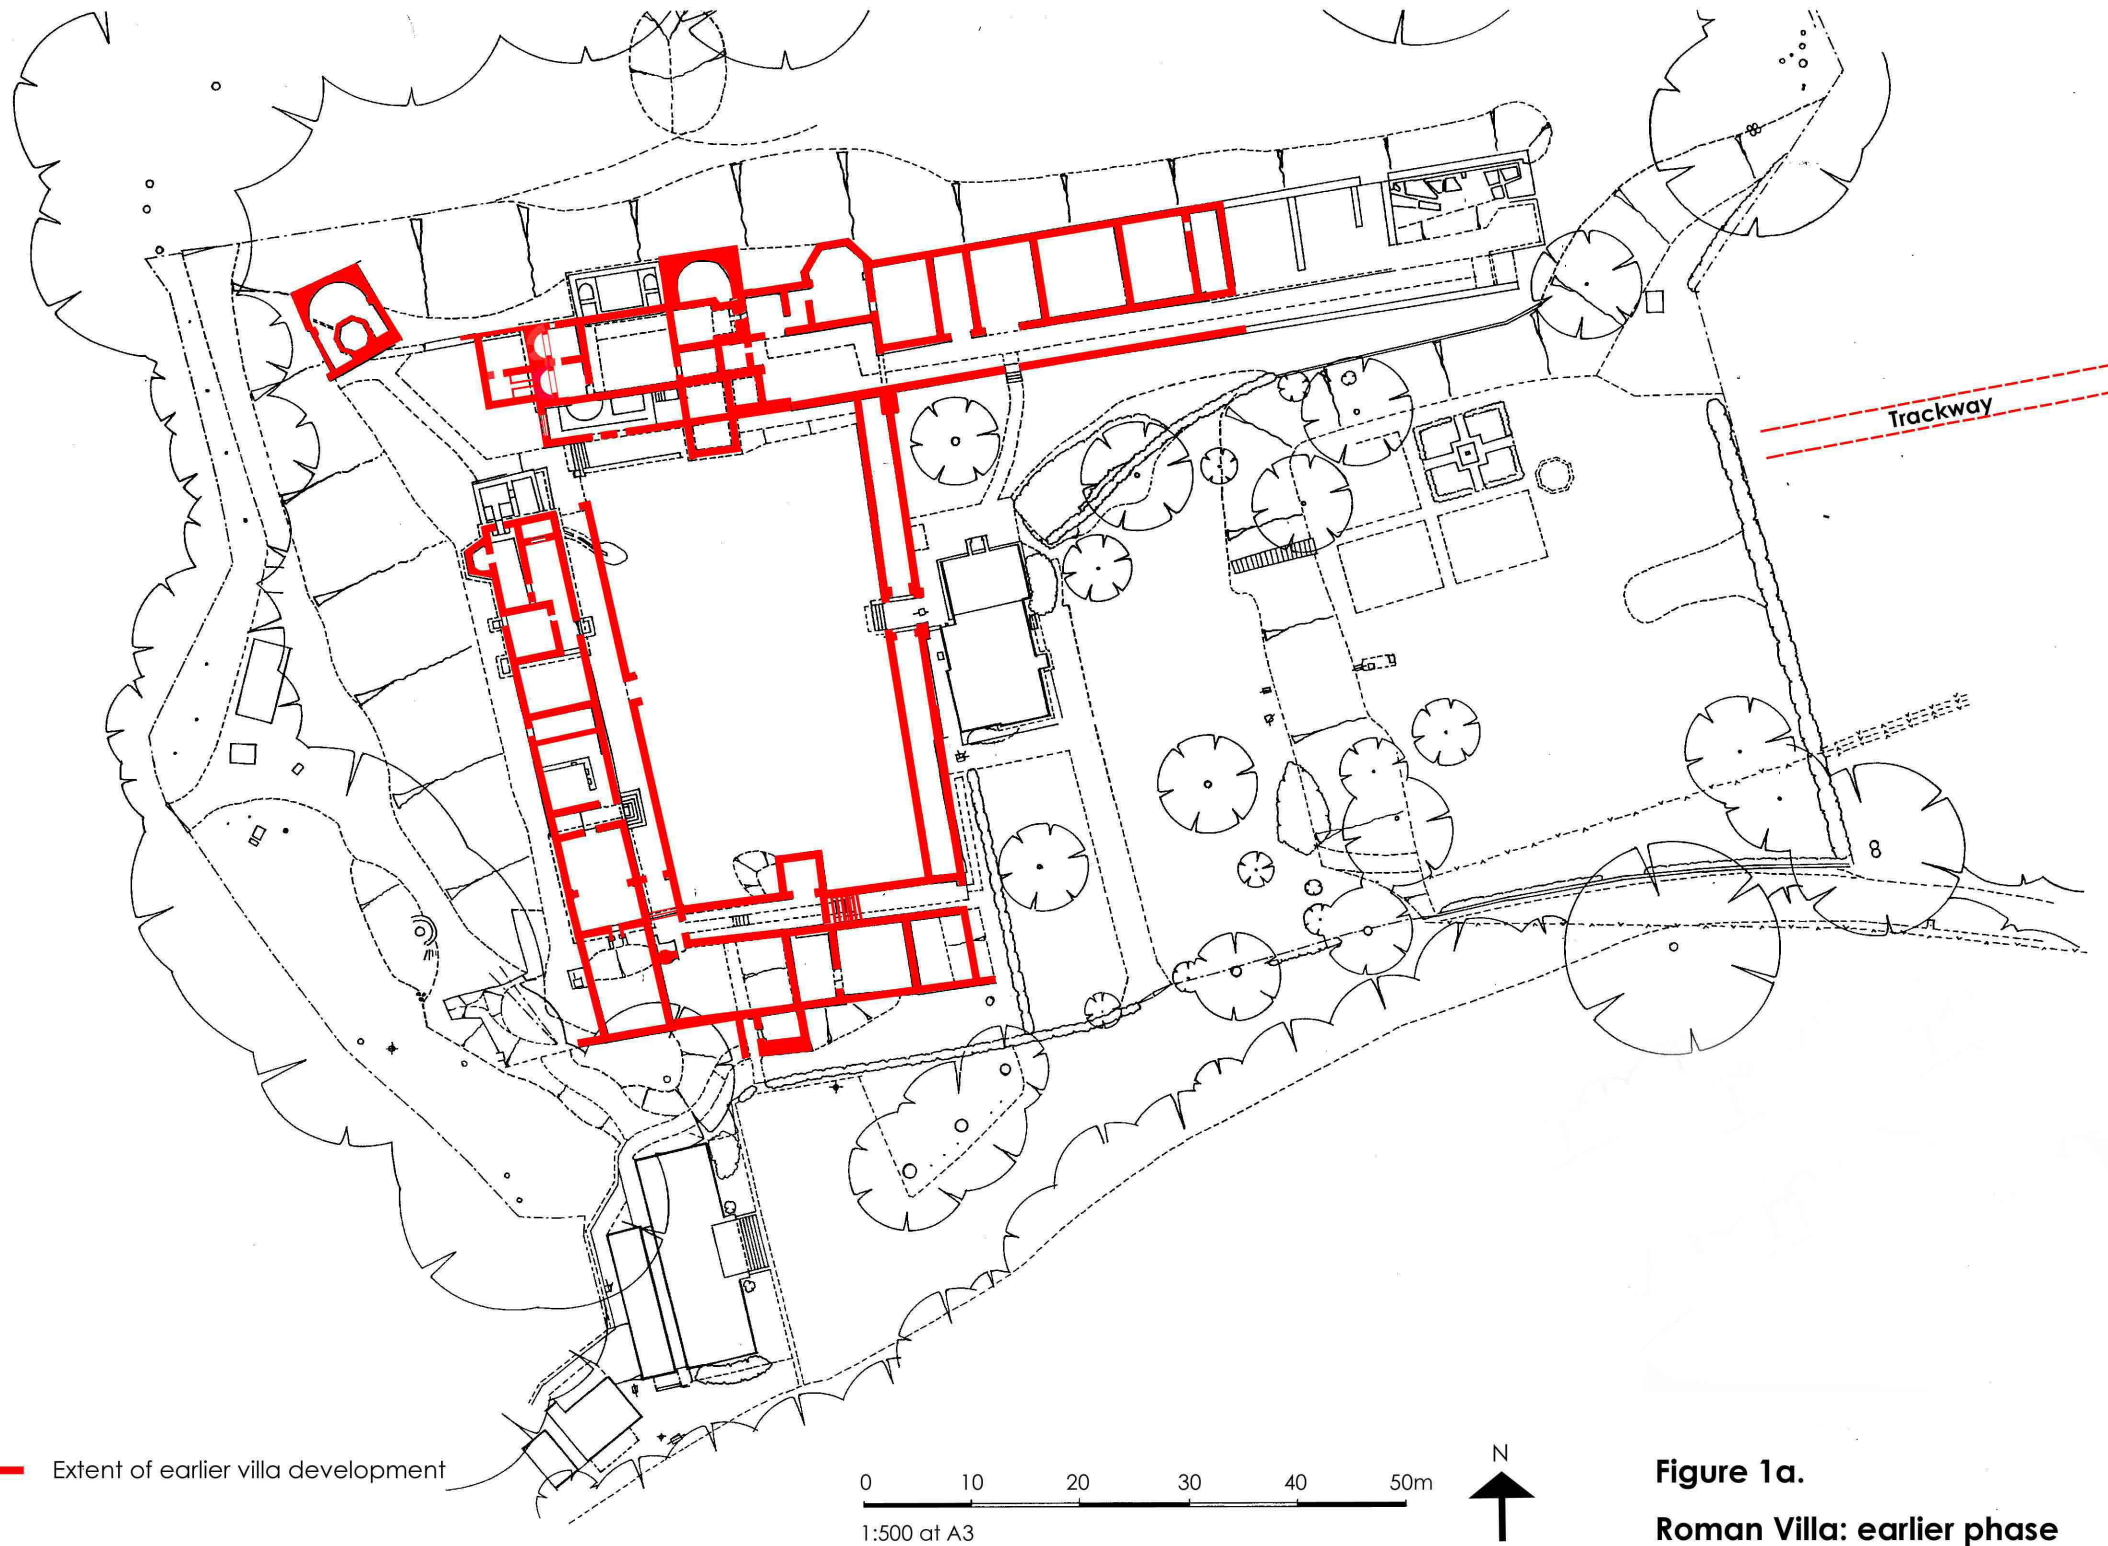
In order to build the villa, the valley floor required terracing and soil was dug from the slopes and placed downhill to create a series of platforms. It is believed that there were two broad periods of development of the villa. In the earlier period, a villa was built around the inner courtyard. It has been suggested that it originated as three separate ranges along the north, west and south sides of the site. In the later phase, during the 4th century, the villa was extended substantially.

The layout to the left, shown in red, is based on an analysis of the villa's development presented in the National Trust's guidebook published in 1979. Subsequent investigations suggest that this may have been a mis-interpretation. The only thing that is reasonably certain is that the early villa occupied the area around the inner courtyard and was probably relatively unpretentious. There is evidence that the early buildings along the west and south sides were burnt down and rebuilt. The later phase entailed substantial re-development of the buildings round the courtyard and construction of the two wings extending eastward towards the river (see Figure 1b).
