**Faringdon to Blunsdon Phase 1  
Water Main Replacement  
Highworth  
Swindon**

**MAGNETOMETER SURVEY REPORT**

**SMB JV**

Ref. no. J748

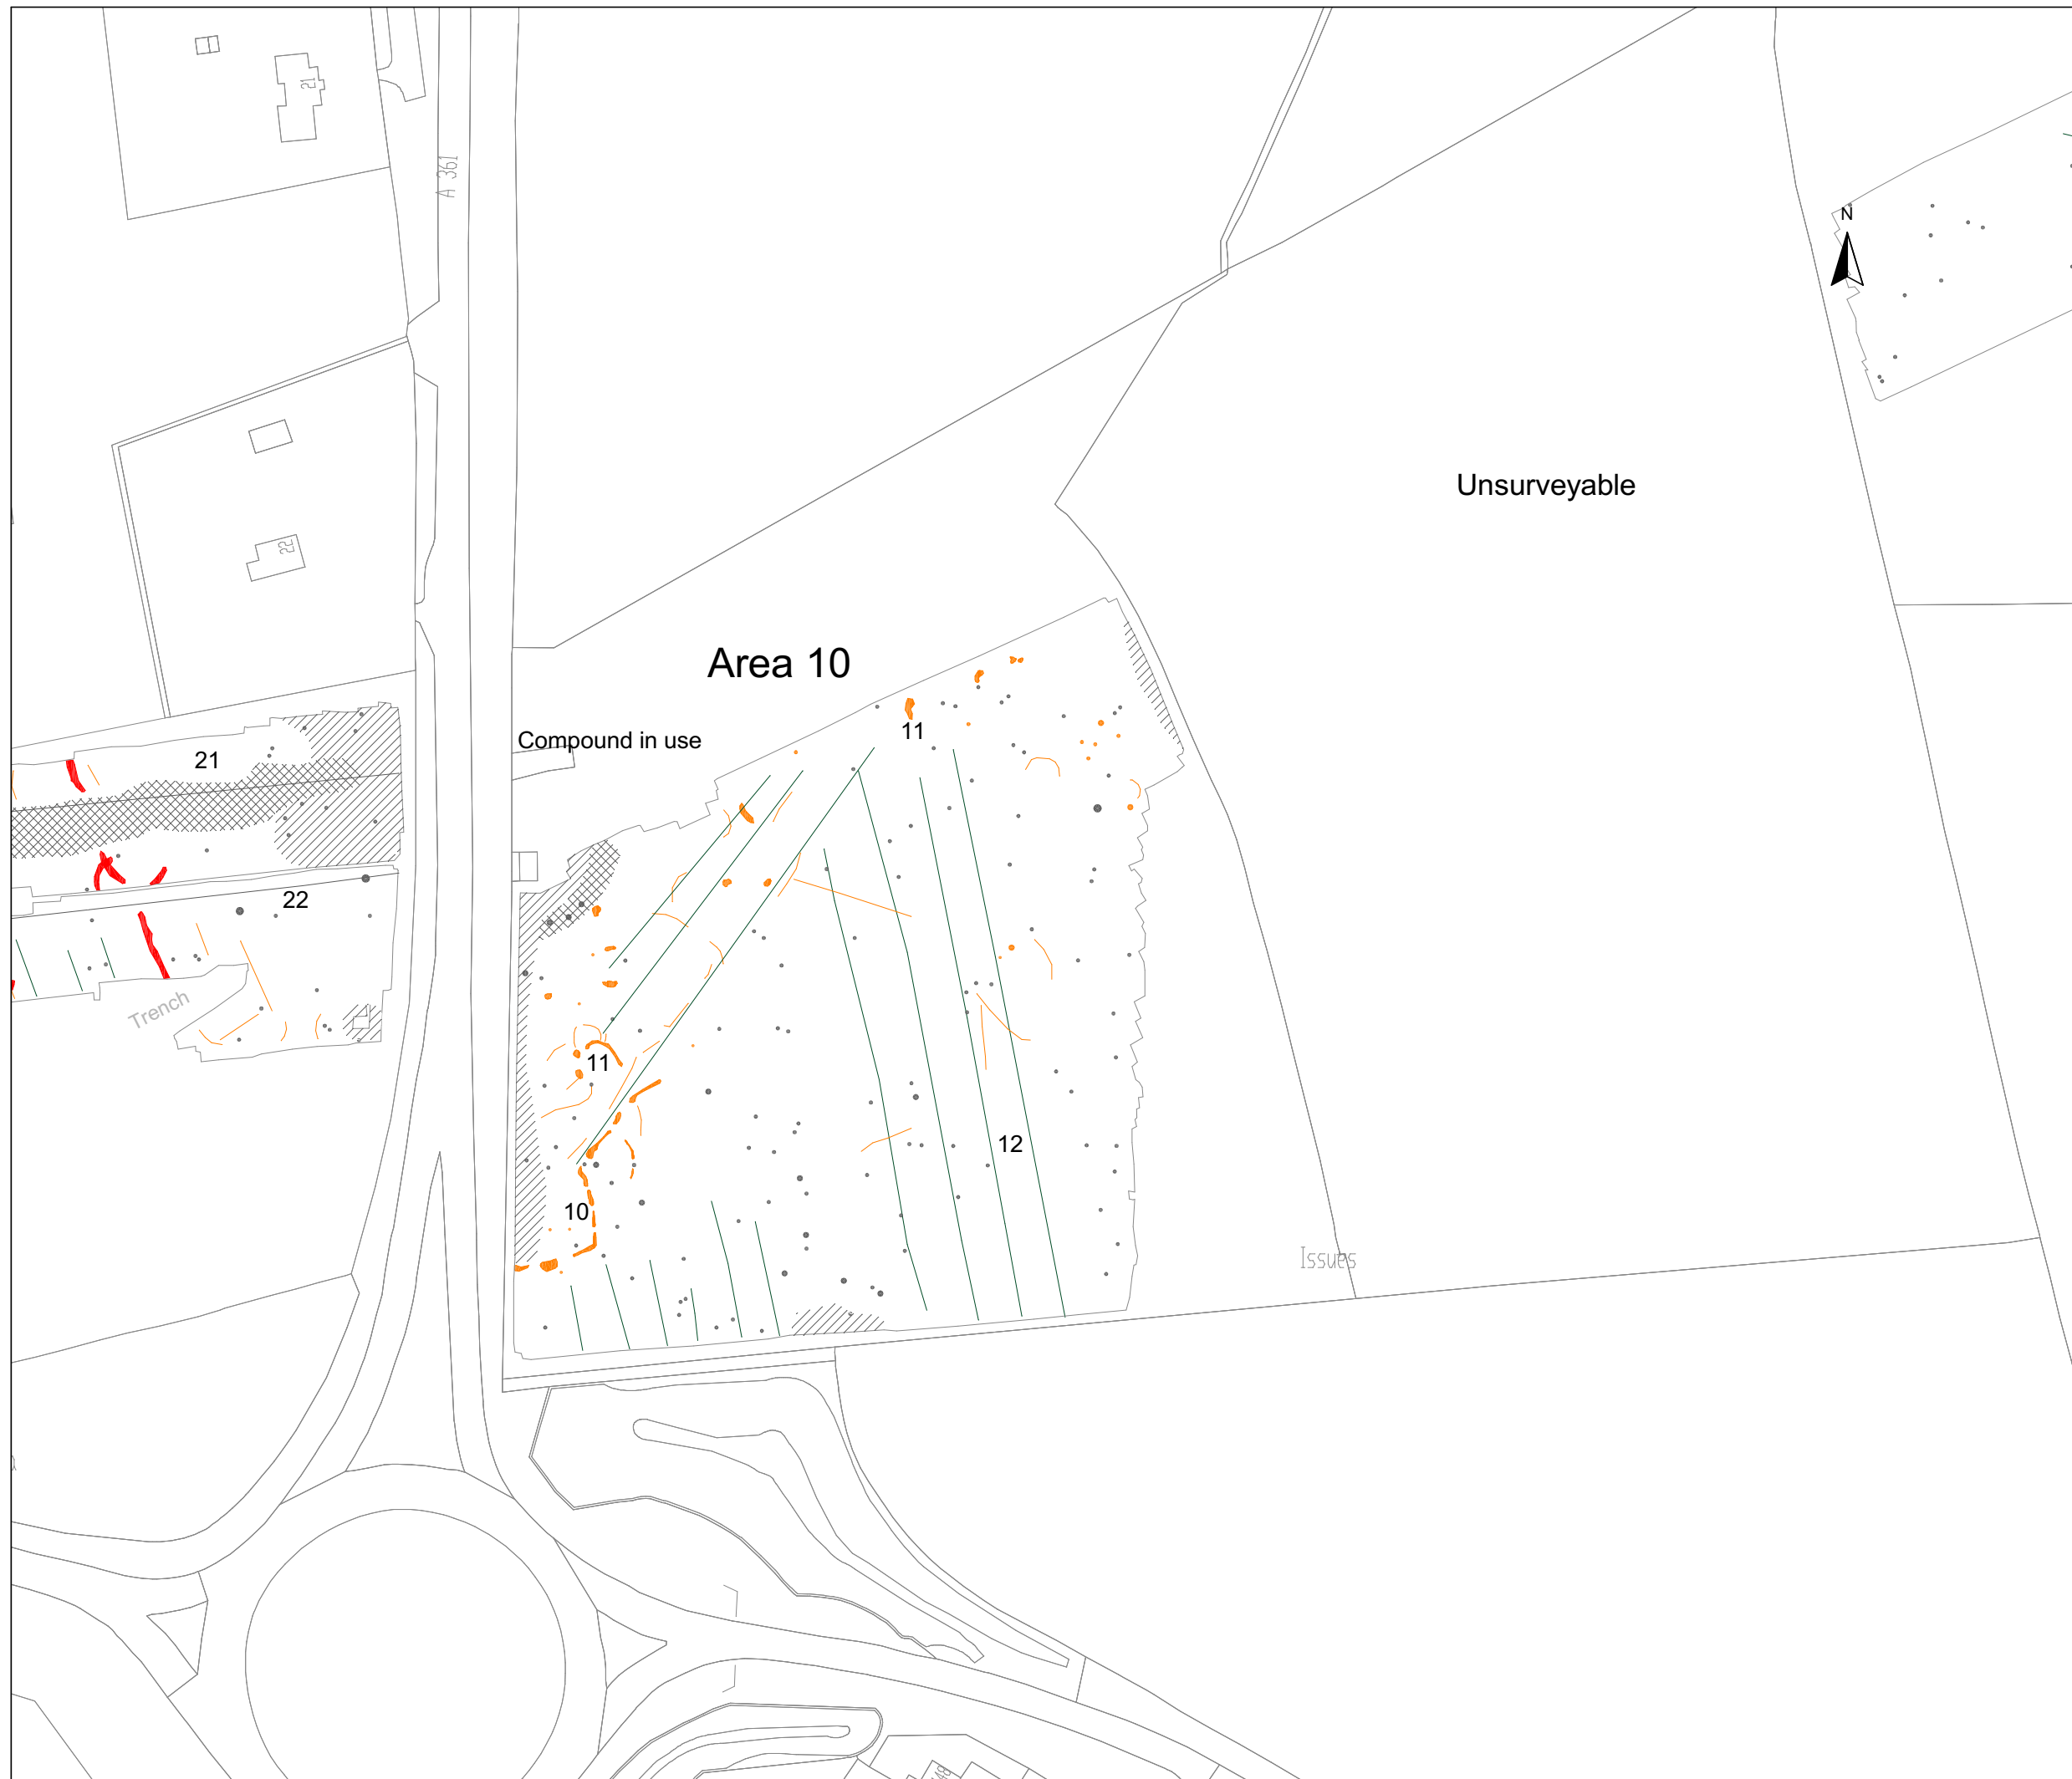
Strong dipolar anomaly - ferrous object

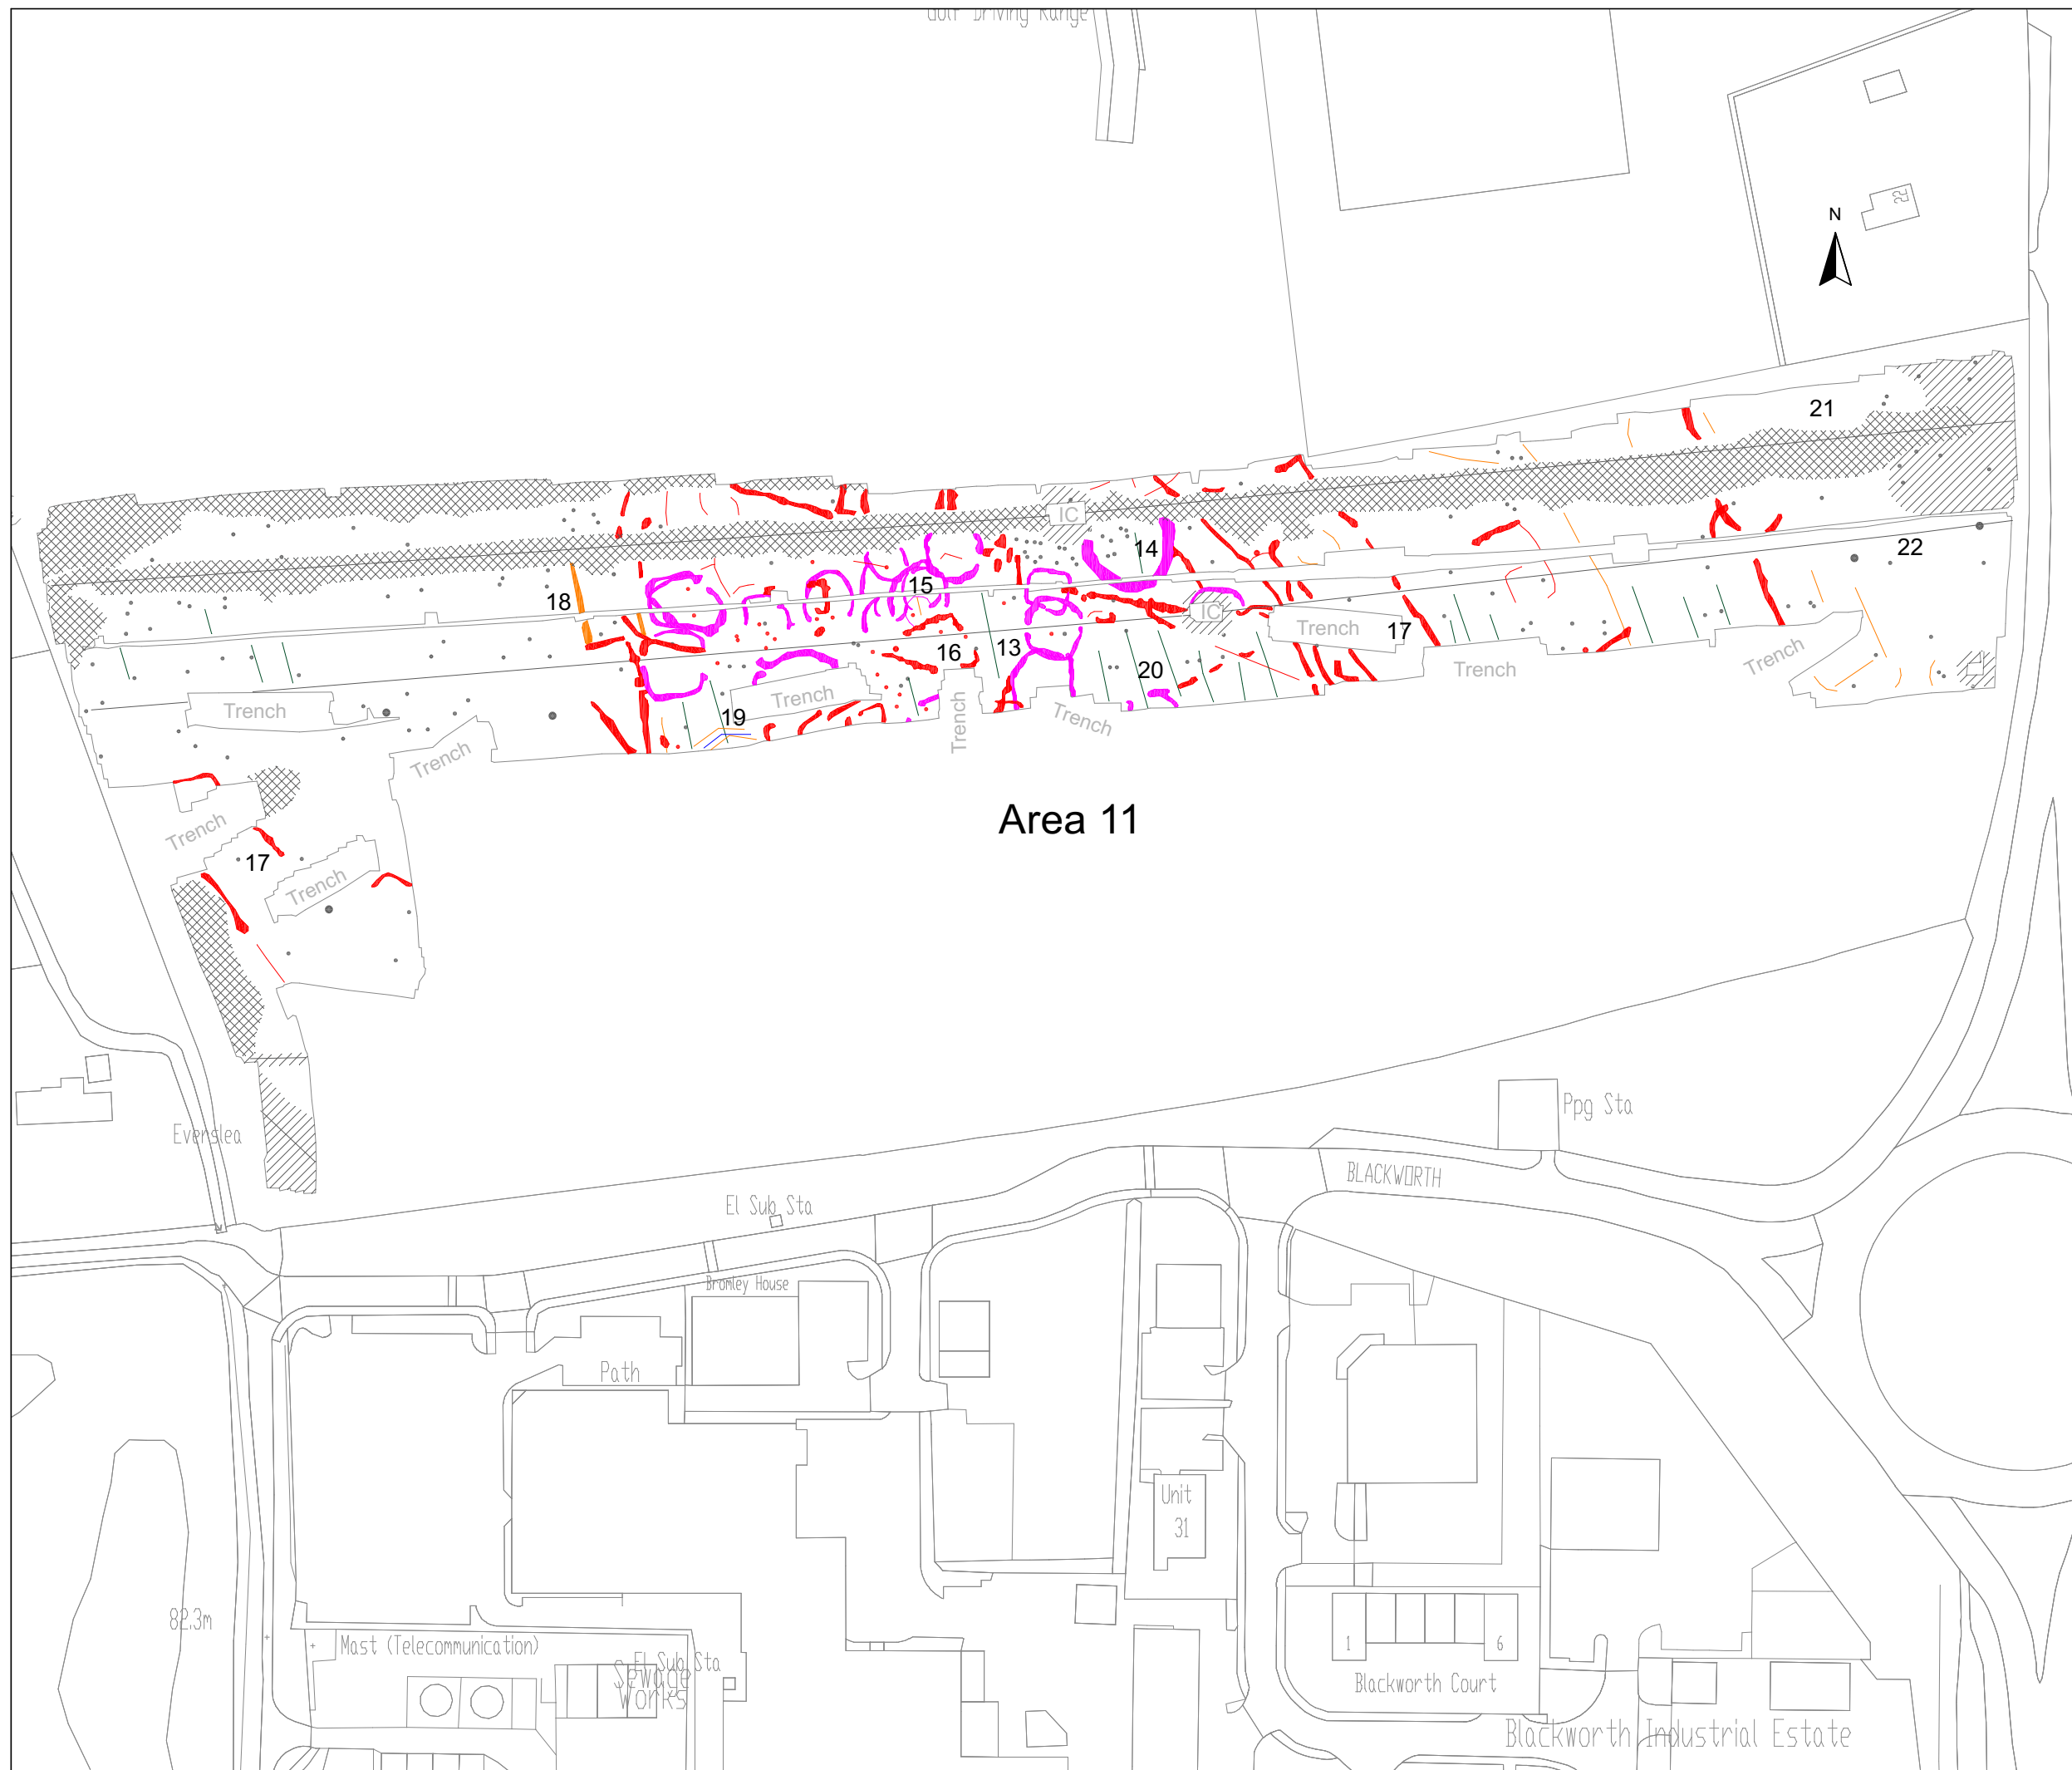
Strong dipolar anomaly - ferrous object

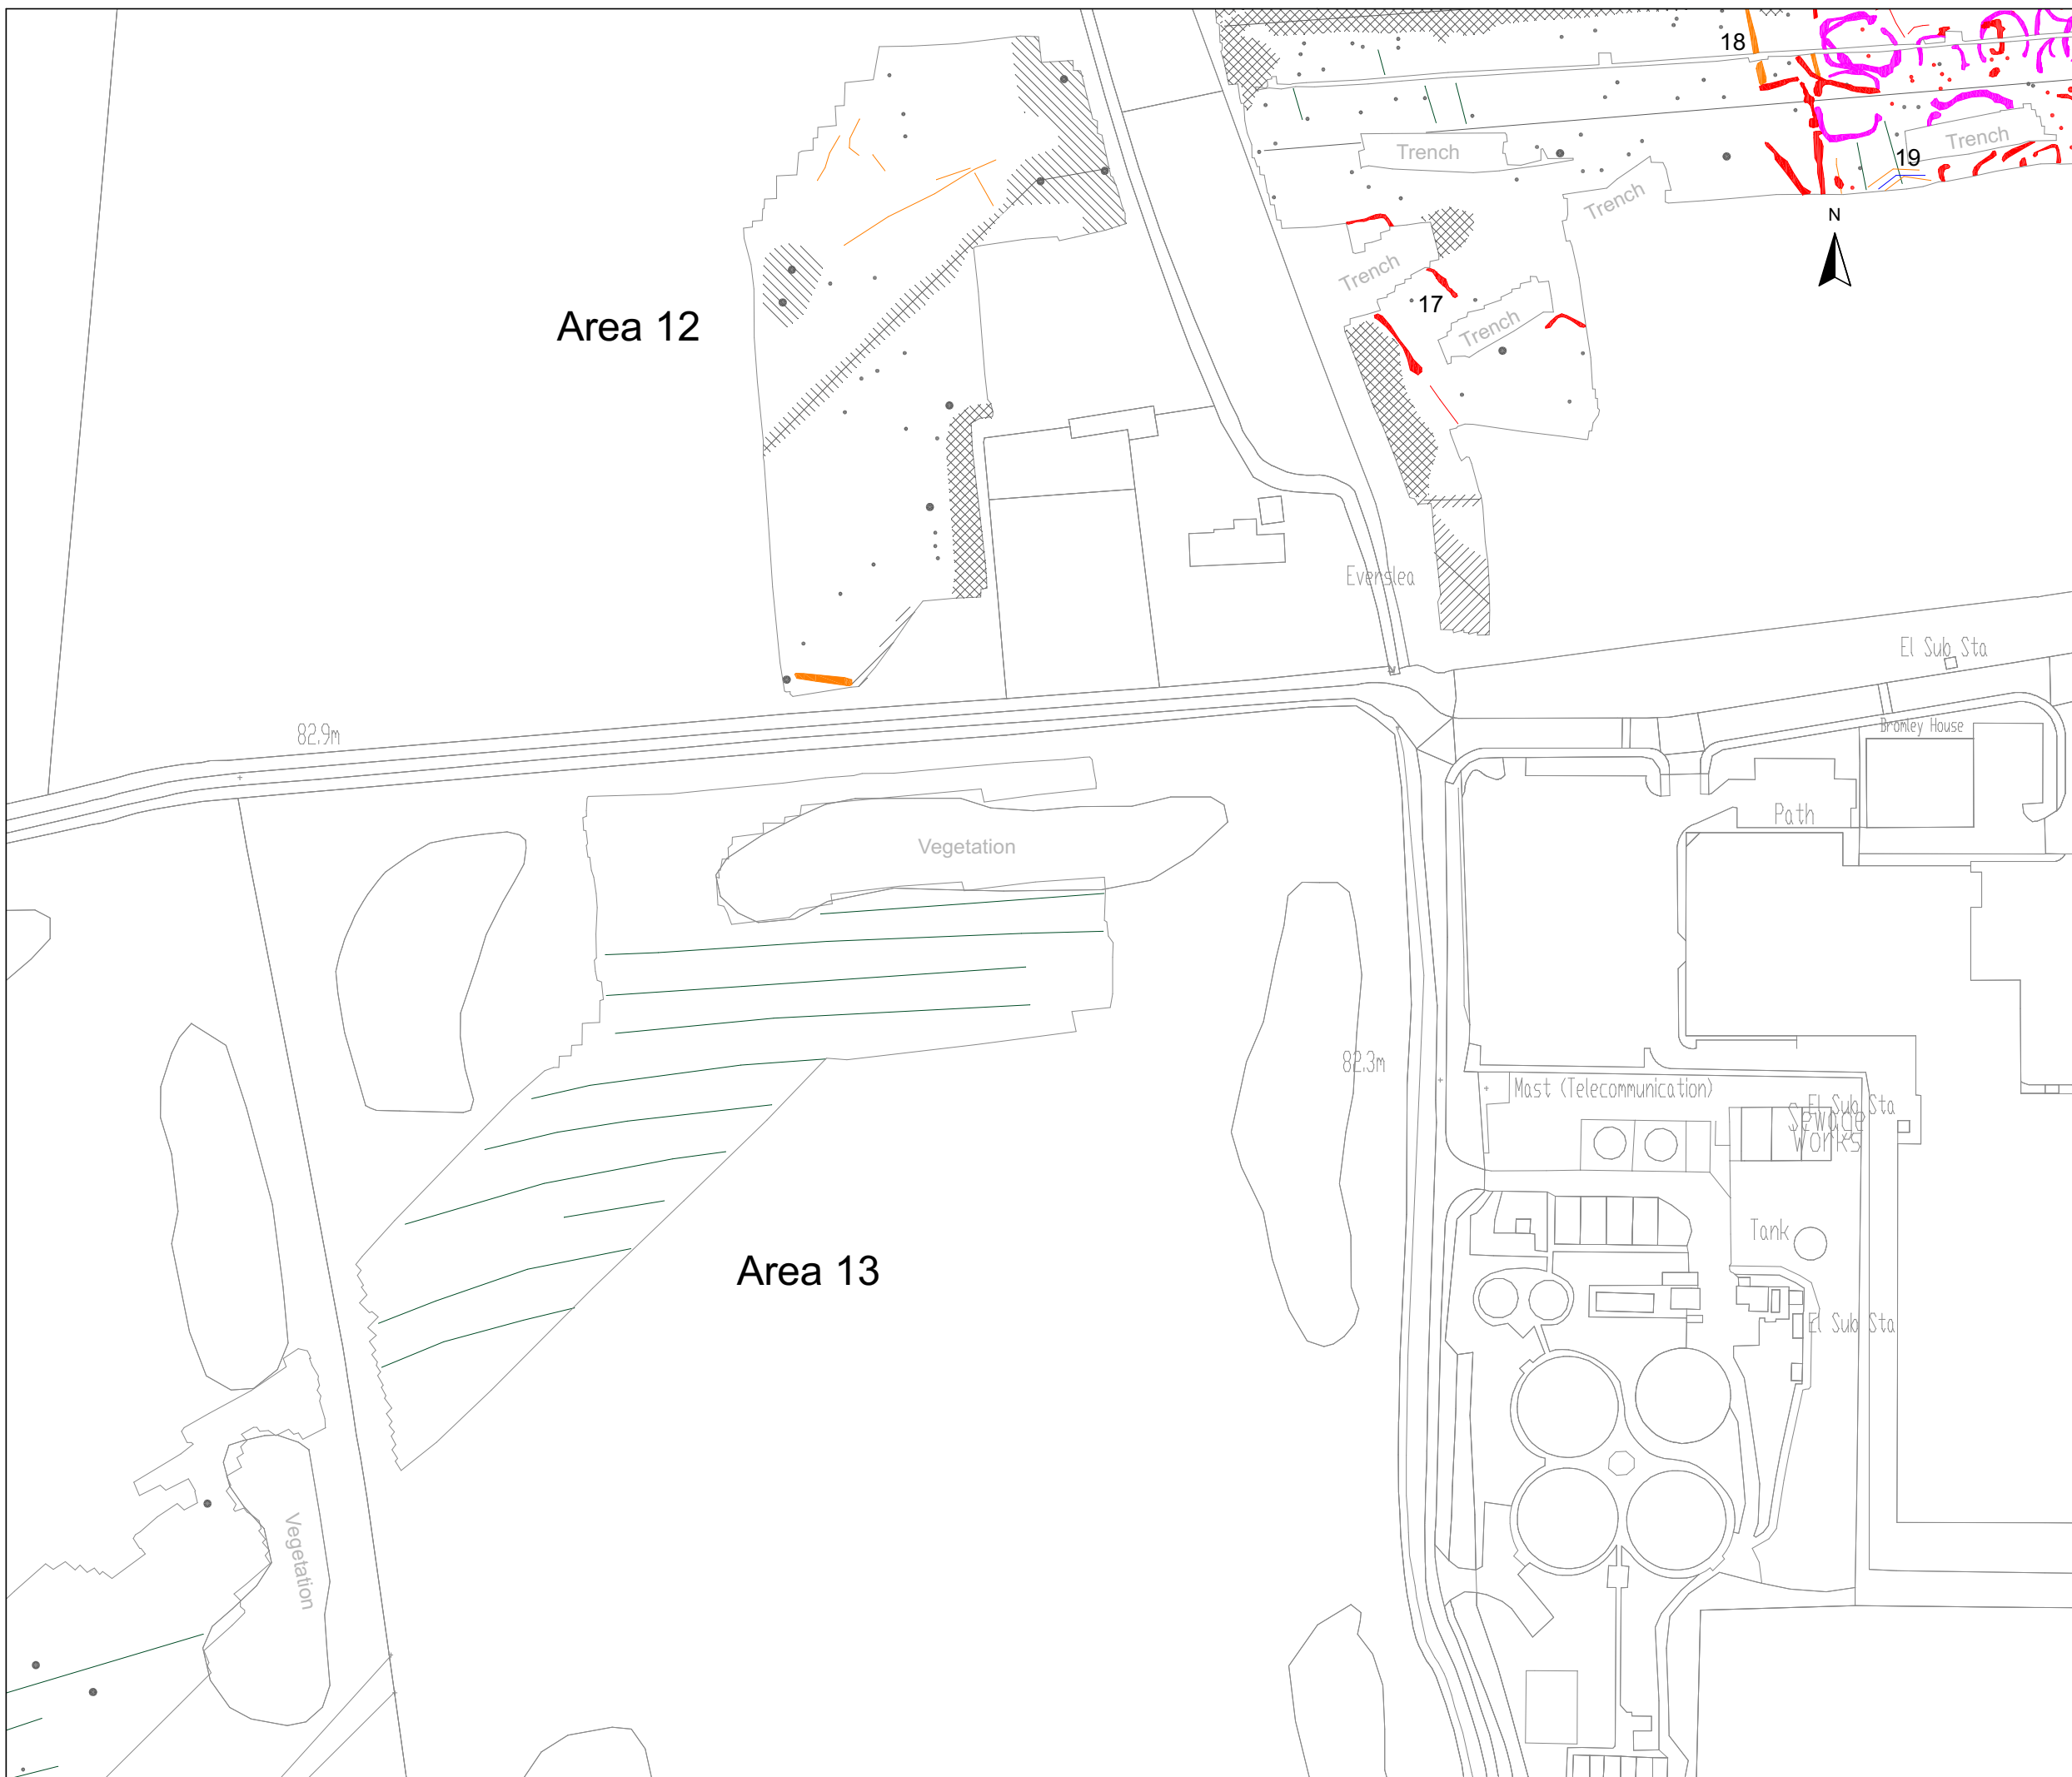
Strong dipolar anomaly - ferrous object
