## Temple Gardens, Lindum Road, Lincoln

### Archaeological Desk-based Assessment

Report No.: 474

Site Code: LRD01  
LCCM Accession No.: 2001.281  
Planning Application No.: -  
NGR: SK 97823 71600

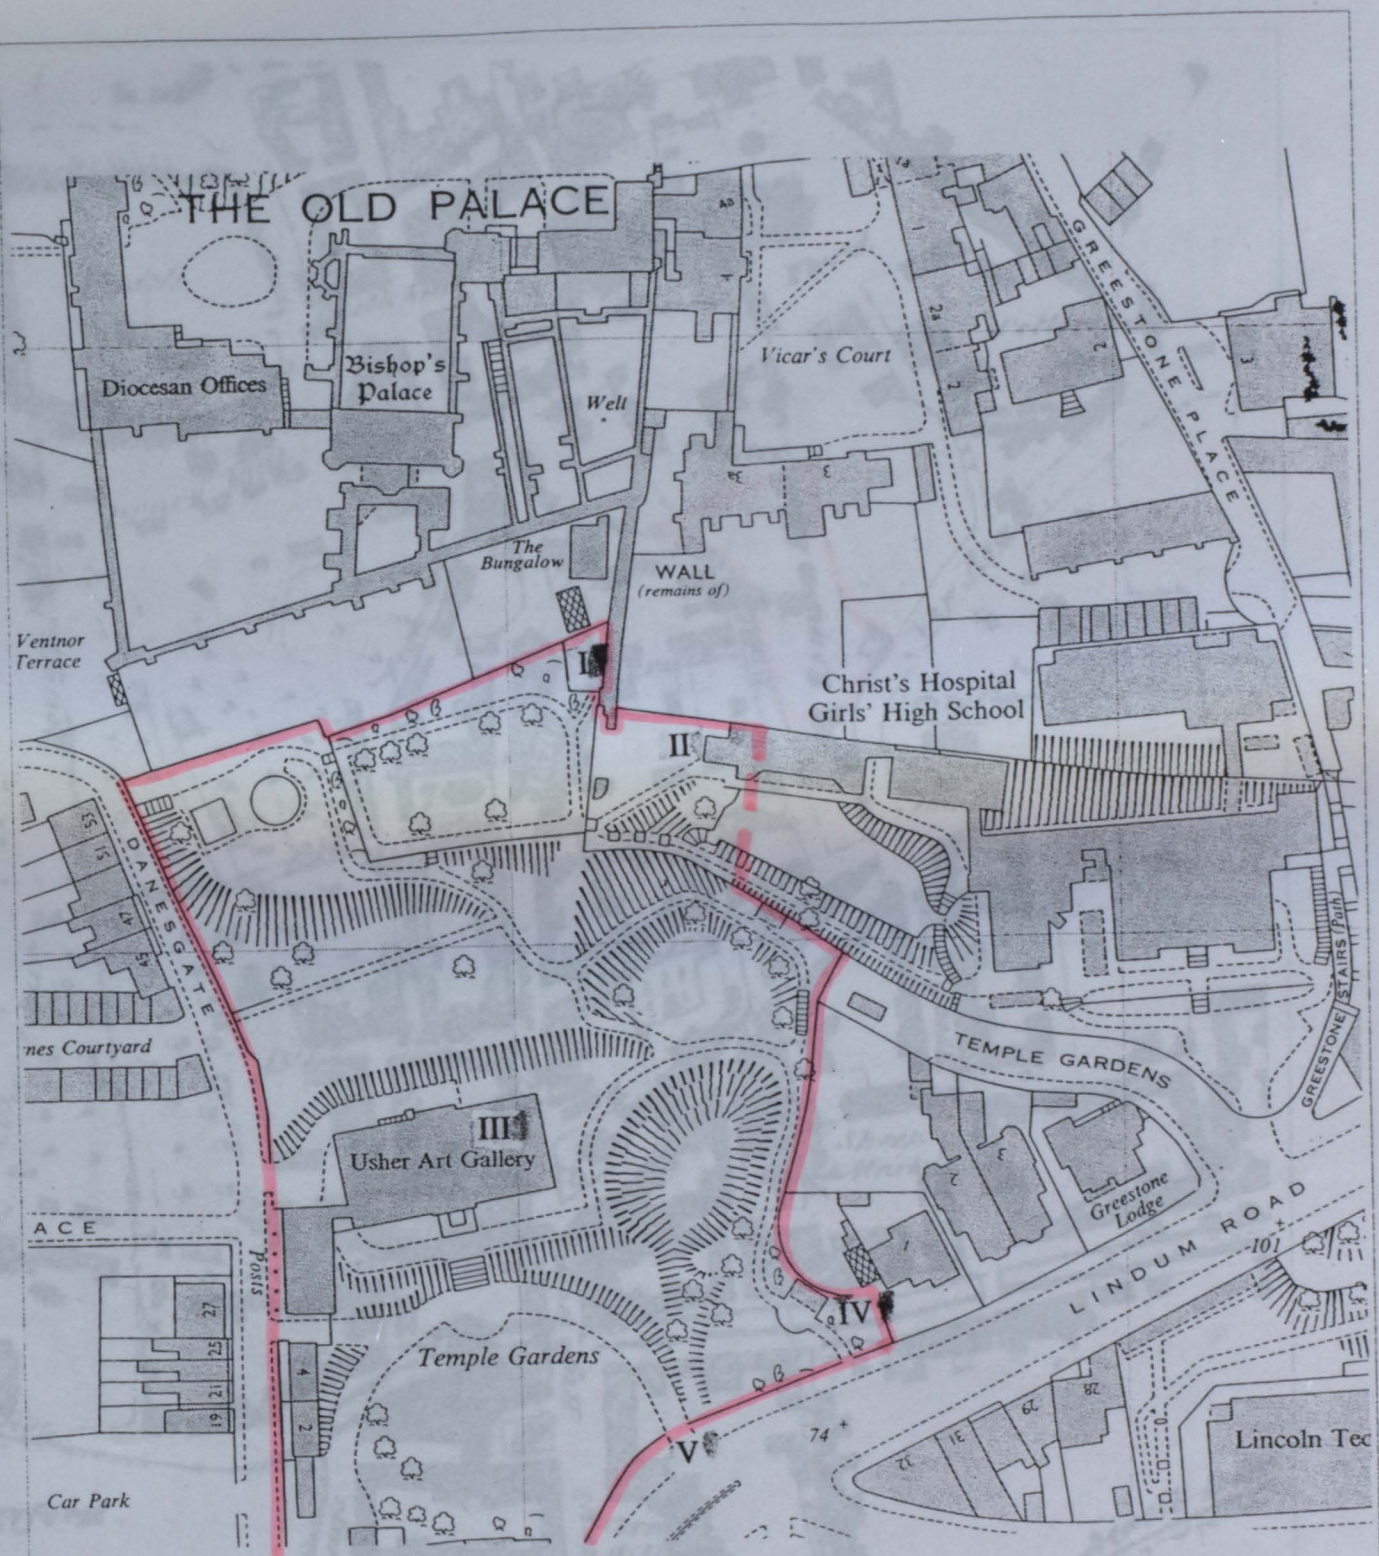
The site includes three Scheduled Ancient Monuments requiring Scheduled Monuments Consent for any development (see Appendix A, Table 1 and Fig. 2), five listed buildings (see Appendix A, Table 3 and Fig. 4) and lies within Cathedral and City Centre Conservation Area No.1.

Formal archaeological work on the site itself has been confined to Archaeological Watching Briefs during the construction of a sign (see Fig. 2, 1), and during the excavation of a series of Geotechnical Test Pits (see Fig. 2, - 2, 3, 4, 5). This work has produced only limited information on the nature of archaeological deposits in the area (see Appendix A - Table 4 and 6.4 below). A watermain trench just east of the site (see Fig. 2, 6) encountered only recent deposits comprising the backfills of earlier service runs.

Table 1 - Scheduled Ancient Monuments (See Fig.2)

Table 4 - Previous Archaeological Recording Within Temple Gardens (See Fig.2)

In 1859, cremation burials were found to the east of the site, during the construction of Nos 1-3, Temple Gardens (Fig. 2, 20). Further north, c. 40m east of the north-eastern corner of the study area, an almost complete Roman pot (possibly a cremation urn) was found during the digging of foundations for an extension to the Art College in 1989 (Fig. 2, 18). The pot lay within a deposit of brown loam immediately beneath the topsoil. Two inscribed tombstones were found to the south of the site - opposite Sessions House and north of Clasketgate - during the digging of foundations for new houses in 1830. One, found in the east wall of the Roman lower city, was inscribed *To the spirits of the departed (and) to Claudia Crysis; she lived ninety years. Her heirs had this set up* (Collingwood & Wright 1965, 88 RIB 263). The other, re-used in the foundations of the east wall of the lower city, was in memory of Lucius Sempronius Flavinus, a Spanish soldier of the Ninth Legion (Ibid, 85 RIB 256). Fragments of another tombstone were seen built into the an outbuilding of Greestone House to the north-east of the site (Ibid, 86 RIB 259). In 1889 carved stone was found in association with the east wall at the northern end of the Temple Gardens.

In 1936, workmen excavating the foundation trenches for an extension to the college at Cathedral Street located a pottery kiln (Fig. 2, 8) with pots still in situ ready to be fired. The kiln, which was excavated by FT Baker, was producing *mortaria* (mortars), each stamped with the name of the potter (VITALIS), in the 2<sup>nd</sup> century AD.

Recent work on sites to the east and south-east at Sessions House (Fig. 2, 9) and Cathedral Street (Fig. 2, 7) and to the east at De Montfort University's Greestone Centre (Fig. 2, 19), has highlighted the potential for an extensive late Anglo-Saxon/Anglo-Scandinavian pottery industry east of the lower city defences.

A late 10<sup>th</sup> century kiln located immediately north of the Sessions House during a trial trench evaluation in 1997 (Fig. 2, 9) provides the most conclusive evidence for this industry. Waste vessels from the site included two ware types – shell tempered (*LSH*), and reduced quartz sand tempered (*SNLS*). The association of the chronologically later ware type (*SNLS*) with the earlier *LSH* hints at an experimental stage in the production of the latter ware type. In the light of this, the material may be regarded as of regional or even national importance (Jarvis 1997, 12-13).
