34 ST PETERS STREET, STAMFORD,

ARCHAEOLOGICAL WATCHING BRIEF

SITE CODE: SPSS01

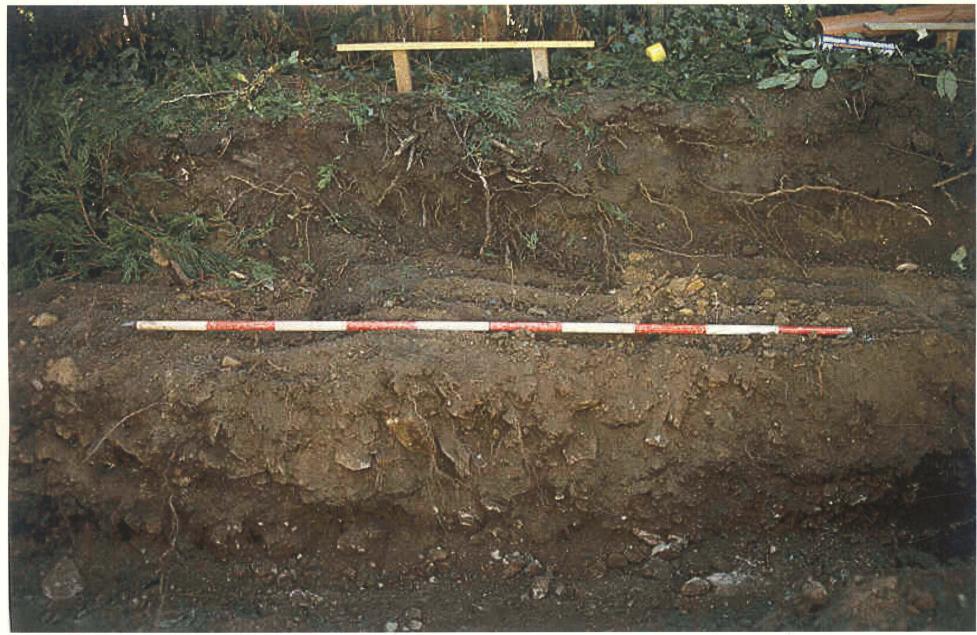
Topsoil and subsoil depth varied due to landscaping of the site from c.1.0m to the north, c. 0.6m towards the middle and 0.9m to the south.

Plate 1: Photograph showing topsoil build-up
