### LINCOLN CASTLE RE-EXAMINATION OF 1983 TRENCH AT WEST GATE

By L Donel & M J Jones

CLAU ARCHAEOLOGICAL REPORT NO: 28

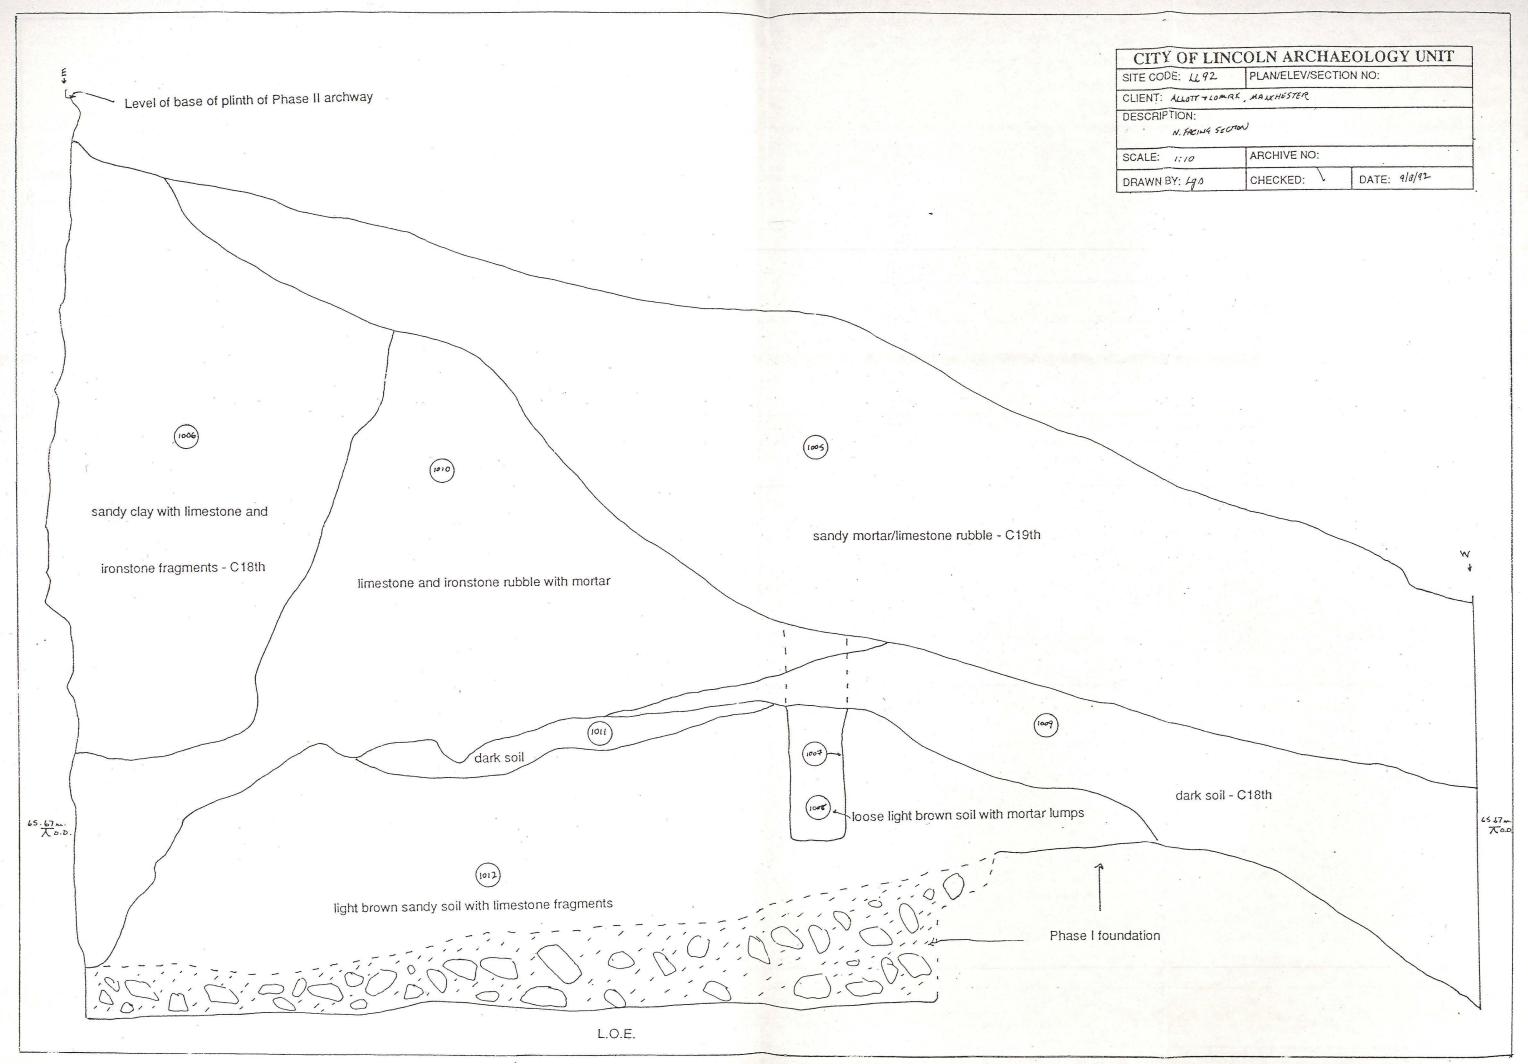
The 1983 trench was originally cut from c. 2m above the foundation level. However, some erosion has taken place since the excavations. The N. facing

section showed a series of modern deposits, probably backfill dated by pottery to the 18th and 19th centuries. There was no evidence to indicate that any of the present infill material was associated with the medieval gate itself (see fig.2).

- The material at the bottom of the 1983 trench, lying c.2m below the gate cill, is part of the raft foundation for the gate. Material above this is of post medieval date and could be removed under archaeological supervision. The raft could be used as a base for the bridge foundations without significant damage to archaeological remains.
- 2. It is probable that the foundations extend along the full extent of the gap between the N and S outer walls. It would, therefore, be useful, should the infill material be removed, for a watching brief to be carried out during the removal. This would allow for the full recording of the complete extent of the remaining foundations and their relationship to the two outer walls of the West Gate.

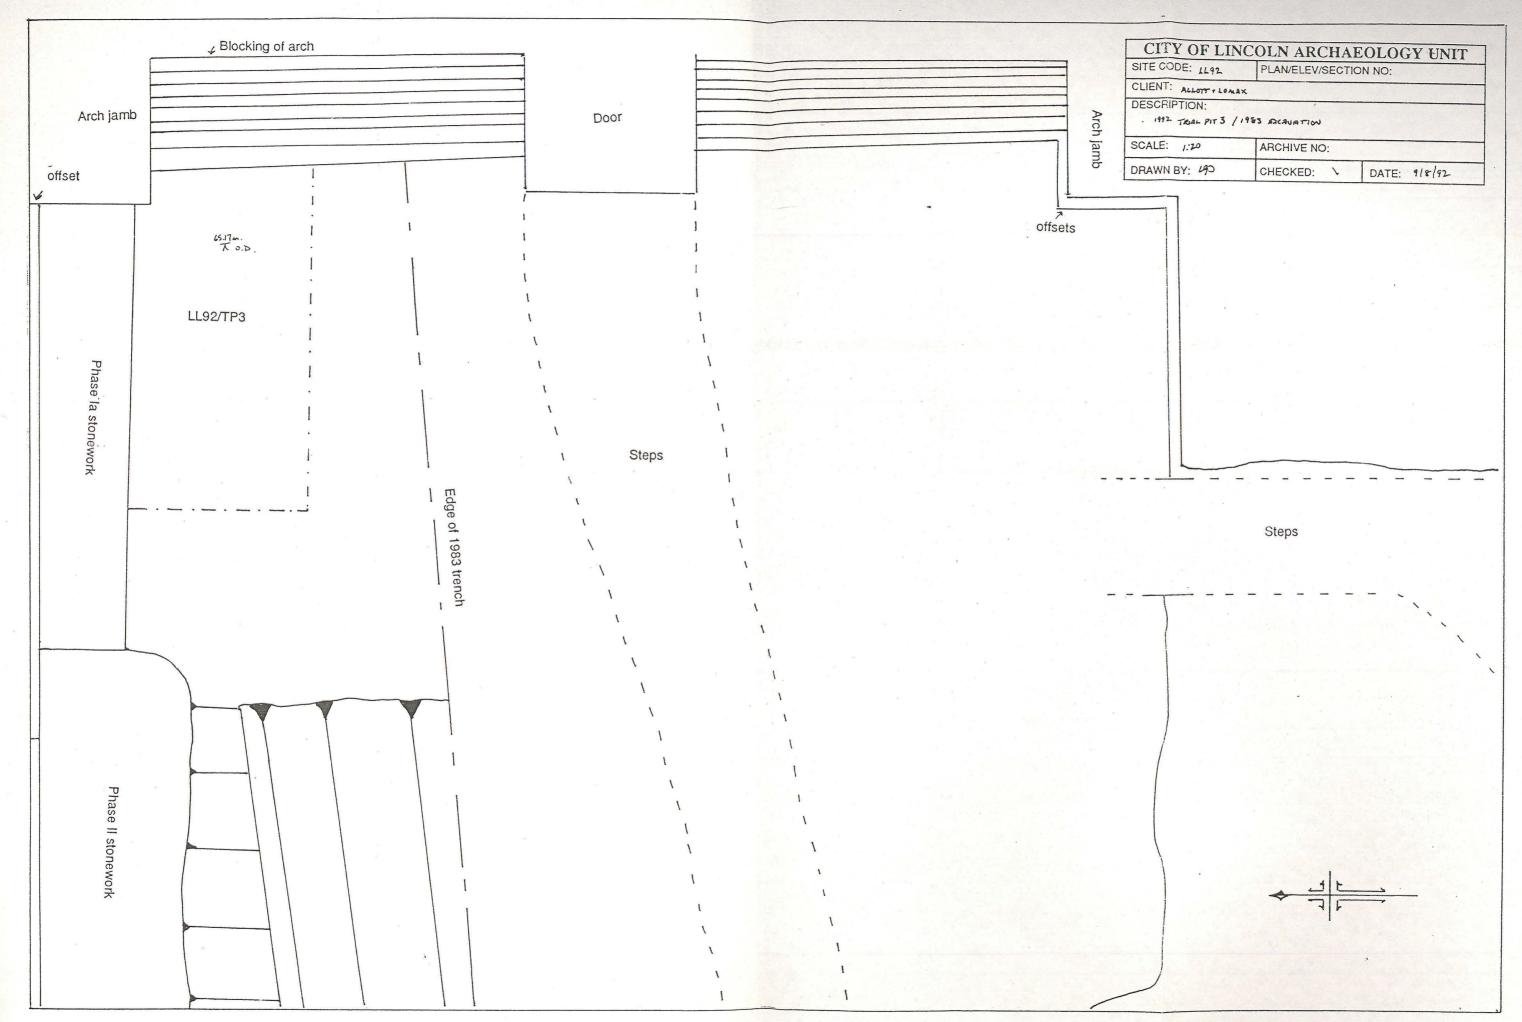
The bottom of the trench, as revealed, had, indeed, been cut into the foundations for the West Gate. These foundations consist of a substantial raft of limestone rubble in a bed of clay and mortar which projects westwards towards the castle ditch. As seen, the foundations included a mixture of yellow mortar and small (10cms) to large (30-40cms) limestone fragments and blocks. Sealing this was a layer of light brown sandy earth (context (1012) from the 1983 excavation) which may represent the top of the raft. At the time, the raft and the earliest foundations found beneath the flanking walls were considered to be structurally earlier than the 12th century gate since the foundations for the gate itself abut them. Higher up, however, the two appear to be bonded in and there seems no reason why they could not be contemporary.

The 1983 excavation had been cut approximately 0.40m into the foundations under the misconception that the layer was natural limestone brash. This supposition was proved incorrect as the excavation moved westwards revealing a more substantial foundation approximately 2m to the W of the gate entrance (fig.3).
