**Land adjacent to All Saints Church,
22 Church Street, Hemswell,
Lincolnshire**

Archaeological Watching Brief

**LAS Report No. 729
March 2004**

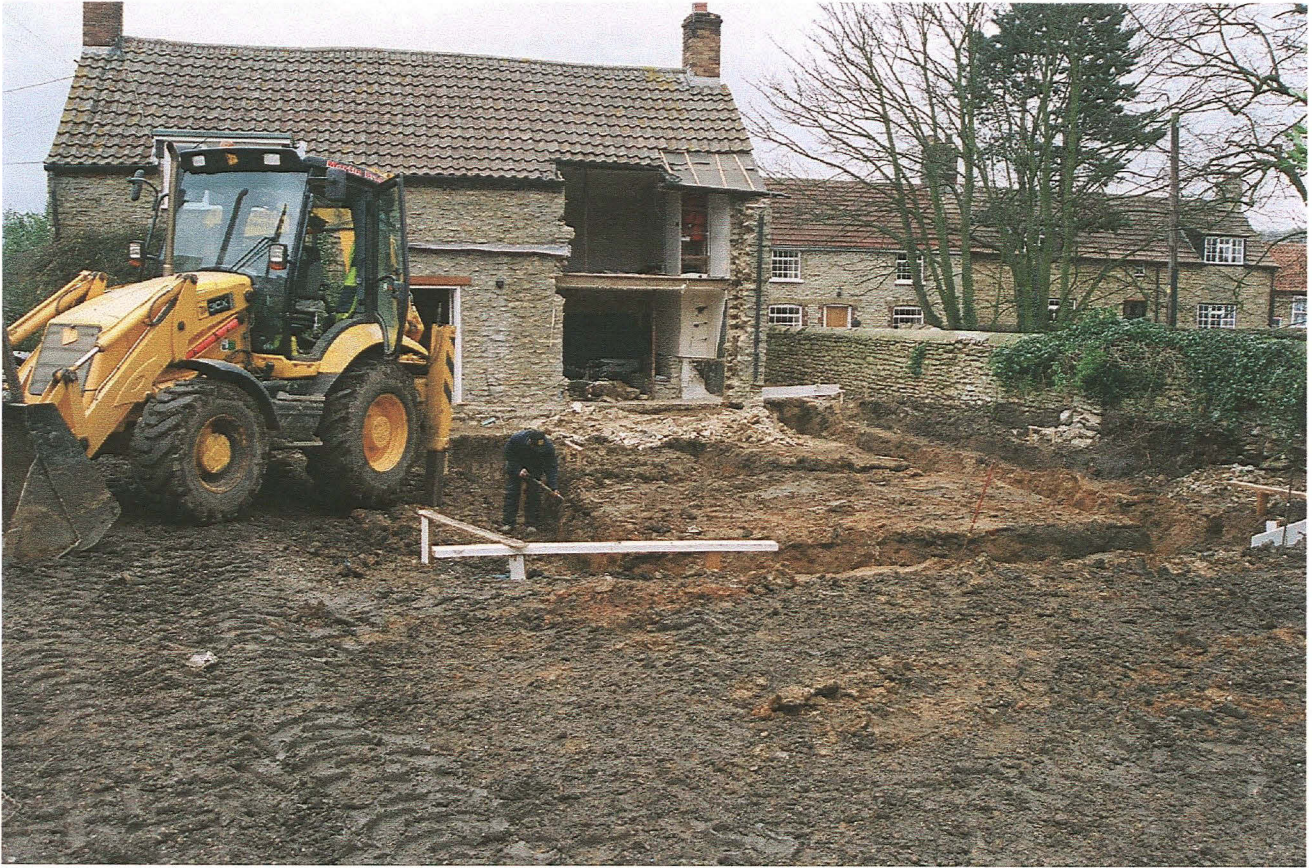
PI.3 View to the rear of the property, showing the demolished southern wall and partially completed excavation of the proposed foundations. Facing north east

External load bearing trenches were excavated to a depth of 1.50m, with a width of 0.85m. Foundations supporting internal partitions were excavated to a depth of 1m, with a narrower width of 0.50m (Pls 3 and 4). A common stratigraphic sequence was recognised across the site, comprising a concrete slab (1) to a depth of 0.25m below existing ground level, overlying mid orange yellow stiff clay (3). Dark brown/black silty topsoil (2), 0.20m in depth, surrounded the concrete slab, and covered the remainder of the site (Pl. 5).

No archaeological finds or features were present within the trenches and only a single fragment of glazed ridge tile was retrieved from the topsoil. Root boles and animal burrows had disturbed much of the site, along with a 19th century soakaway [4] associated with the existing property (Pl. 6). Added to this, a certain amount of unavoidable disturbance had occurred from the movement of machines across the site (Pls 3-4).

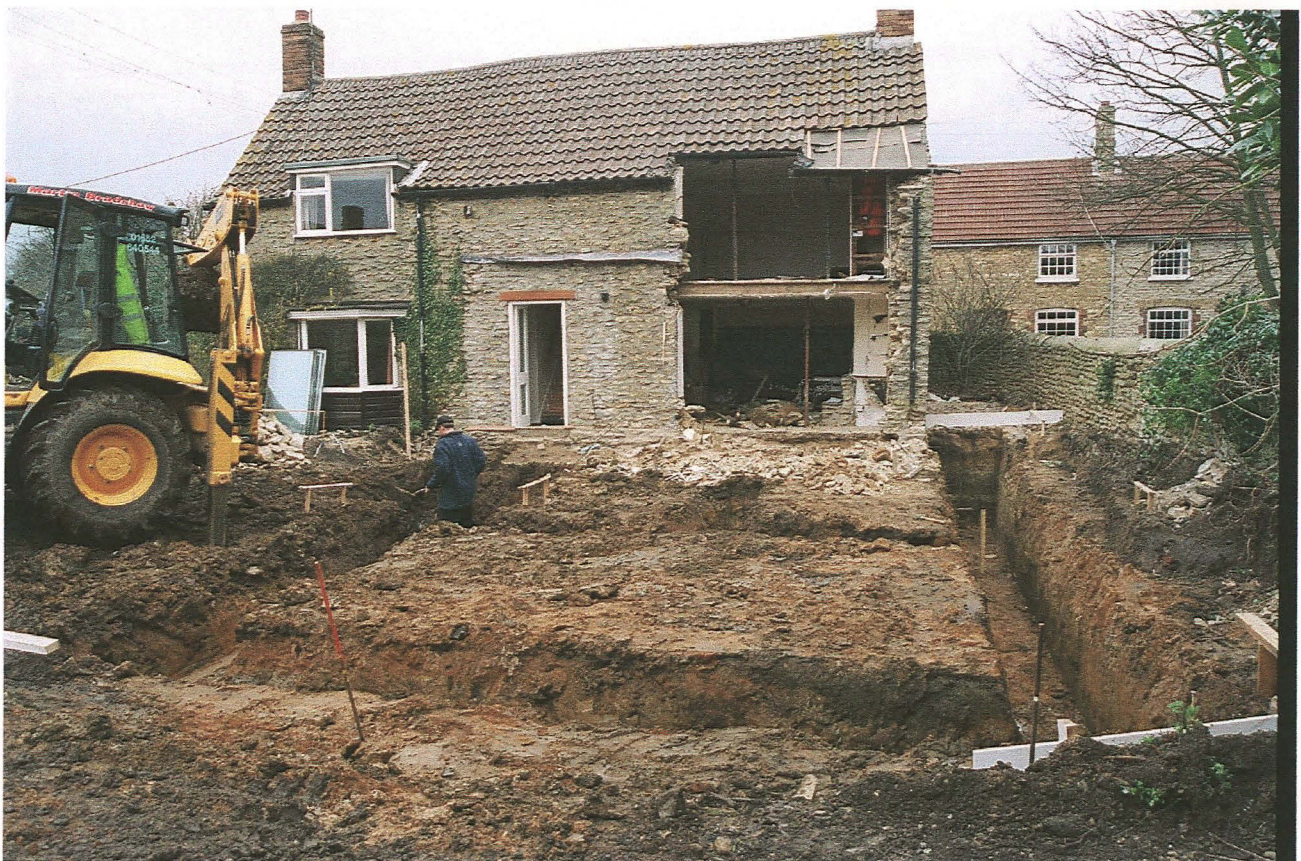
PI.4 View to the rear of the property, showing the demolished southern wall and partially completed excavation of the proposed foundations. Facing north.

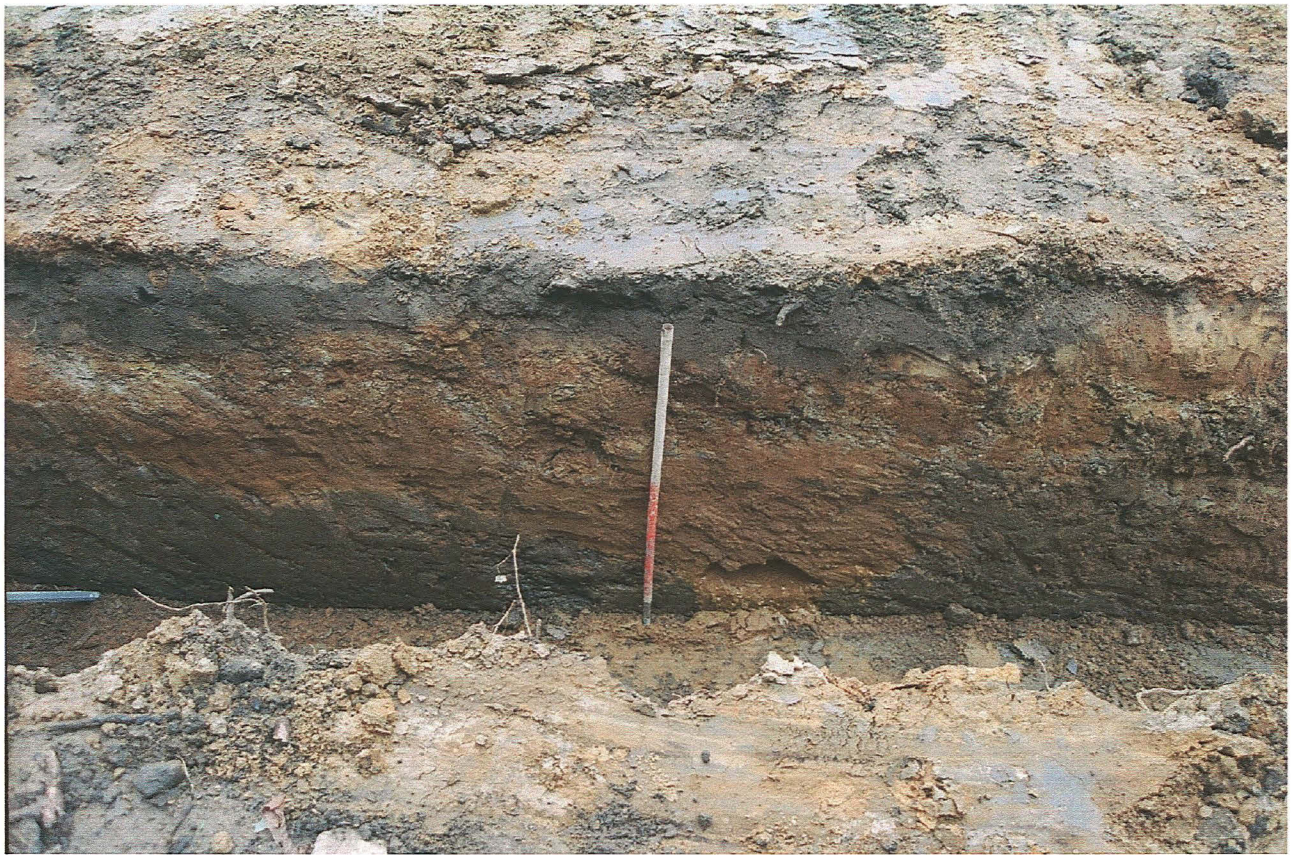
PI.5 Typical section showing the natural clay (3) deposits. This profile was common across the entire (excavated) site.

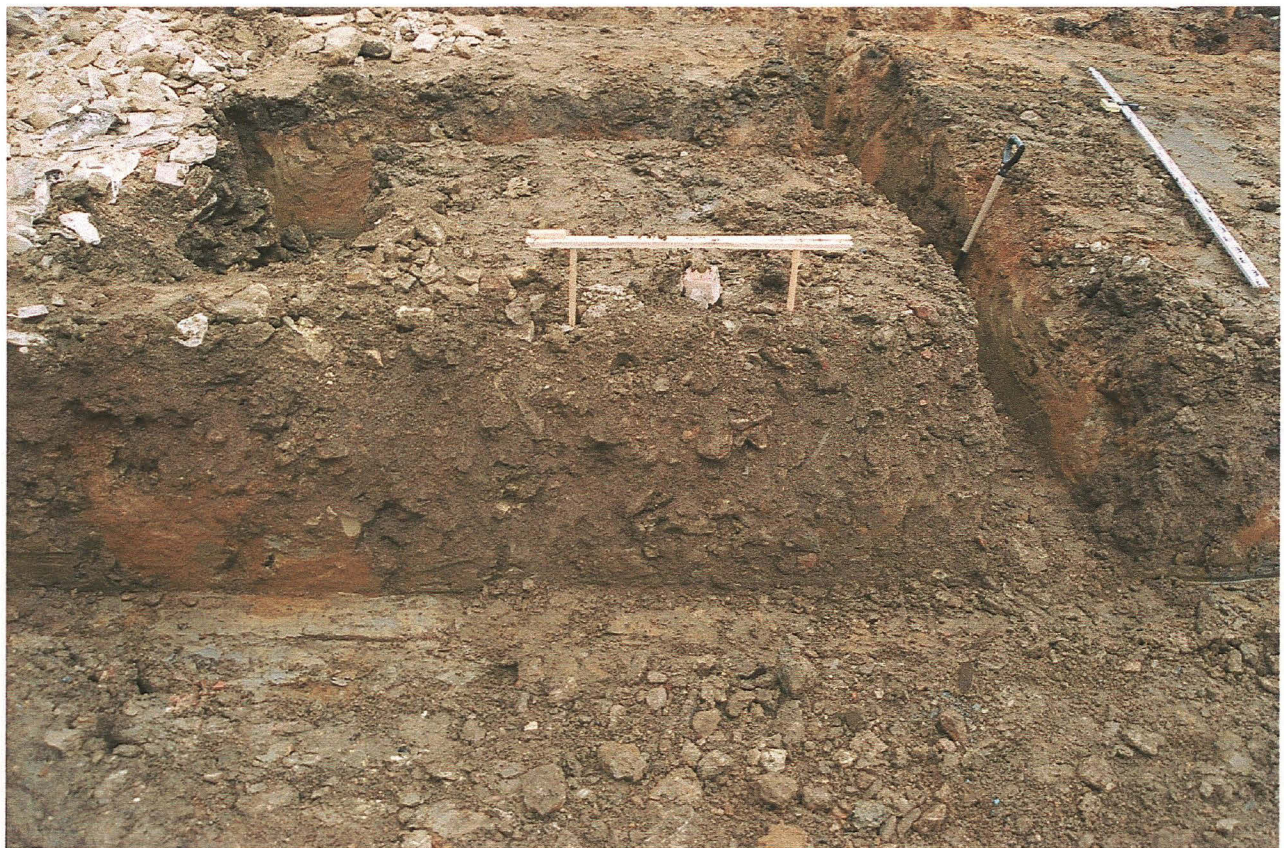
PI.6 Soakaway [4], facing east
