ARCHIVE REPORT

Lodge Hotel, 38-40 Nettleham Road, Lincoln

CLAU CODE : ON552 PLANNING APPLIC.LD12/0750/94 FIELD OFFICER K.Wragg

DATE OF INTERVENTION: 2/3/95-8/3/95 TYPE OF INTERVENTION: Watching brief

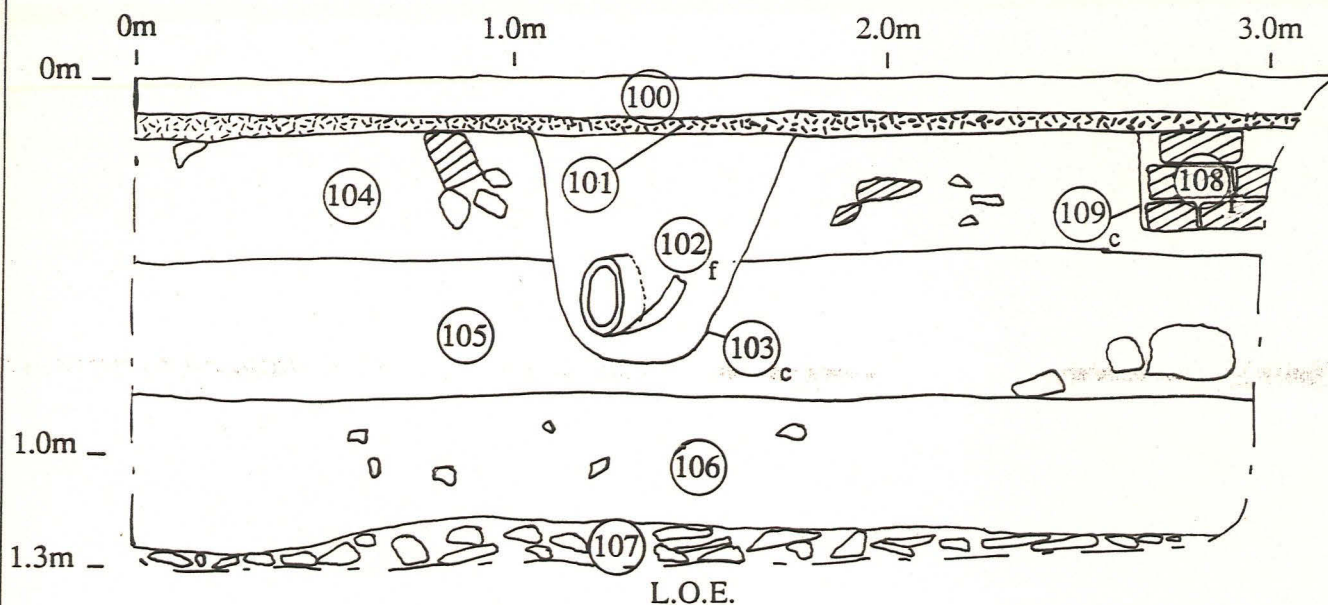
SITE CODE: ON552	PLANE/ELEV/SECTION NO:	
CLIENT: Foxby Court Developments Ltd.		
DESCRIPTION: West Facing Section		
SCALE: 1:20	ARCHIVE NO:	
DRAWN BY: KW	CHECKED:	DATE: 08/03/95
MUSEUM ACCESSION NO:

- 100 Modern concrete floor, laid on plastic D.P.M.;
- 101 Bedding for 100: well-moderately compacted mid yellow crushed limestone/sand mortar;
- 102 Fill of modern service cut: mixed mid brown sandy earth containing small pieces of l/s, brick, intrusive roots and 2 service pipes;
- 103 Service trench (probably linear), only seen in south and west facing sections;
- 104 Moderately compacted, mixed mid-light brown sandy earth containing frequent small pieces of brick, l/s and concrete etc.;
- 105 Moderately compacted, mid brown sandy earth containing only occasional small-medium sized irregularly shaped pieces of l/s;
- 106 Moderately compacted, mid-dark brown sandy earth containing only occasional small pieces of l/s;
- 107 Moderate-well compacted, friable, dull orange-brown limestone brush;
- 108 Modern brick feature: possible wall;
- 109 Linear cut for 108, oriented E-W.

In the event, excavation continued to the upper surface of the natural limestone brash [107] (see Fig.1.), which occurred at a maximum depth of c.1.30m below the existing ground surface. This layer was sealed by a series of three mid-dark brown sandy earth deposits ([104], [105], [106]) containing varying proportions of small-medium sized limestone inclusions. The uppermost of these deposits, [104], also contained frequent modern brick and concrete pieces. Unfortunately owing to the lack of any finds, it is impossible to determine the date of these deposits.

The remaining features and deposits revealed by the trenching were all obviously modern in origin, including a linear service trench oriented approximately N-S (fill [102], cut [103]), and the remains of a section of brick built foundations which appeared at the south-east corner of the trench ([108], [109]). Both of these features were cut into the aforementioned layer [104], and were in turn sealed by the hardcore and mortar bedding ([101]) for the existing modern concrete floor and damp-proof membrane [100].
