**KINGS PAVILION, UNIVERSITY ROAD, ABERDEEN, AB24 3UB
WATCHING BRIEF FOR REPLACEMENT OF TENNIS COURT
FLOODLIGHTING**

Alison Cameron
Cameron Archaeology
15 June 2014

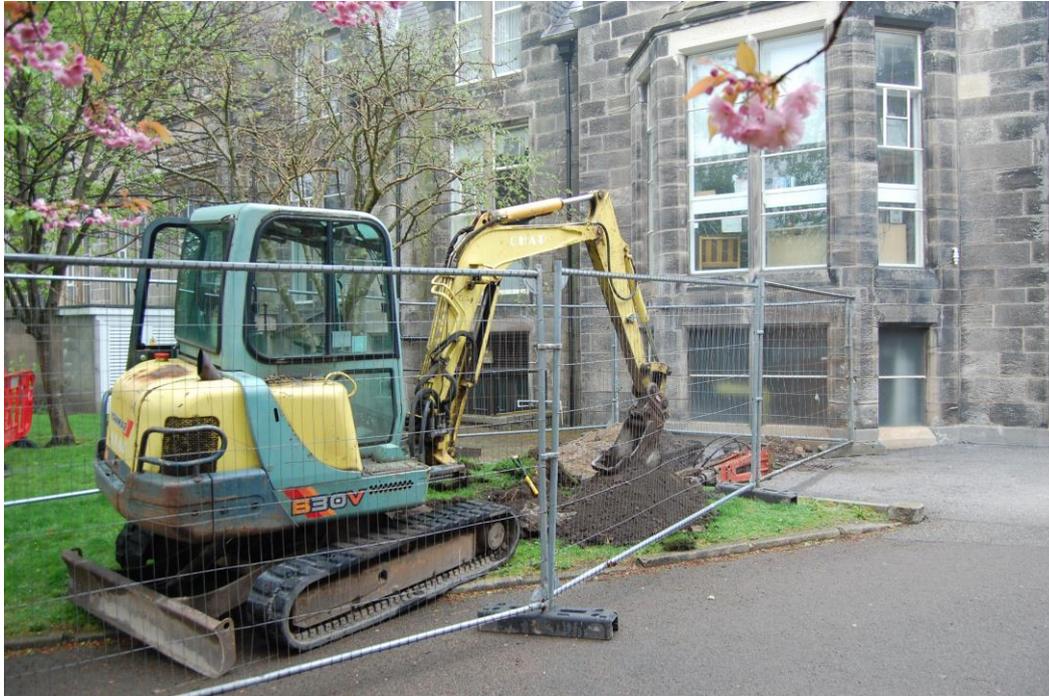
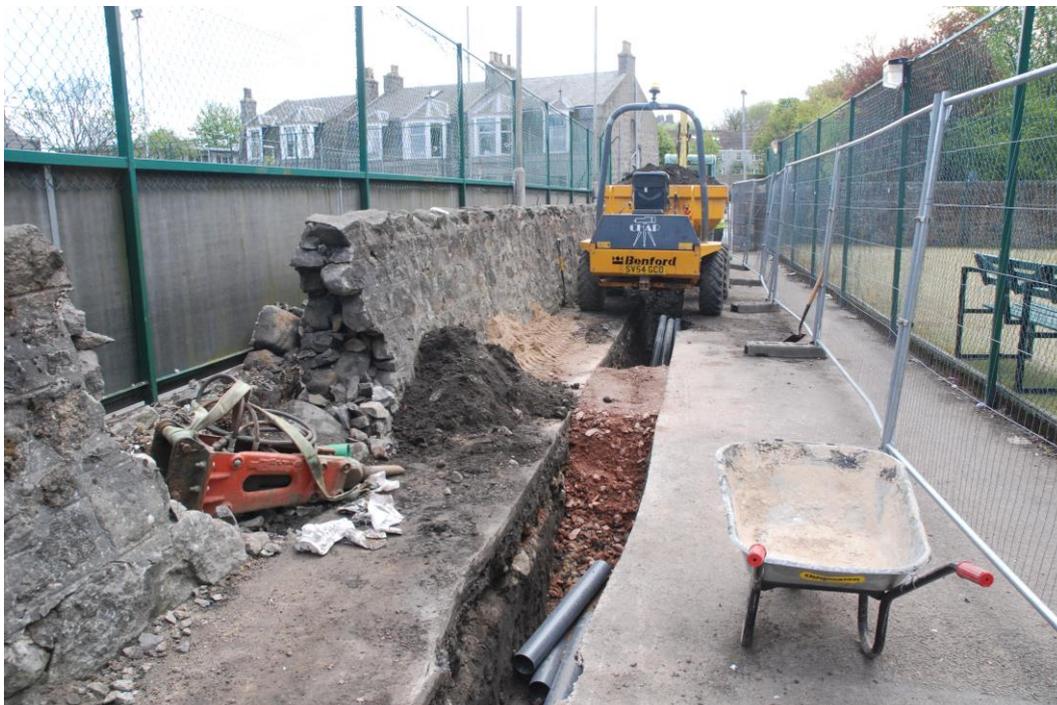
Cover top North end of north arm of trench with King's College in background; bottom the south arm of west trench showing location for lighting tower

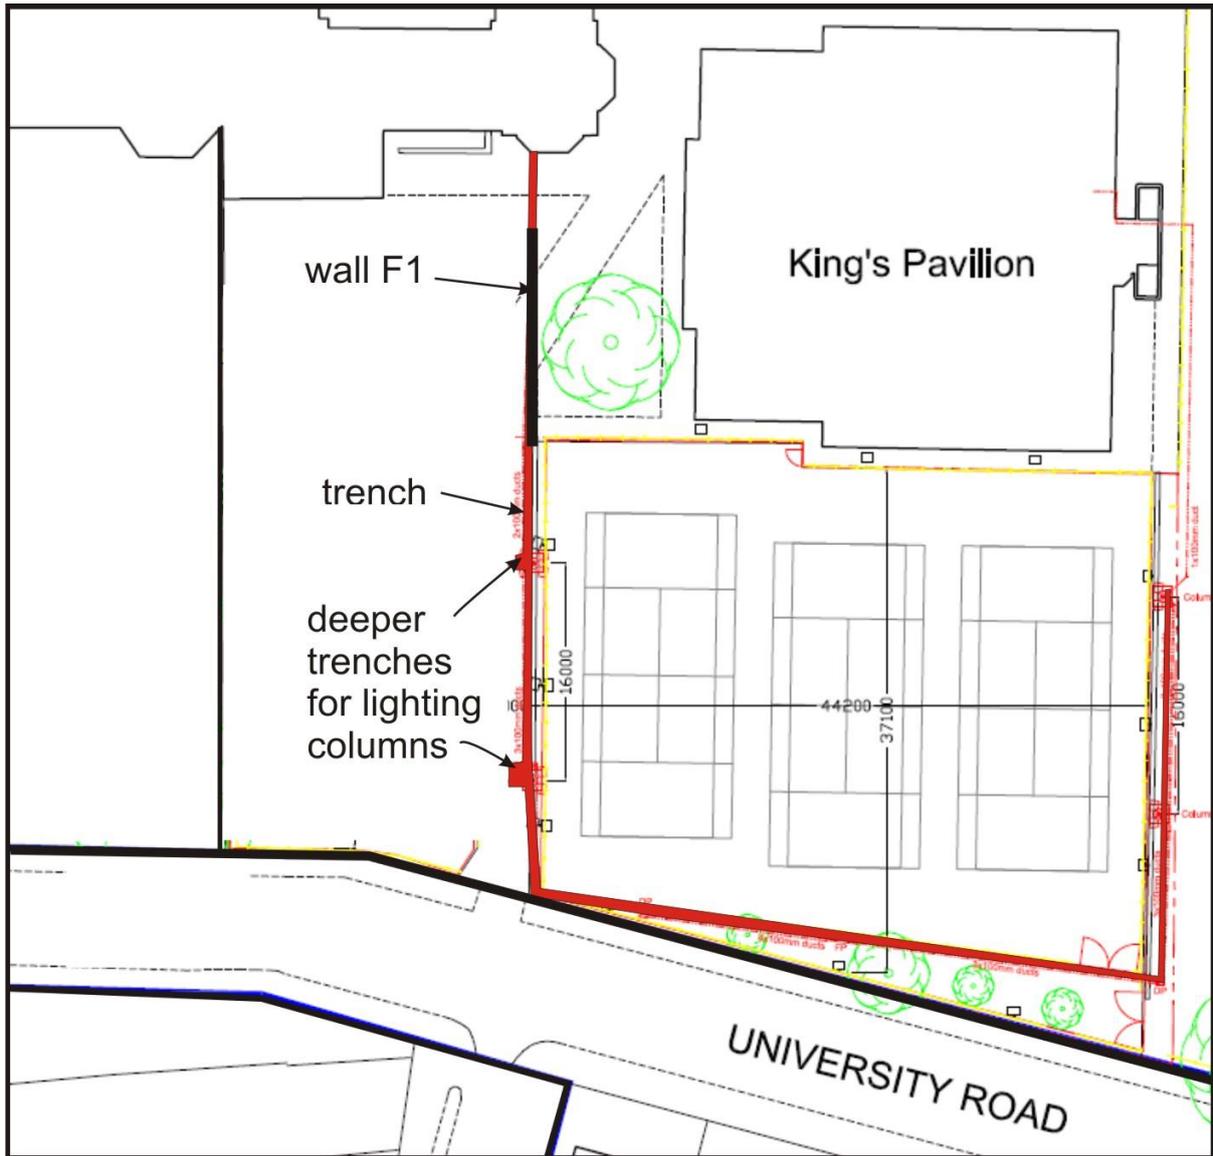
Illus 2 Plan with excavated trench in red (copyright University of Aberdeen).

A watching brief was maintained from 23 April-9 June 2014 during the excavation of the trench for the new lighting at King's Pavilion. The trench was typically 0.5m wide and 0.4m deep with deeper sections where the lighting columns were to be sited (Illus 2).

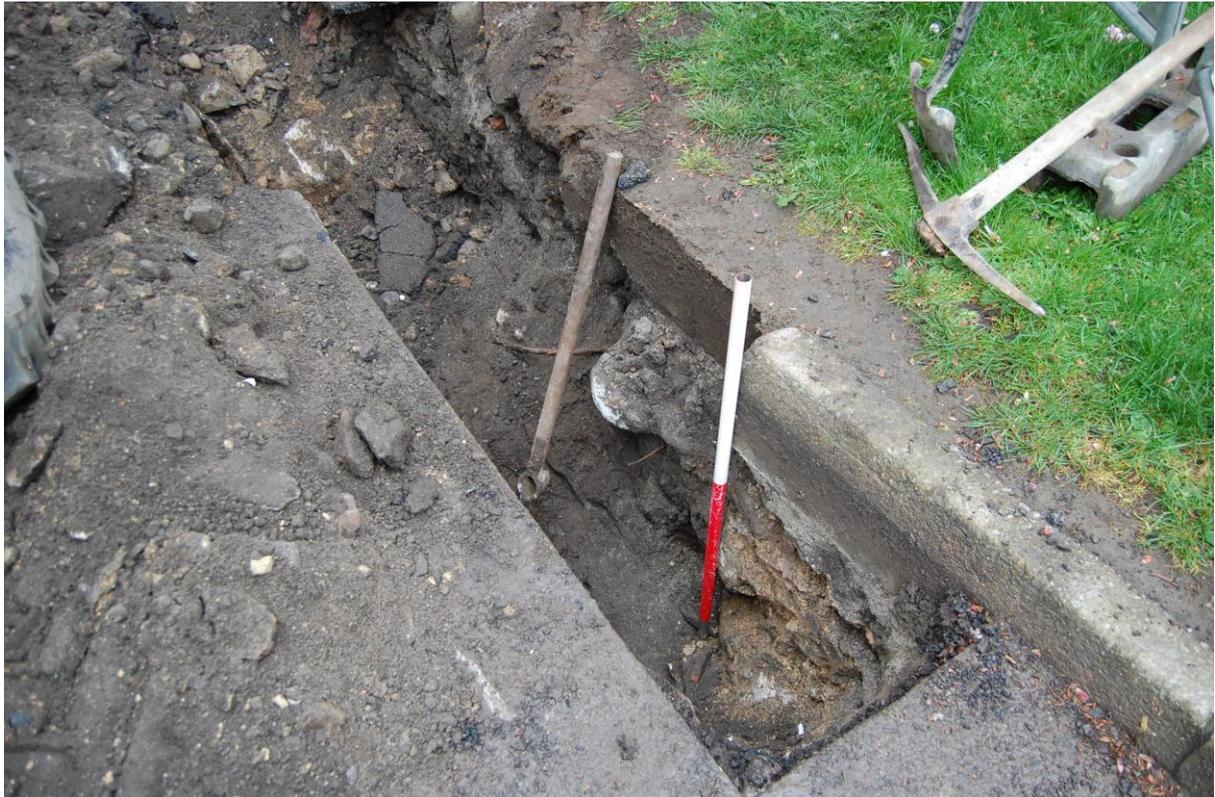
The west arm of the trench contained a large stone wall foundation (F1; Illus 3) which is the remains of a boundary wall constructed between the First and second OS maps (1867-1900). The south and east arms of the trench contained a shallow layer of soil above sand natural subsoil (Illus 4). No other features and no finds were recovered and the trench is now complete and infilled.

Illus 3 West arm of trench Wall F1; facing NE

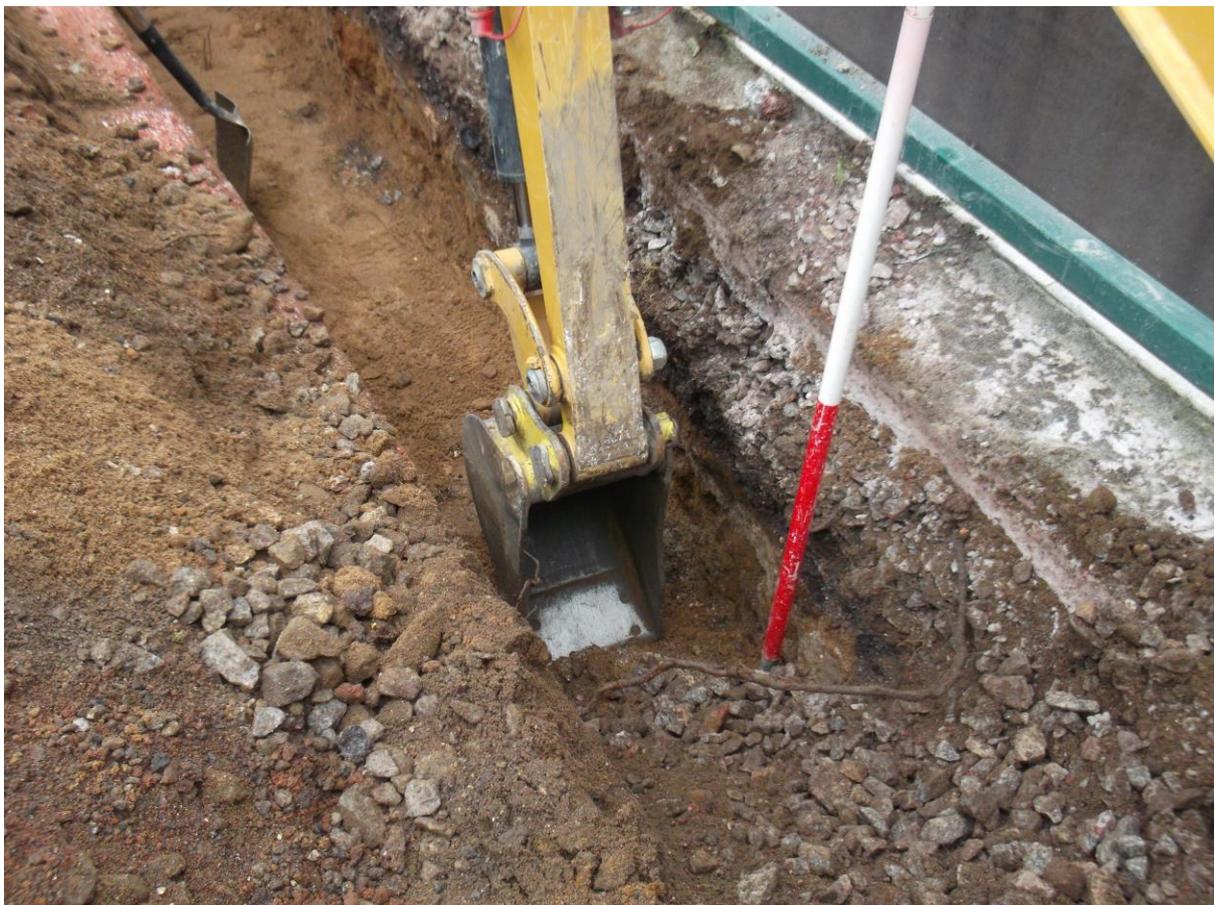
Illus 4 South arm of trench showing sand natural subsoil; facing NW
