**Proposed Erection of One Wind Turbine, Associated
Tracks and Substation
South Lasts Farm, Contlaw Road, Milltimber, Aberdeen,
AB13 0ES**

Aberdeen City Council planning application P131859

Report on archaeological watching brief

**Alison Cameron
Cameron Archaeology
16 December 2014**

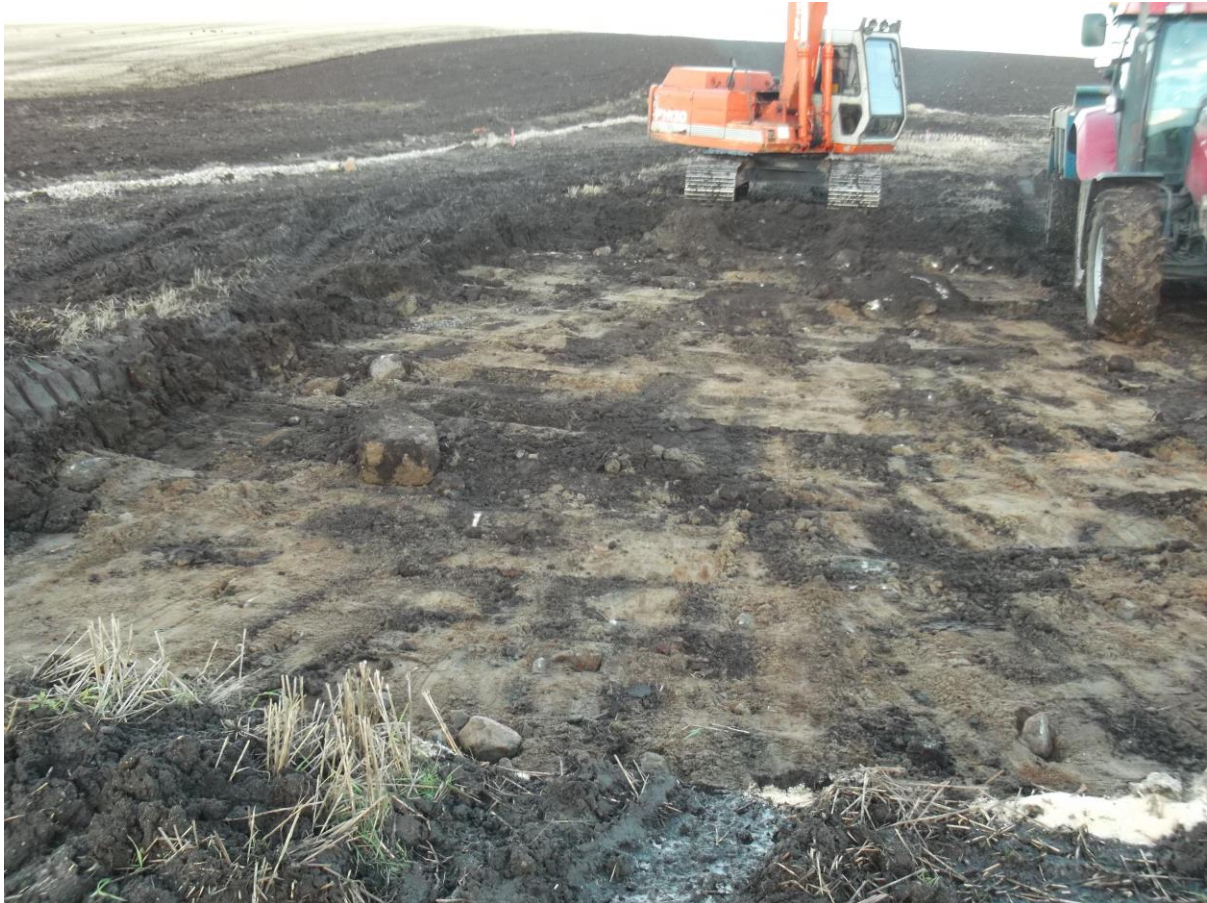
Cover the centre of the watching brief area showing field drains, shallow topsoil and large earthfast boulder

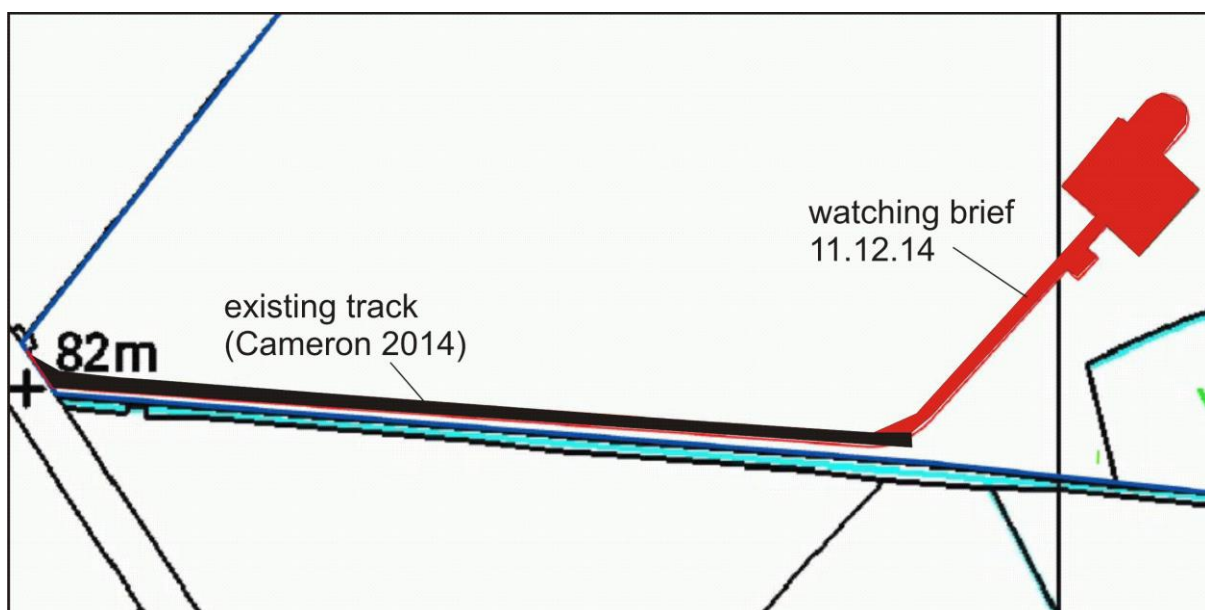
Illus 2 Proposed sub-station and associated access pad (copyright Locogen Ltd)

The watching brief took place on 11 December 2014. The weather was sunny and very cold. The field is on a gentle west facing slope and the area has a historical and current issue with waterlogging. The area was covered by 0.2m deep topsoil, with large earthfast boulders in the natural subsoil. There were numerous field drains in several phases including modern ceramic pipe in narrow trenches with type 2 infill and stone drains. No archaeological deposits or finds were observed during this work and it is therefore recommended that no further archaeological work is required during the current development.
