Holme Sluice Fish Pass, Colwick, Nottingham.

**Archaeological Monitoring and Recording (Watching Brief) of Ground
Investigations and Boreholes**

Report Number: 090/2017

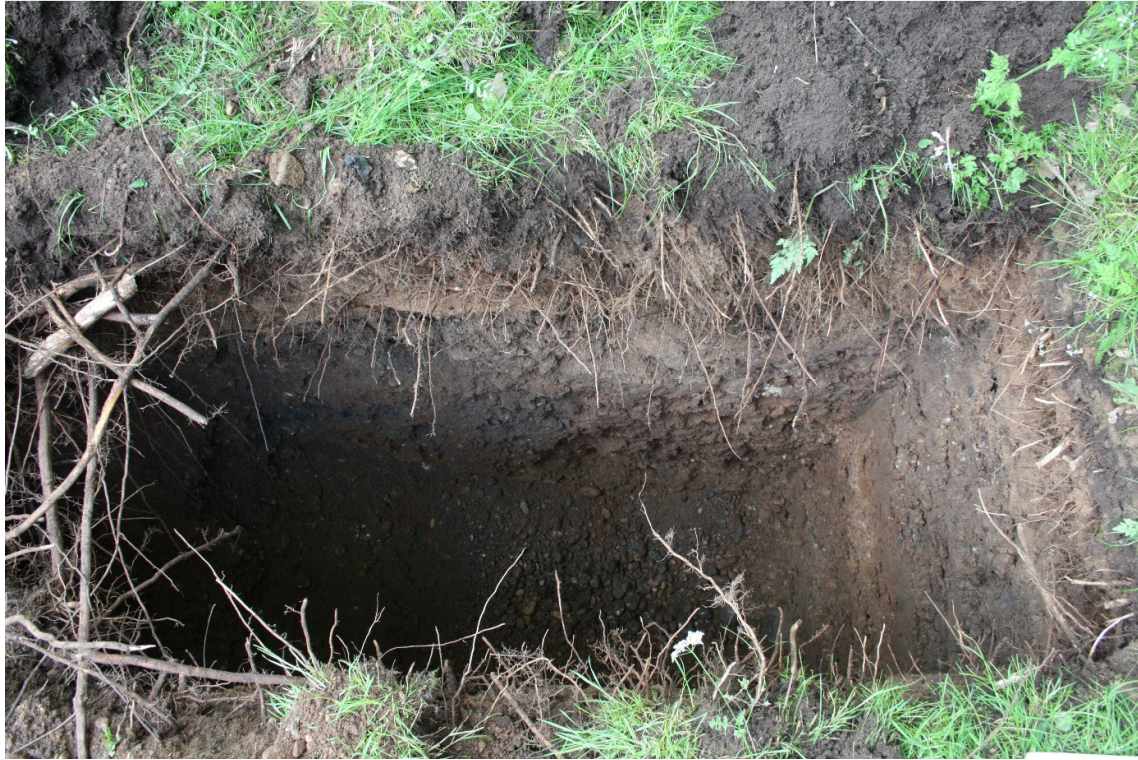
2.1.3 **TP01:** TP01 was located to the western extent of the site on the south side of southwest-northeast aligned River Road / Swan Meadow and attained a total depth of 1.5m. From the ground surface at 0.00m to 0.20m was dark brown sandy silt with grass roots and rootlets, interpreted as topsoil. Between 0.20m and 0.50m there was a mid yellowish-brown sandy (medium-coarse) silt with continuation of the roots from above, interpreted as subsoil. Below this from 0.50m to 0.90m there was dark brownish-grey gravelly clay with inclusions of medium-coarse sand and round / sub-rounded stones and cobbles of sandstone and mudstone. In addition to this there were fragments of brick. It is likely this is made ground consisting of redeposited sands and gravels mixed with both topsoils and subsoils. From 0.80m there was evidence of hydrocarbon contamination which also leached downwards into the sands and gravel below. Between 0.90m and the trial pits end at 1.50m was a mid yellowish-orange silty sand and gravel with clay lenses. The gravel was rounded / sub-rounded and the sand was medium to coarse. This became darker with depth past 1.30m. This has been interpreted as the superficial sands and gravels.

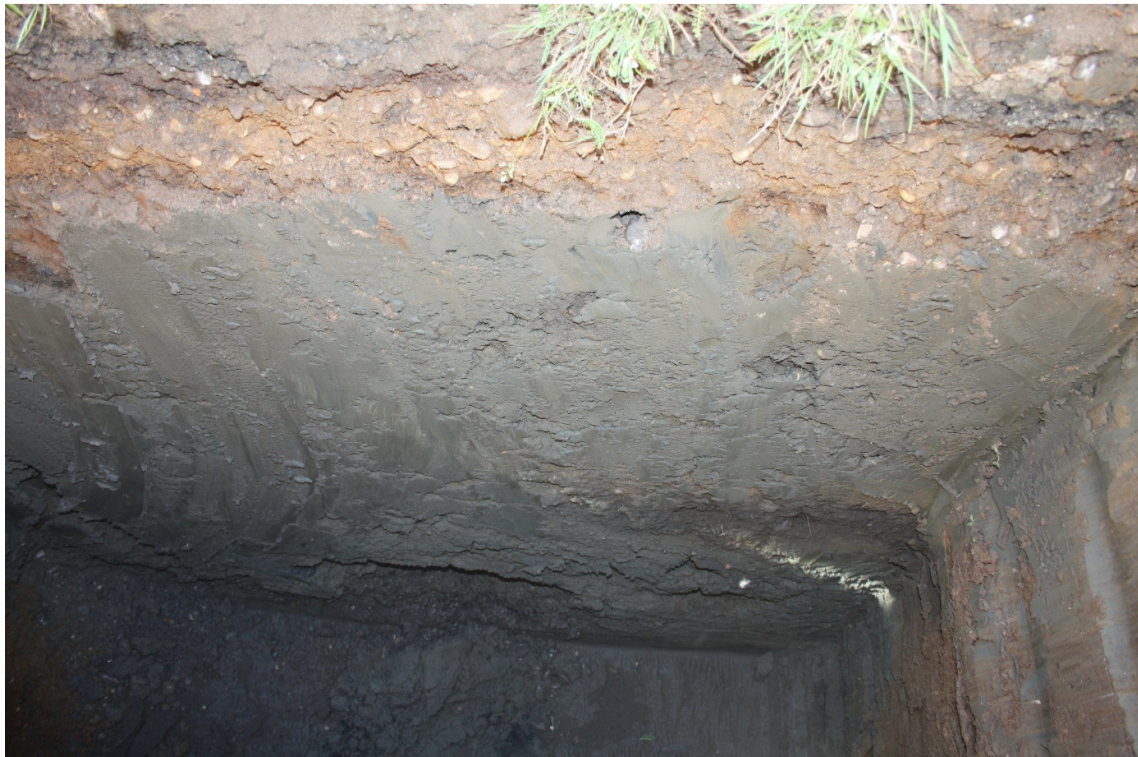
2.1.4 **TP02:** TP02 was located ~37m northeast of TP02 on the northern side of River Road / Swan Meadow and attained a total depth of 2.20m. From the ground surface at 0.00m to 0.20m was dark brown slightly sandy clayey silt with grass roots and rootlets, interpreted as topsoil. Between 0.20m and 1.50m there was mid yellowish-brown clayey sandy (medium-coarse) gravel, with a continuation of the roots from above, interpreted as subsoil and likely made ground. From 1.50m to 2.00m there was loose light-mid brownish grey sandy (medium-coarse) gravel (sub-round – sub-angular) with lenses of sandy clay, also likely to be made ground. Below this and to the

bottom of the trial pit at 2.20m there was a sandy bluish grey alluvial clay with silt and gravel at a similar size to the gravel encountered in the layer above.

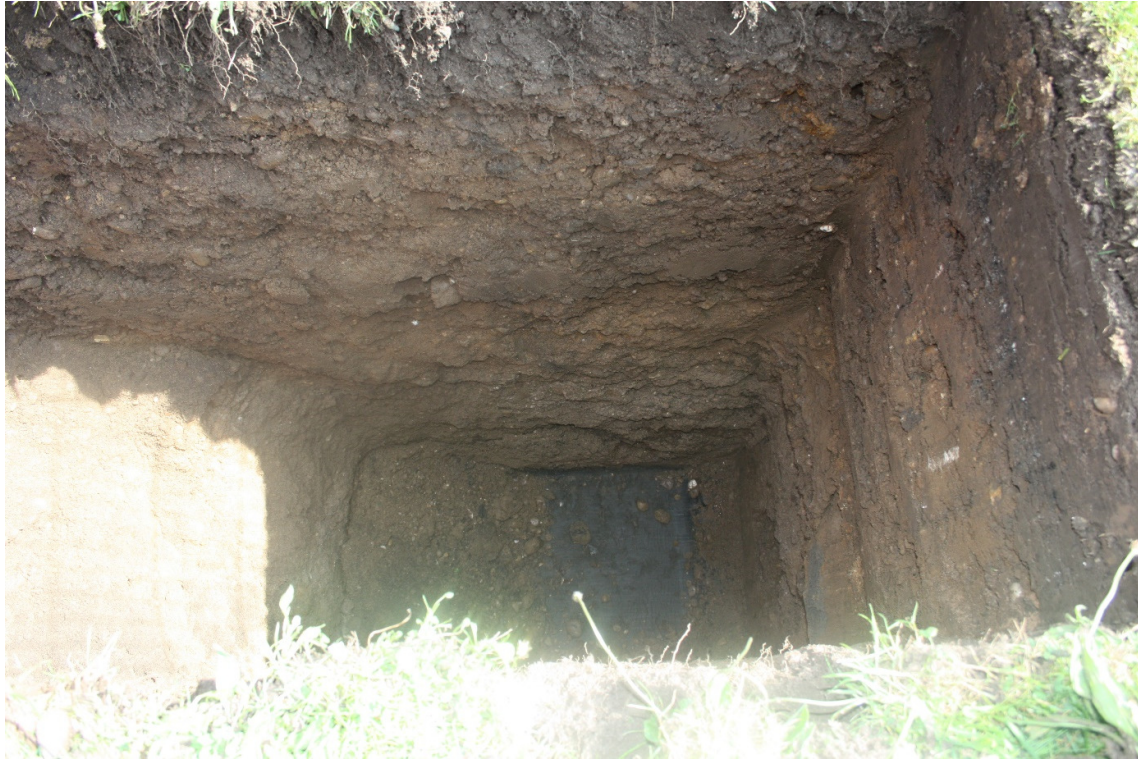
TP03

- 2.1.5 **TP03:** TP02 was located within the western EA waste management compound ~19m south southeast of TP02 and reached a depth of 2.20m. From 0.00m to 0.10m there was topsoil consisting of mid-dark greyish brown slightly sandy clayey silt with grass roots and rootlets. Below this from 0.10m to 0.50m was a yellowish / orangey brown clayey gravel (round – sub angular) and sand (medium-coarse) representing made ground / redeposited superficial sands and gravels. Below this from 0.50m to 1.90m was mid bluish grey organic sandy (medium) silt with frequent gravel inclusions. Becoming increasingly sandy with depth there was a gradual change in the colour of the deposit past 1.25m to a darker bluish grey eventually becoming mottled with a mid brown, likely representing differentiation in levels of gleying but still alluvial, but redeposited, in nature. Between 1.90m and 2.10m there was a dark bluish grey gravel (round to sub-round) and sand (medium to coarse). This became darker with depth past 2.10m eventually becoming peaty silty clay alluvium. Samples were taken at 1.00m and 2.10m.

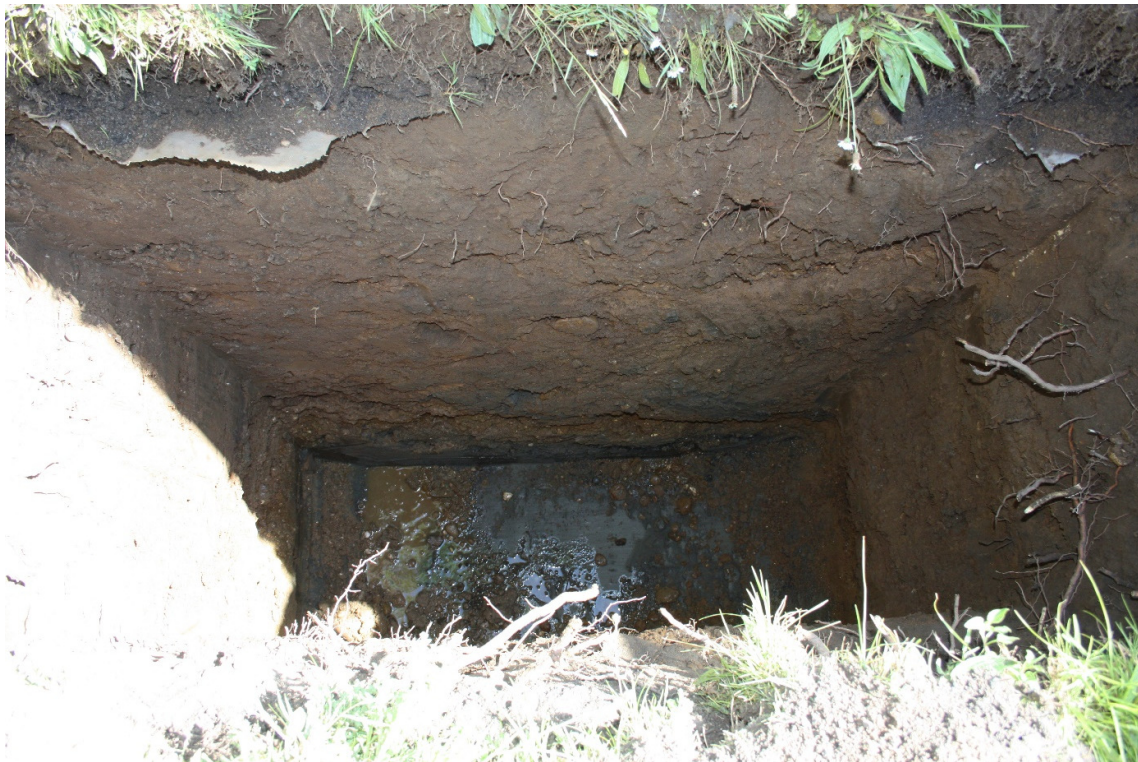
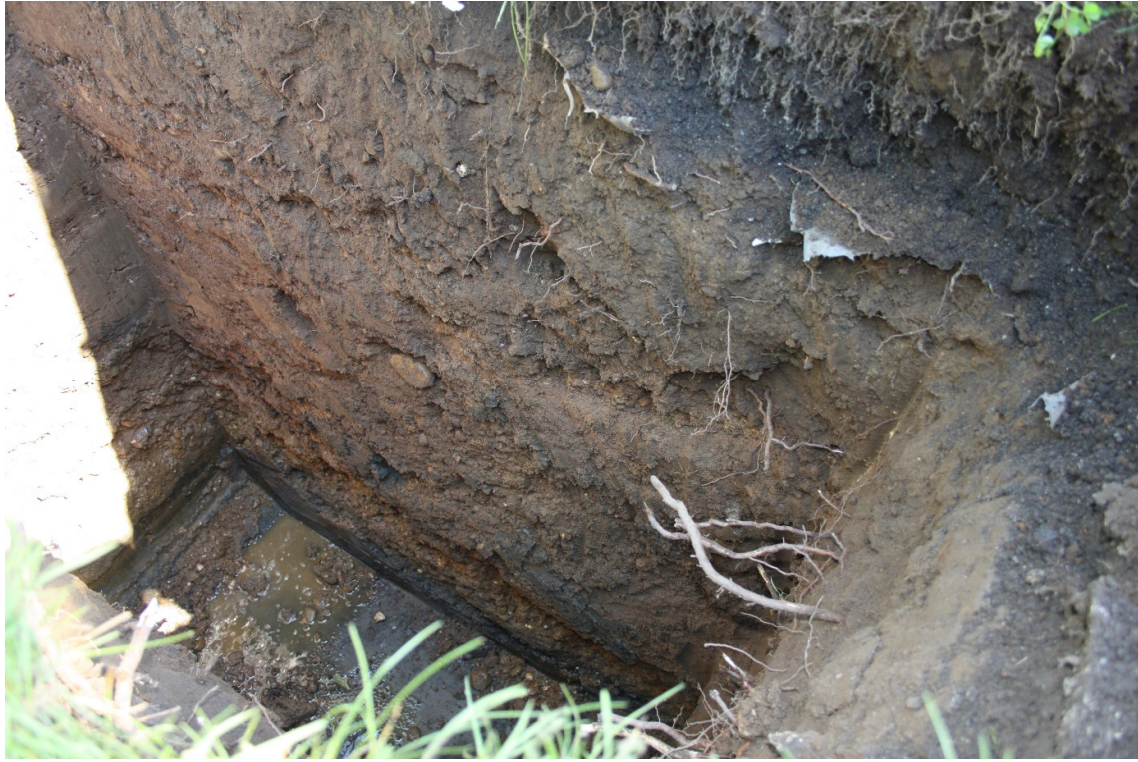
- 2.1.6 **TP04:** TP04 was located ~24m east northeast of TP03 within the western EA compound in an area known to have formally been a garden for the Holme Sluice operators house (demolished c. 2005) and reached a depth of 2.20m. From the grass turn surface at 0.00m to 0.10m there was mid-dark greyish brown slightly sandy clayey silt with grass roots and rootlets, being topsoil. Between 0.10m and 0.20m there was a levelling layer of made ground consisting of clinker/ash, brick and glass fragments as well as a synthetic matting. Below this from 0.20m to 0.60m was a mixed gravelly clayey mid brownish grey subsoil with glass, clinker and gravel, similar to that above but separated by the synthetic matting. It is likely this also represents made ground. Between 0.60m and 1.85m was mid orangey greyish brown sandy (medium) clay with gravel (round – sub-round). Past 1.00m this became more of clayey gravel and became lighter in colour past 1.20m as the gravel content increased. Water began to seep in rapidly at 1.30m. It is likely this also represents made ground including mixed redeposited superficial sands and gravel with subsoils. At 1.85m to the trial pit base at 2.20m was mid-dark sandy (medium-coarse) bluish grey silt with clay, representing alluvium. A sample was taken at 1.90m

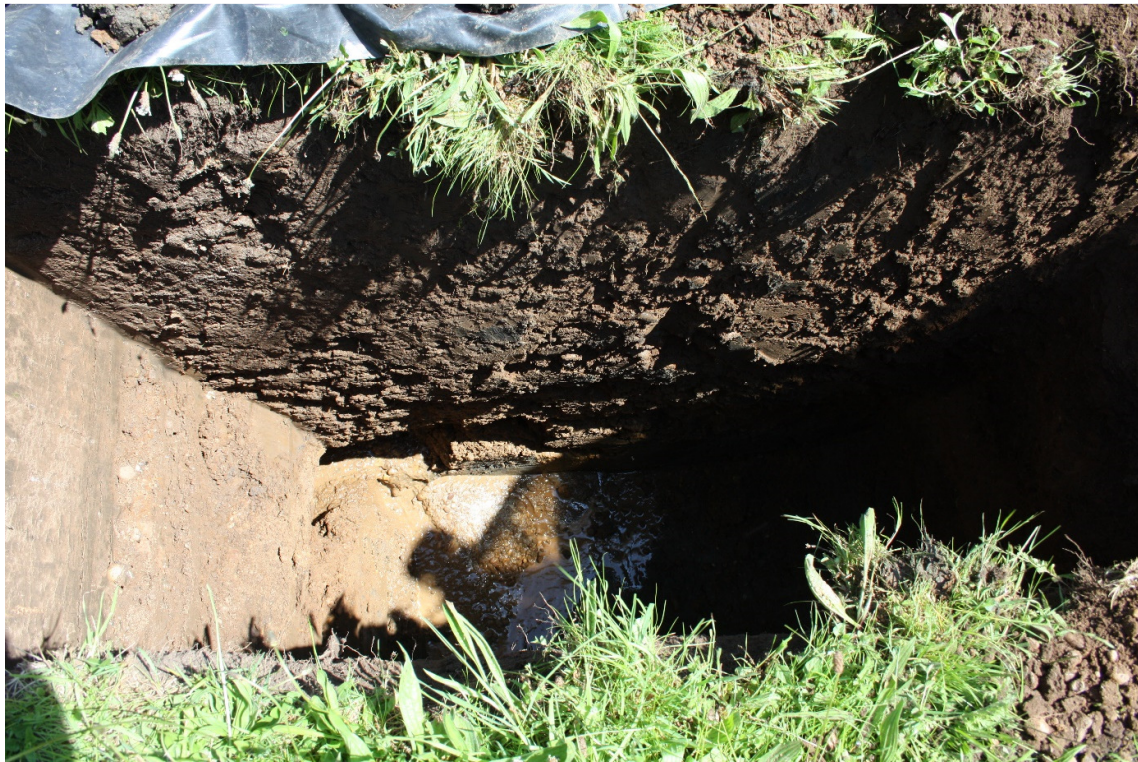
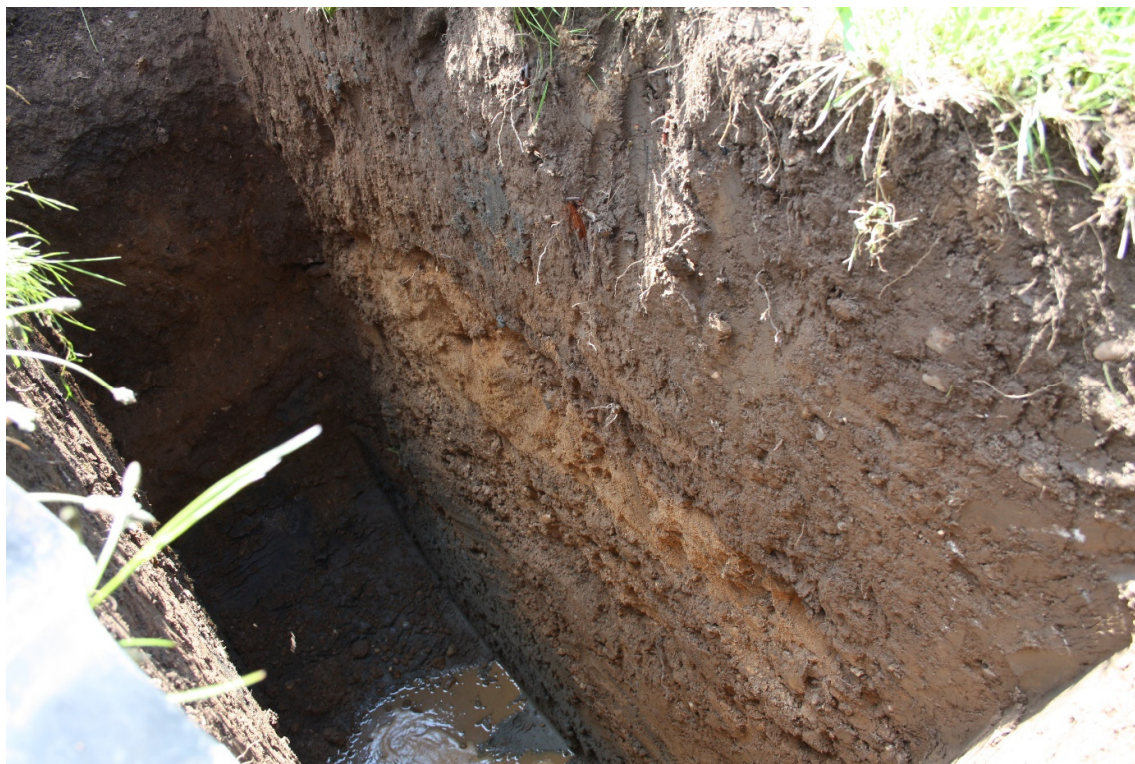
- 2.1.7 **TP05:** TP05 was located ~16m south southeast of TP04 still within the same garden area immediately to the west of the current eastern EA compound and reached a depth of 2.20m. From 0.00m to 0.20m there was topsoil consisting of mid-dark greyish brown slightly sandy clayey silt with grass roots and rootlets. Below this between 0.20m and 0.60m was a mixed gravelly clayey mid brownish grey subsoil with glass, clinker and gravel similar to that encountered in TP04, likely representing made ground. From 0.60m to 0.80m there was mid orangey greyish brown sandy (medium) clay with gravel (round – sub-round). From 0.80m to 1.70m this became a silty gravel and sand with rapid water seepage at 1.55m From 1.70m to 2.20m was a mid-dark bluish grey silt with clay similar to that encountered in TP04, representing alluvial deposits.

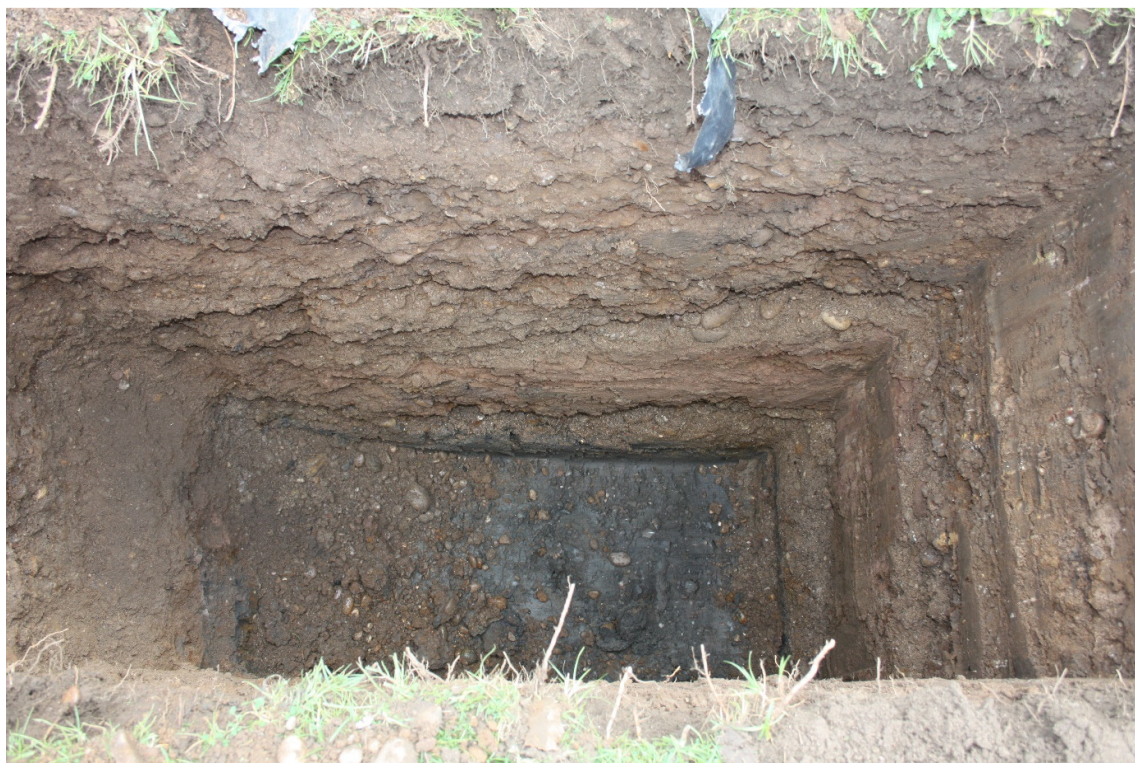
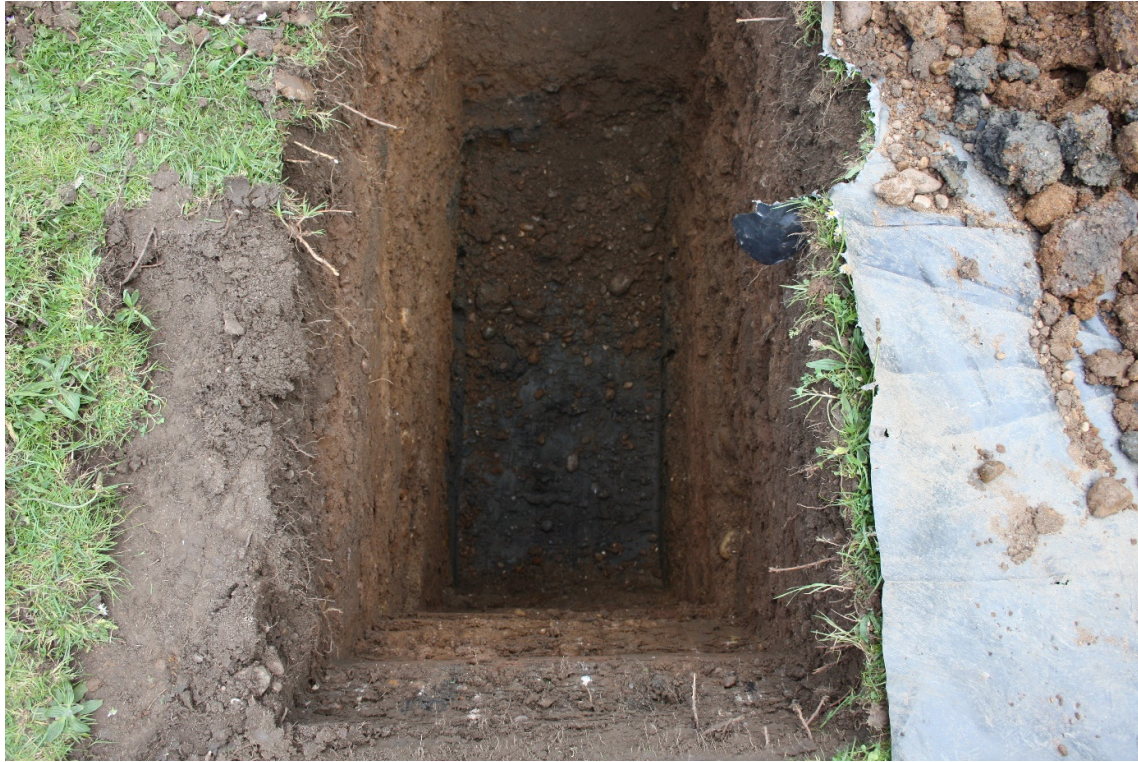
- 2.1.8 **TP06:** TP06 was located ~27m east northeast of TP02 on the northern side of River Road / Swan Meadow and reached a total depth of 2.00m. From 0.00m to 0.20m there was topsoil consisting of mid-dark greyish brown slightly sandy clayey silt with grass roots and rootlets. From 0.20m to 1.10m there was mid-dark orangey greyish brown sand (medium) and gravel (round-sub rounded) with some clay. Some organics and roots are present from above and it likely represents made ground / subsoil. From 1.10m to 1.90m there was very loose sandy gravel with less clay of a similar description to the above layer and also represents made ground and probable redeposited superficial deposits. From 1.90m to 2.00m there was a clear change to a firm dark bluish grey sandy (medium-coarse) and gravelly organic silt and clay. There appeared to be some laminations of sand and unlikely to be reworked and appeared fairly well sorted.

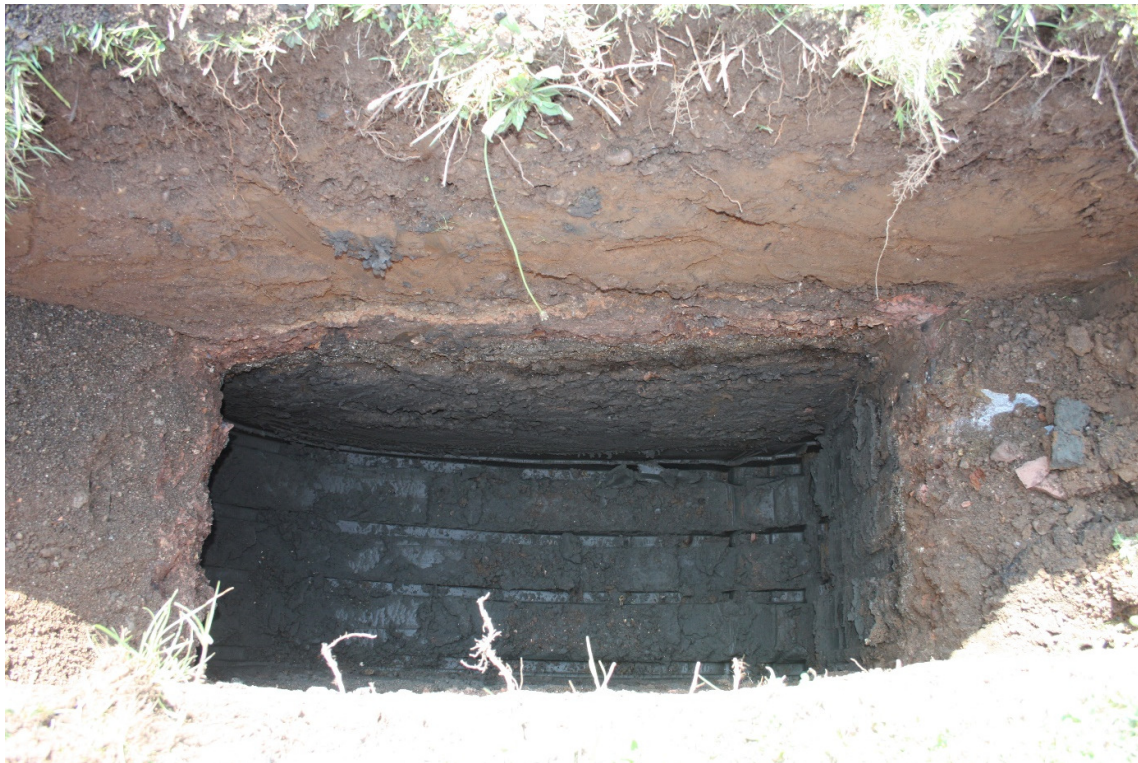
- 2.1.9 **TP07:** TP07 was located ~28m east northeast of TP06 immediately to the west of a wooded area and reached a maximum depth of 2.10m. From 0.00m to 0.30m there was topsoil consisting of mid-dark greyish brown slightly sandy clayey silt with grass roots and rootlets and also contained frequent gravel, and is likely in part made ground. From 0.30m to 0.70m was mid orangey brown clayey sand with silt and some organic inclusions and represents made ground. Below this from 0.70m to 1.20m was a made ground clinker layer containing brick fragments and rubble, ash and gravel. From 1.20m to 2.10m was a reworked and heavily contaminated (hydrocarbons) alluvium

consisting of dark slightly bluish grey silt and clay. Within this was gravel, sand, brick and clinker/ash. Beyond 1.80m there were less inclusions and contamination whilst becoming more organic, well sorted and more like deposited alluvium.

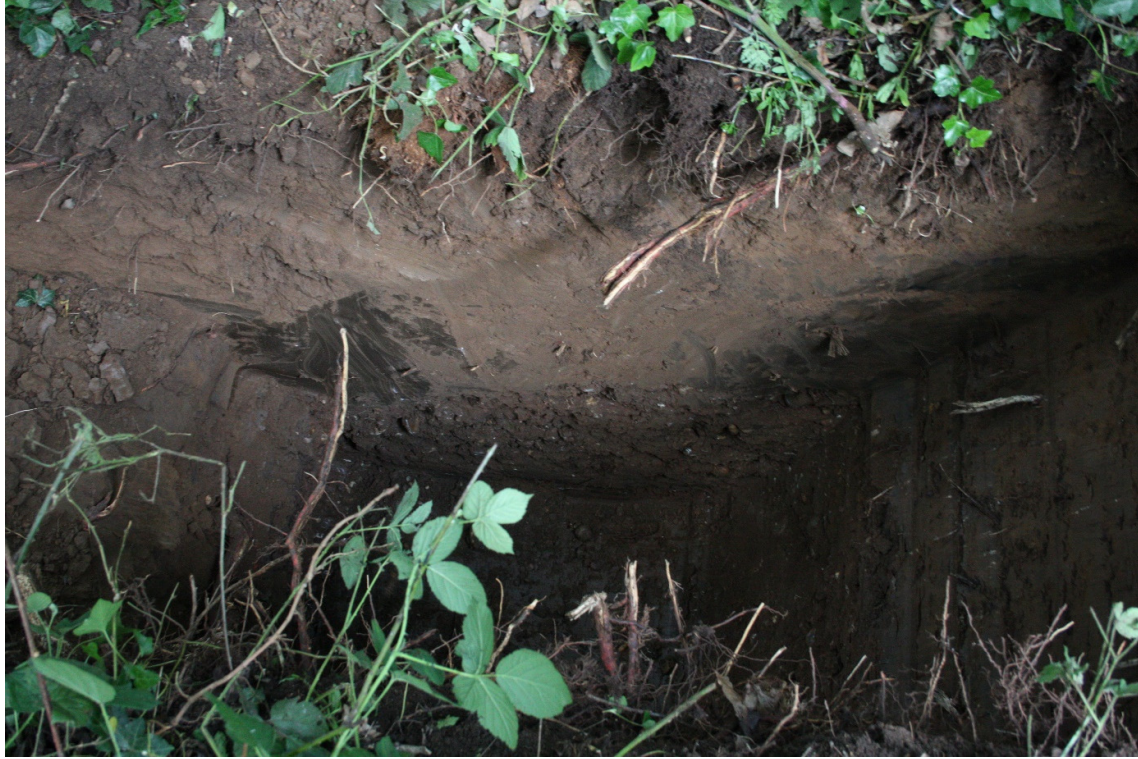
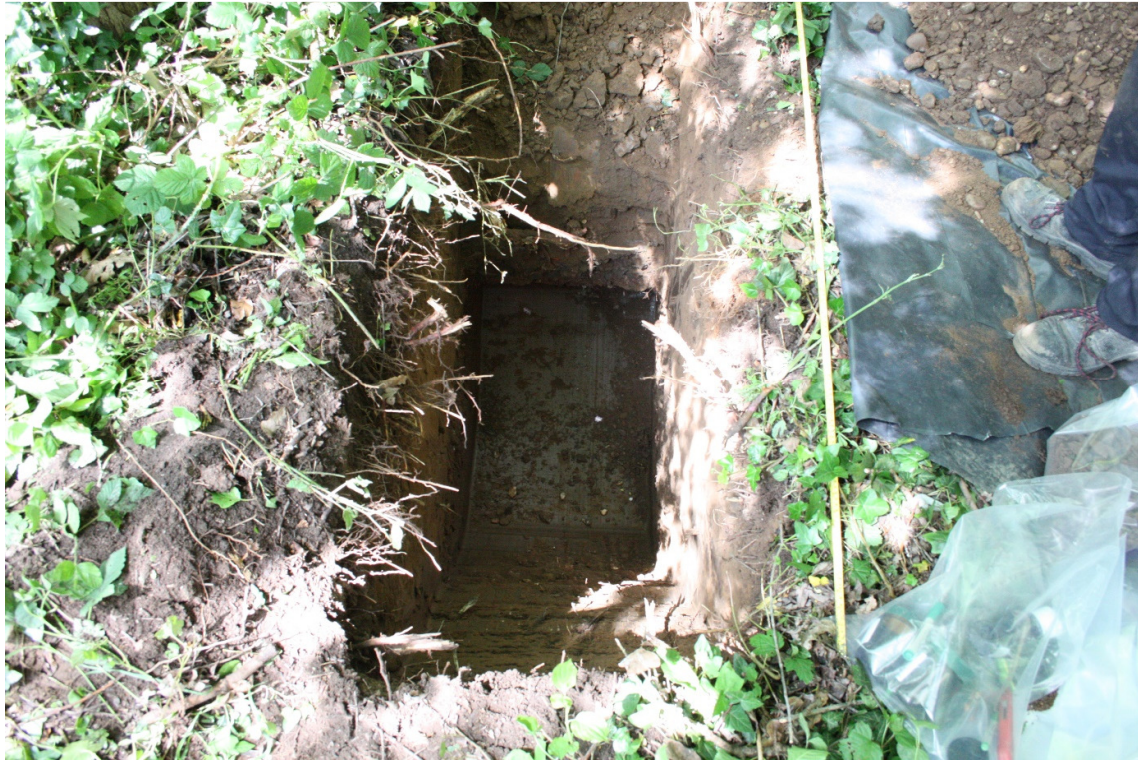
- 2.1.10 **TP08:** TP08 was located ~35m east northeast of TP08 within a wooded area and reached a total depth of 1.55m. From 0.00m to 0.20m there was topsoil consisting of dark brown humic sandy silt with organics / roots / rootlets. From 0.20m to 0.90m there was firm mid yellowish brown clayey silt with occasional small rounded pebbles, becoming stiff past 0.70m. From 0.90m to 1.35m there was a stiff to very stiff dark brownish grey gravelly silt with clay lenses. Brick fragments were observed in the upper portion of this layer. Past 1.00m this becomes lighter and more gravelly. From 1.35m to 1.55m there was stiff bluish grey clayey silt with occasional sand (fine). This likely represents desiccated alluvium but could also be reworked / redeposited alluvium.

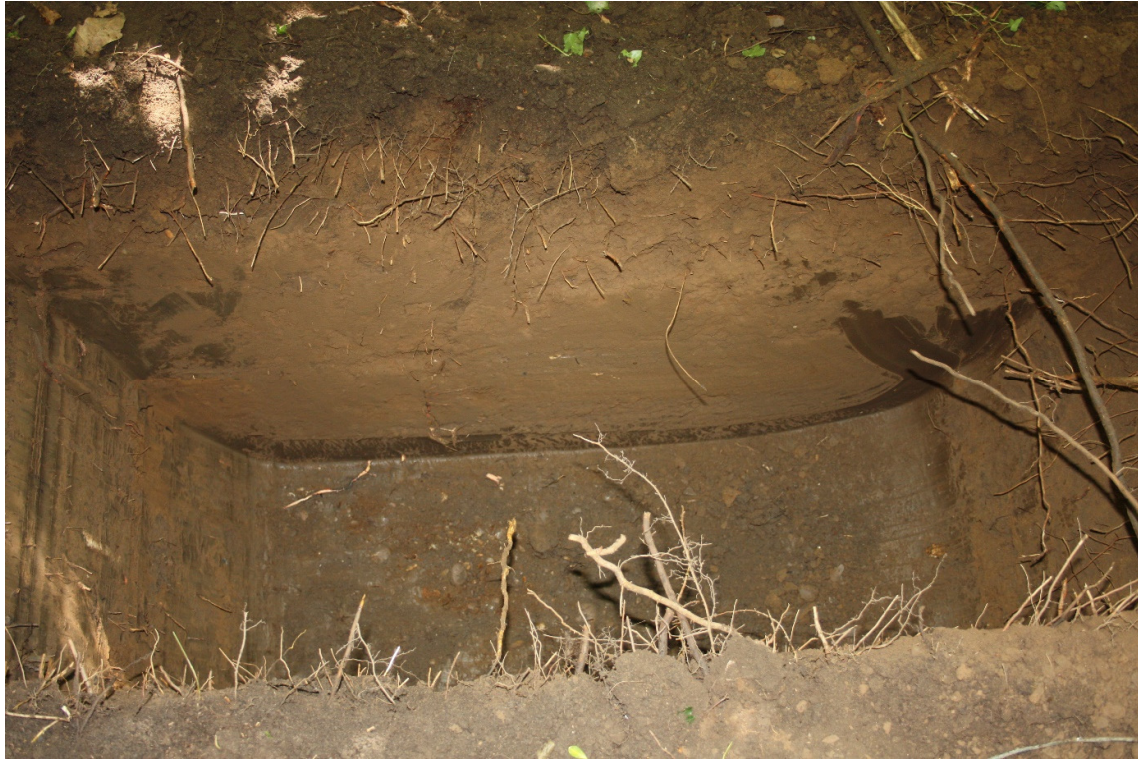
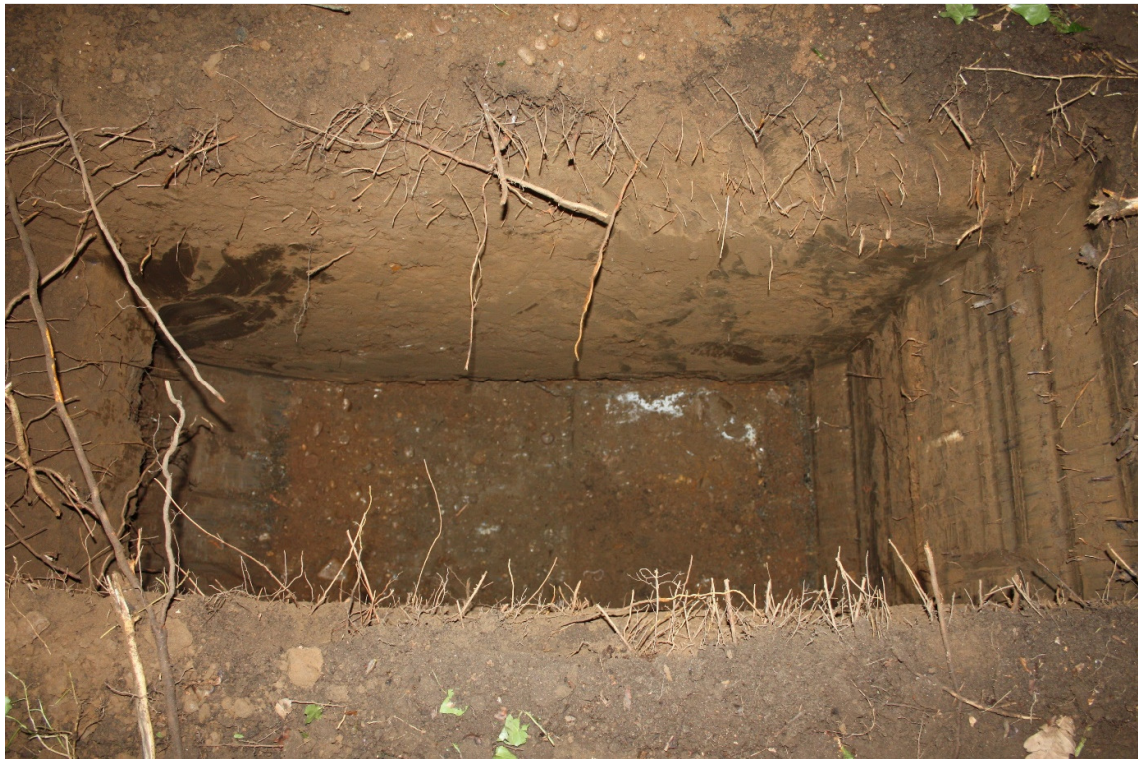
- 2.1.11 **TP09:** TP09 was located ~25m southeast of TP08 within a smaller wooded area immediately to the west of the western EA compound and reached 1.55m in depth. From 0.00m to 0.10m there was topsoil consisting of dark brown humic sandy silt with organics / roots / rootlets, interpreted as topsoil. From 0.10m to 1.00m there was firm mid yellowish brown clayey silt with occasional small rounded pebbles and roots from above, likely to be subsoil and possibly made up ground. From 1.00m to 1.20m there was gravelly (round – sub-round) clay with silt. Past 1.20m this becomes slightly darker and with a lack of gravel but occasional brick fragments. From 1.20m to 1.30m there was a dark humic band of silty clay. From 1.30m – 1.55m there was a reddish brown/grey gravel (rounded – sub rounded) and sand (medium-coarse). Within this there was a large concrete boulder at ~1.50m. Past 1.50m the gravel became darker, hinting at the possibility of alluvium below and becoming more organic. It is likely this gravel is made ground.

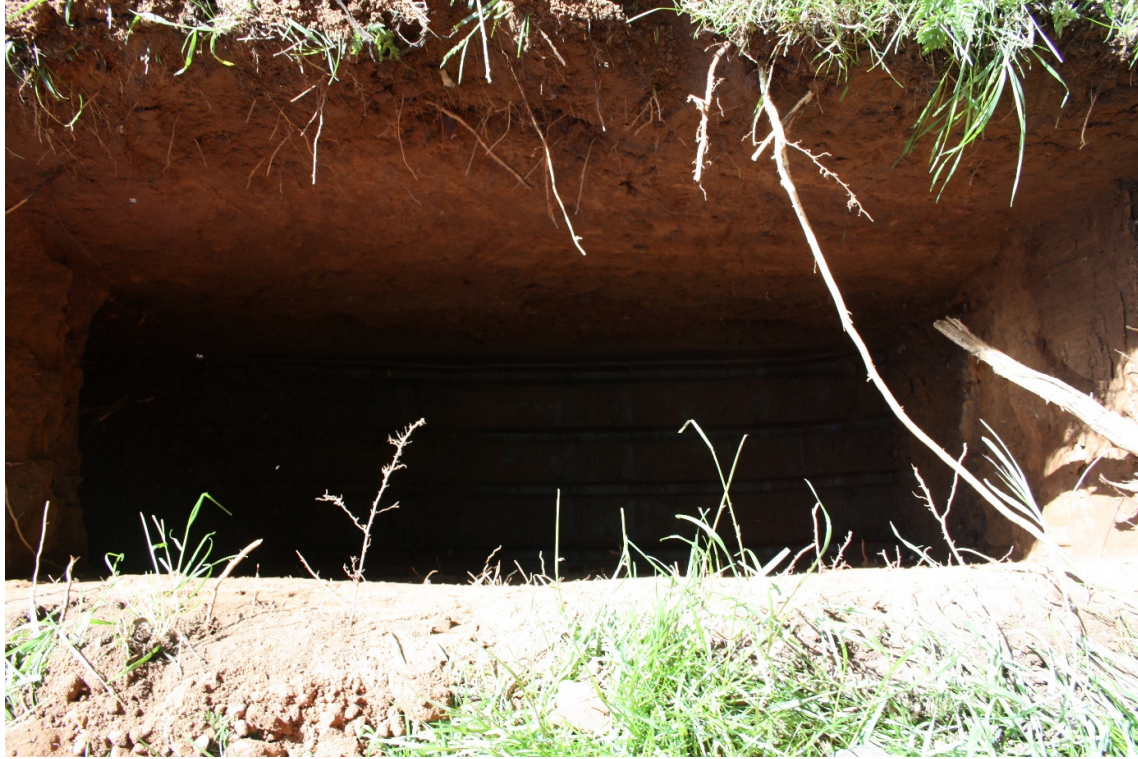
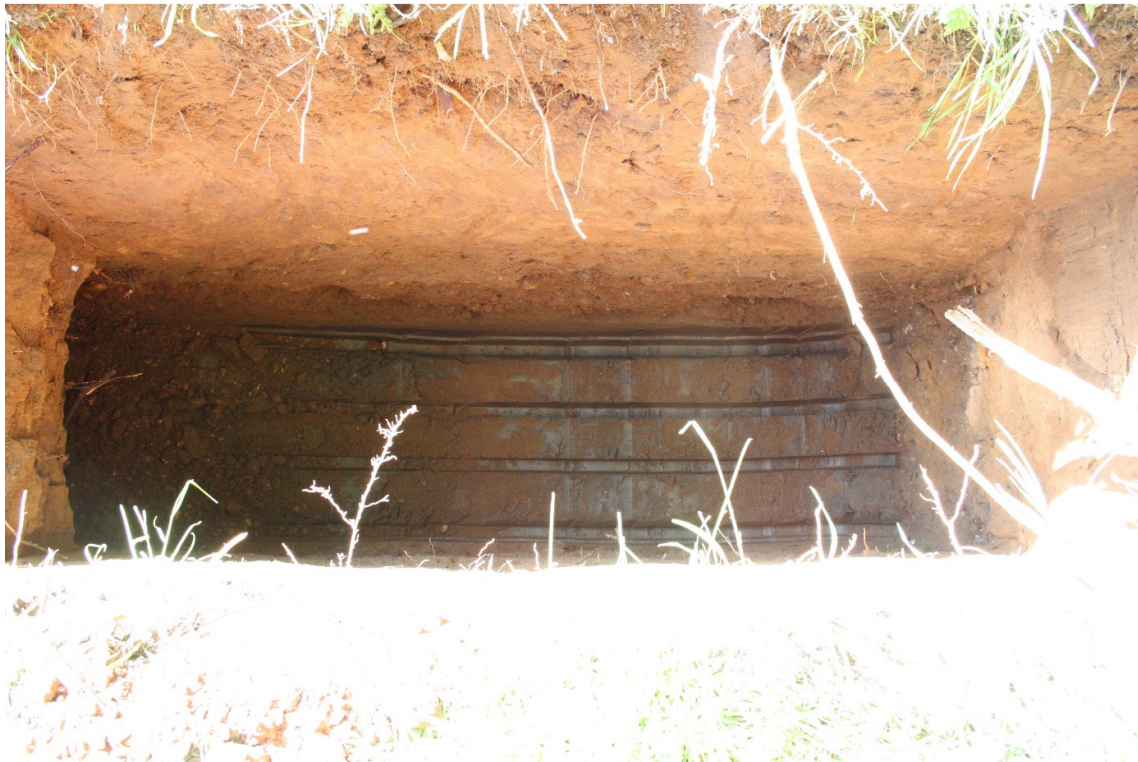
- 2.1.12 **TP10:** TP10 was located ~15m east of TP09 on the grass bank close to the sloping masonry on the north side of the River Trent, reaching a total depth of 2.00m. From 0.00m to 0.10m there was topsoil consisting of mid brown humic sandy silt with organics / roots / rootlets, interpreted as topsoil. From 0.10m to 1.10m there was orangey grey/brown silty clay with gravel (round – sub rounded). From 1.10m to 1.30 this becomes clayey gravel with evidence for gleying after 1.30m. From 1.30m to 1.65m this becomes sandy gravel with occasional clay lenses and becoming darker with depth. From 1.65m to 1.80m this becomes stiff gravelly dark grey humic clay. Beyond 1.80m this becomes more organic with no gravel but frequent sand (medium), likely representing the start of alluvial layers. Past 2.00m this becomes bluish grey and very stiff.

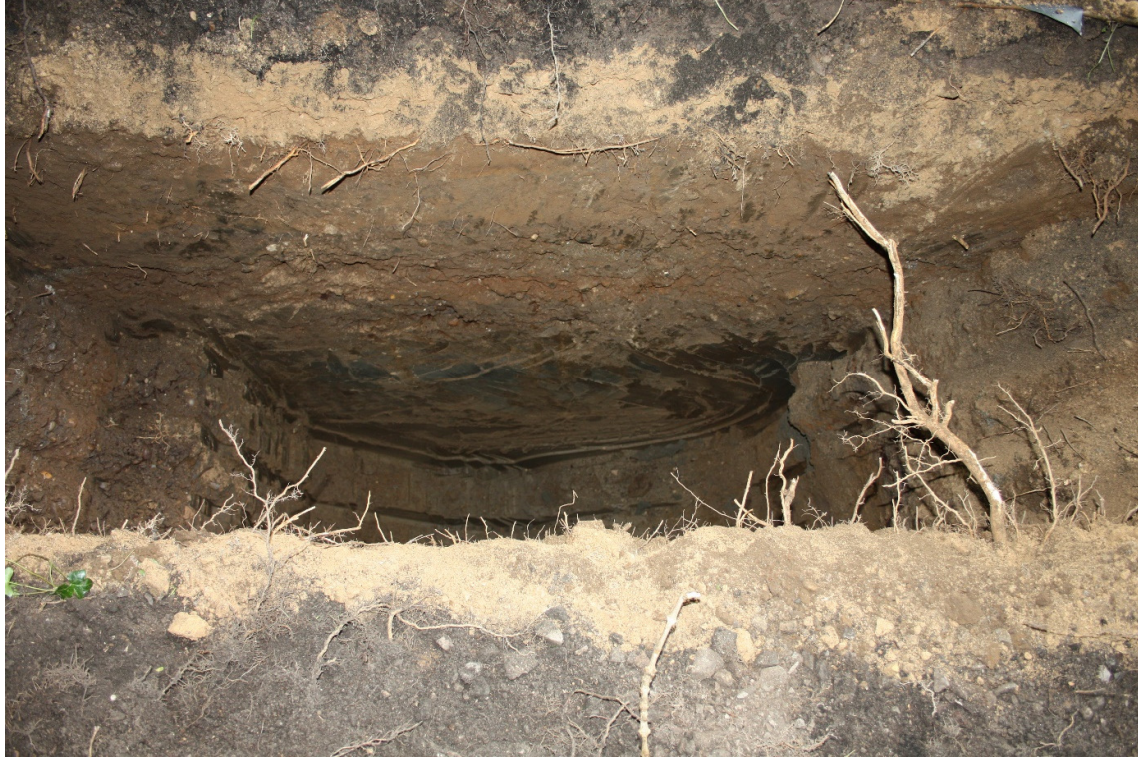
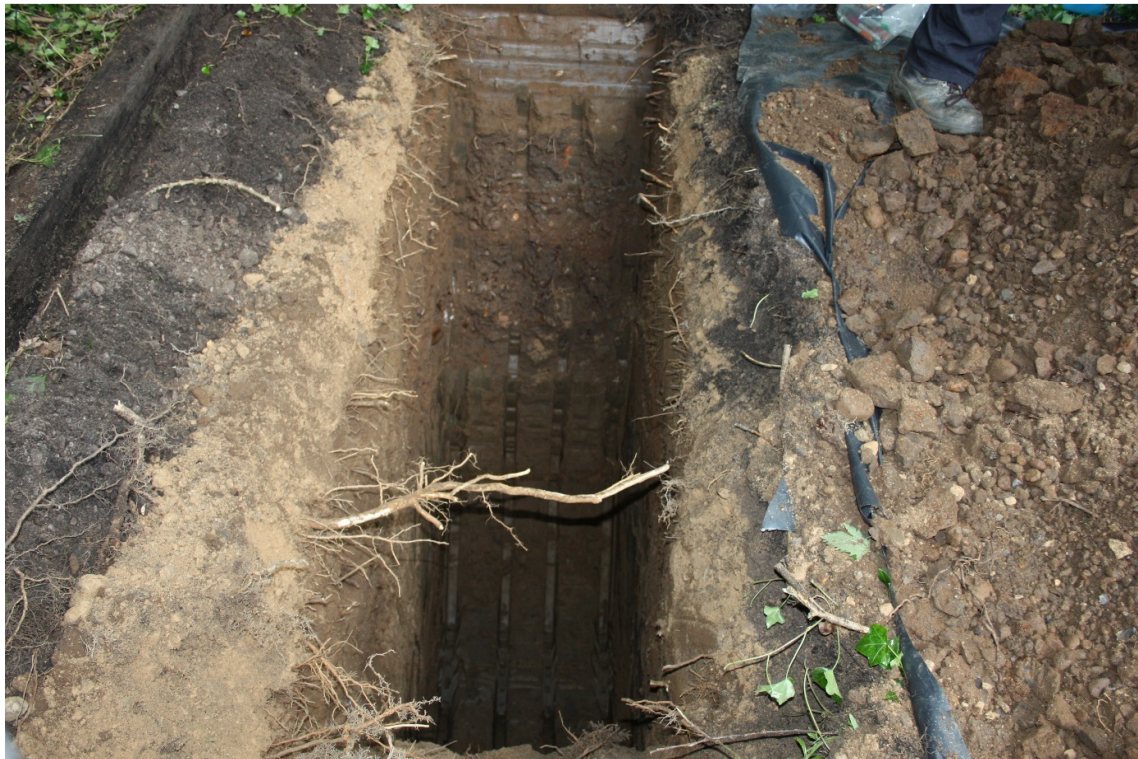
- 2.1.14 **TP12:** TP12 was located ~30m east of TP11 on the southern extent of the disused car park and reached a total depth of 2.30m. From 0.00m to 0.10m there was topsoil consisting of dark greyish brown sandy silt with gravel inclusions, roots and rootlets. Below this from 0.10m to 0.30m was mid yellowish brown artificial sand and gravel using as a levelling layer, presumably in the creation of the now disused car park. Between 0.30m and 0.65m there was a mid reddish brown sandy silt with clay which is also likely to be levelling layers and therefore made ground. From 0.65m to 1.10m this changes to mid brownish grey clayey gravel (round – sub-round) which also contains brick fragments and also represents made ground. From 1.10m to 1.75m there was dark bluish grey very stiff sandy alluvial clay. From 1.75m to 2.30m there was light-mid mottled yellowish/orangey brown sandy clay with silt, becoming sandier with depth. Past 2.10m this became dark bluish grey again. It is possible this represents alluvium but it is more likely that it has been reworked / redeposited.

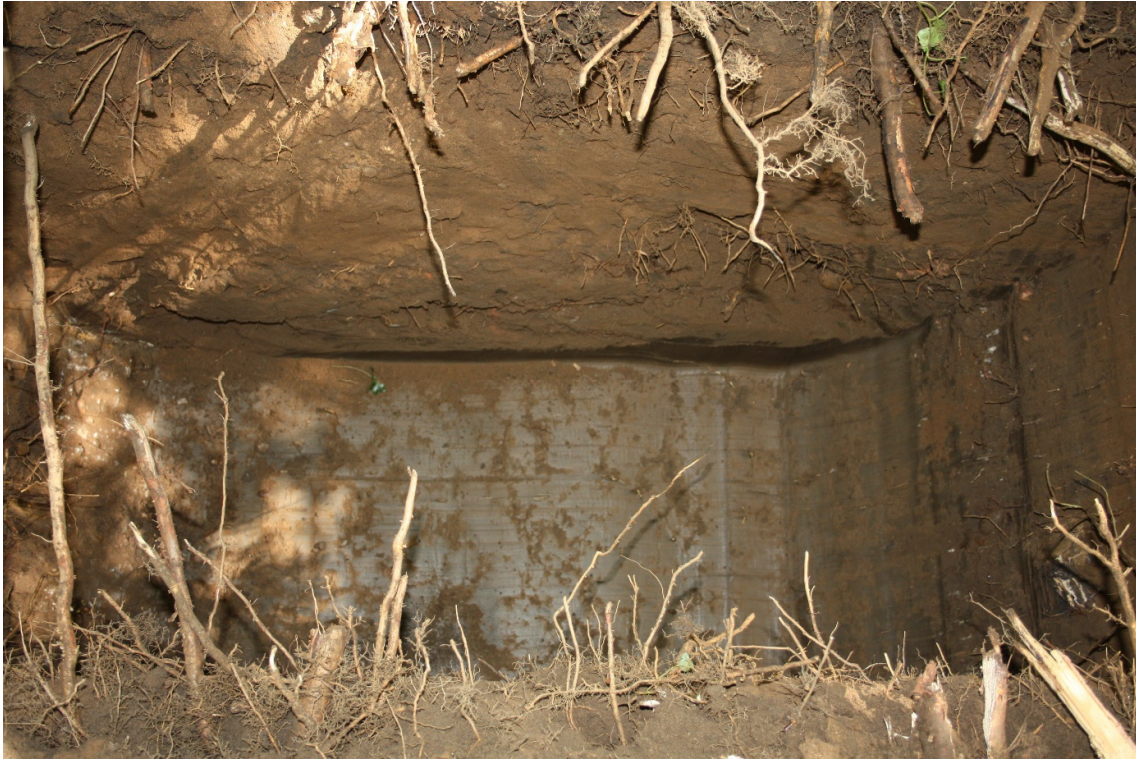
- 2.1.15 **TP13:** TP13 was located ~35m northeast of TP13 immediately west of the entrance to the unused car park and reached a total depth of 1.50m. From 0.00m to 0.20m there was topsoil consisting

of dark brown humic sandy silt with lots of organics / roots / rootlets. Between 0.20m and 0.65m there was mid yellowish brown slightly silty sand (medium – coarse) with occasional gravel (rounded – sub rounded), more than likely being made ground. From 0.65m to 1.05m there was firm/stiff dark brownish grey slightly sandy clay with silt. This contained modern glass fragments, with organics throughout as well as fragments of brick and rubble. This represents made ground. From 1.05m to 1.30m this was the same with the absence of objects constituting made ground. From 1.15m onwards there is no longer gravel. From 1.30m to 1.50m was dark bluish grey very stiff silty clay. This was humic and is likely to be alluvially deposited.

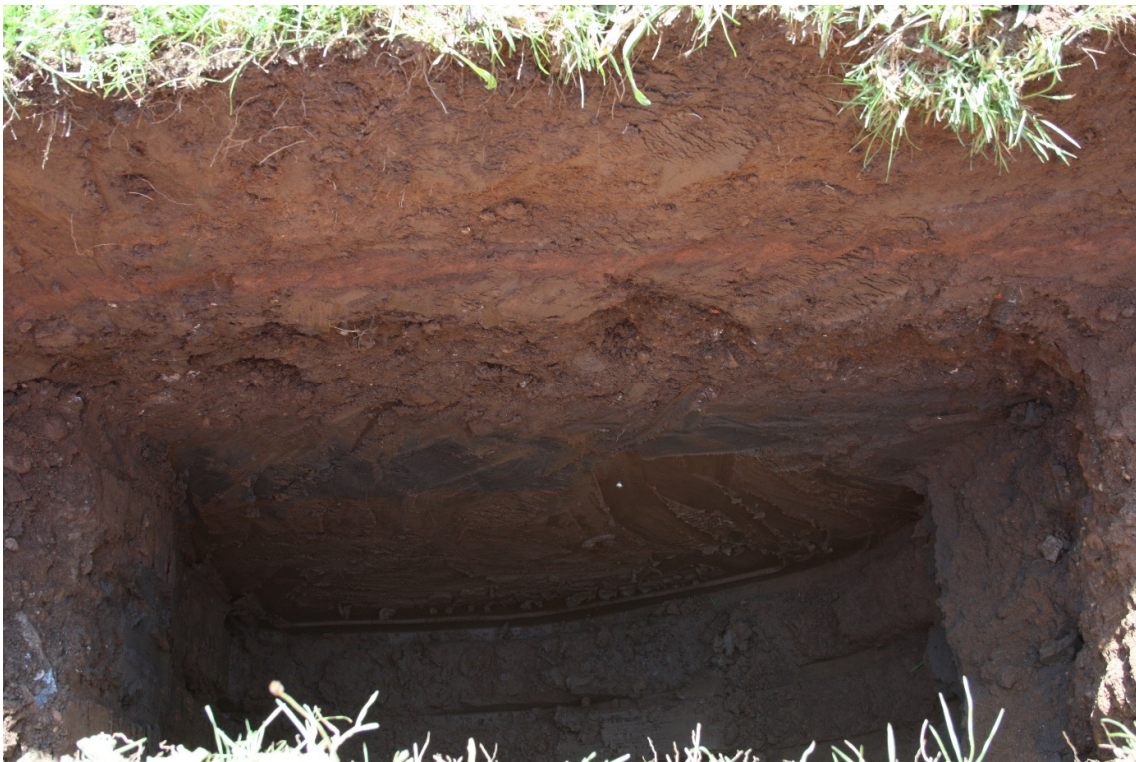
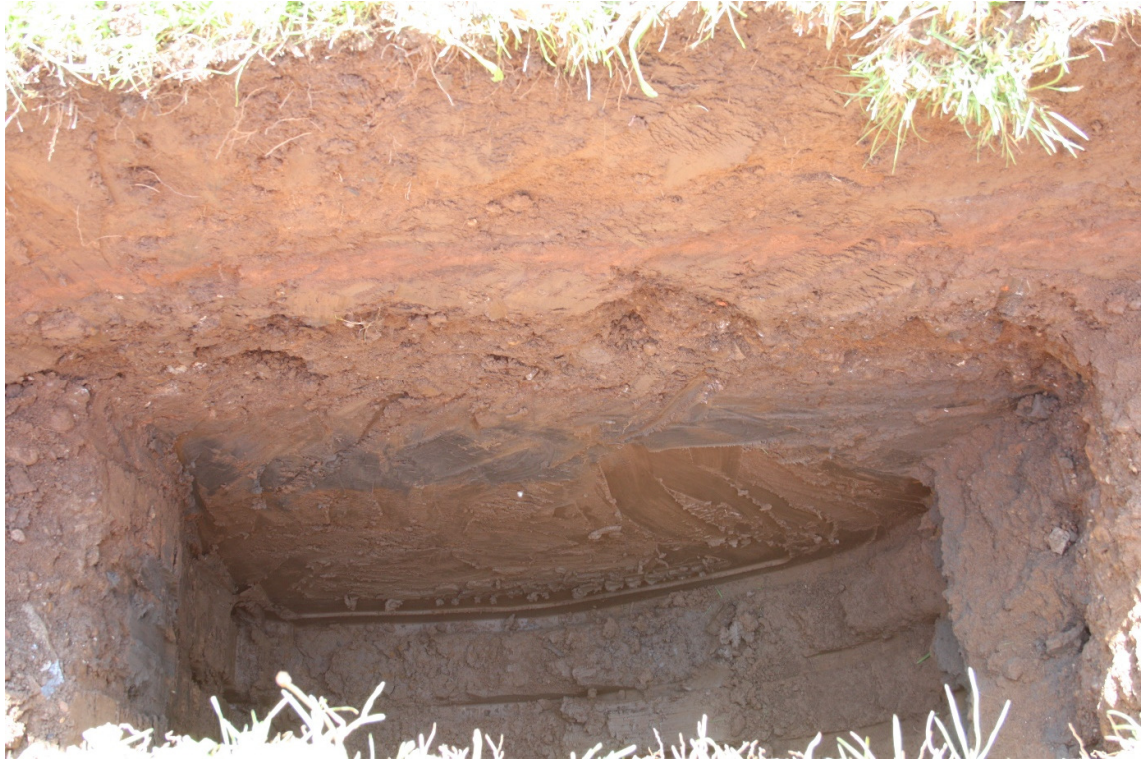
- 2.1.16 **TP14:** TP14 was located ~46m north northeast of TP10 on the grass bank to the north of the River Trent and opposite the entrance to the unused car park, reaching a total depth of 2.50m. From 0.00m to 0.20m there was topsoil consisting of mid brown humic sandy silt with organics / roots / rootlets. From 0.20m to 0.50m there was orangey grey/brown silty clay with gravel (round – sub rounded) with brick fragments and rare gravel, likely reflecting made ground. From 0.50m to 1.10m there was mid greyish brown stiff clay. Within this there were large cobbles of concrete. At 0.70m there was reddish brown clay, being made ground. Past 1.10m to 2.30m there was stiff dark greyish sandy alluvial clay with macros. This becomes lighter and less stiff past 1.60m and not organic or sandy becoming firm. Past 2.30m to 2.50m there is was mottled mid orangey / bluish brown grey gleyed sandy clay, likely representing alluvium.
