Holme Sluice Fish Pass, Colwick, Nottingham.

**Archaeological Monitoring and Recording (Watching Brief) of Ground
Investigations and Boreholes**

Report Number: 090/2017

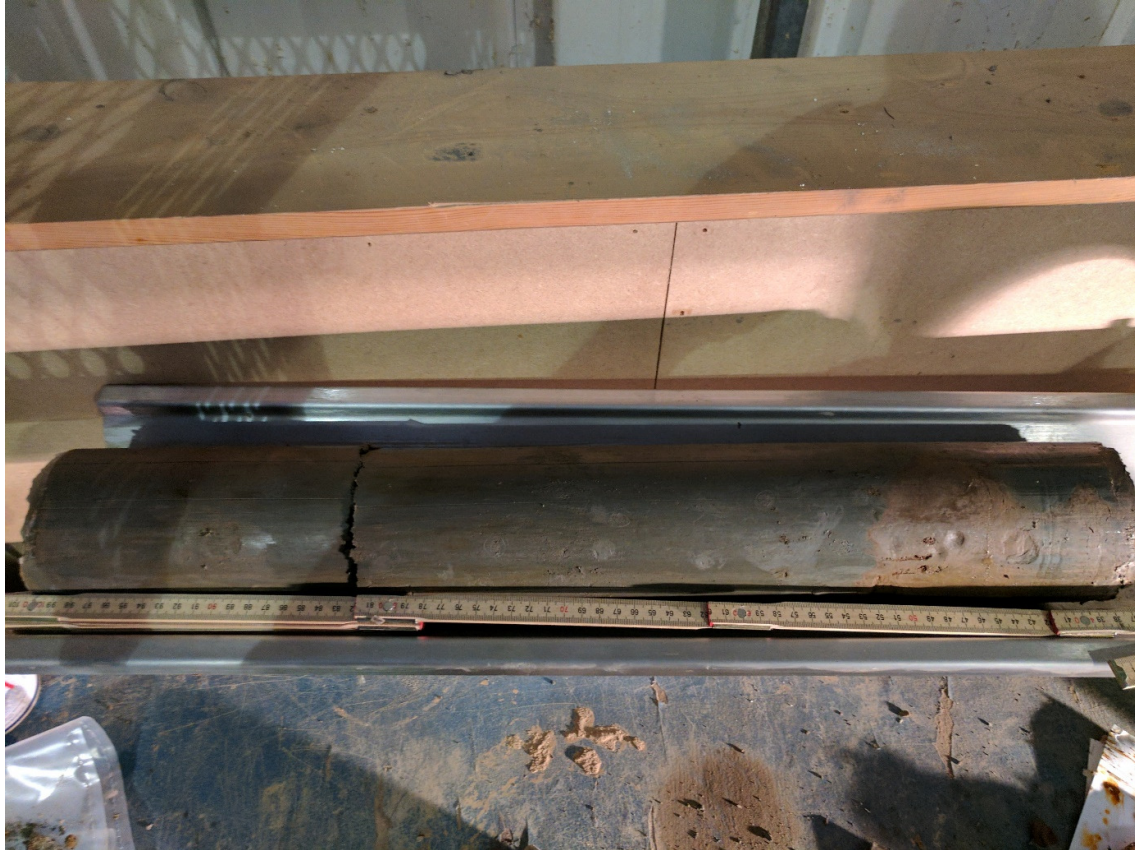
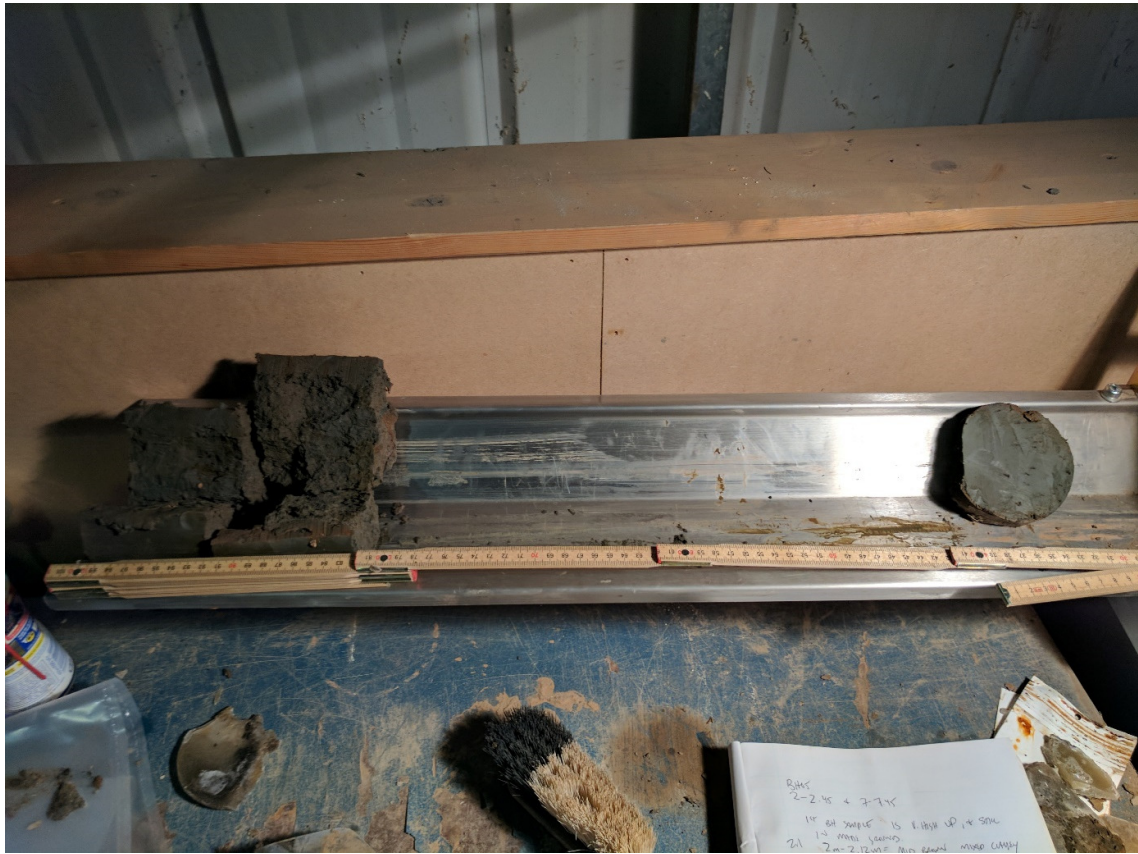
3.00-4.00m

One sample was observed from between depths of 3.00-4.00m. Between 3.00 and 3.37m there was no recovery. From 3.37-3.80m there was mid brownish grey silty clay with possible silt laminations. Sand (fine) increased with depth. From 3.80m to 3.90m this becomes sandy clay with frequent iron panning and slightly laminated with the sand becoming medium. From 3.90m to 3.40 was humic silt and becoming slightly darker.

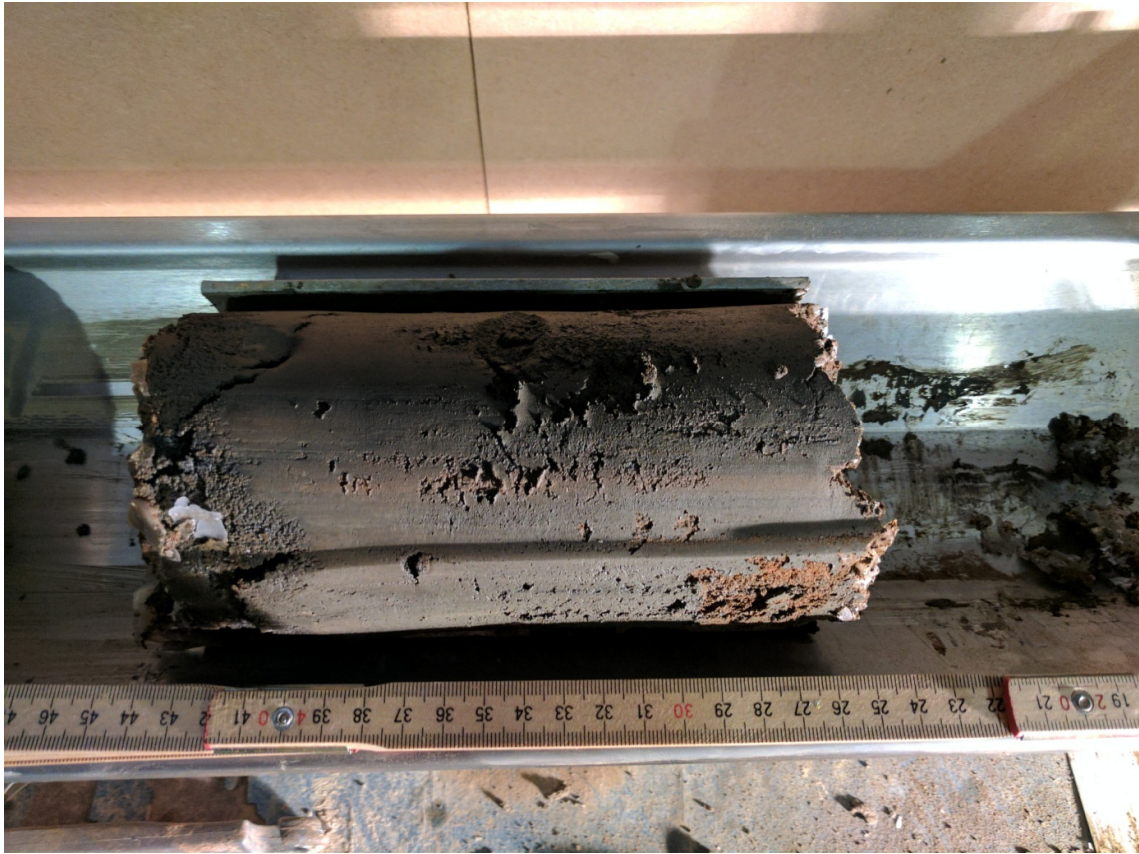
2.00-2.45m

A single sample was observed during the extruding of the samples between the depths of 2.00 and 2.45m. From 2.00m – 2.23m there was no recovery. From 2.23-2.41m there was dark brown silty clay with fine sand as well as hydrocarbon contamination. From 2.41-2.45m there was possible laminated sand, however, the extent of this could not be seen as the sample was unable to be split for closer inspection due to it being needed for geotechnical testing.

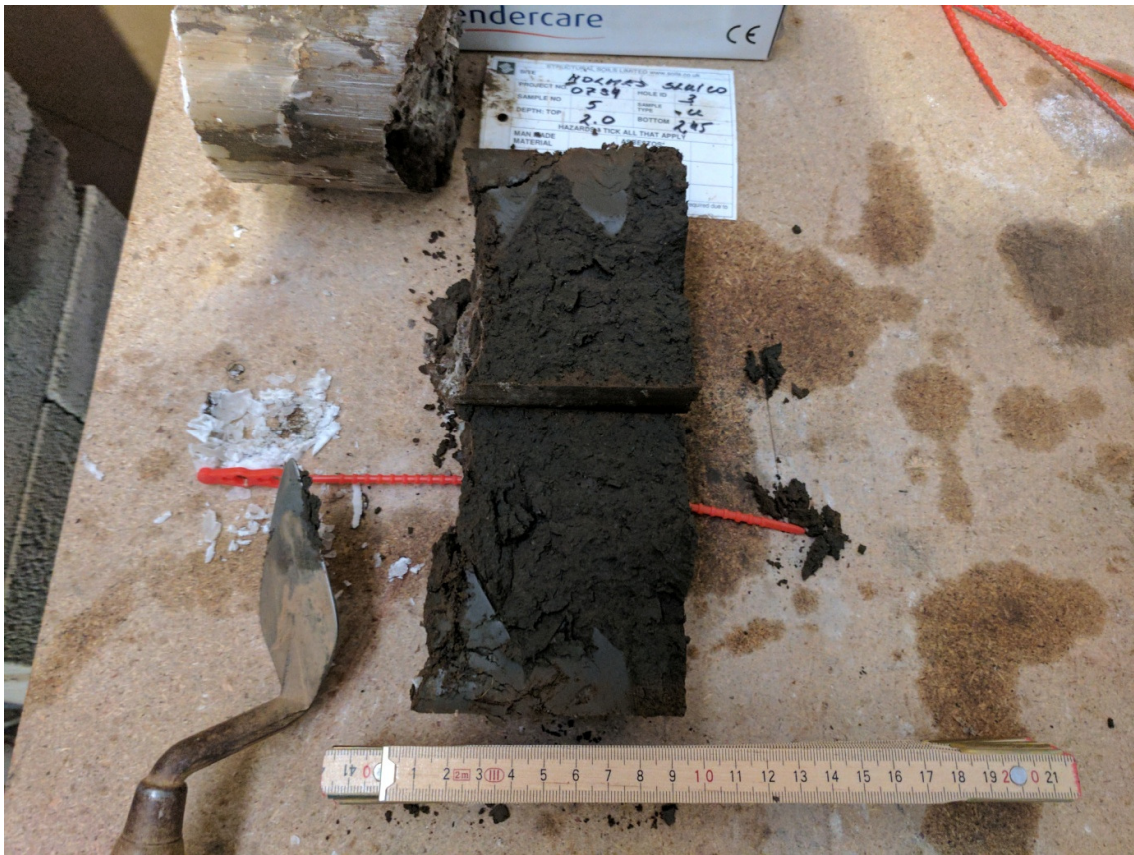
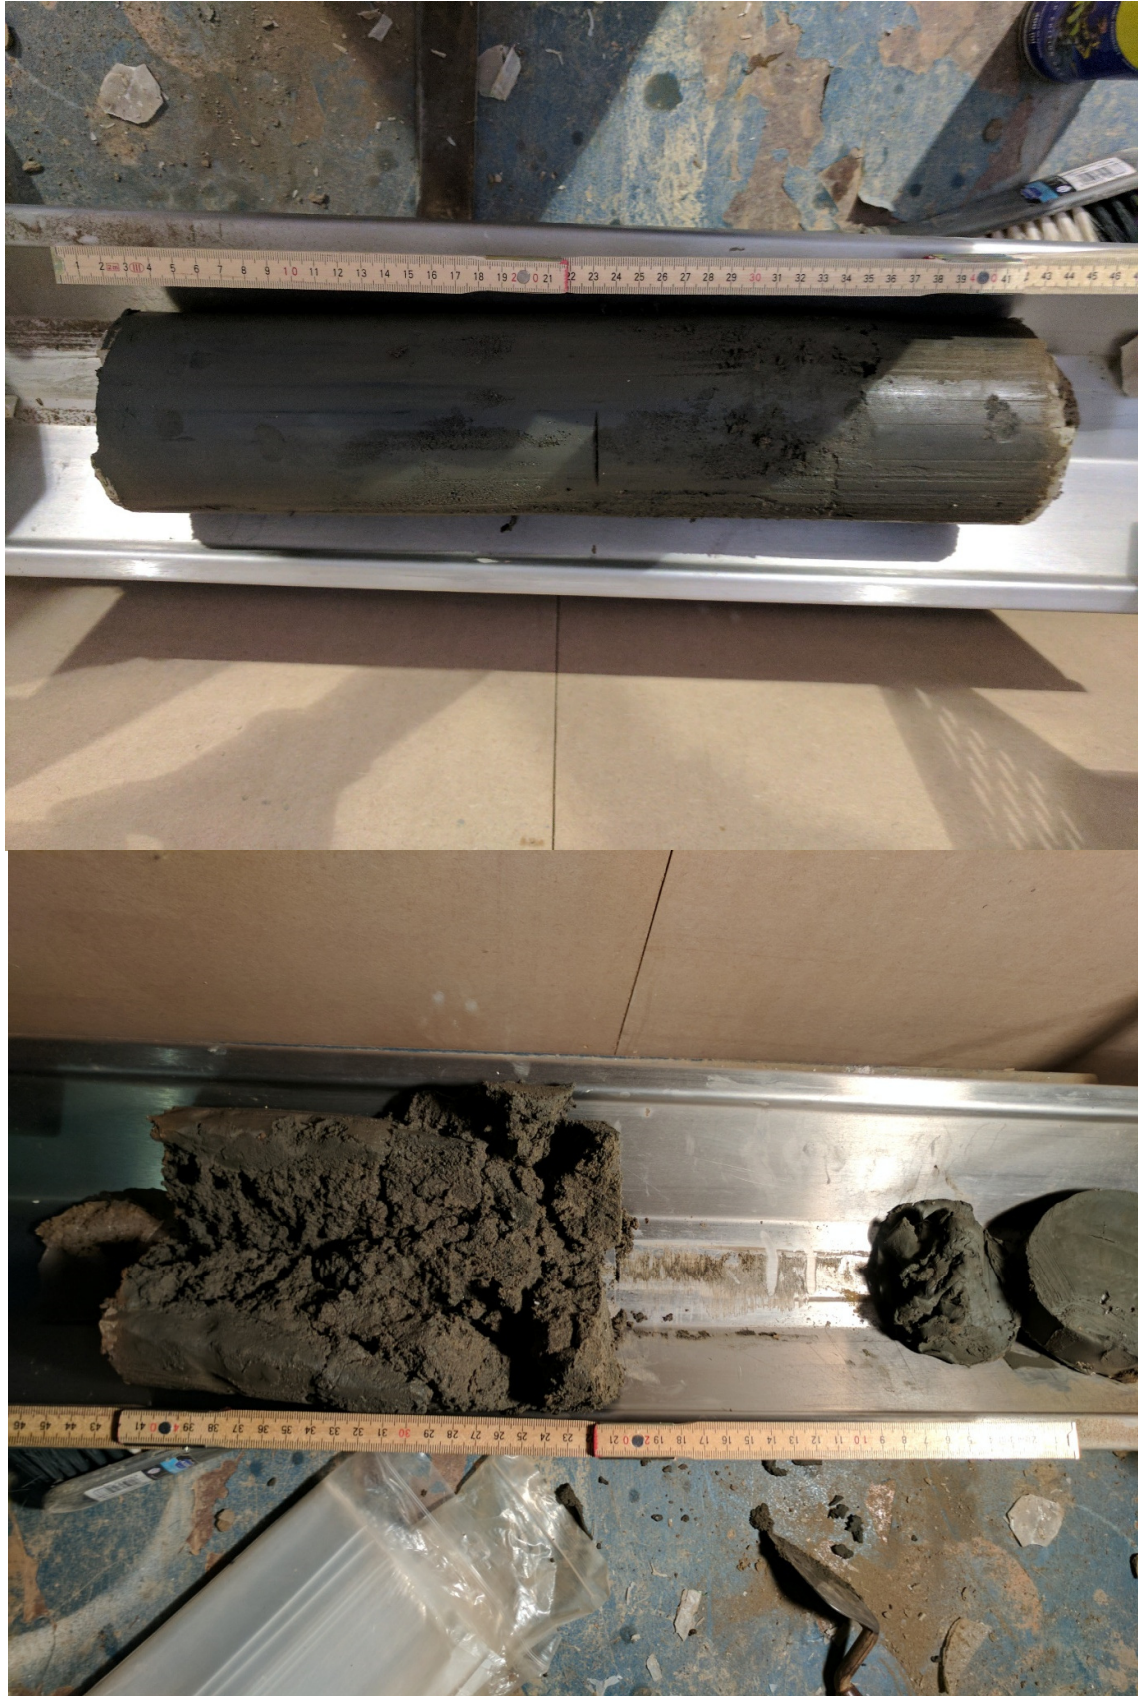
BH03:

Two samples were observed from 2.00-2.45m and 2.70-3.15m. From 2.00-2.45m there was very stiff dark greyish brown clay with very fine silt and sand. It is structureless and likely to be reworked as well as being contaminated by hydrocarbons. Between 2.45-2.70m there were no samples to observe however, between 2.70-3.15m the description is the same. Within this between 2.90 and 3.05 there was a coarse quartz sand band with silt, still dark greyish brown and slightly less contaminated than the silty sandy clay above. From 3.05 to 3.15 there was a humic silt of similar colour to that above with less sand.

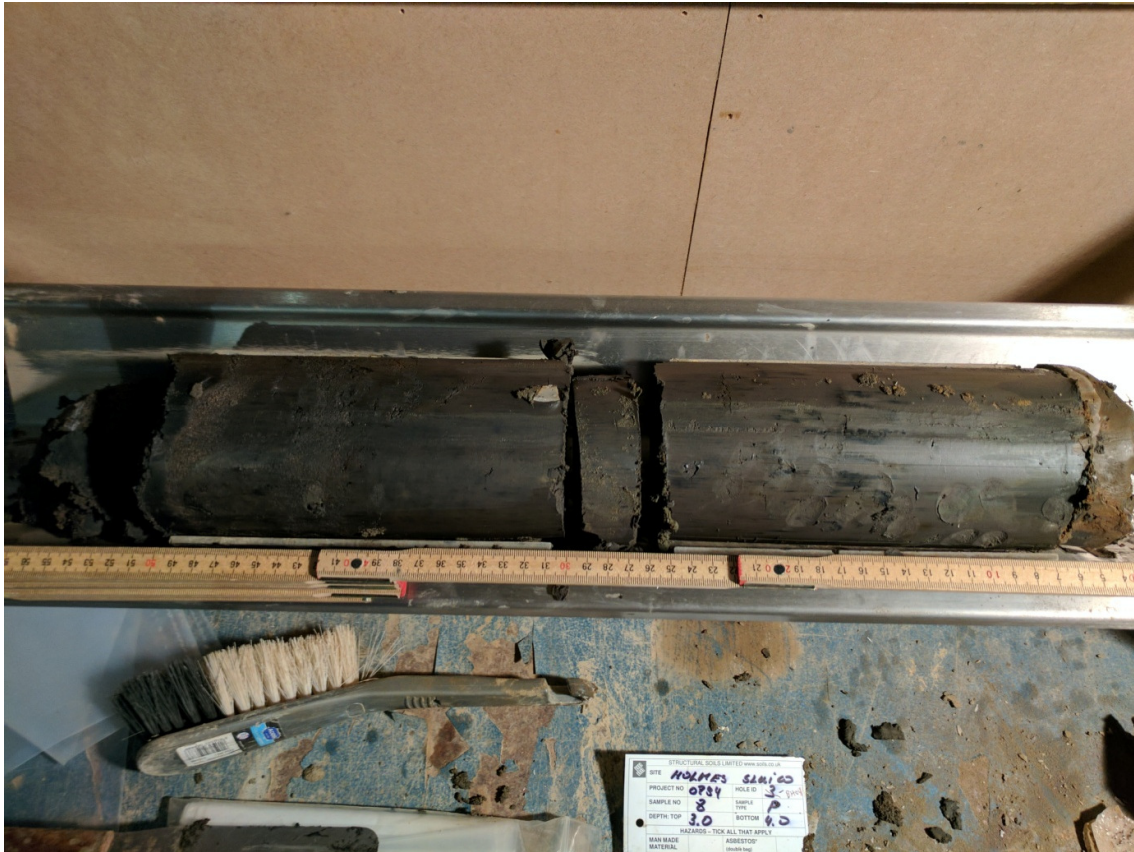
3.00-4.00m

One sample was observed between 3.00-4.00m. From 3.00 to 3.45m there was no recovery. Between 3.45 and 3.87m there was dark brown silty clay with silt and fine sand as well as contamination from hydrocarbons. From 3.87 to 4.00m there were laminated bands of coarse sand and humic silt. The silt was humic and platy and the same was angular and medium-coarse.

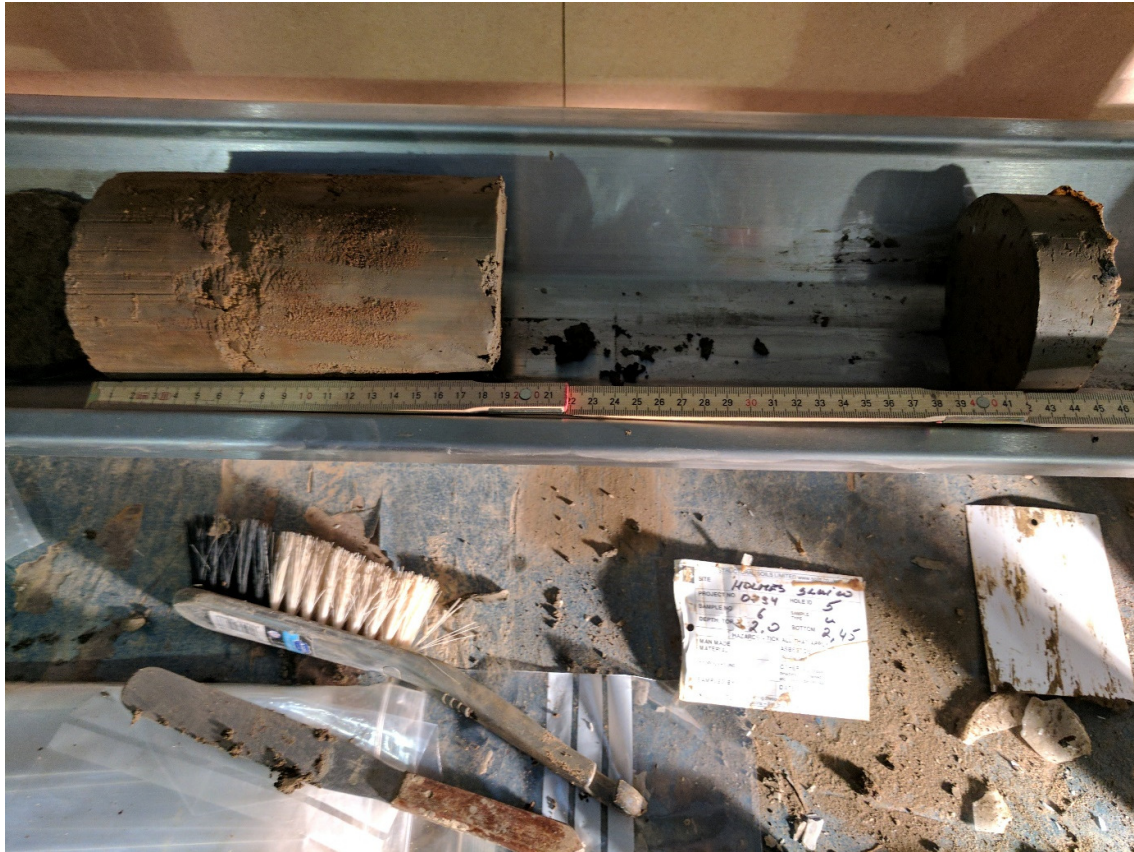
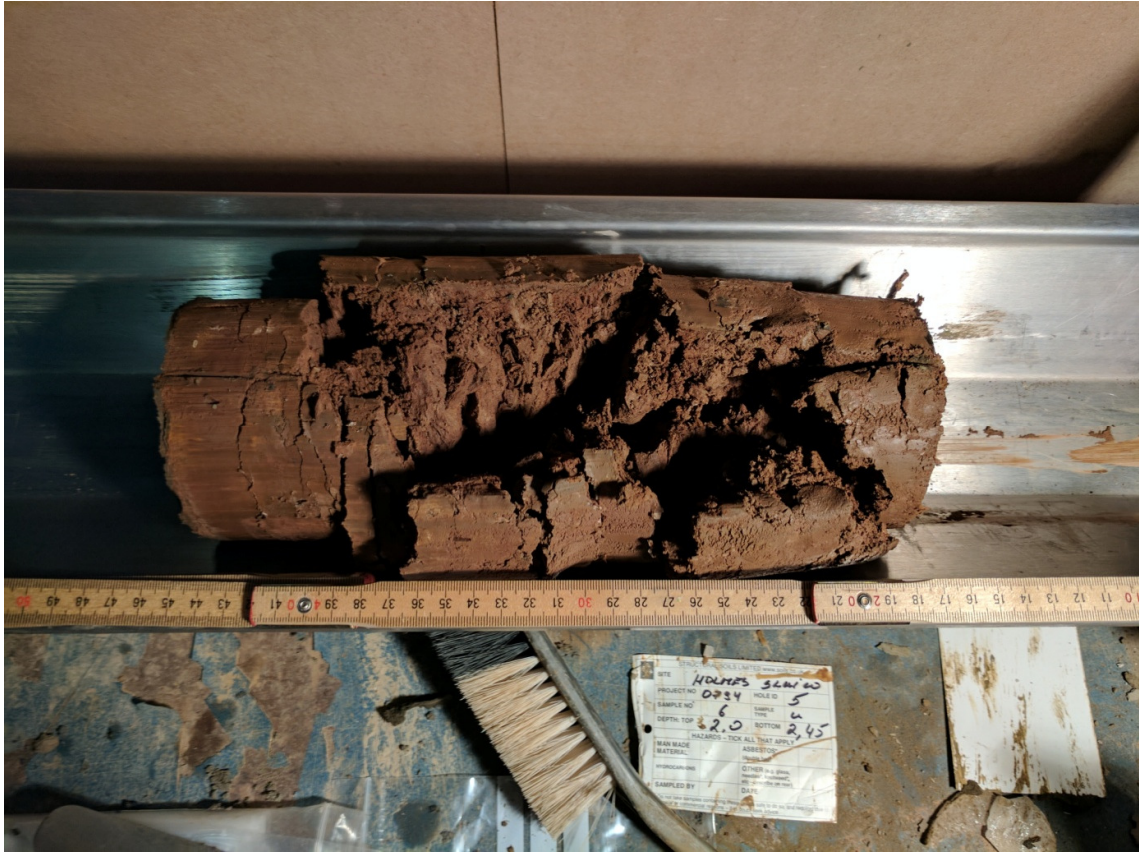
BH05:

Two samples were observed from 2.00-2.45m and 7.00-7.45m. From 2.00-2.12 there was mid brown clayey silt representing made ground. From 2.12 to 2.45m this becomes dark greyish brown silty clay with rare silt and fine sand. It is also likely that this is made ground towards the top of the alluvially deposited layers. From 7.00-8.00 was the mudstone bedrock.
