Dartmoor National Park Histor	ic En	vironment Re	co	ra
Civil Parish & District:	National Grid		N	Number:
	Reference:			
Dean Prior, South Hams	SX 7129 6340			
Subject:				Photo attached:
Archaeological evaluation and historical building recording at				Y
Moorshead, Deancombe, Devon.				
Planning Application no:		Recipient museum:		
0135/11		Plymouth Museum		
OASIS ID:		Museum Accession no:		
oakforda1-122153		2012.12		
Contractor's reference number/code:		Dates fieldwork undertaken:		
DA1036 08-03-2		08-03-2012	3-2012	
Description of works				
<b>Description of works:</b> An archaeological trench evaluation and historic building recording was undertaken by Oakford				
Archaeology in March 2012 in advance of development at Moorshead, Deancombe, Devon (SX 7129)				
6340). The site (Fig. 1) is part of a Dartmoor longhouse, probably built during the middle of the 15 <sup>th</sup>				
century, and fallen into ruin during the 20 <sup>th</sup> century. The work was required under a condition attached to the grant of planning permission (ref. 0135/11).

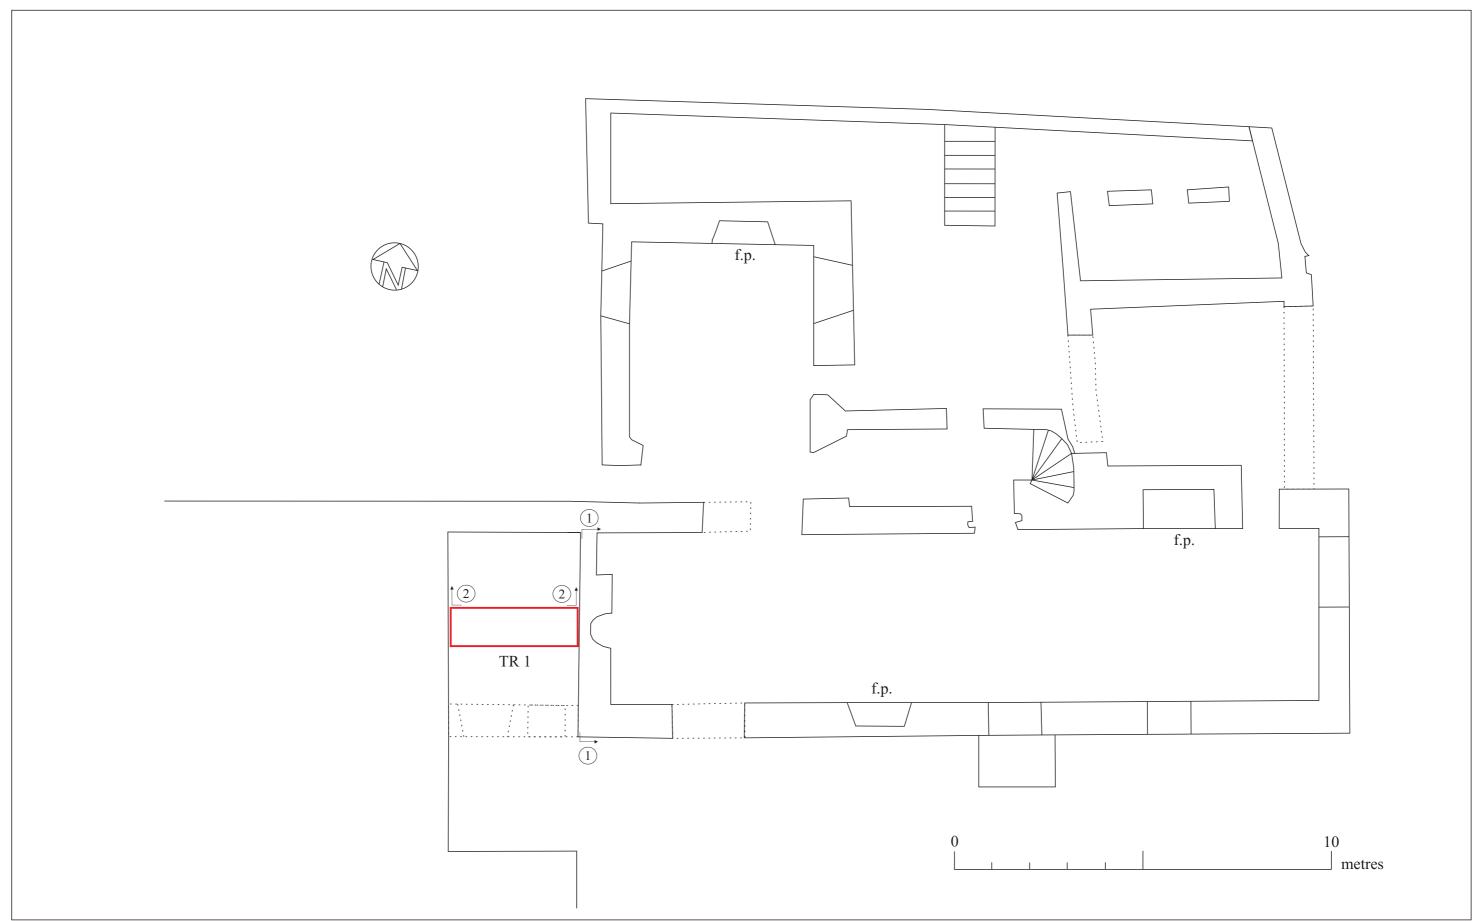
Fig. 2 Plan of Moorshead Manor House and location of building elevation and evaluation trench.

to the grant of planning permission (101, 0133/11)	١.			
Results (figs. 2-3, pl 1-2):				
Prior to commencing works the south-west elevation of the longhouse was drawn. Unfortunately this				
had been re-pointed in anticipation of the works. Little information could be gathered from this, other than that the south-east corner of the building had been partly re-built in recent years to support the roof				
over the garage.				
The evaluation comprised the excavation of a sin

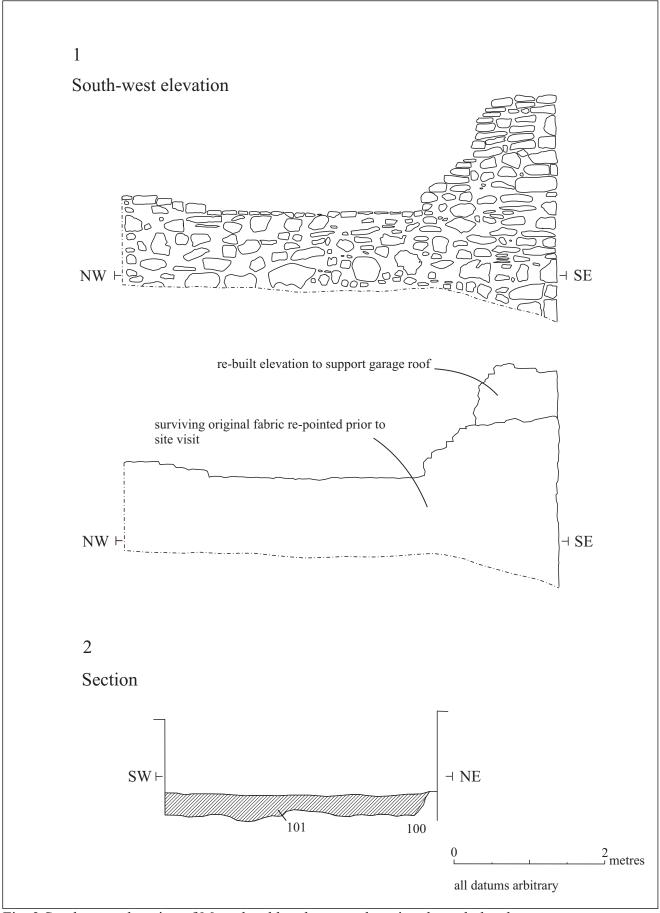
Fig. 3 South-west elevation of Moorshead longhouse and section through development area.

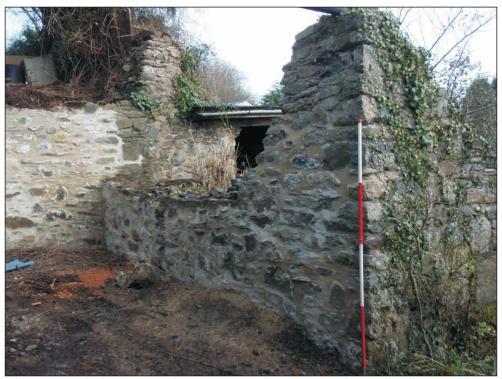
Pl. 1 General view of south-west manor house elevation to be obscured by development. 2m scale. Looking north.

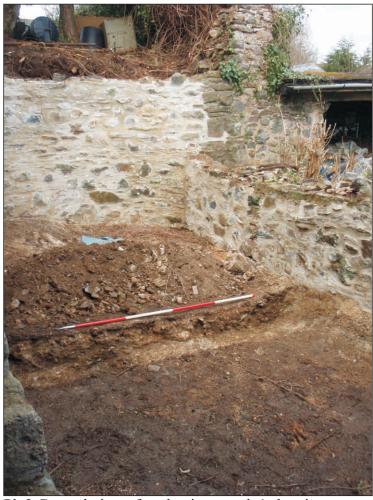
Pl. 2 General view of evaluation trench 1 showing modern disturbance (101) in development area. 2m scale. Looking north.

0.35m deep. Trench 1 was archaeologically sterile. The area had previously been reduced and infilled with concrete rubble and soil (101), thereby removing any potential archaeological remains.				
Discussion:				
The evaluation has demonstrated that the area of the proposed development is archaeologically sterile. No features or deposits were found to indicate archaeological activity within the trench. The area had				
been reduced by the previous owners sometime in the 1980's. The lack of pottery and lithics from the				
site, despite examination of spoil heaps, further indicates that the potential for significant archaeological				
survival is low. As a result, it was agreed with the DNPA Archaeologist that no further archaeological				
site work was necessary. This is the only report o	n these w	Orks.		
Project archive				
The site records have been compiled into a fully integrated site archive which is currently held at the
