St. Luke's Bell Tower, Carluke Data Structure Report Project 4267

St. Luke's Bell Tower, Carluke

Data Structure Report

Project Number: 4267

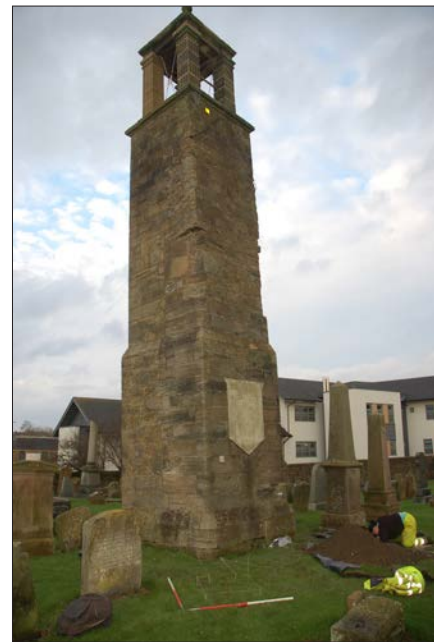
Plate 1: Working shot of trench 1 and pre-ex of trench 2.

6.1 In the first instance contextual photographs (Plate 1) were taken from all available aspects of each of the areas proposed for trench excavation.

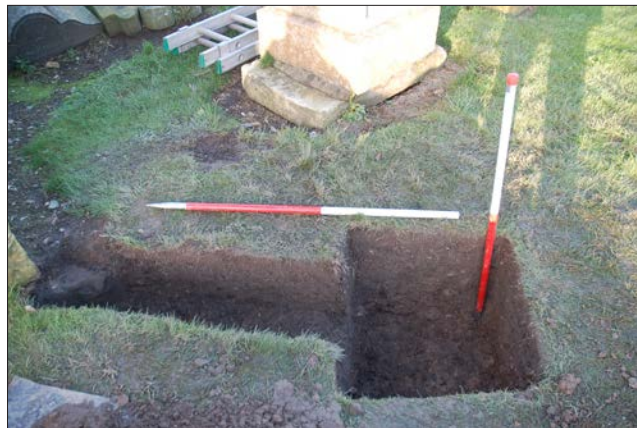
7.1.1 Both trenches were stripped of topsoil 001 which consisted of grey/brown clayish silt measuring between 0.15 m and 0.35 m thick. An intermediate layer of yellow brown silty clay 002 with frequent angular pebbles and cobbles (at least 0.2 to 0.25 m thick) was identified in Trench 1. A total of 63 pieces of disarticulated human bone, belonging to at least one adult and one sub-adult, as well as eight pieces of possible coffin furniture in the form of iron nails and possible hinges were also recovered from this trench. Adjacent to the tower and within the topsoil deposit, a single piece of sandstone 003 with no bonding material was identified (Plate 2). Due to the trench restrictions its full extent was not exposed and therefore recorded, but its alignment does suggest that it could be part of the foundation wall of the eighteenth century church.

Plate 2: South-east facing section showing possible foundation stone.

| Context No. | Area | Description | Interpretation |
|---|---|---|---|
| 003 | Trench 1 | One irregular/trapezoidal drystone sandstone. Not fully exposed by trench one, dimensions in section and plan = 0.17 m x 0.22 m x 0.18 m. | Possible foundation stone from the robbed stone church that was previously attached to ST Luke's belltower. Only one stone was exposed by Trench 1, but it is attached to the bell tower on the appropriate side (and seems to run in the appropriate direction) to have been part of the early church. |
