Eastern Infrastructure, Salisbury Plain Training Area, Wiltshire

Archaeological Field Evaluation

WA Ref: 63213.02

## April 2007

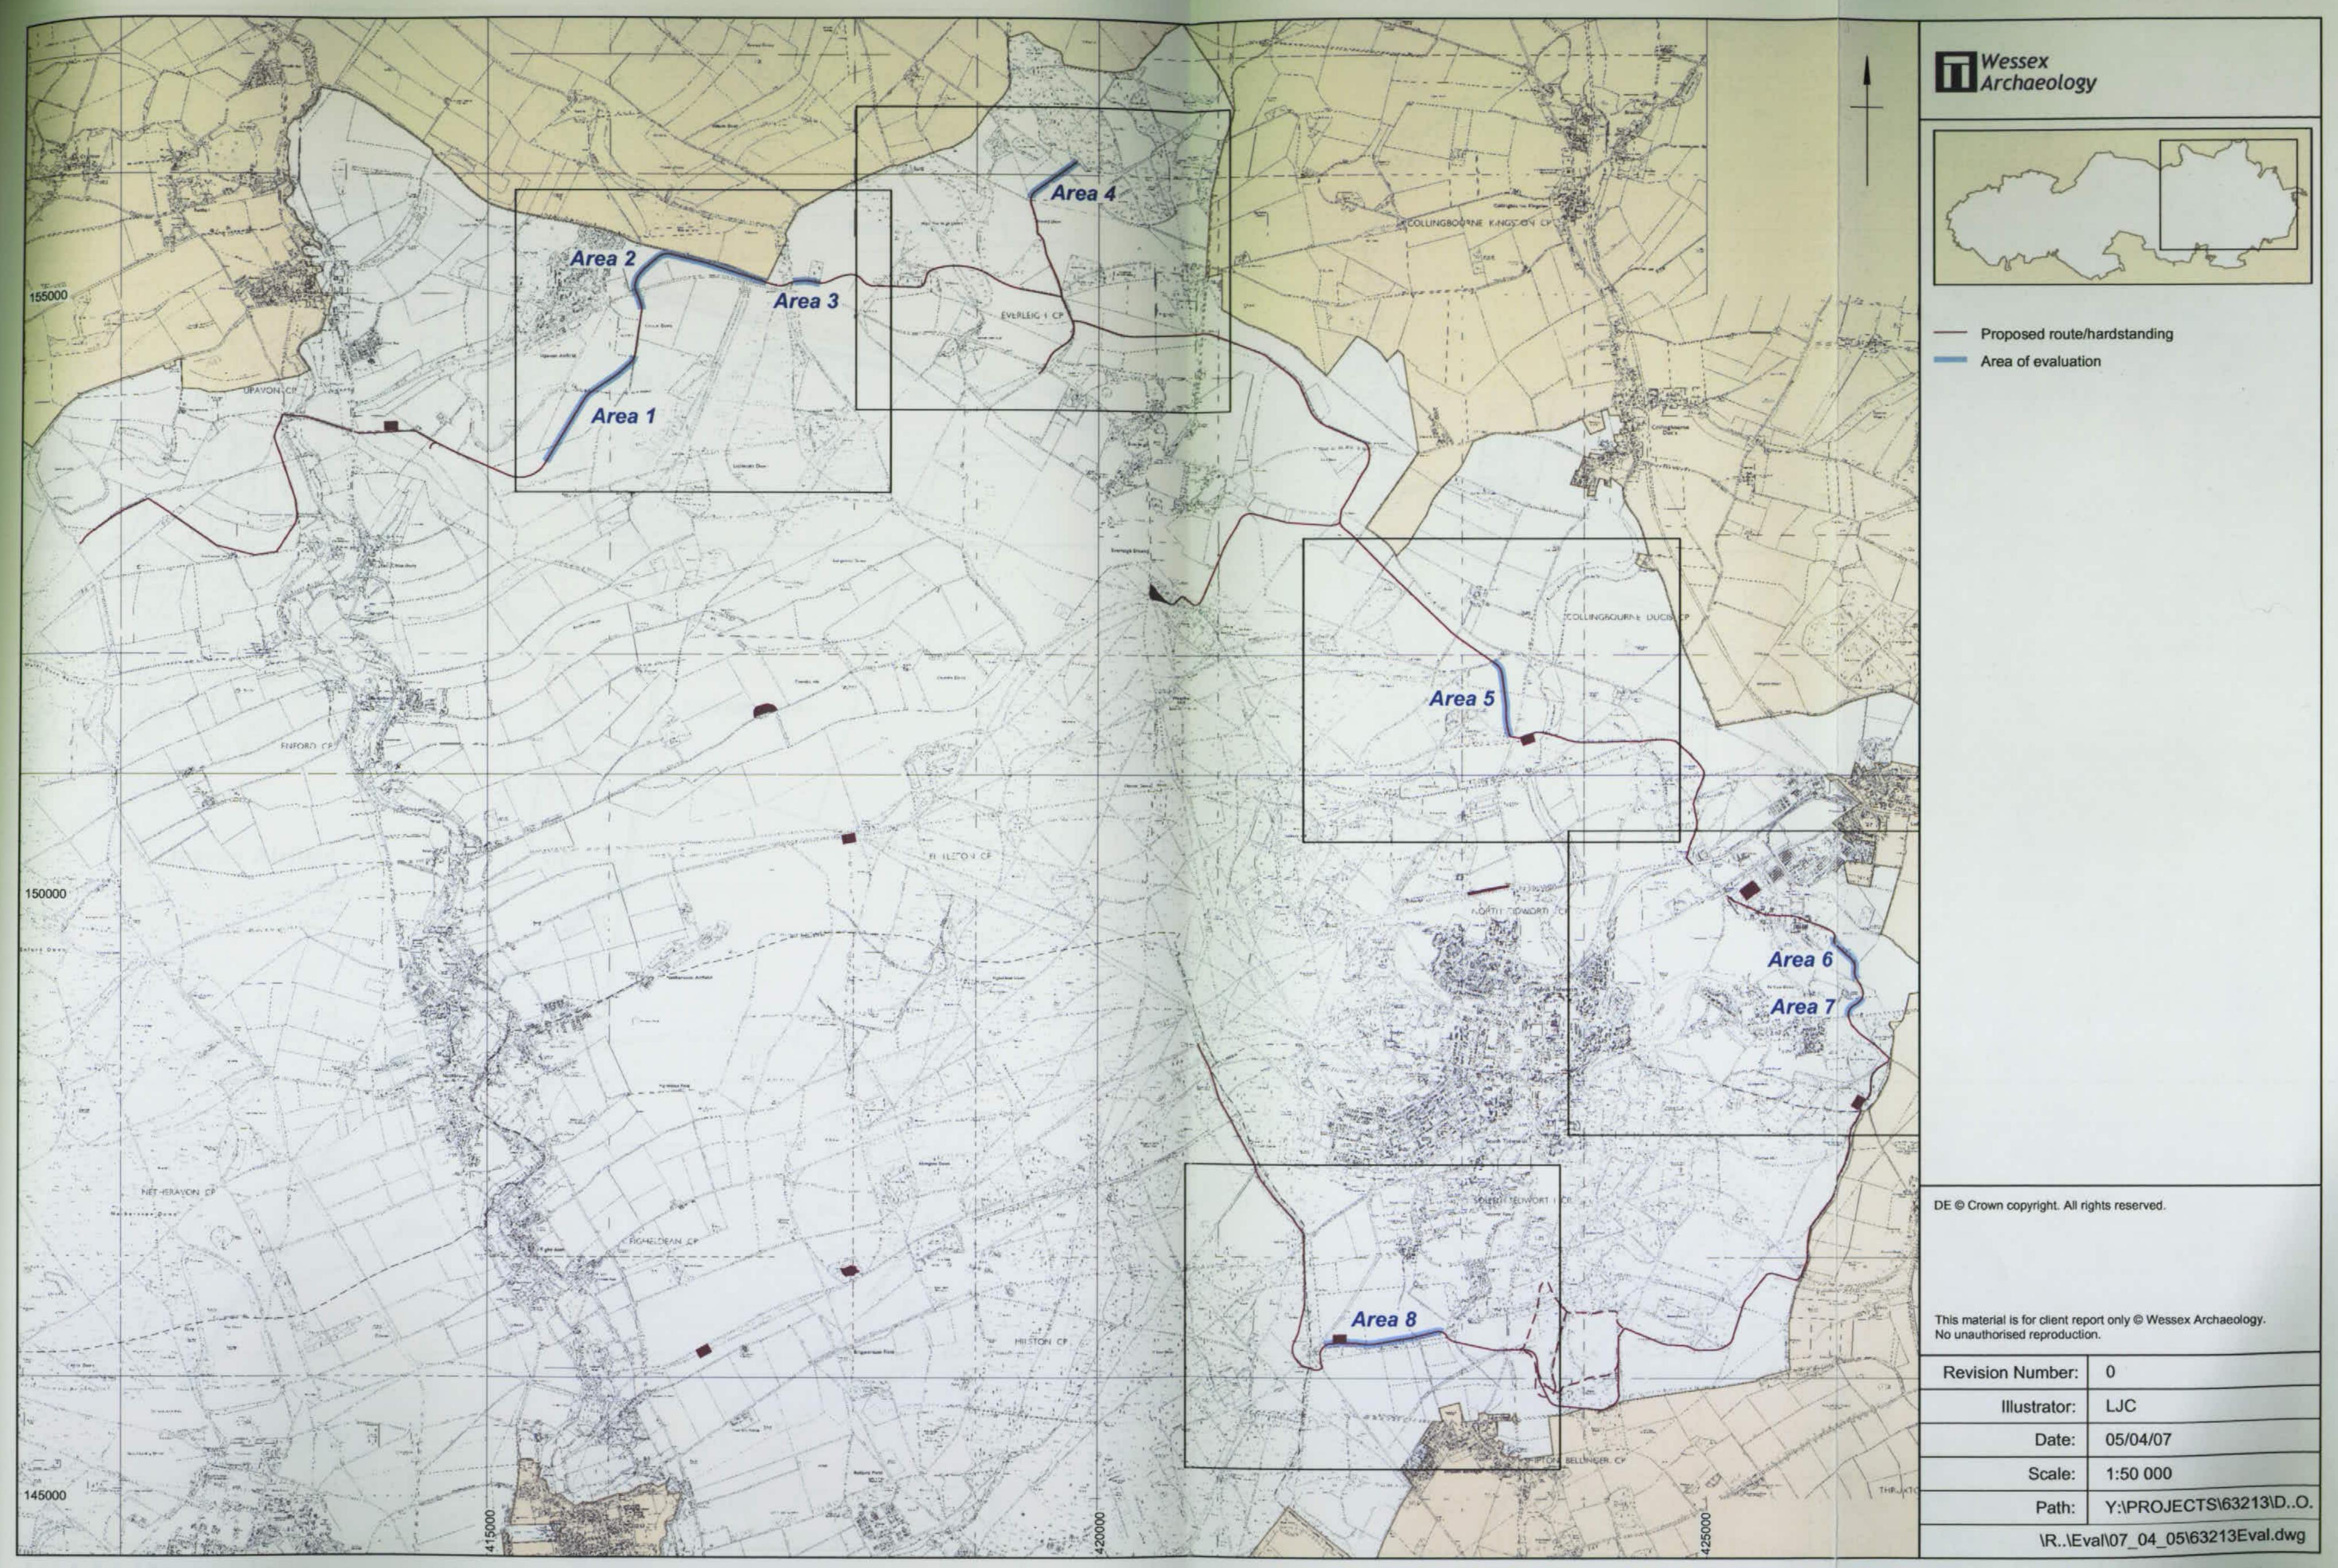
Location of Evaluation Areas along the proposed track

- 1.1.3 The evaluation trenching, totalling 59 machine excavated trenches between 10m and 50m in length, was undertaken in eight areas (**Figure 1**) along the proposed route. The trenches were targeted on anomalies and blank areas detected by the geophysical surveys carried out in January/February 2007. The fieldwork was undertaken between 27<sup>th</sup> February and 15<sup>th</sup> March 2007.

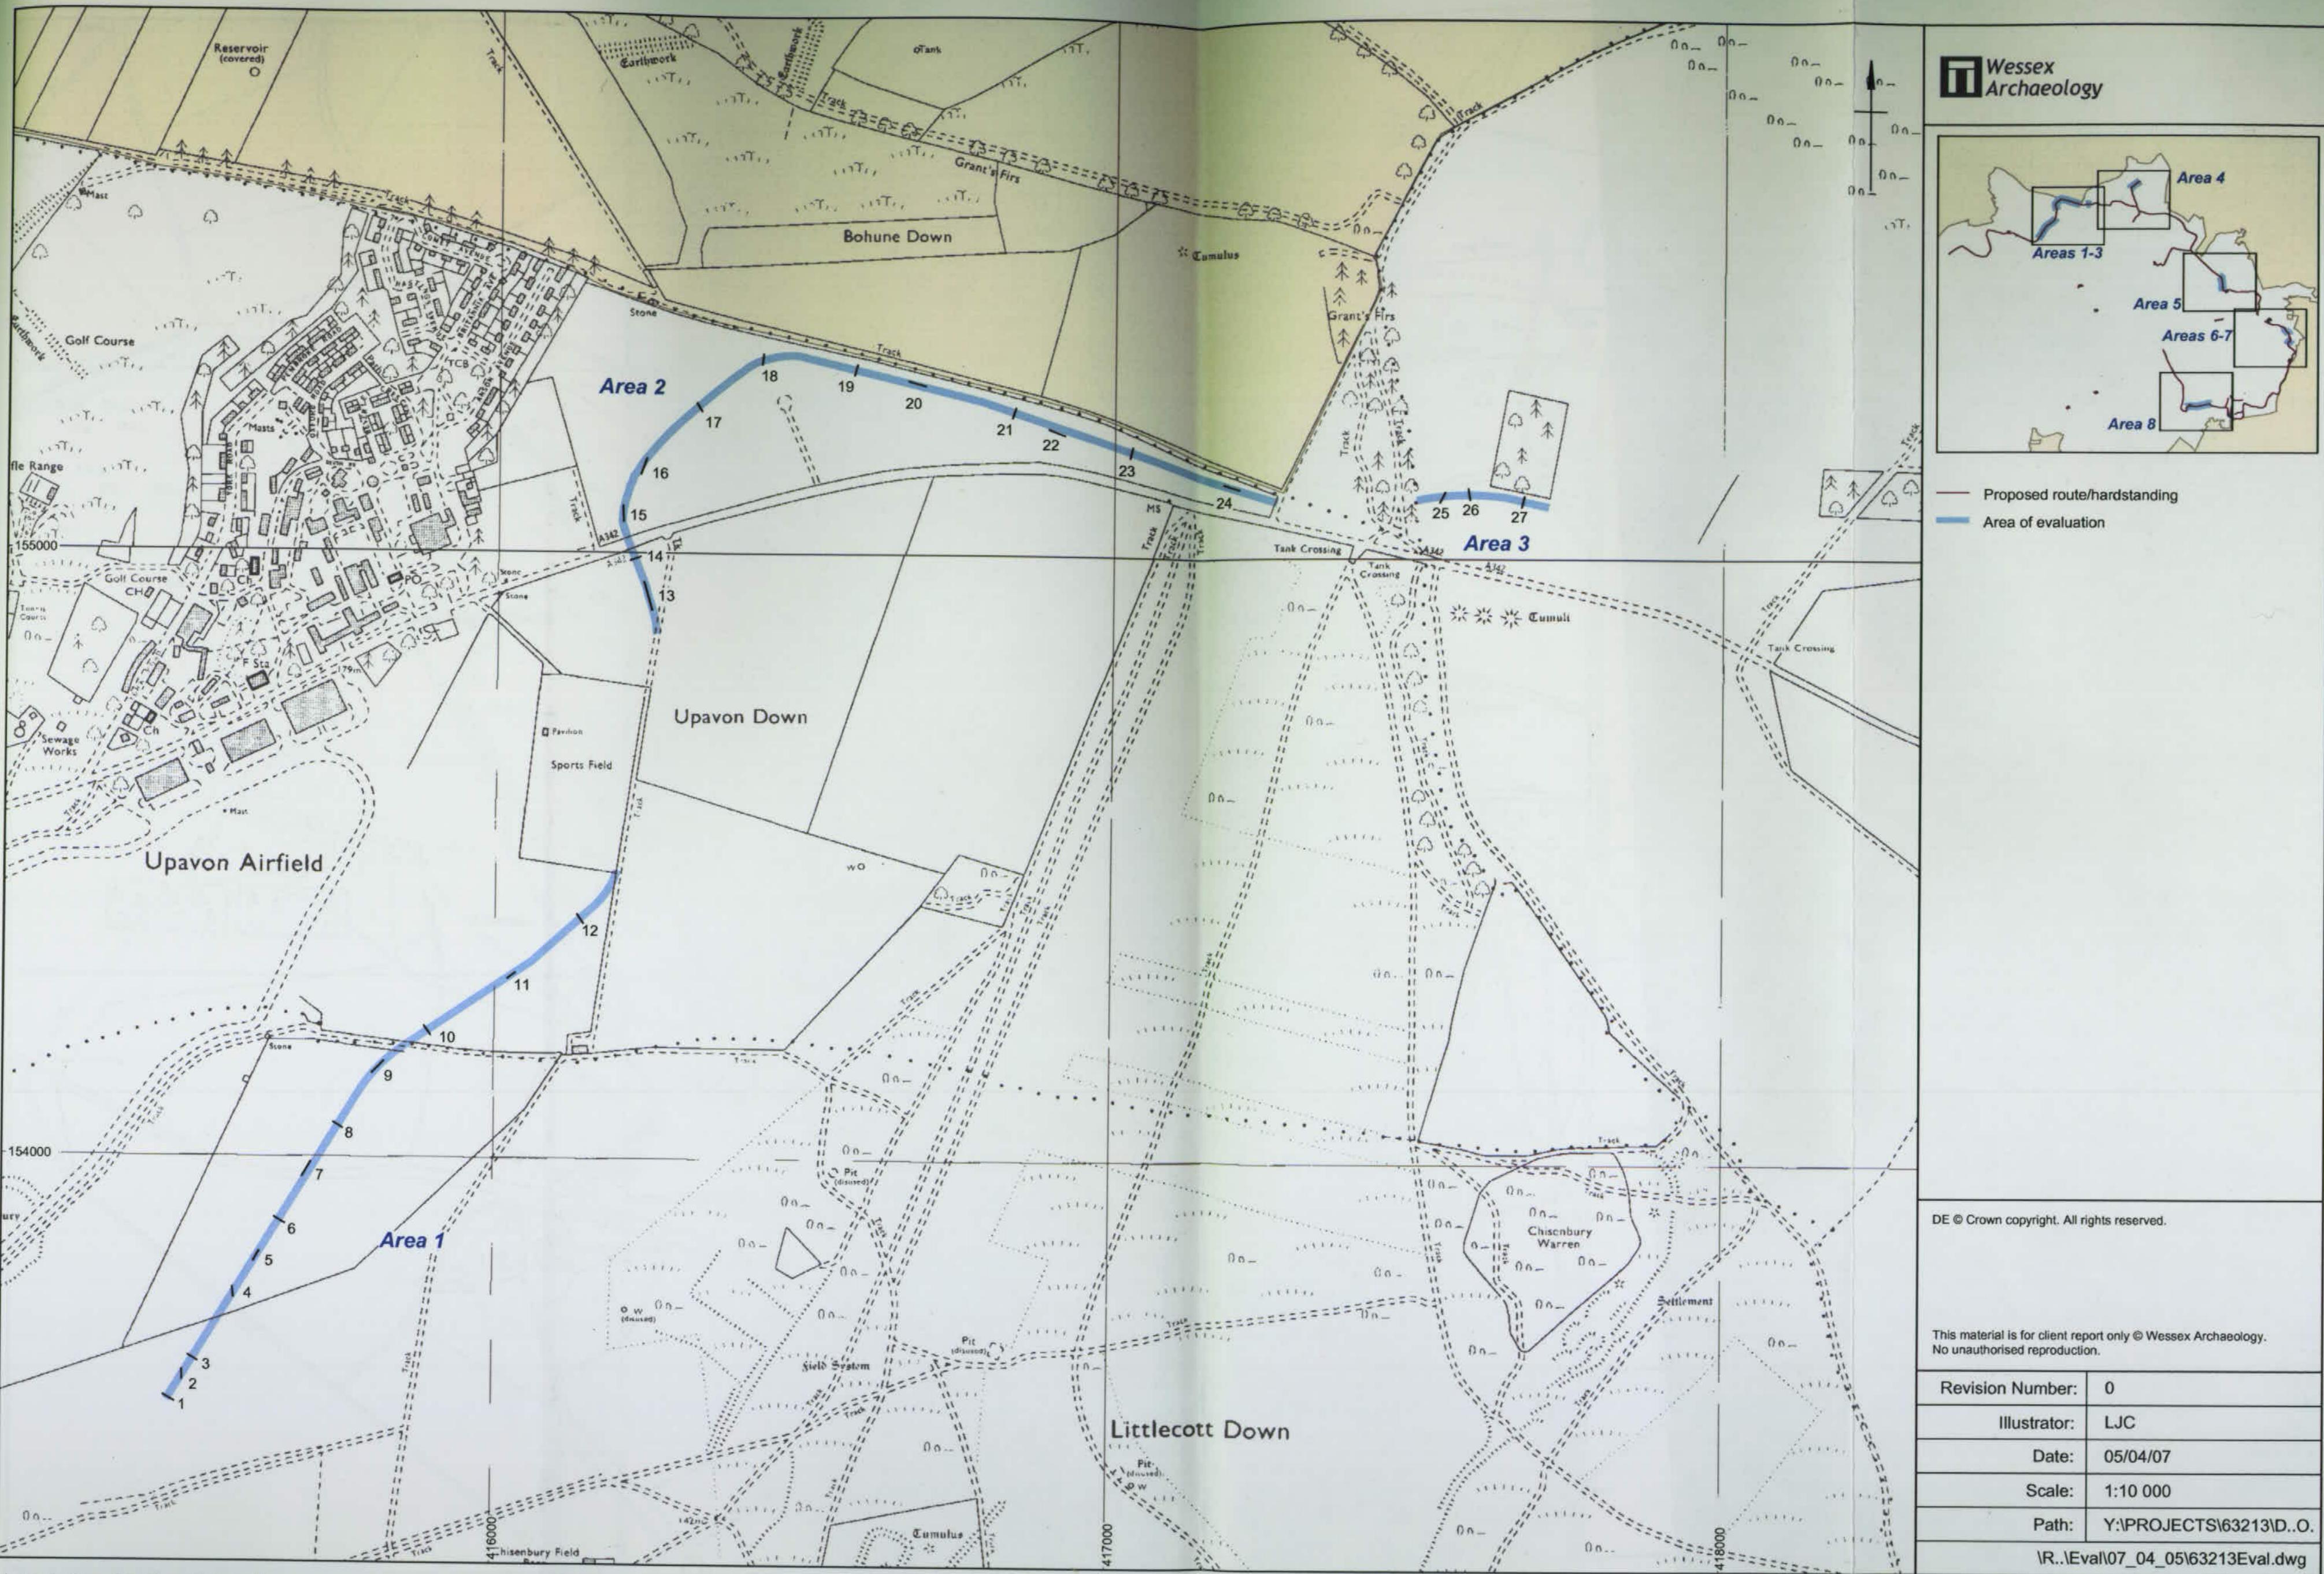
Area 1, 2 and 3 Trench locations

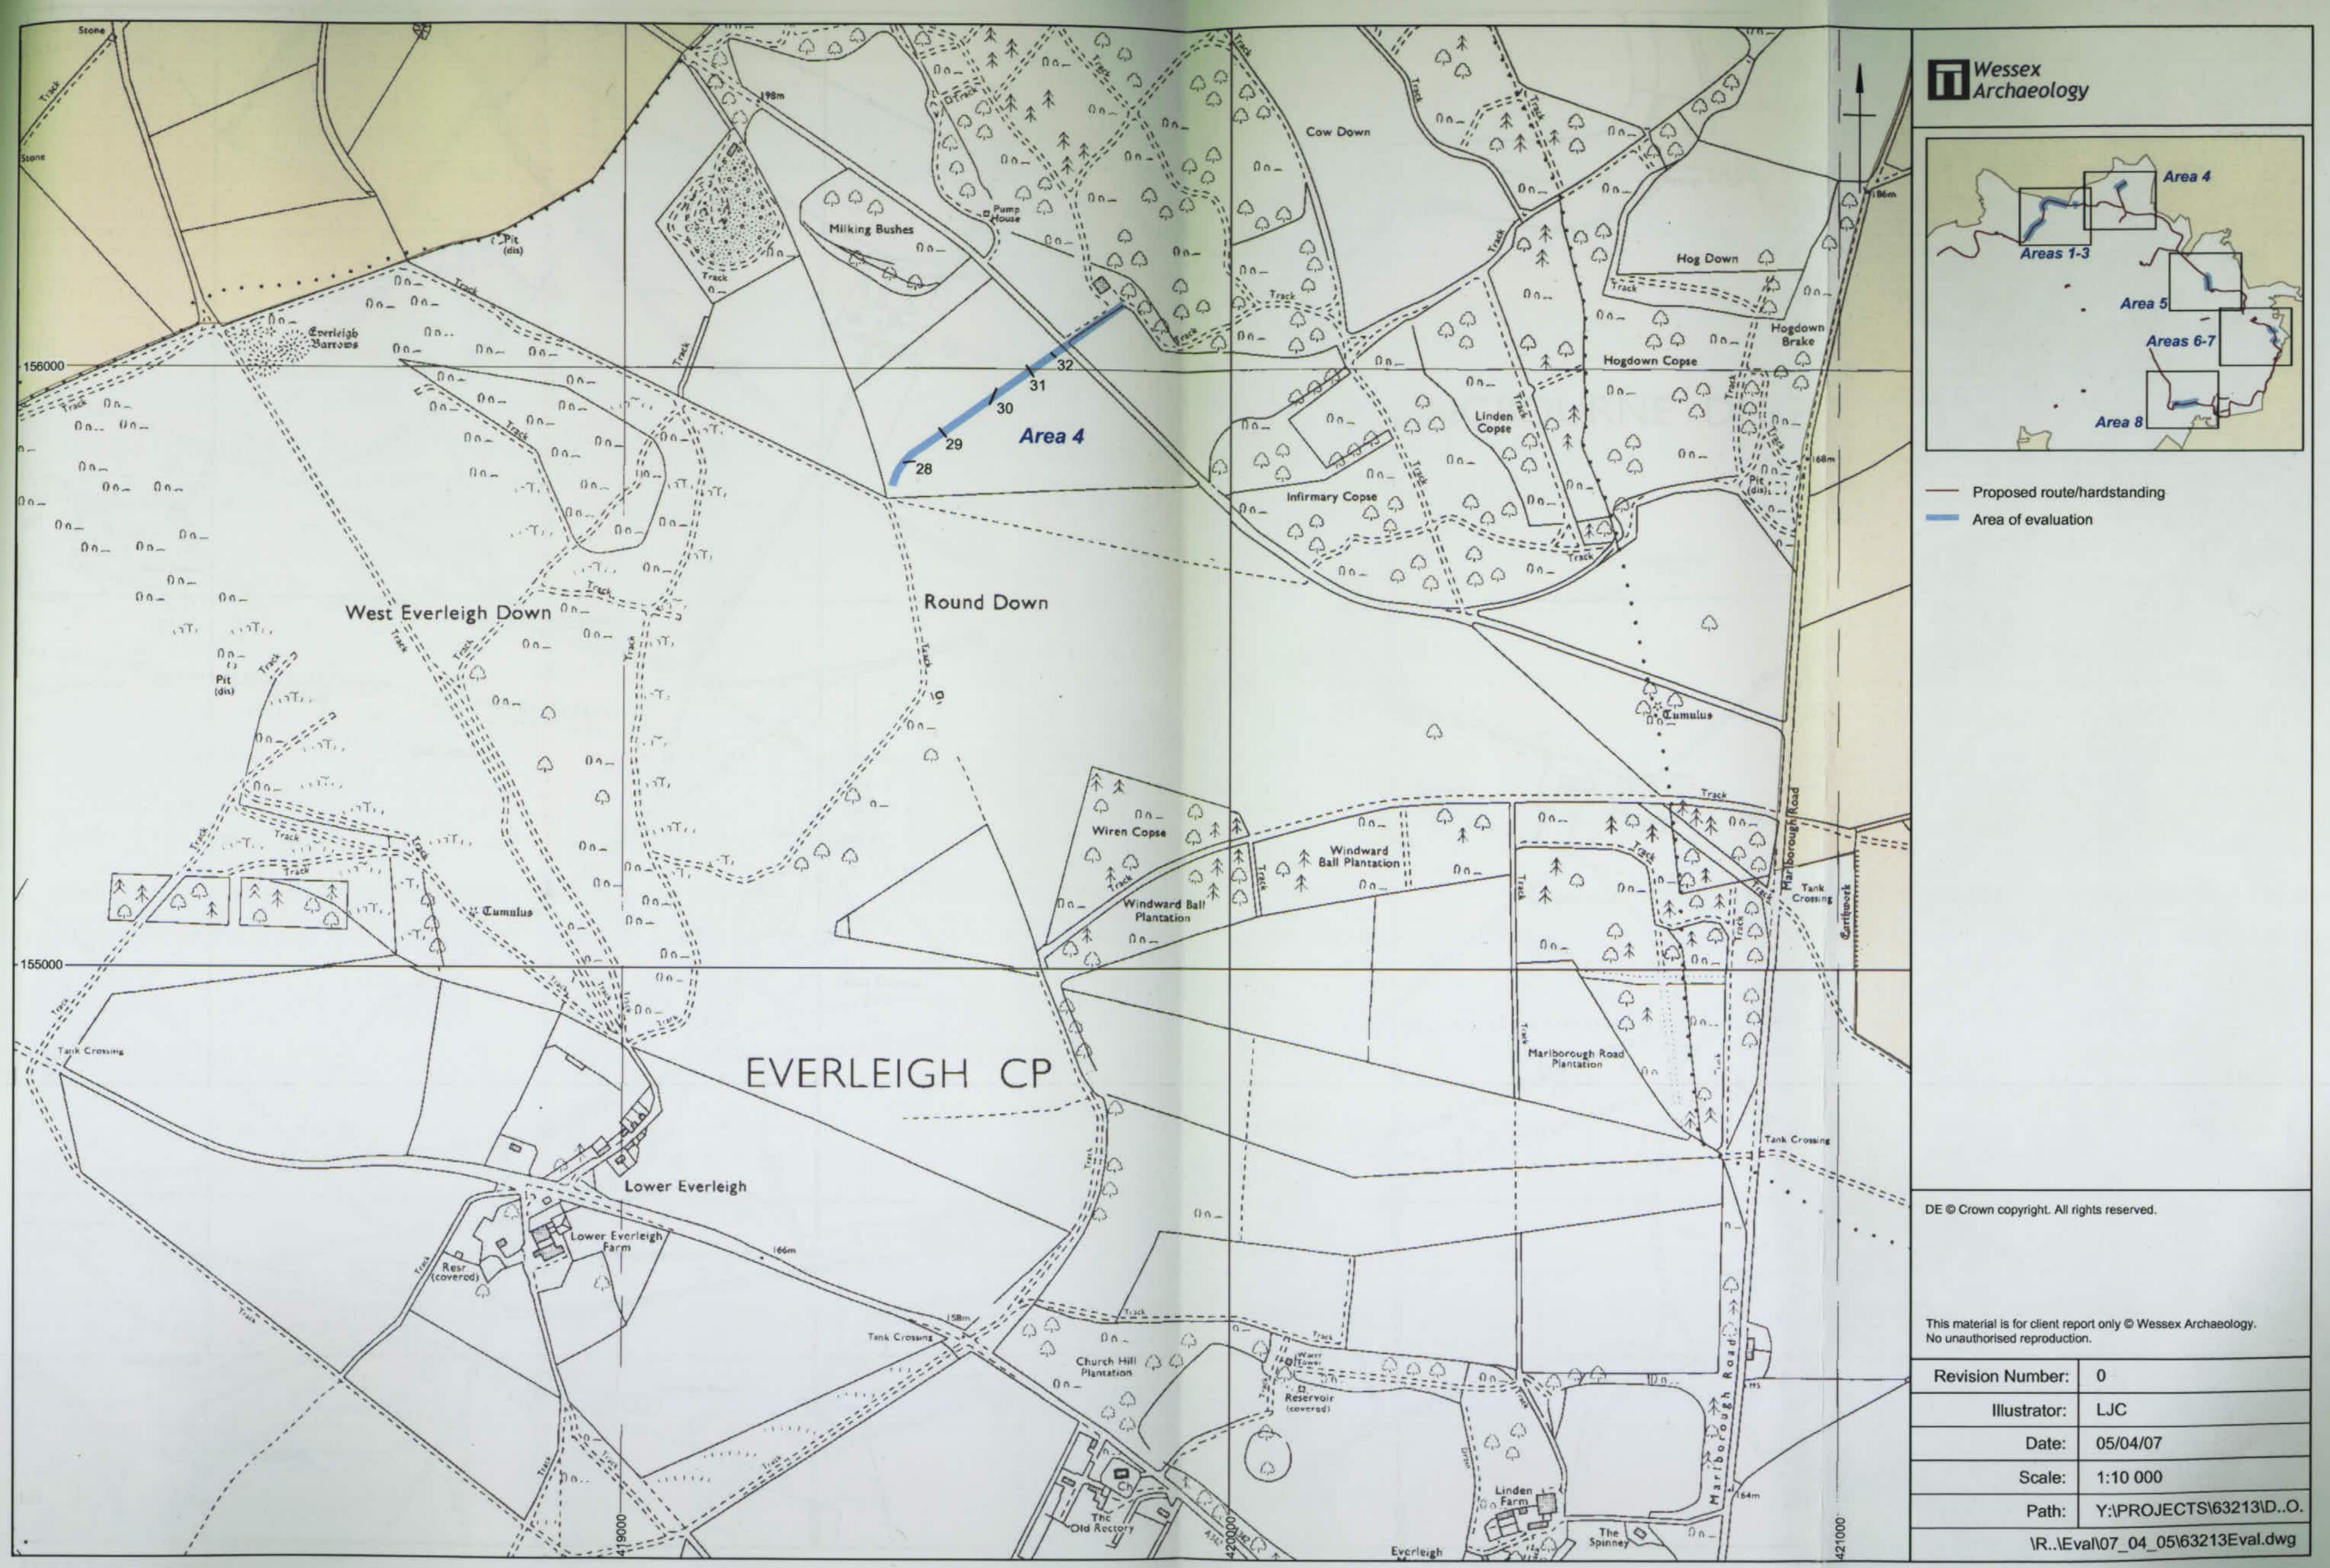
Area 4 Trench locations

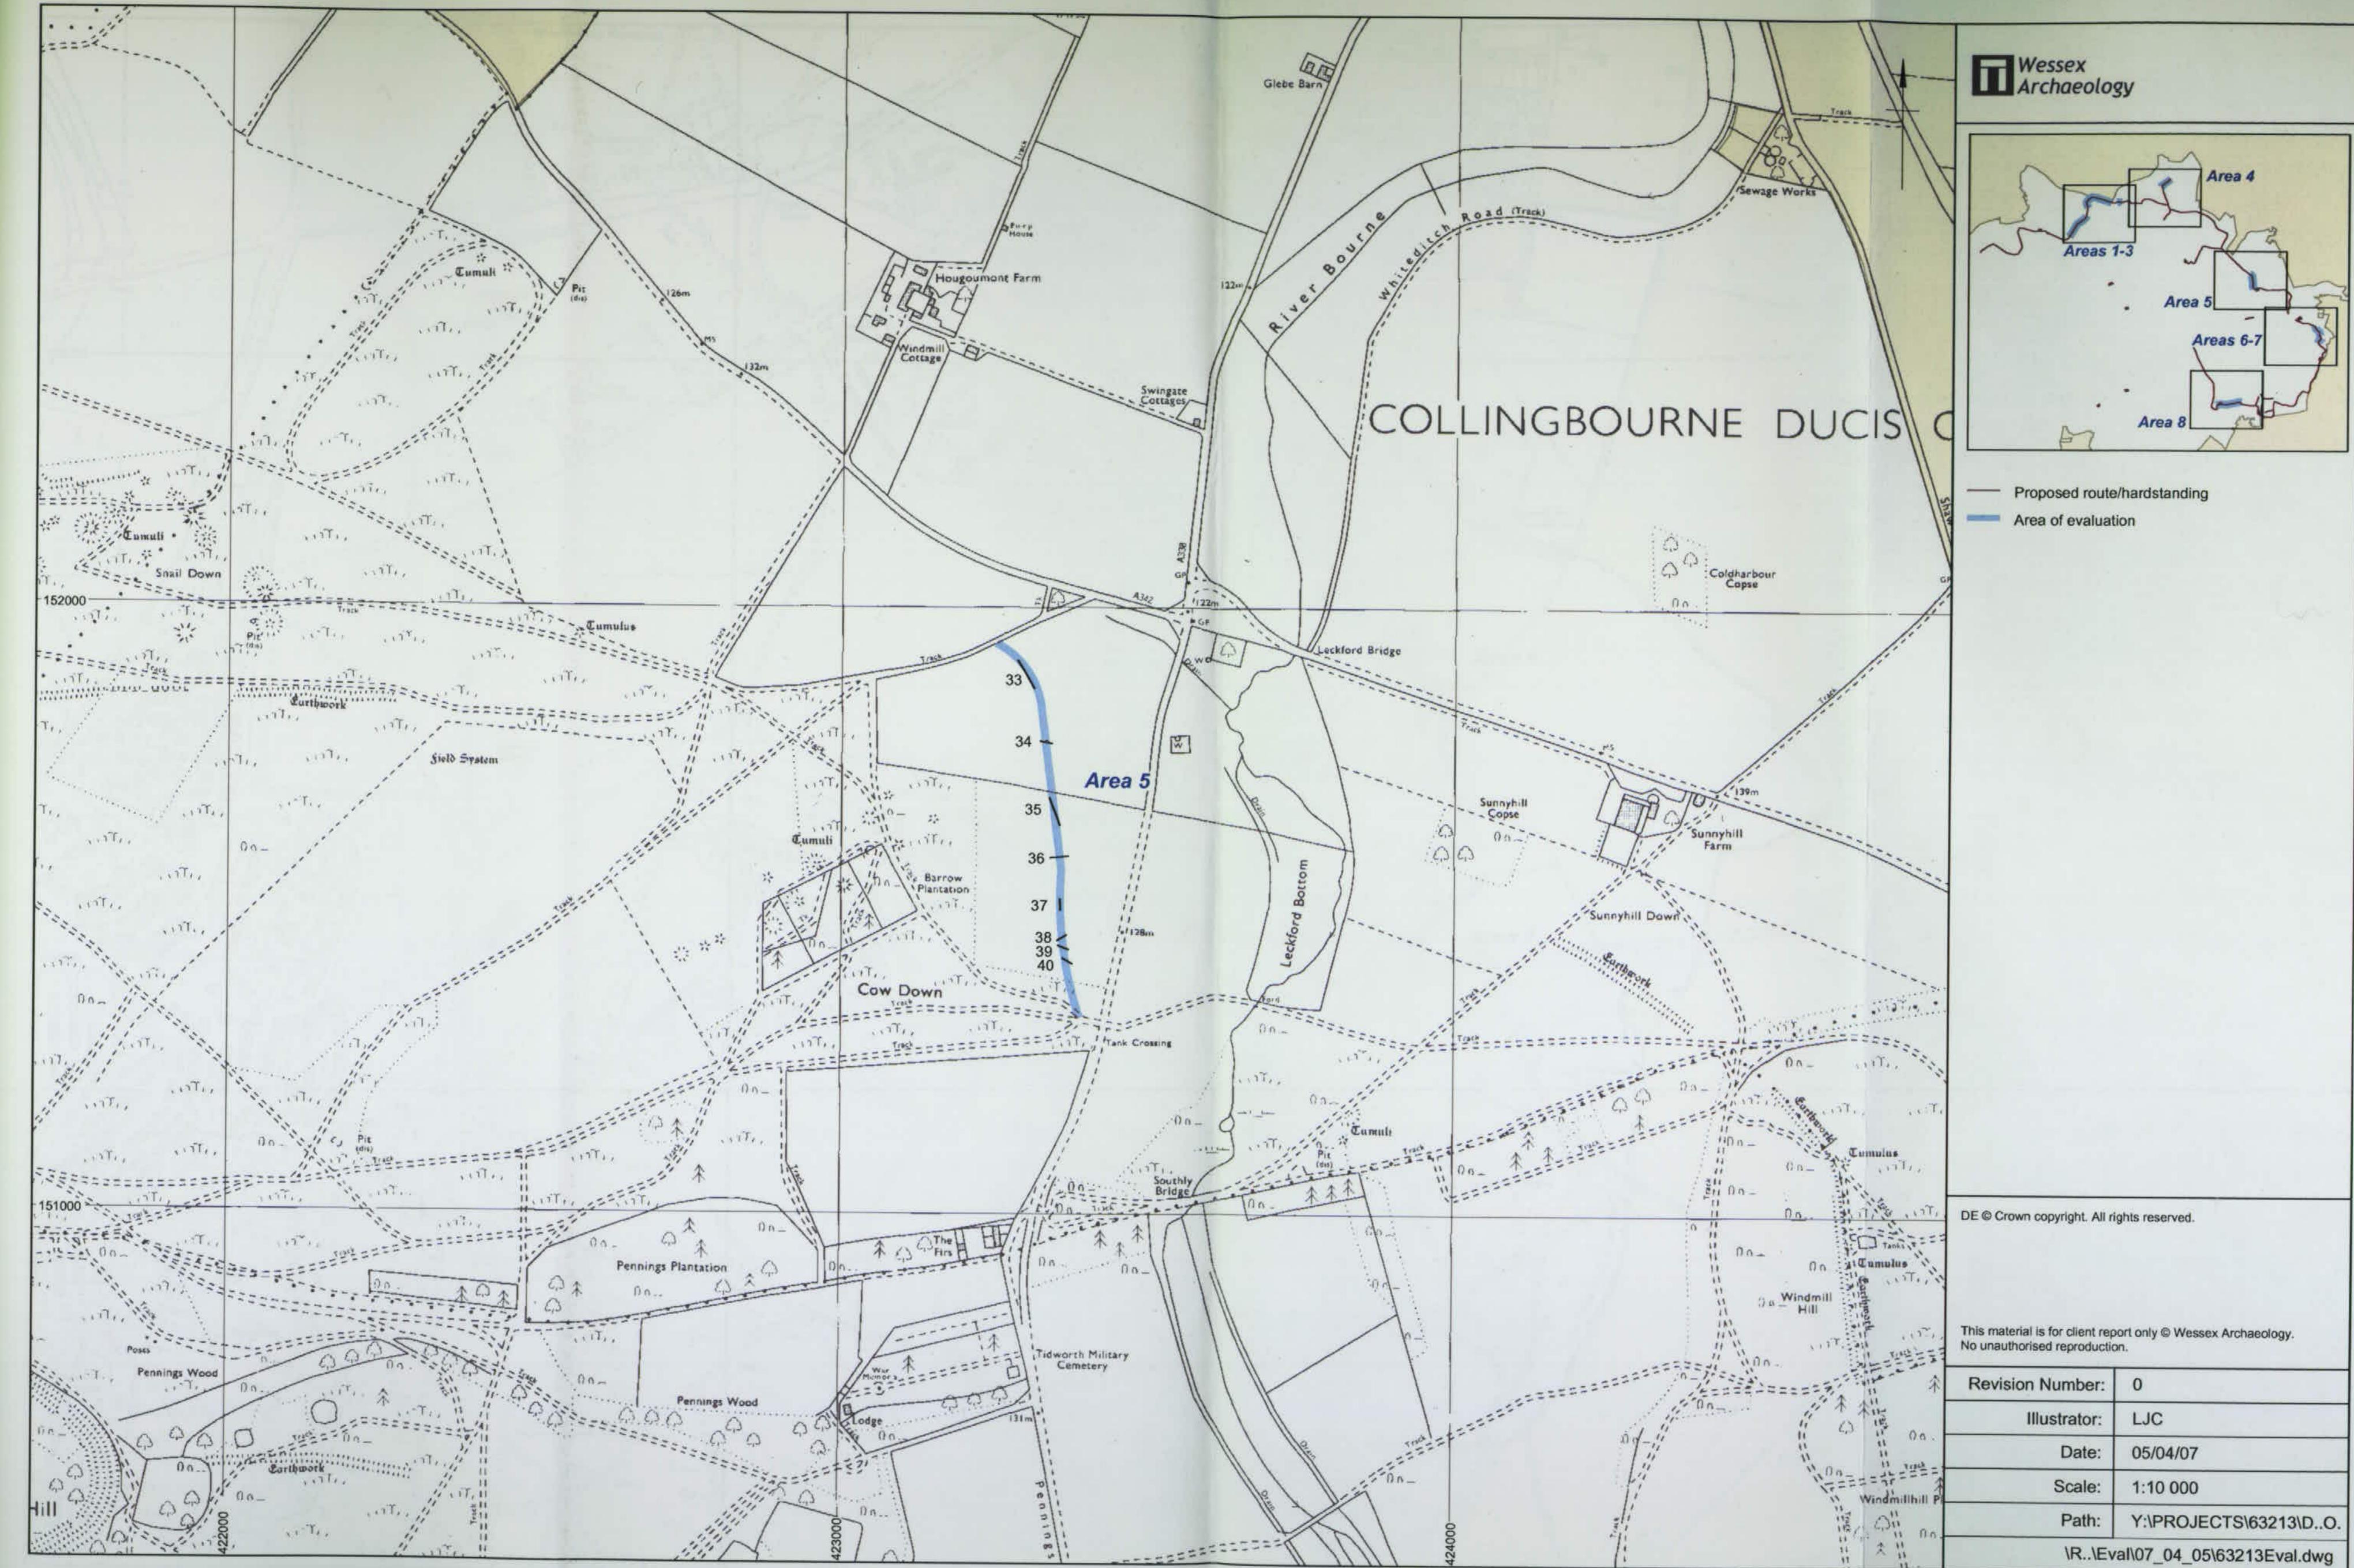
Area 5 Trench locations

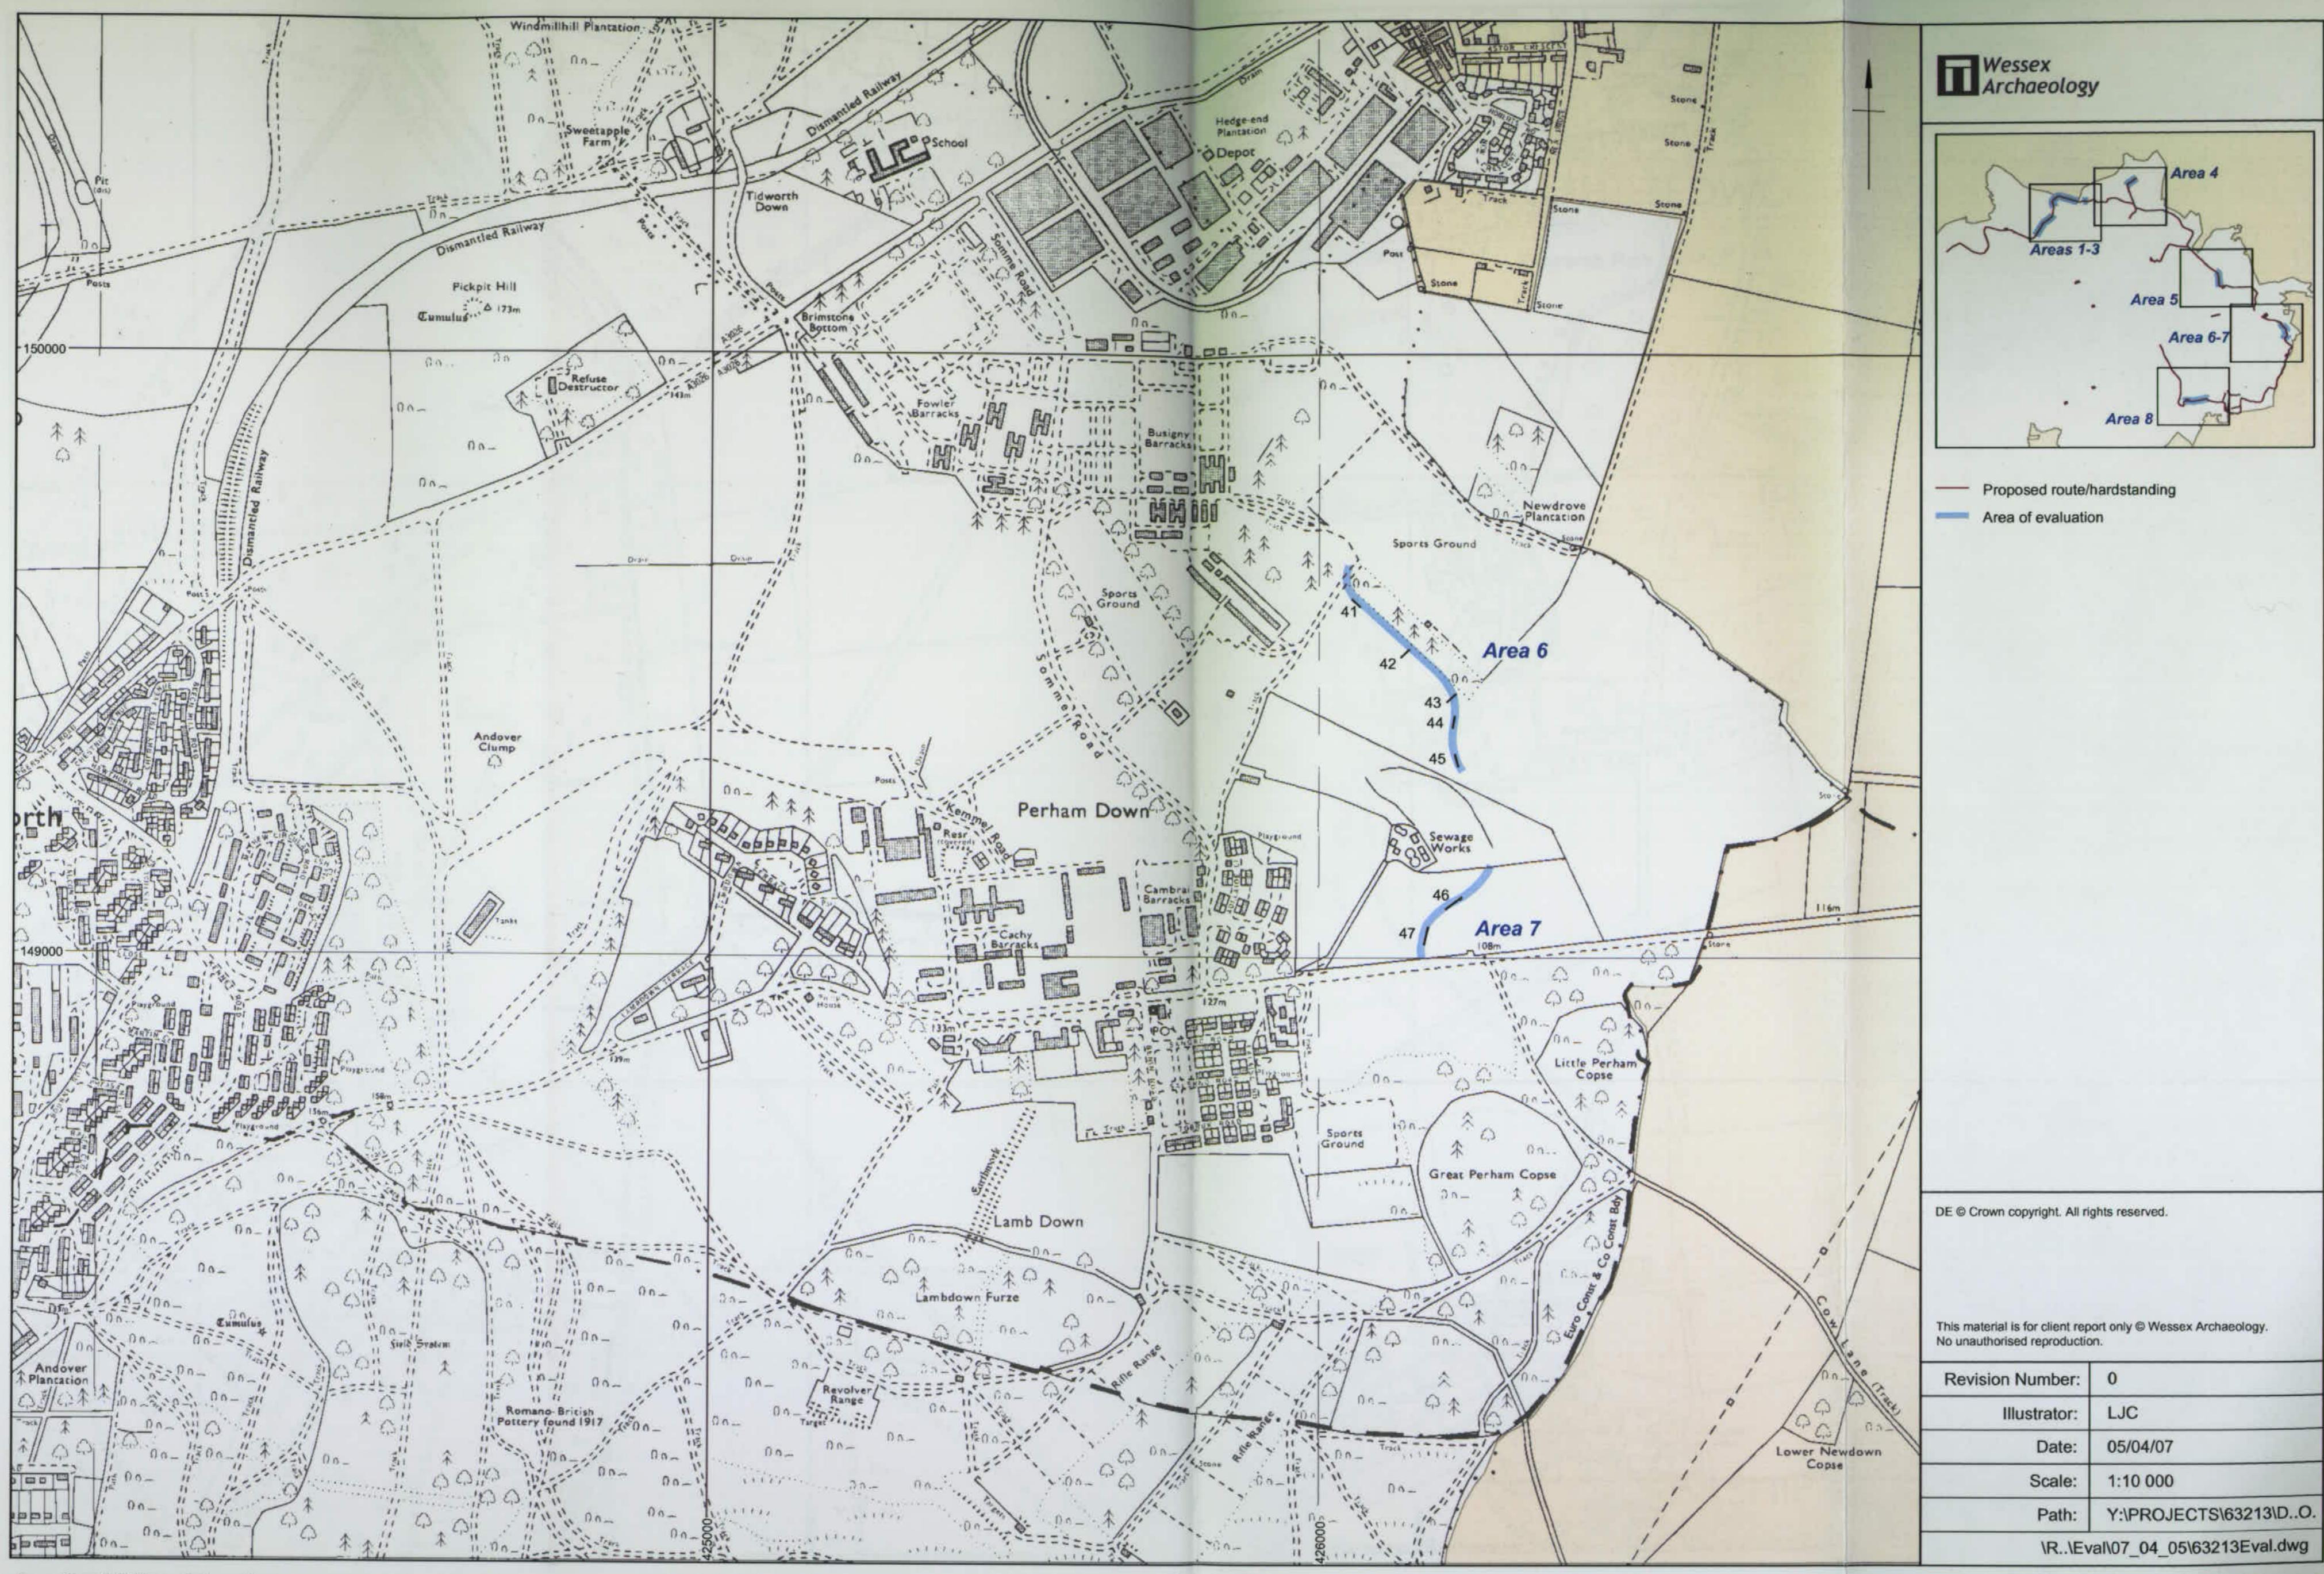
Figure 5

Area 6 and 7 Trench locations

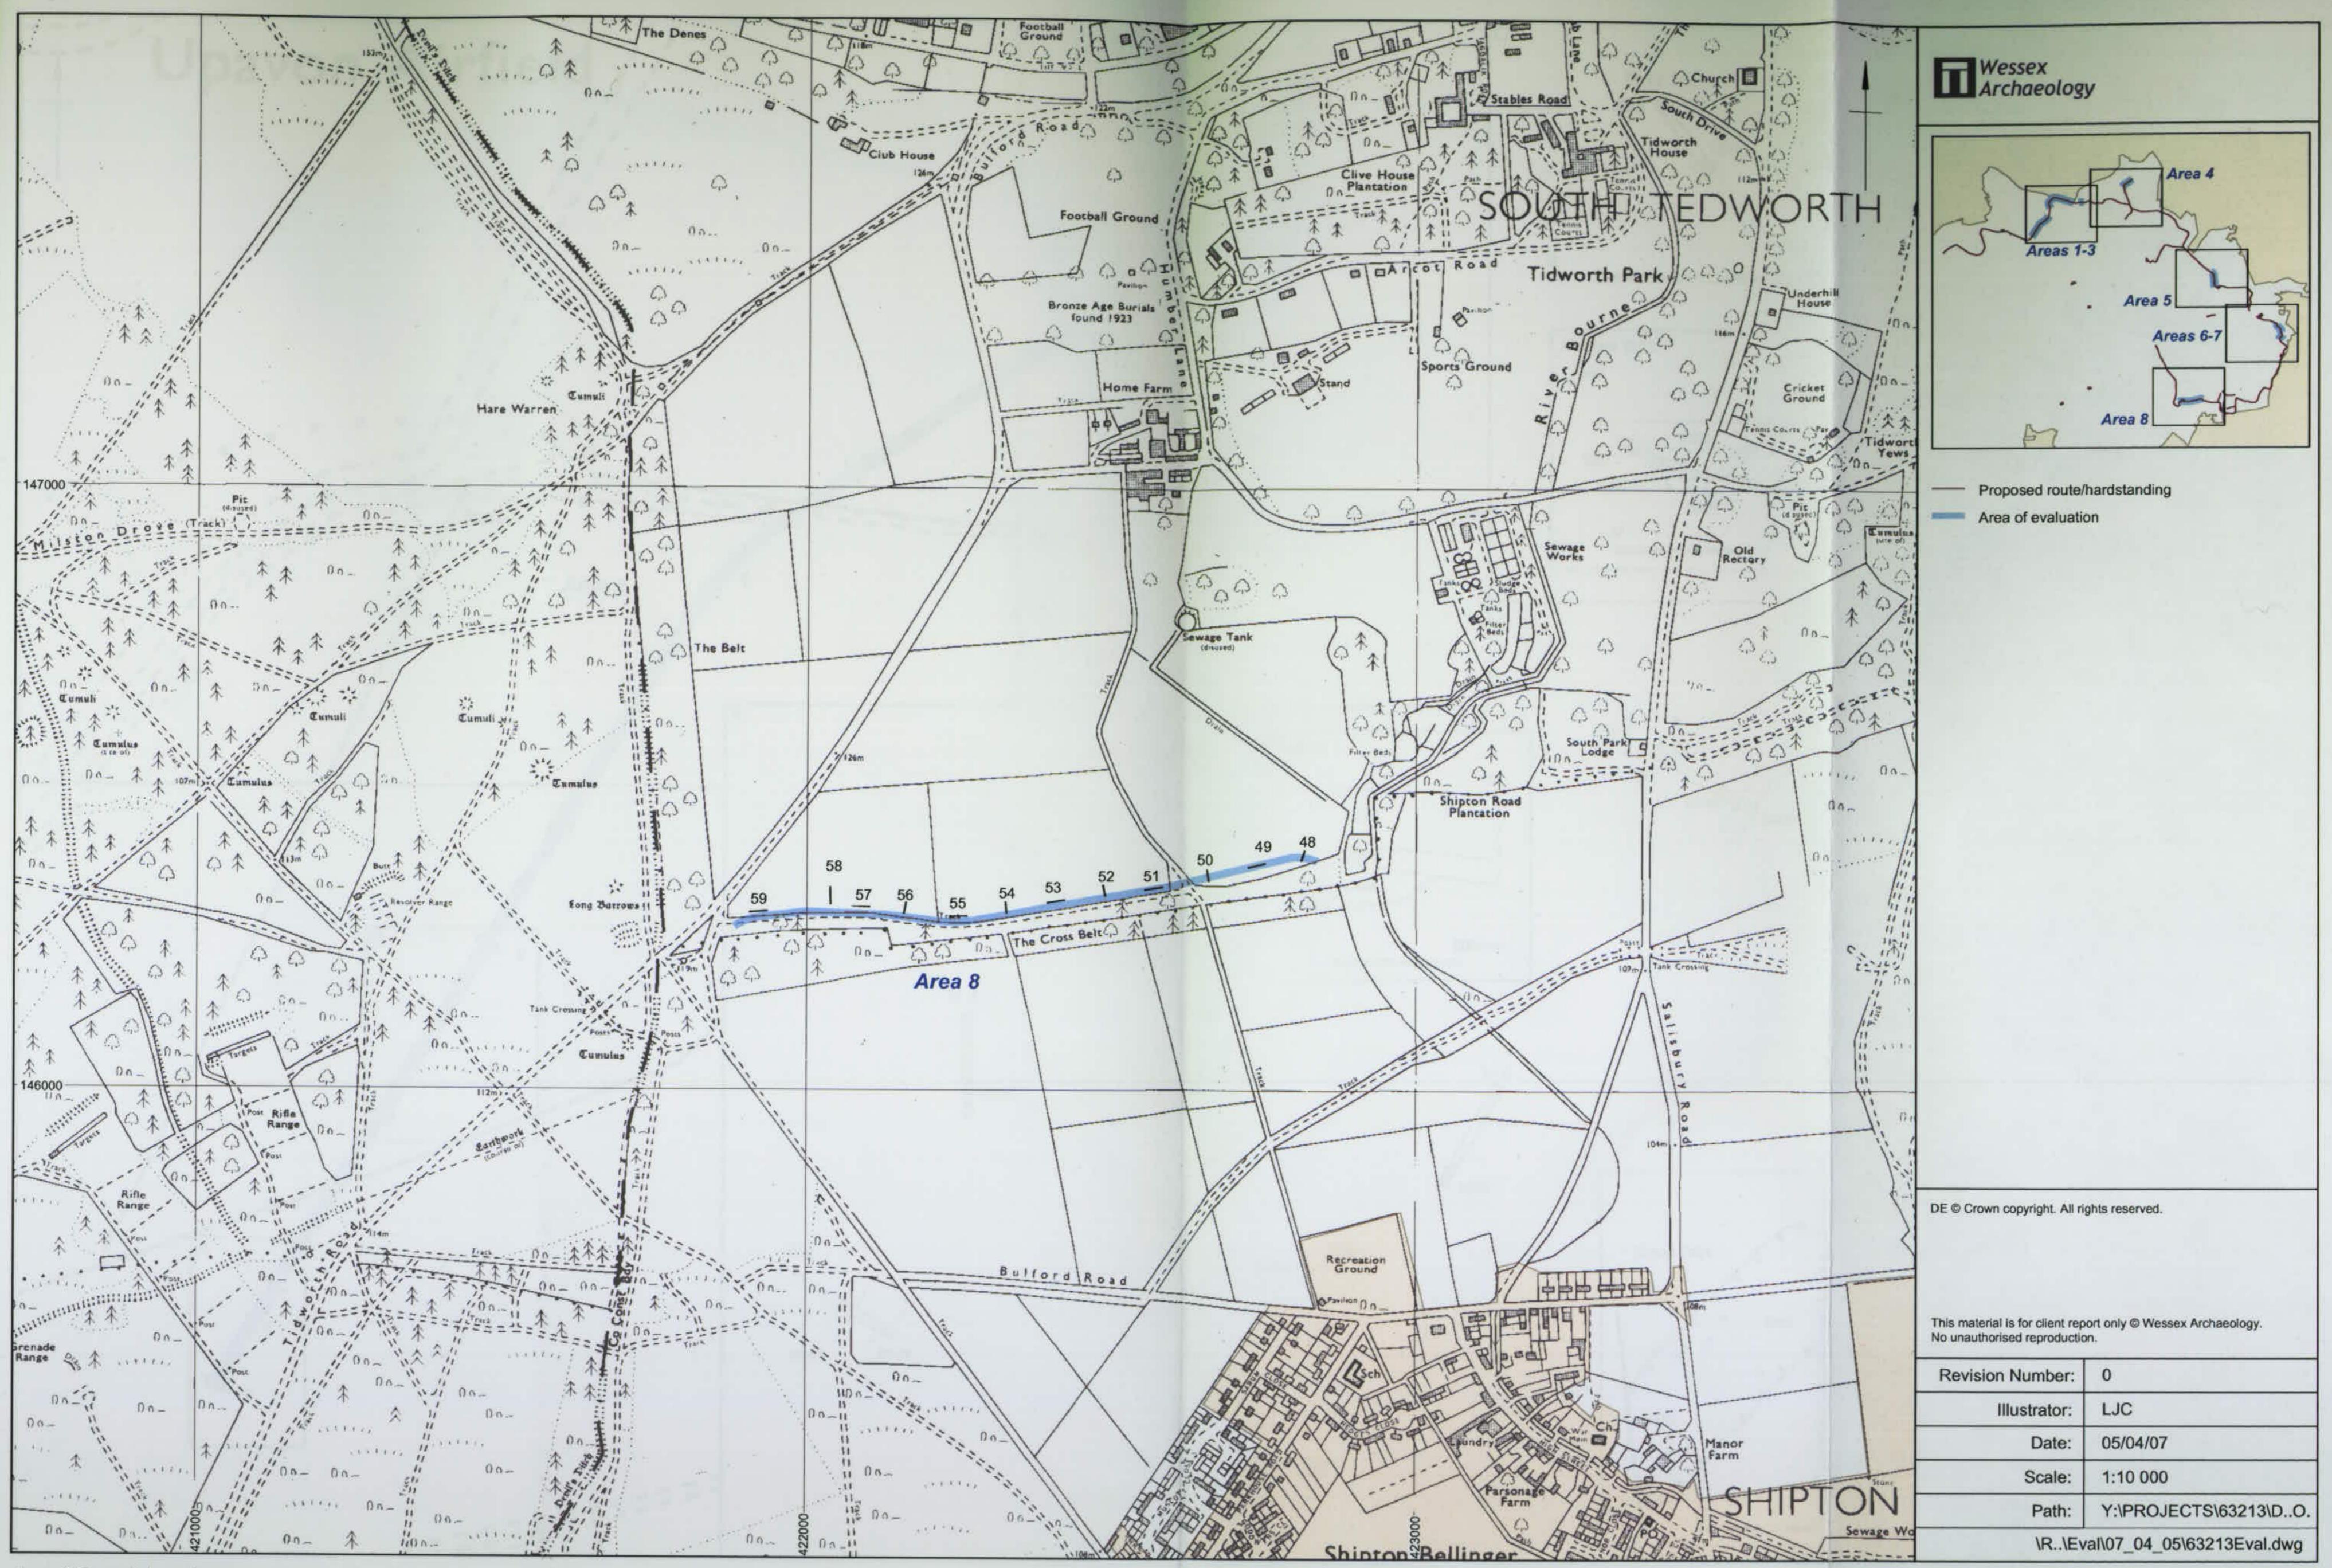
Figure 6

Area 8 Trench locations
